## **MARINE SAFETY ALERT**

Safety Alert 05-25-CH1

## **IMPORTANCE OF ADHERING TO HOT WORK PROCEDURES & IMPLEMENTING ROBUST LOCKOUT/TAGOUT PROGRAMS**

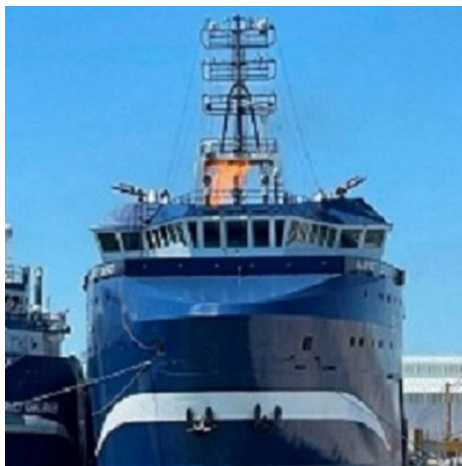
The Coast Guard's investigation revealed that two crewmembers were conducting hot work in a known hazardous zone on the air castle deck of a tri-fueled vessel (LNG, diesel, battery). The hot work was being conducted in an area that should have been avoided as the vessel was using LNG as a fuel source at the time. Coast Guard investigators suspect that a malfunctioning actuator for the engines' purge valve subsequently vented methane vapors into the hot work area. Unaware of the vapors, a crewmember struck a lighter, igniting the methane and resulting in severe burns and a fire onboard.

Figure 2. Image of fire on air castle deck

The International Code of Safety For Ships Using Gases or Other Low-Flashpoint Fuels (IGF Code) section 18.7.1 requires *“Hot work in the vicinity of fuel tanks, fuel piping and insulation systems that may be flammable, contaminated with hydrocarbons, or that may give off toxic fumes as a product of combustion shall only be undertaken after the area has been secured and proven safe for hot work and all approvals have been obtained.”* Although the IGF Code was not specifically applicable to this vessel at the time of the incident, it is highly recommended that this prescriptive requirement be taken into consideration on all vessel's operating with LNG as a fuel source. The crewmembers in this incident performed hot work in the area without applying lockout/tagout procedures, as described in the IGF Code.

- **Review and Implement Lockout/Tagout Procedures.** Ensure LNG systems are tagged out before conducting any hot work in or near hazardous areas. Crewmembers must verify the lockout/tagout status of the system before beginning work.

- **Develop Multi-Fuel System Procedures.** Establish procedures to ensure all crewmembers are aware of the additional hazards posed by multi-fuel systems, with a clear focus on what work is permissible based on the active fuel type.
