## **MARINE SAFETY ALERT**

Safety Alert 05-25

## **IMPORTANCE OF ADHERING TO HOT WORK PROCEDURES & IMPLEMENTING ROBUST LOCKOUT/TAGOUT PROGRAMS**

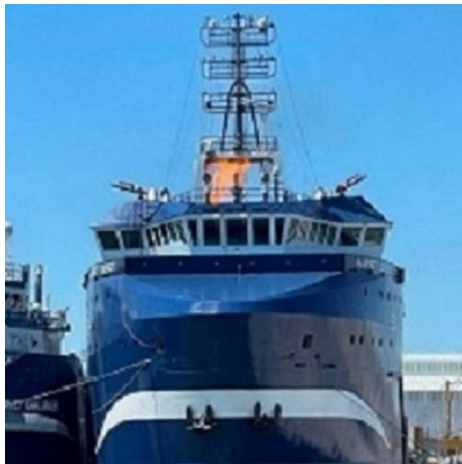
The Coast Guard's investigation revealed that two crewmembers were conducting hot work in a known hazardous zone on the air castle deck of a tri-fueled vessel (LNG, diesel, battery). Unaware that the vessel was currently using LNG as its fuel source, the crew initiated hot work in an area they would have otherwise avoided had they known about the active fuel source being used at the time. Compounding this risk, the actuator for the engines' purge valve malfunctioned, causing methane vapors to vent into the hot work area. Mistaking the area as being gas-free, the crewmembers struck a lighter, igniting the methane and resulting in severe burns and a fire onboard.

Figure 2. Image of fire on air castle deck

- **Review and Implement Lockout/Tagout Procedures.** Ensure LNG systems are tagged out before conducting any hot work in or near hazardous areas. Crewmembers must verify the lockout/tagout status of the system before beginning work.

- **Develop Multi-Fuel System Procedures.** Establish procedures to ensure all crewmembers are aware of the additional hazards posed by multi-fuel systems, with a clear focus on what work is permissible based on the active fuel type.
