MARINE SAFETY ALERT

Safety Alert 06-25

BOW SEATING EJECTION HAZARD

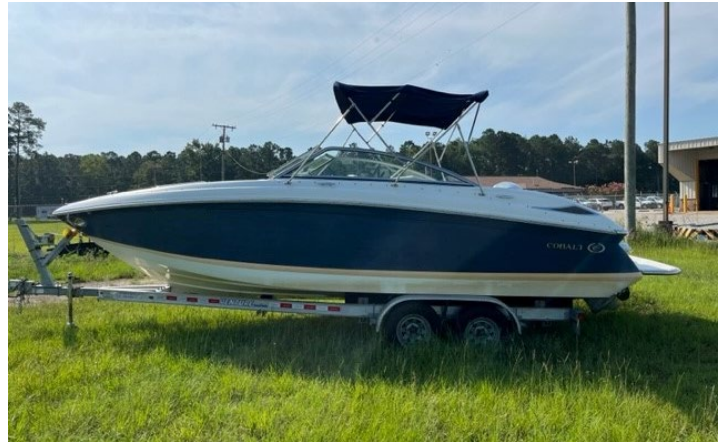
This Safety Alert addresses the dangers identified for passengers seated at the bow of bow rider style vessels, while the vessels are on plane or in rough sea conditions. A 23-foot Cobalt bow rider style recreational vessel was underway with 12 passengers onboard on the Atlantic Intracoastal Waterway when it encountered a large wake created by another vessel ahead. The wake caused the Cobalt to roll severely and pitch forward, swamping the bow. Nine of the occupants were ejected. The passenger seated at the forwardmost bow seat was subsequently struck by the vessel's propeller and killed. A similar fatal accident occurred in July of 2022, when an overloaded 24-foot boat capsized while traveling at high speeds in the Hudson River off Manhattan with passengers seated in the bow area.

Swamping of the bow can happen quickly and without warning, even when a boat is loaded in compliance with the manufacturer's capacity plate, as in the scenario described above. The operator's judgment is crucial in considering securing access to the bow area when the vessel is operating in less than ideal sea conditions. The likelihood of the vessel experiencing unstable or erratic motion will increase with greater sea state, speed, and vessel loading conditions with passengers and gear at the bow. These circumstances, as well as individual passenger capabilities, should be considered when determining if the closure of the bow area is necessary.

The U.S. Coast Guard **strongly recommends** that operators of bow rider style vessels adhere to manufacturer's recommended occupant positions as applicable. If no manufacturer recommendations are available, operators should relocate passengers from the bow seating area to aft seats while their vessels are operating on plane, above 5 mph, or in rough conditions.

- Designate occupant positions and weight allowances for vessels operating on plane, above 5 mph, or in rough conditions. The occupant positions should be illustrated on a label aboard the boats, as well as in the owner's manual. Placards and updated owner's manuals should be distributed to existing boats.

- Establish an advisory of the hazards of using bow seats while the vessel is on plane, above 5 mph, or in rough conditions. This advisory should be posted on a label aboard the boats, as well as in the owner's manual. Placards and updated owner's manuals should be distributed to existing boats.
