**REPORT OF INVESTIGATION
INTO THE
COMMERCIAL DIVE VESSEL NIUHI
(O.N. 1093374), PASSENGER LOSS OF LIFE AT
BRASS WRECK 20 NM SOUTHEAST OF
PENSACOLA, FL ON OCTOBER 06, 2023**

MISLE ACTIVITY NUMBER: 7805561

**LOSS OF LIFE WHILE DIVING FROM THE SMALL PASSENGER VESSEL
NIUHI (O.N. 1093374) AT THE BRASS WRECK DIVE SITE, 20 NAUTICAL
MILES SOUTHEAST OF PENSACOLA, FLORIDA ON OCTOBER 6, 2023**

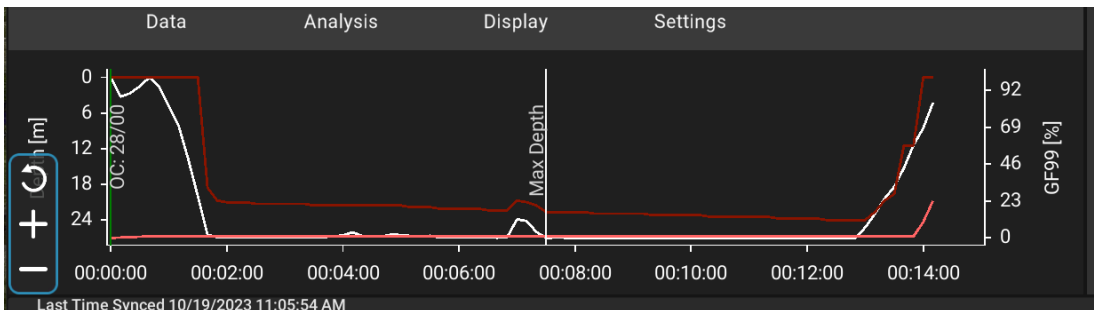
4.1.9.3. Dive 5. Passenger 1 made an initial descent to 10 feet and then briefly resurfaced for approximately 1 minute, then his body made a rapid sharp descent to 89 ft.

Figure 3: Graph of Passenger 1's fifth dive retrieved from his personal dive computer. (March 20, 2024/USCG)

- 5.2. *Lack of adherence to decompression dive time.* Recognized decompression dive tables show recommended decompression stops and surface interval time (SIT), which allow for adequate “off gassing” of inert gasses from the body. In addition, many dive experts have general guidelines for decompression, which include the 120-Rule for underwater time and the “One-Hour Golden” rule for surface time. The 120-Rule is that the depth in feet underwater and the time spent underwater should never equal to more than 120. For example, a diver can spend 60 minutes at 60 feet, 30 minutes at 90 feet, and 20 minutes at 100 feet. The “One-Hour Golden” rule is general guidance to spend one hour on the surface between each dive. Passenger 1’s Dive 1 was at 112 feet for 23 minutes and Dive 2 was 116 feet for 19 minutes. Both dives fell outside the recommendation of the decompression tables and dive expert general guidance.

According to the decompression table, Dive 2 exceeded the recommended total underwater time following Dive 1 increasing the residual nitrogen levels in Passenger 1's body for each subsequent dive. In addition, the SIT of 30 minutes between dives 4 and 5, fell outside the recommended dive table SIT. According to the Decompression Tables and Passenger 1 dive computer record, Passenger 1 was required a 55-minute SIT between dive 4 and 5 to allow for adequate "off gassing". Passenger 1's SIT of 30 minutes between Dives 4 and 5 was not adequate amount of time. If Passenger 1 adhered to the decompression table or general guidance during all his dives, specifically his final dive, he could have decreased his chances of succumbing to decompression sickness and death.

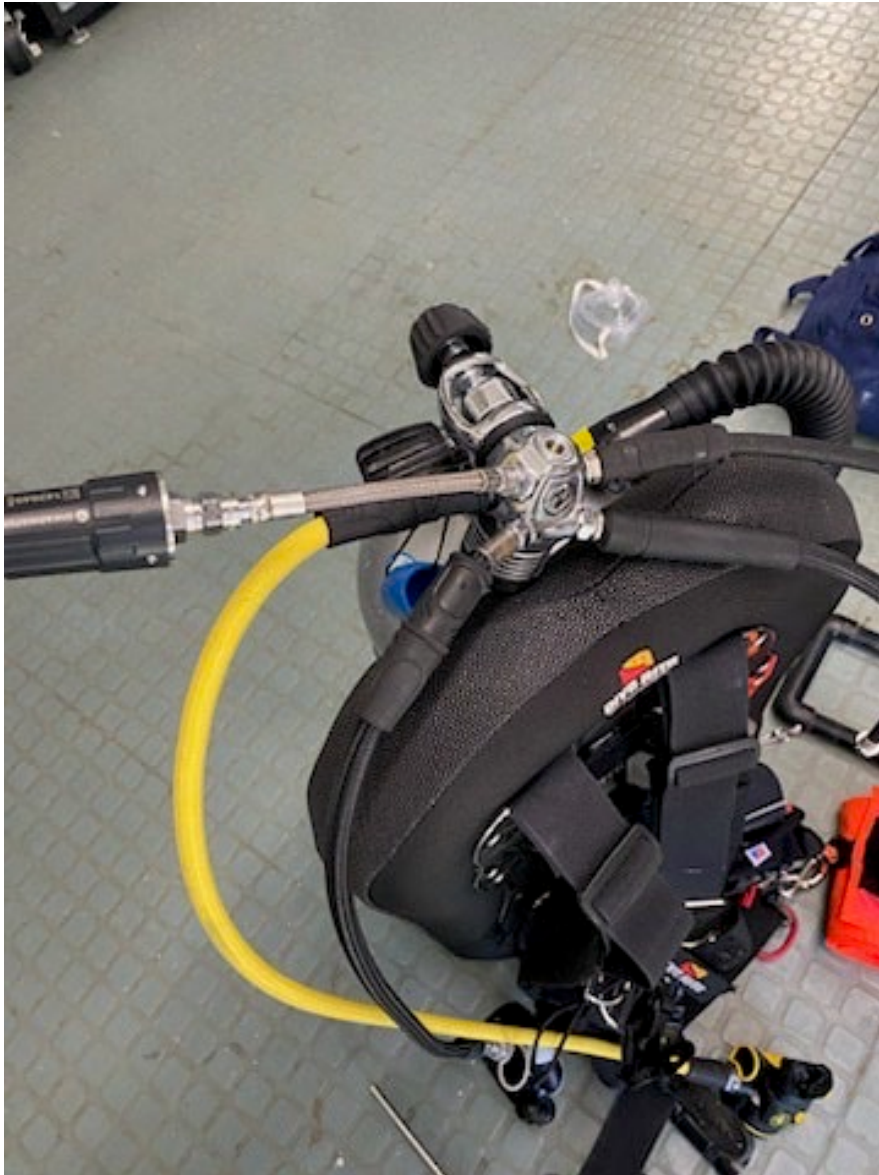
4.2.9. On October 9, 2023, Coast Guard had Dive Pros, a dive equipment inspection company, conduct an inspection on Passenger 1's Aqualung Legend Regulator and Nitrox tanks. The inspection report showed that all hoses and connections on the regulator passed the safety inspection. The inspection also showed that the Oxygen level in the tanks used during the last dive was sufficient.

Figure 4: Passenger 1's diving gear and equipment. (October 9, 2023 /USCG)

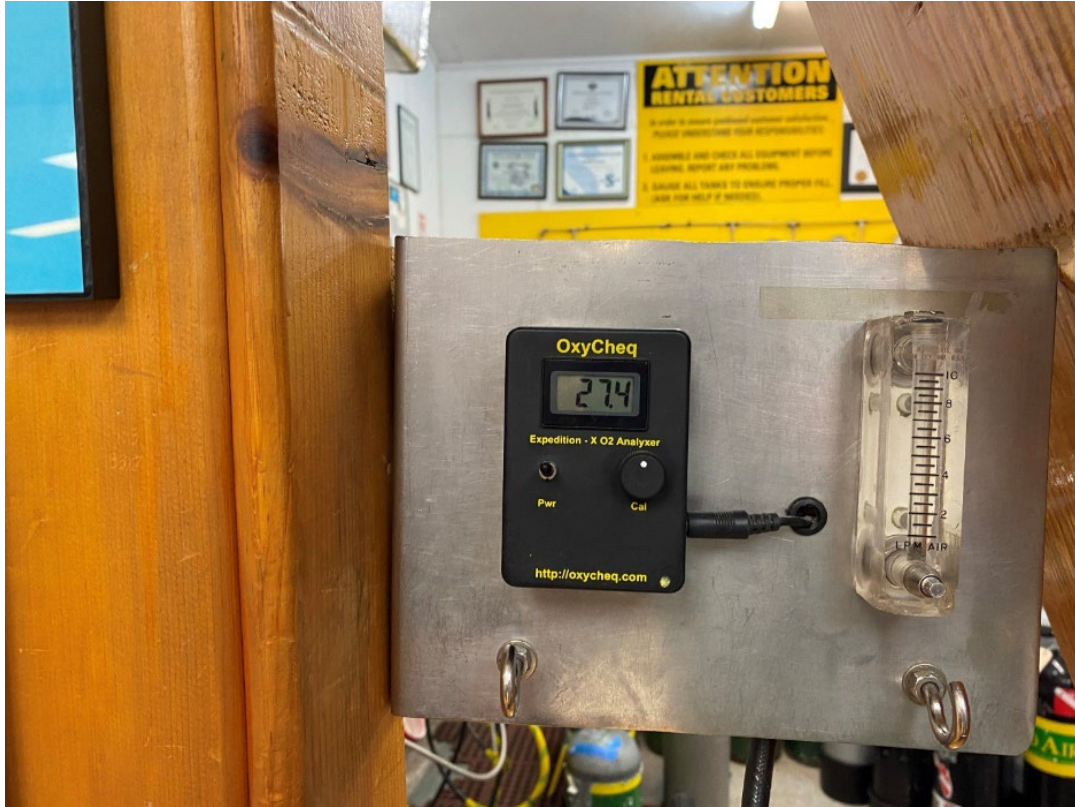
4.2.11. Passenger 1 dove with a 28% O₂ and 72% N₂ Nitrox mix bottle attached to their BCD. According to dive experts, this was considered a normal mixture.

Figure 5: Inspection of Oxygen levels in Passenger 1's diving tank. (October 9, 2023/USCG)
