# UNITED STATES COAST GUARD

## REPORT OF THE INVESTIGATION

RONNIE R (ON 1245550) AND GA6620ZT COLLISION ON THE SAVANNAH RIVER  
INVOLVING INJURIES AND LOSS OF LIFE ON AUGUST 27, 2021

MISLE ACTIVITY NUMBER: 7300444

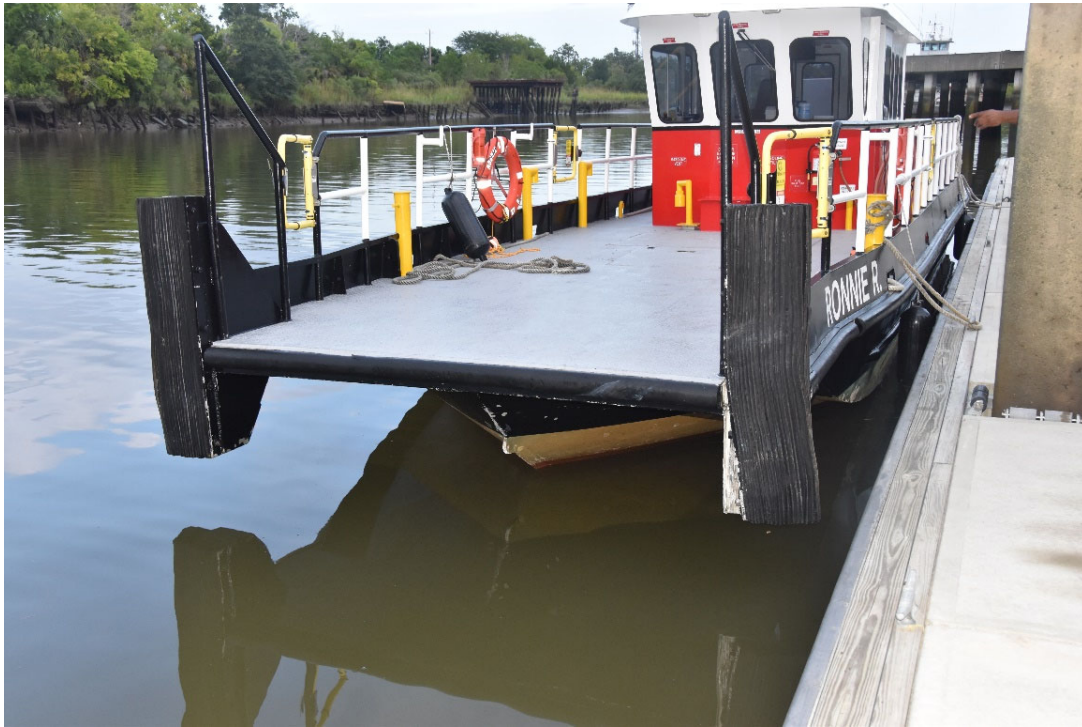
Figure 1. RONNIE R. provided by SC DNR

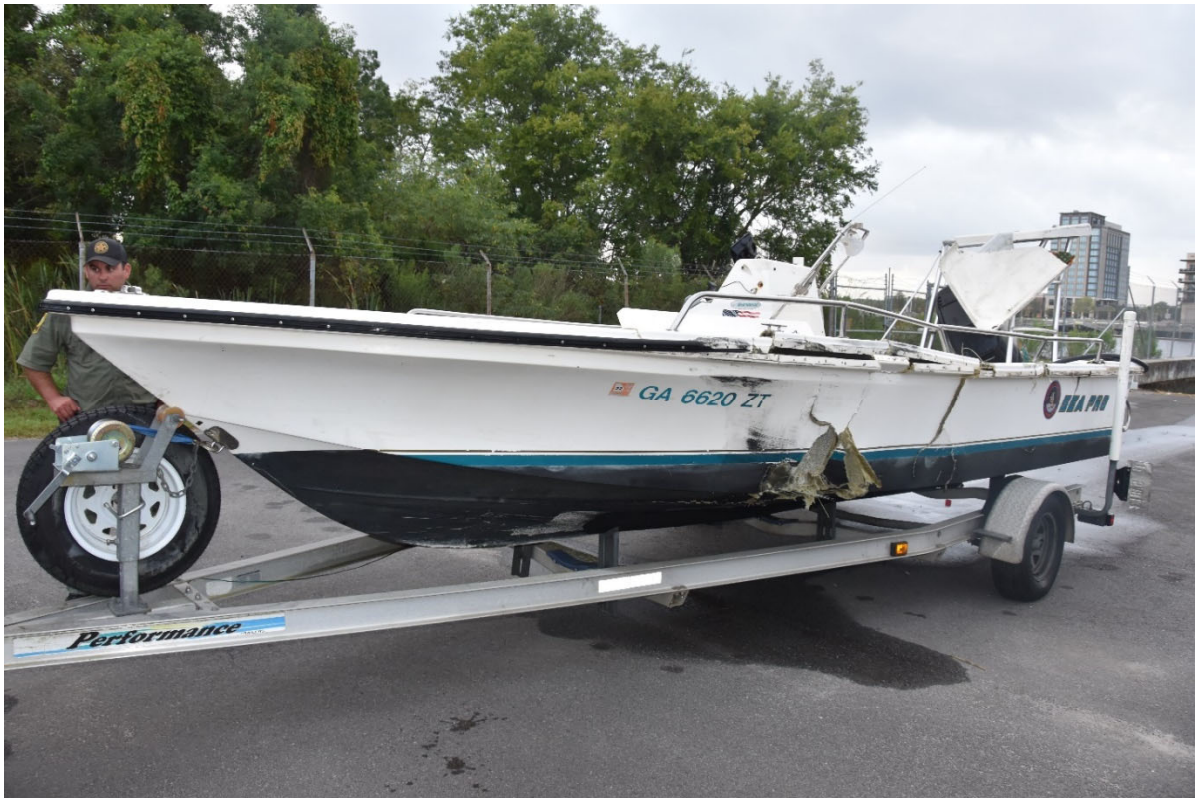
Figure 2. GA6620ZT post incident photograph taken by SC DNR

- 4.1.20. At 2106 hours, a rescued passenger on the RONNIE R called Chatham County Emergency Management Services (EMS) to report the incident.
- 4.1.21. At 2115 hours, the GA6620ZT was reported as severely damaged (See Figure 2) and capsized in the vicinity of the incident.

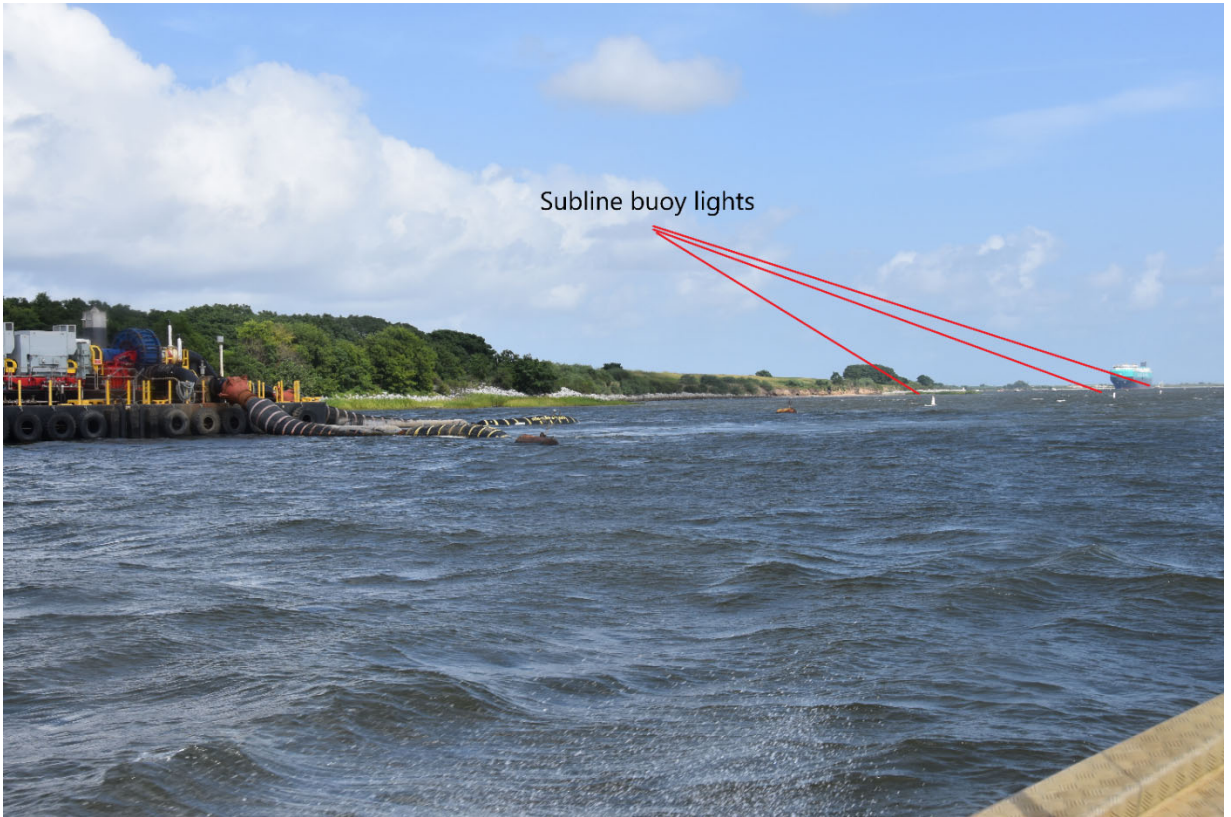
Figure 3. Subline buoy lights that were inspected the night of the incident by the RONNIE R., Buoy 40 is not pictured but located to the right of the first highlighted subline light. Booster Barge 187 is located to the left. Photograph taken by SC DNR, labels place by USCG.

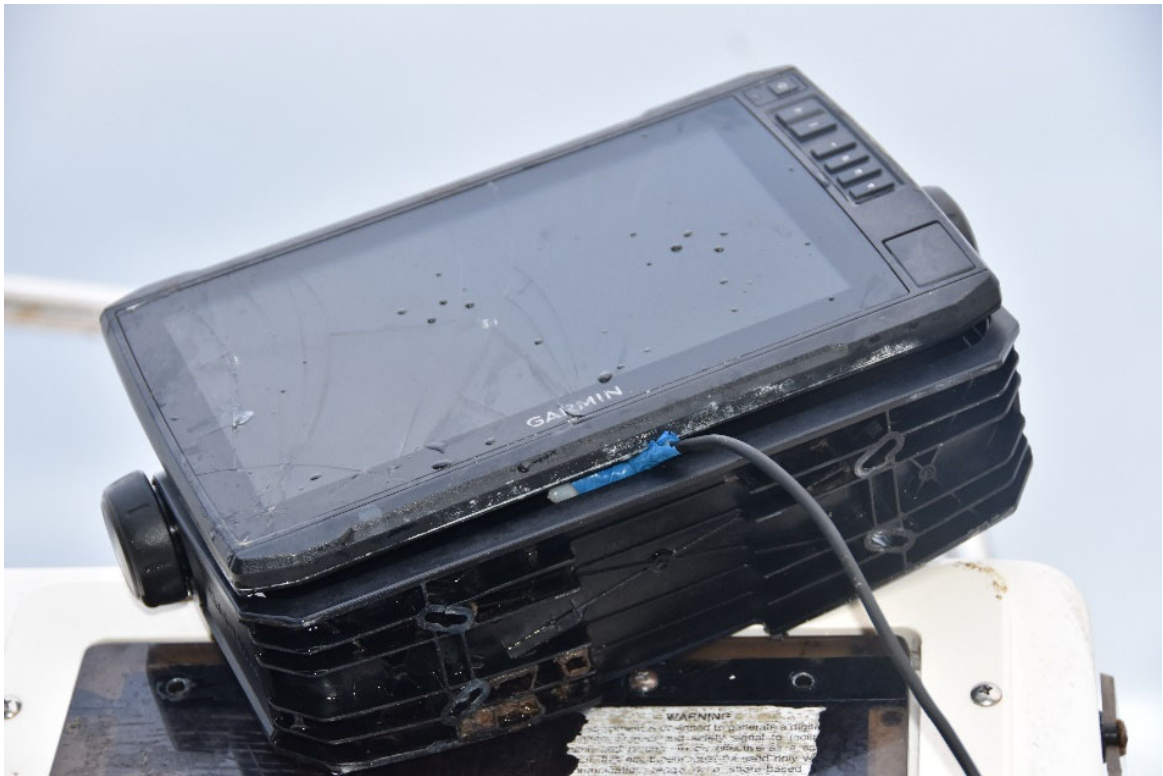
4.2.1.2. The GA6620ZT is a 21-foot center console fiberglass recreational vessel powered by one 200 horsepower outboard. The vessel was equipped with an automatic engine cut-off switch. The vessel had a Global Positioning System (GPS) Unit GARMIN model ECHOMAP Plus 93sv. The GPS was severely damaged and submerged in salt water after the incident. All attempts to extract voyage data was unsuccessful.

Figure 3. GPS from GA6620ZT. Photograph taken by SC DNR

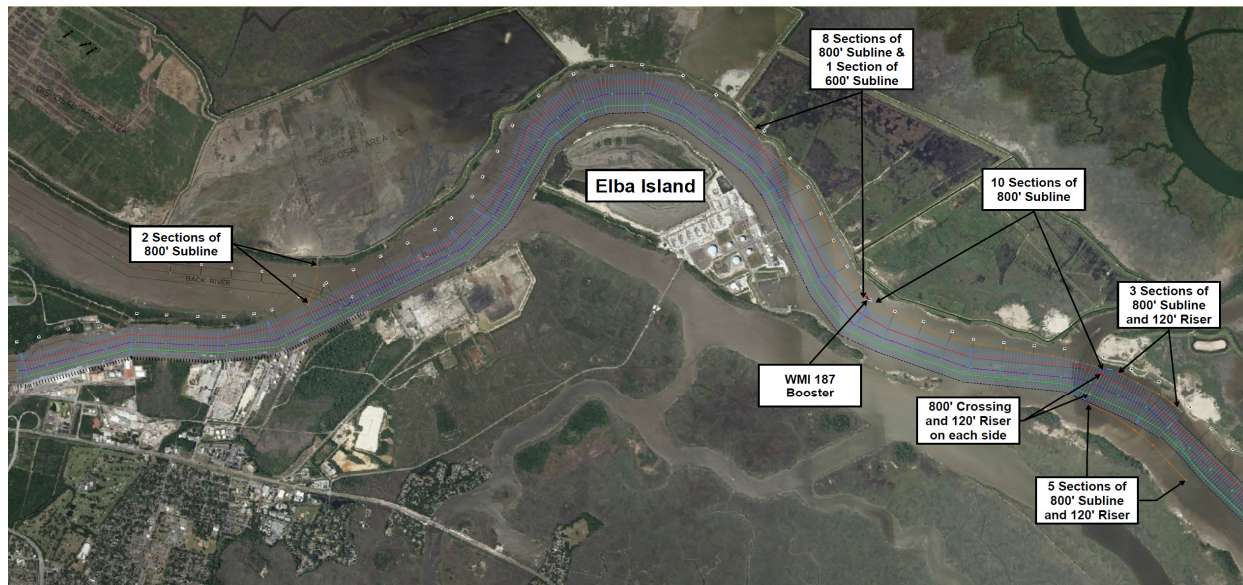
4.2.4.2. Location of Booster 187 and submerged dredge lines:

4.2.4.1. On August 2, 2021 the USCG issued a Local Notice to Mariners (LMN:31/21) informing mariners of the following: “Weeks Marine has placed a submerged pipeline on the North side of the Savannah River Channel between Barnwell Island Flats Lighted Buoy 50(LLNR 4970) and Long Island Crossing Range Lighted Buoy 32 (LLNR 4815). The submerged pipeline will remain and not be removed until the completion of dredging operations. All dredged material will be pumped using a combination of floating and submerged line to the assigned disposal area. Continuing until approximately December 25, 2021 the hydraulic dredge J.S. CHATRY and attendant plant will be operating between Long Island Crossing Long Island Crossing LB 33 (LLNR 4820), and Tybee Knoll Cut Range Lighted Buoy 21 (LLNR 4735). Weeks 187 ELECTRIC BOOSTER will be located approximately 1000 feet upstream of Elba Island Lighted Buoy 40 (LLNR 4855). Work limits for dredging operations along the Savannah River Channel will be bound by the following approximate positions: Tybee Knoll Cut Range Lighted Buoy 21 (LLNR 4735) approximate position: 32-02-05.33N / 80-52-23.04W, and ACL TURNING BASIN LIGHT 60 (LLNR 5020) approximate position: 32-04-52.182N / 81-04-14.644W. Dredging operations will continue 24/7. The dredge will monitor VHF-FM Channels 13 and 16. Mariners are urged to use extreme caution and transit the area at their slowest safe speed to create minimum wake after passing arrangements have been made.”

Figure 4. Booster location and subline provided by USACE, labels placed by USCG.

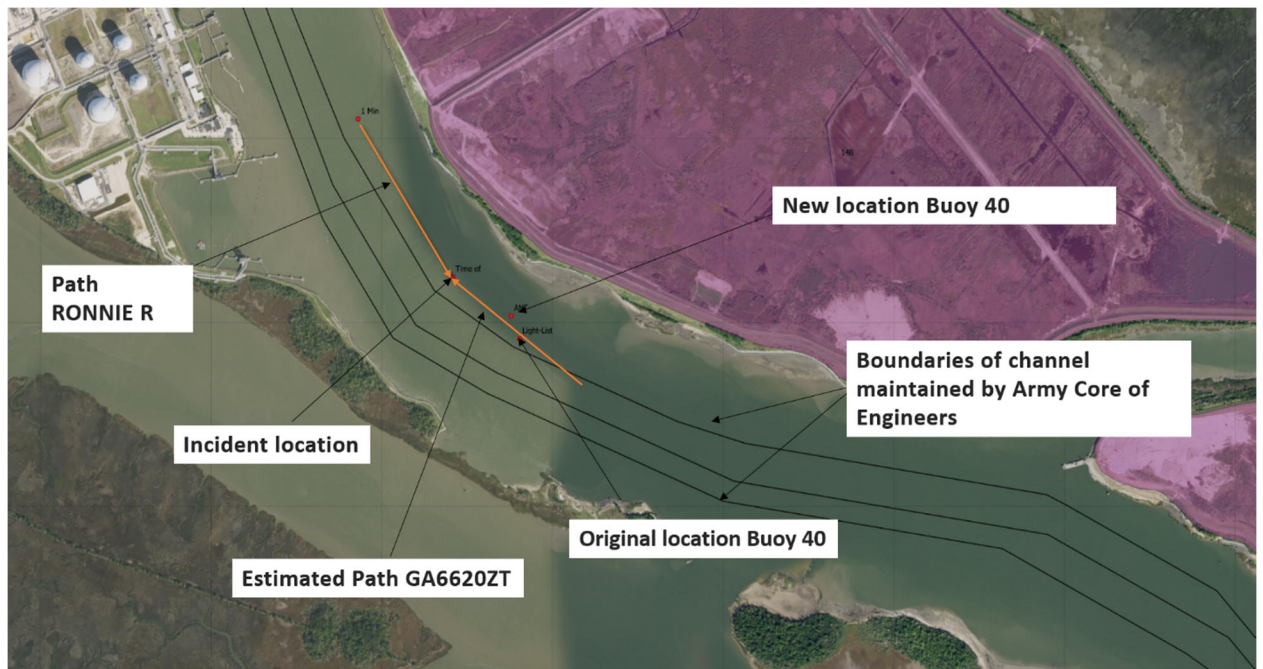
4.2.4.3. Aids to Navigation, Elba Island Lighted Buoy 40:

4.2.4.3.1. Aids to Navigation (ATON) are structures utilized by mariners to determine positions and safe courses. The locations of ATONs are shown on published nautical charts, USCG published light list, and most marine GPS systems. On November 10, 2020, Weeks Marine was authorized by USCG District 7 Waterways Management Division to move Buoy 40 from its original published location at 32 04

40.979N, 080 58 49.219W to 32 04 43.436N, 080 58 50.330W in preparations for dredging operations. Weeks Marine stated in their request that they would move the buoy back to its original location in a few days and notify the USCG once it was completed. On November 15, 2020, Weeks Marine emailed the USCG stating they successfully moved Buoy 40 to the temporary location and would return it to its original location once the dredge surveys were conducted which was scheduled to be completed as early as November 16, 2020. The Buoy was not moved back to its original location until after the incident on August 27, 2021. Although required by USCG policy (COMDTINST 16500.7A), the temporary location was not published in the Local Notice to Mariners.

Figure 5. Location of Buoy 40, overlay provided by USACE, labels placed by USCG.

6.7.2.1. The USCG maintains the ATON system to assist mariners in the process of navigation. In accordance with 33 CFR Subpart 62.21, "The Coast Guard makes reasonable efforts to inform the navigator of known discrepancies, and to correct them within a reasonable period of time, depending upon resources available. Occasionally, a temporary aid to navigation, which provides different but similar service, is deployed until permanent repairs can be made to the original aid. Notification of such temporary changes is made through the notice to mariners' system." In November of 2020, Buoy 40 was moved by Weeks Marine from its published location and although Weeks Marine stated in an email dated November 15, 2020, they would move Buoy 40 back to its original location as early as November 16, 2020, it was not moved back until after the incident. Additionally, the USCG did not make the required notice to the public per the USCG Aids to Navigation Manual Administration COMDTINST 16500.7A when Buoy 40 was moved to its temporary location on November 15, 2020.

8.1.1. Safety Recommendation 1: Recommend Aids to Navigation and Position, Navigation, and Timing Division (CG-NAV-1) develop and implement procedures to ensure USCG Aids to Navigation Manual Administration COMDTINST 16500.7A is followed during and after the temporary movement of Aids to Navigation on the navigable waterways of the United States. Additionally, revise the Memorandum of Understanding between the USCG and USACE titled Interagency Coordination of Aids to Navigation Needs at USACOE Navigation Projects, (in effect as of June 13, 2013) to include additional funding to the USCG to assist with the temporary movement of ATON during dredging operations.

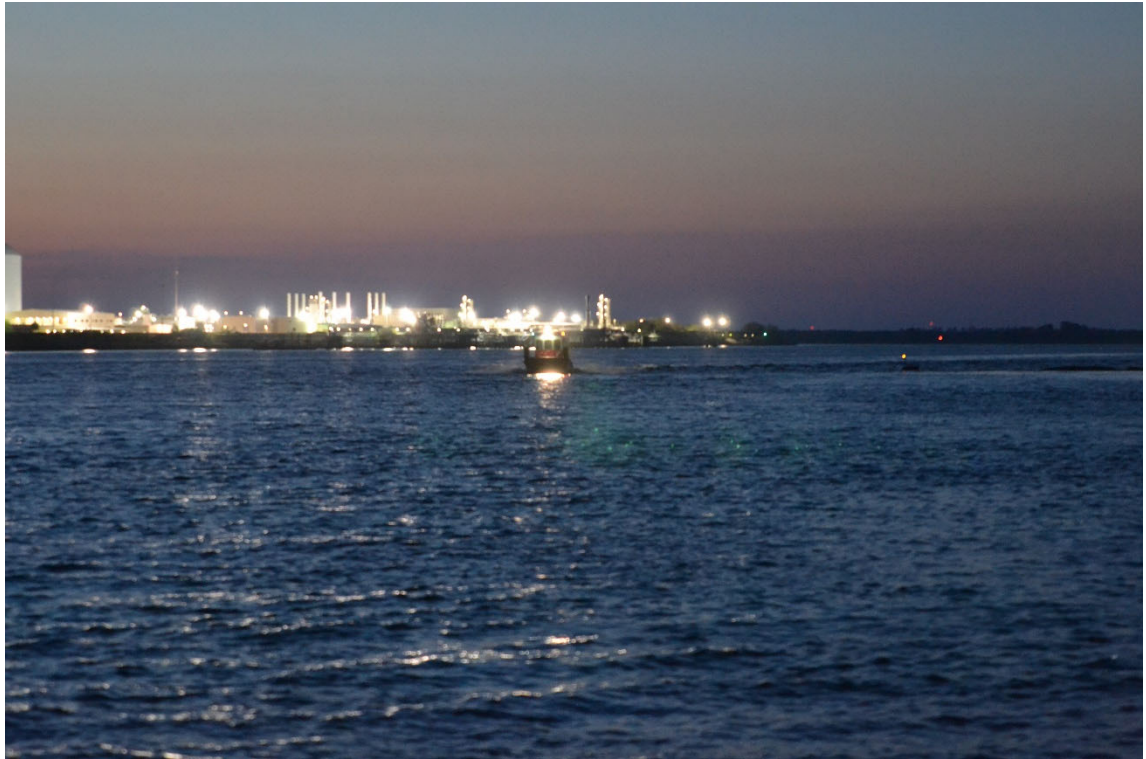
4.2.5.1. Two passengers on the recreational vessel stated they did not observe navigation lights on the RONNIE R prior to the collision. The Master of the RONNIE R stated the navigation lights were energized and USCG Investigators observed the next morning that the navigation lights were operable. On September 29, 2021, USCG Investigators re-created the conditions of the incident by observing the RONNIE R on the same approach it took the night of the incident. Multiple runs by the RONNIE R were conducted including one at sunset and one at twilight. Runs were also completed with the RONNIE R's spotlight on and off. USCG Investigators made the observations from a USCG vessel drifting at the approximate location of the GA6620ZT the night of the incident. See figures 6, 6b, 7 and 7b.

Figure 6. Photograph of RONNIE R. approaching buoy 40 approximately 8 minutes after twilight end with spotlight energized during the re-creation of the incident. Note: Lighting enhanced due to advanced camera lens taken by USCG Investigator.

5.6.1. The RONNIE R had a spotlight energized above the operating station between its navigation lights at the time of the incident in violation of Rule 20. During a reenactment by USCG Investigators of the path the RONNIE R traveled on the night of the collision, it was noted that the lighting at a nearby facility could make the navigation lights of approaching vessels difficult to observe. Additionally, the RONNIE R's spotlight was energized for inspection of the subline buoy lights, this further impaired the visibility of its required navigation lights as indicated in Figures 6, 6b, 7, and 7b.

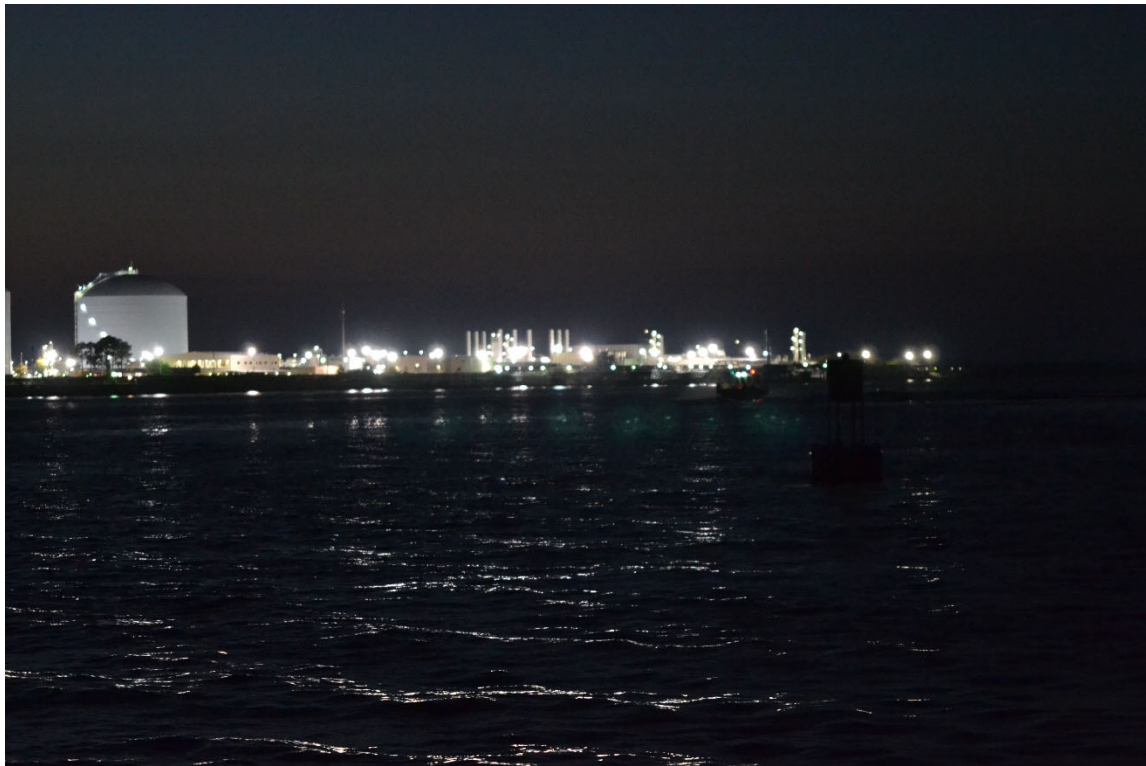
Figure 7. Photograph of RONNIE R. approaching buoy 40 approximately 15 minutes after twilight end. Note: Unenhanced photograph taken by USCG Investigator.

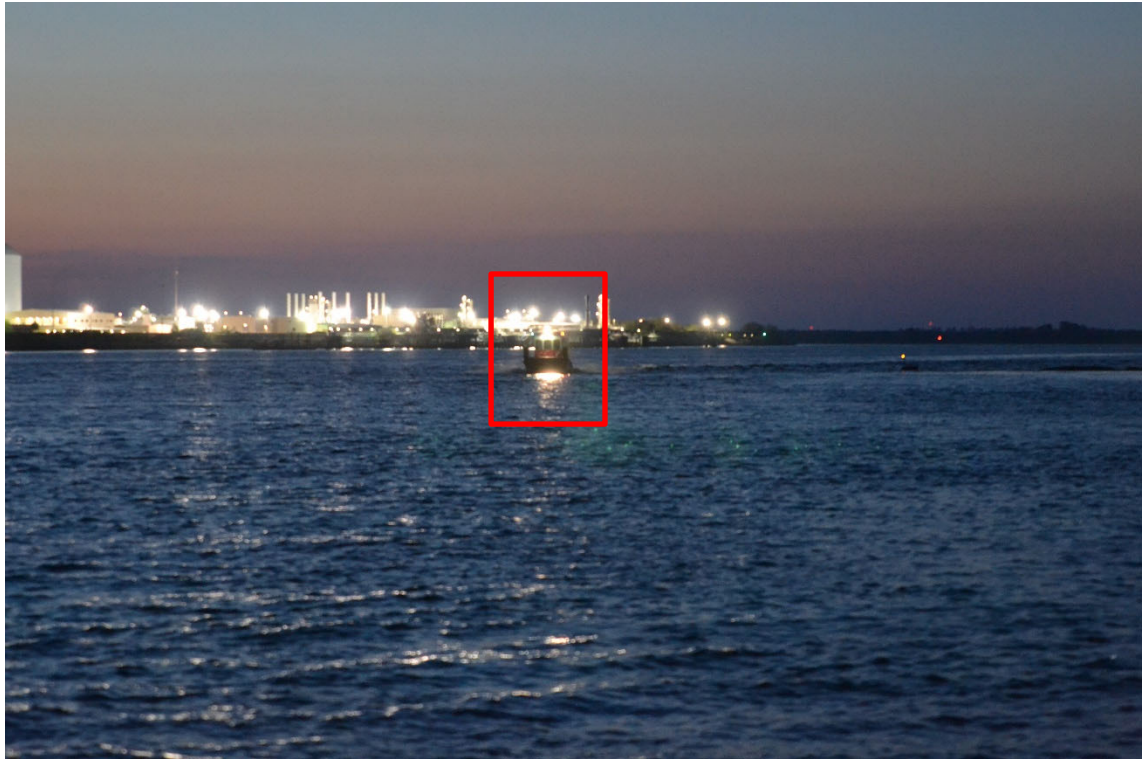
Figure 6b. RONNIE R. highlighted in red box. Note: Background light are from waterfront facility. Photograph taken by USCG Investigator.

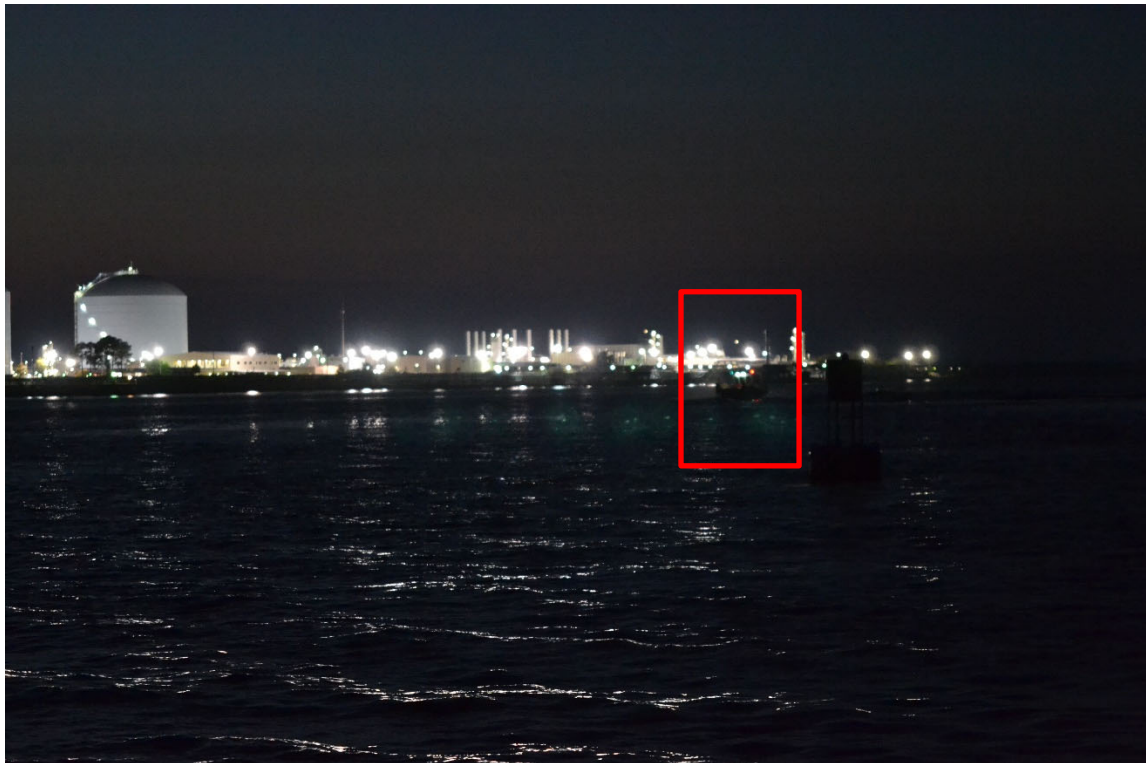
Figure 7b. . RONNIE R. highlighted in red box. Photograph taken by USCG Investigator.

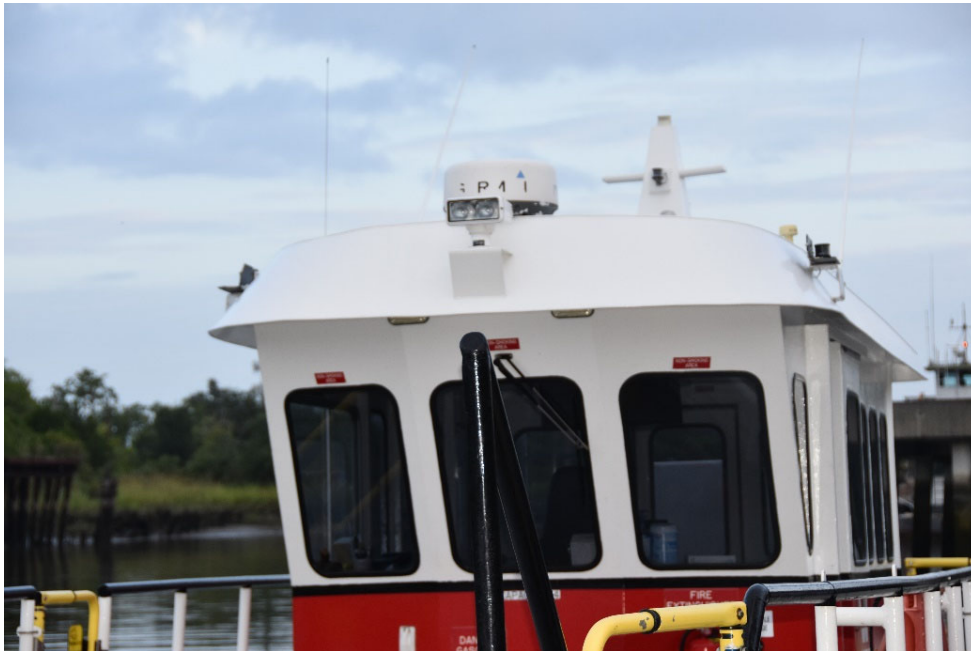
Figure 8. Spotlight used by master of RONNIE R. to inspect subline lights, taken by USCG.
