**REPORT OF THE INVESTIGATION
INTO THE
SURE SHOT (O.N. 978662) COLLISION
WITH AN UNIDENTIFIED VESSEL, 16
NAUTICAL MILES SOUTH OF
SHINNECOCK, NY, IN THE ATLANTIC
OCEAN, WITH THE LOSS OF ONE LIFE,
ON OCTOBER 12, 2022**

16732/IIA #7577027
25 March 2025

**COLLISION OF THE RECREATIONAL VESSEL SURE SHOT (O.N. 978662) WITH
AN UNIDENTIFIED VESSEL, RESULTING IN THE LOSS OF ONE LIFE, IN THE
ATLANTIC OCEAN 16 NAUTICAL MILES SOUTH OF SHINNECOCK, NEW YORK,
ON OCTOBER 12, 2022**

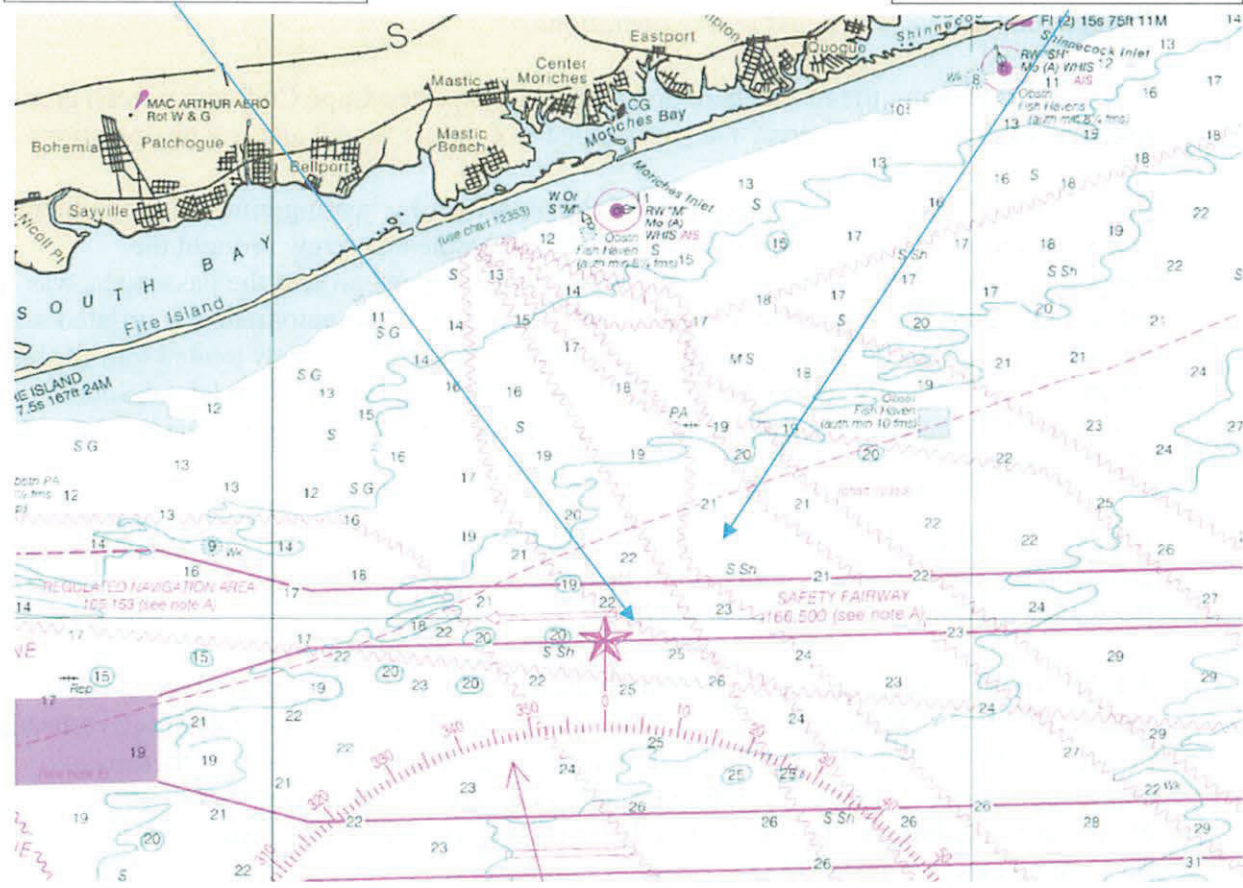
Approximate location of collision

Approximate location of recovered passenger

Figure 02. Enhancement of Chart 12300. From NOAA.gov on October 17, 2022.

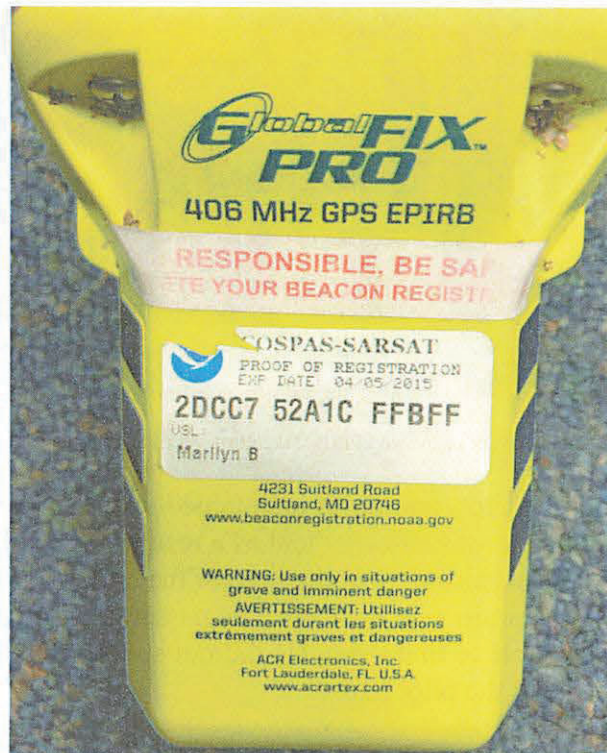
4.2.10.1. Following the collision, the passenger retrieved the EPIRB and believed he activated it because he noted lights illuminated on the unit. He asked the owner if it was activated, and the owner replied it was. When the EPIRB was recovered by the Coast Guard, it was found with the test mode activated. Both the passenger and the owner believed the EPIRB was transmitting a distress signal immediately after the collision. In fact, the EPIRB only began transmitting a signal after being water-activated when the SURE SHOT sank.

Figure 04. Photograph of recovered EPIRB. Taken by [REDACTED] on October 27, 2022.

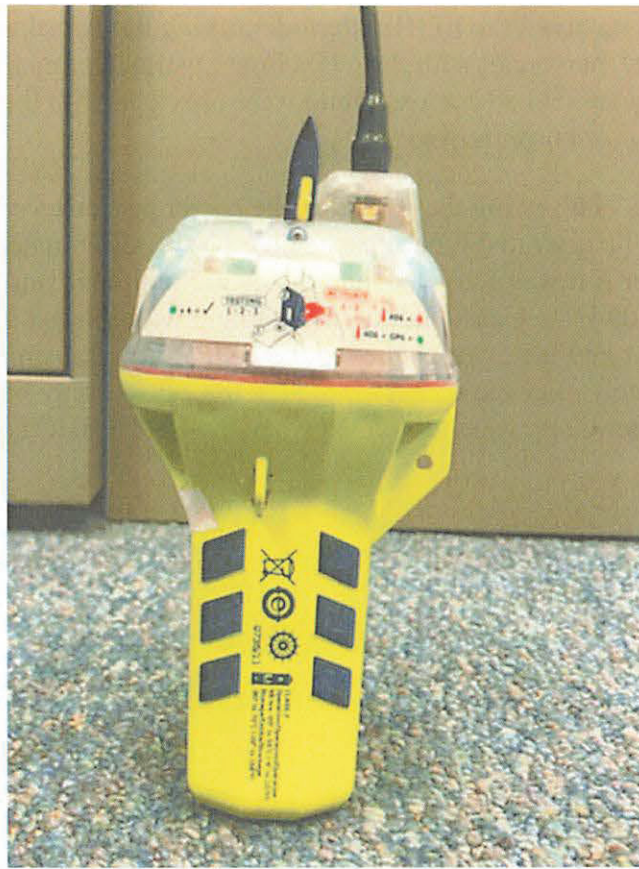
Figure 05. Photograph of recovered EPIRB. Taken by [REDACTED] on October 27, 2022.

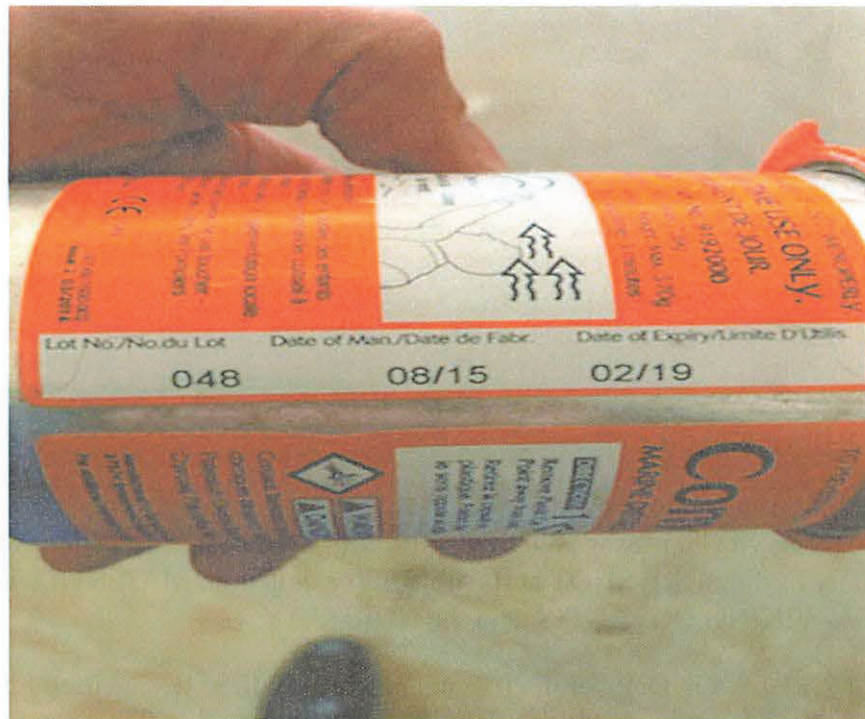
Figure 07. Photograph of recovered life raft expired smoke flare. Taken by [REDACTED] on October 27, 2022.

6.8.1. While not a causal factor, it was unsafe for the owner to not properly service and maintain vital safety equipment on board.

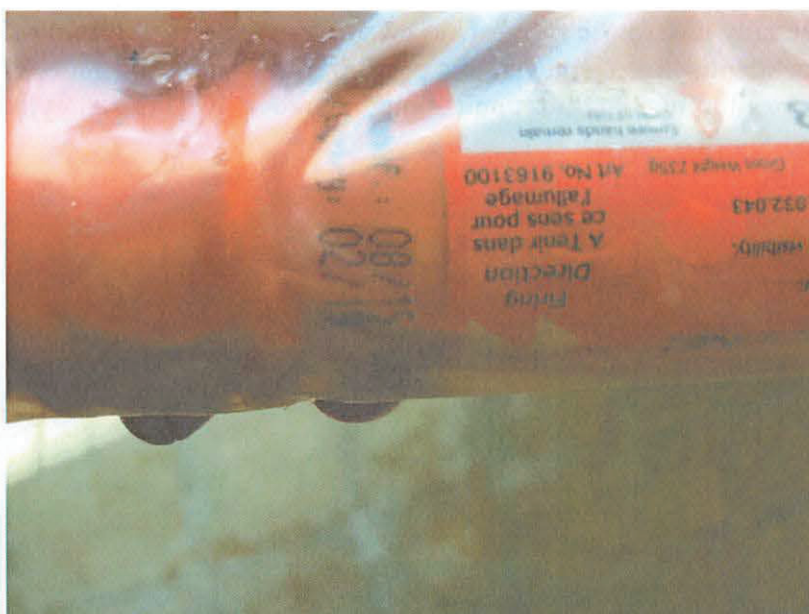
Figure 08. Photograph of recovered life raft expired parachute flare. Taken by [REDACTED] on October 27, 2022.

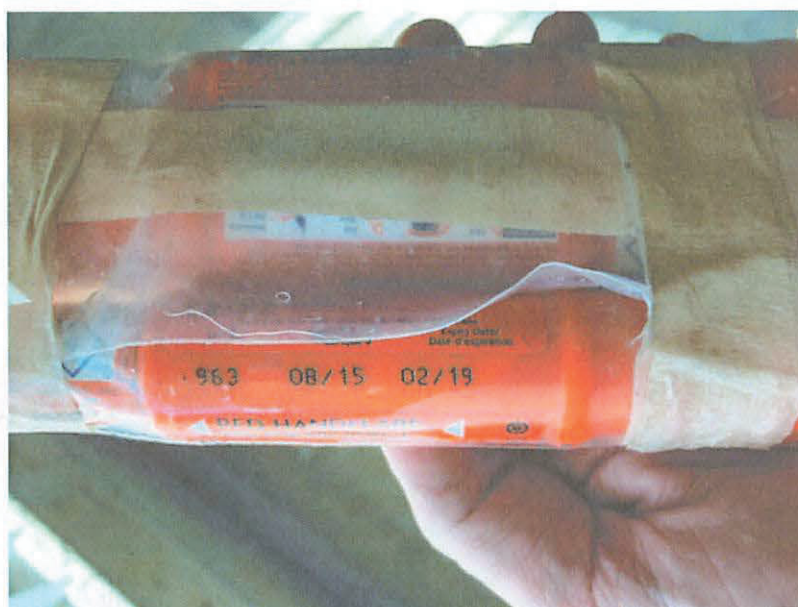
Figure 09. Photograph of recovered life raft expired red handheld flare. Taken by [REDACTED] on October 27, 2022.

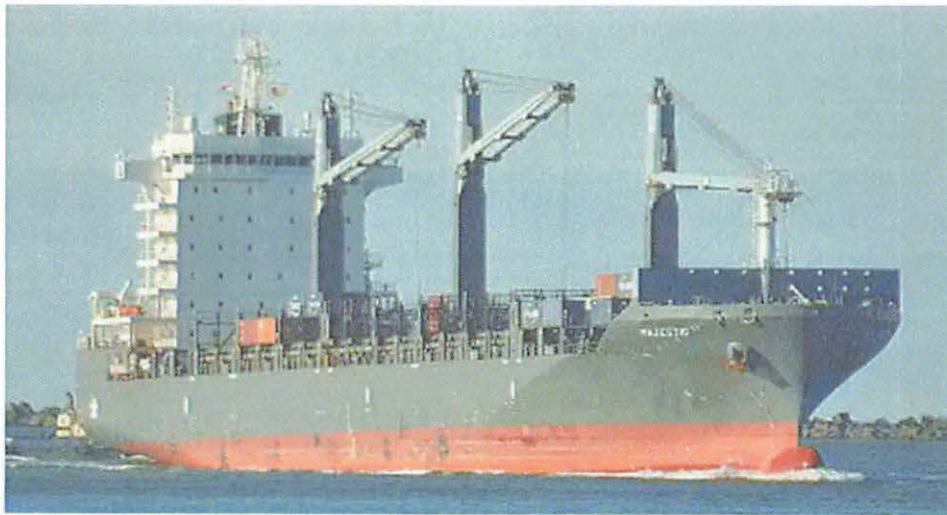
Figure 10: Photograph of the MAJESTIC, taken from internet by [REDACTED] on October 14, 2022.

Master of the vessel. A visual survey was conducted of the exterior of the vessel for recent damage/scrapes. The data on the vessel's Voyage Data Recorder (VDR) was obtained and reviewed. Based on the available information obtained, there was no evidence that indicated the MAJESTIC was involved in a collision with the SURE SHOT.

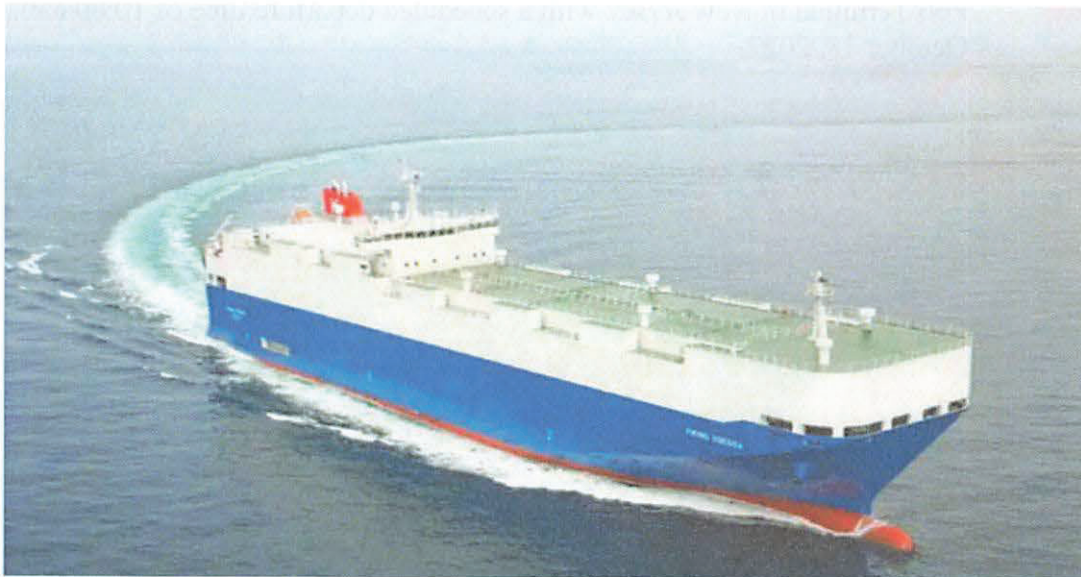
Figure 11: Photograph of the VIKING ODESSA, taken from internet by [REDACTED] on October 14, 2022.

5.5.2. VIKING ODESSA: The VIKING ODESSA's GPS track line, bridge logbooks, ECDIS, radar, chart plotter, and navigation plan were all reviewed. Interviews were conducted with the crew members on watch at the time of the collision, and with the Master of the vessel. A visual survey was conducted of the exterior of the vessel for recent damage/scrapes. The ship was properly equipped with a Simplified Voyage Data Recorder (S-VDR). These units store data for a 12-hour period and then the data is overwritten with data from the next 12-hour period. More than 12 hours had passed before the vessel was made aware they may have been involved in a marine casualty. Therefore, no S-VDR data was recovered and available for review. Based on the available information obtained, there was no evidence that indicated the VIKING ODESSA was involved in a collision with the SURE SHOT.

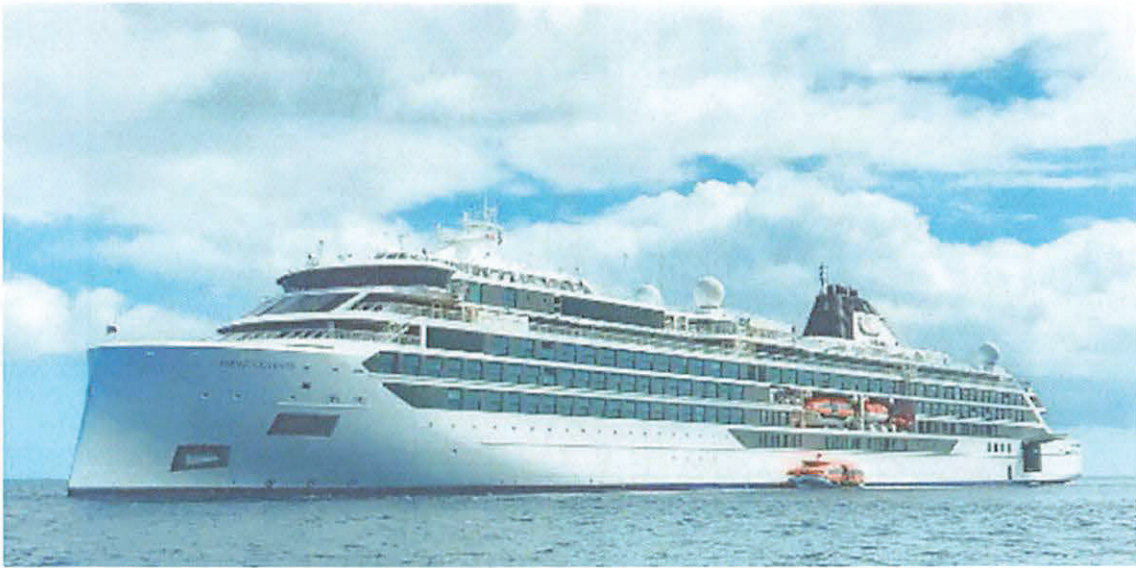
Figure 12: Photograph of the VIKING OCTANTIS, taken from internet by [REDACTED] on October 14, 2022.

5.5.3. VIKING OCTANTIS: The VIKING OCTANTIS's GPS track line, bridge logbooks, ECDIS, radar, chart plotter, and navigation plan were all reviewed. A visual survey was conducted of the exterior of the vessel for recent damage/scrapes. Interviews were conducted with the crew members on watch at the time of the collision and with the vessel Master. The vessel was equipped with closed circuit television footage which recorded data 24 hours a day. That data was reviewed by CG Investigators, as well as the data obtained from the vessel's VDR. Based on the available information obtained, there was no evidence that indicated the VIKING OCTANTIS was involved in a collision with the SURE SHOT.

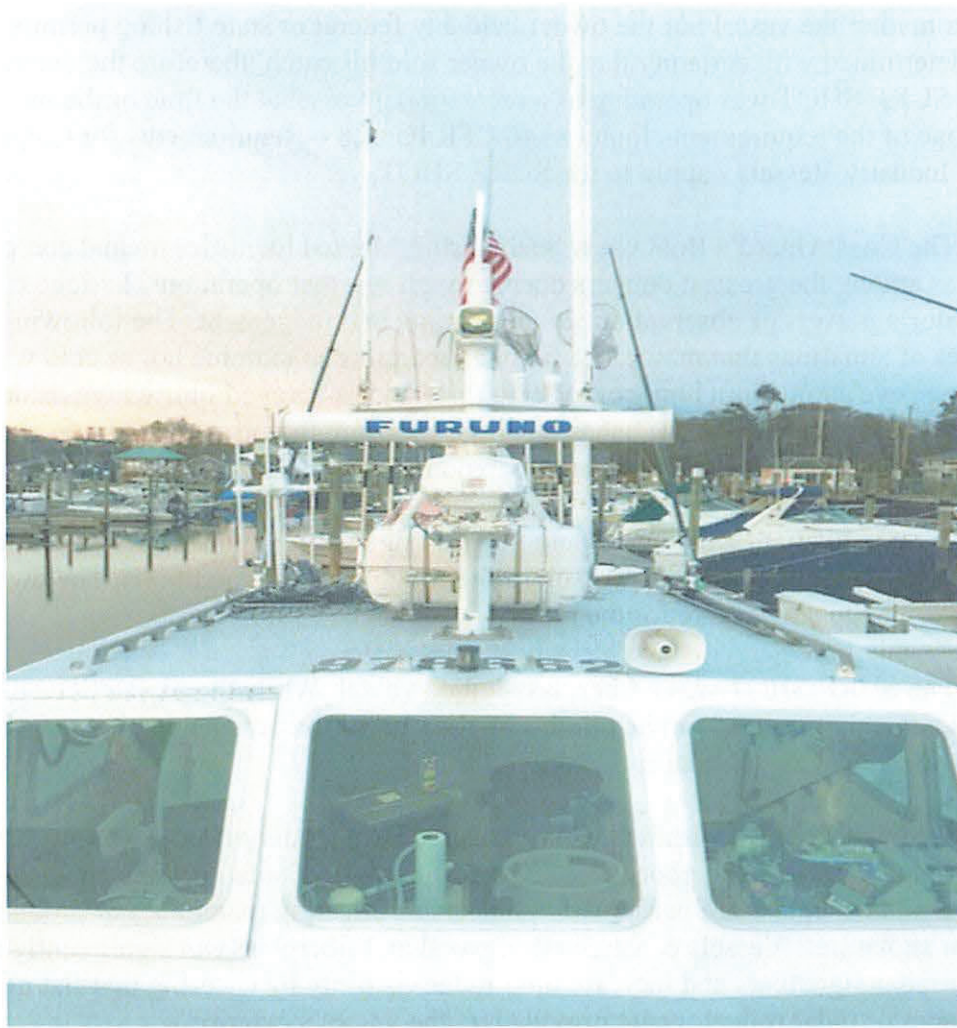
5.3. The SURE SHOT was a fiberglass-hulled vessel. While the SURE SHOT had a radar unit and a metal mast head on the pilothouse roof, all of the obtainable pictures of the vessel showed no evidence of a radar reflector.

5.3.1. In accordance with U.S. Coast Guard Marine Safety Alert 04-97, wood and fiberglass vessels make poor radar targets. Operators of small vessels are cautioned that wood and fiberglass are particularly poor radar reflecting materials and produce weak radar signatures. Vessels constructed of wood and fiberglass can significantly improve their radar signatures and increase their radar visibility by ensuring that flat metal surfaces or radar reflectors are provided on the vessel’s exterior.

Figure 14. Photograph of top of pilot house of SURE SHOT. Provided by Good Samaritan on November 1, 2022.
