**UNINSPECTED PASSENGER VESSEL
WICKLIFFE CREWBOAT (O.N. 1221644),
CREWMEMBER LOSS OF LIFE IN THE OHIO
RIVER NEAR MILE MARKER 981 IN CAIRO, KY
ON MARCH 03, 2022**

**LOSS OF LIFE ONBOARD THE UNINSPECTED PASSENGER VESSEL
WICKLIFFE CREWBOAT (O.N. 1221644) ON THE OHIO RIVER AT
MILE MARKER 981, NEAR CAIRO, KENTUCKY ON MARCH 3, 2022**

INVESTIGATING OFFICER'S REPORT

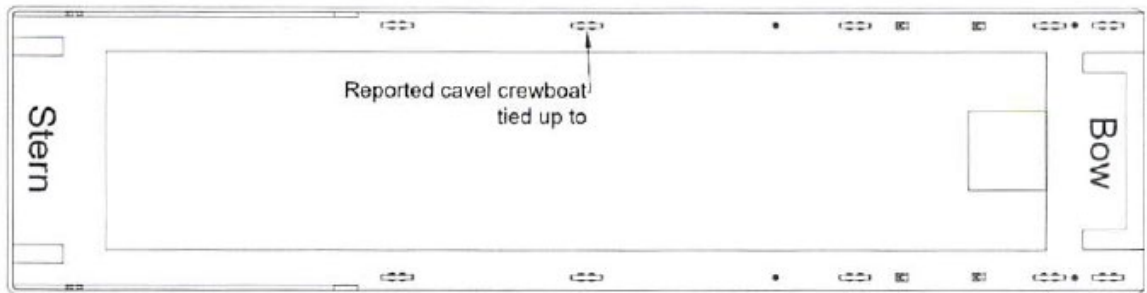
Reportedly, the “Wickliffe Crewboat” was tied of to the 4th cavel aft of the headlog as follows:

Figure 3. Top-down of the towing vessel LUKE BURTON Tie Off Diagram, obtained from the General Condition Survey completed on 3/5/2022, by [REDACTED].

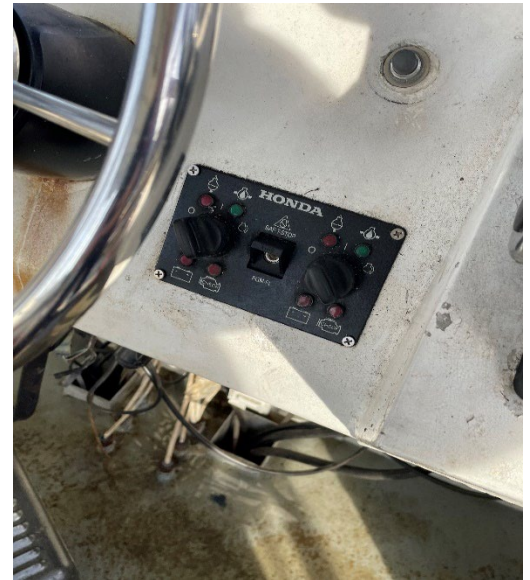
Figure 4. Photograph of the WICKLIFFE CREWBOAT with engines shutdown. Taken on 3/29/2022 by the Coast Guard at Wickliffe, KY.

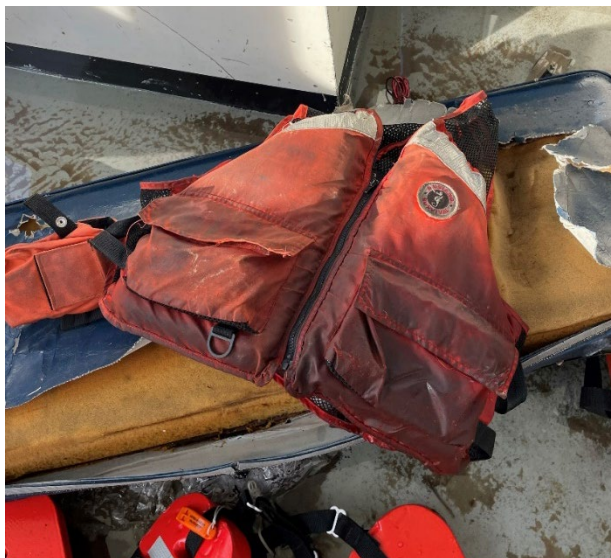
Figure 5. Lifejacket found inside the WICKLIFFE CREWBOAT after it was righted. Taken on 3/29/2022 by the Coast Guard at Wickliffe, KY.

5.12. Failure of Deckhand 1 to Don a Lifejacket. Deckhand 1's lifejacket was found inside the cab zipped up on the WICKLIFFE CREWBOAT once the vessel was righted. He had been trained on proper use of personal protective equipment. It was a U.S. Coast Guard approved Type-I size Adult Large/XL with the adjustment straps extended all the way making it as large as possible. The Type-I is designed to turn most unconscious wearers face-up and to the surface of the water preventing drowning. There was not conclusive evidence that the operator was wearing a lifejacket before the vessel capsized. A witness stated he did not see Deckhand 1 wearing a lifejacket while inside the cab, while others stated he was wearing it, but it was unzipped while inside the cab. The lifejacket was found zipped up and fully extended inside the cab of the crew boat after the incident. It is possible the lifejacket was on and slipped off Deckhand 1 during the vessel capsizing into the water. It is also possible Deckhand 1 was not wearing a lifejacket while inside the cab. It is only required by Economy Boat Stores that crewmembers wear a life jacket fully fitted and secured when there is a risk of falling overboard or conducting deck operations. Deckhand 1 was inside the cab prior to the vessel capsizing, it is good marine practice not to wear a lifejacket while inside the vessel. Deckhand 1 was not out on the deck but was waiting inside the cab of the crew boat and may have taken off the lifejacket and felt there was no a risk of falling into the water while he was inside the cab. If he was not wearing a lifejacket, Deckhand 1 likely did not have enough time to don his lifejacket before entering the water since the vessel capsized very quickly.

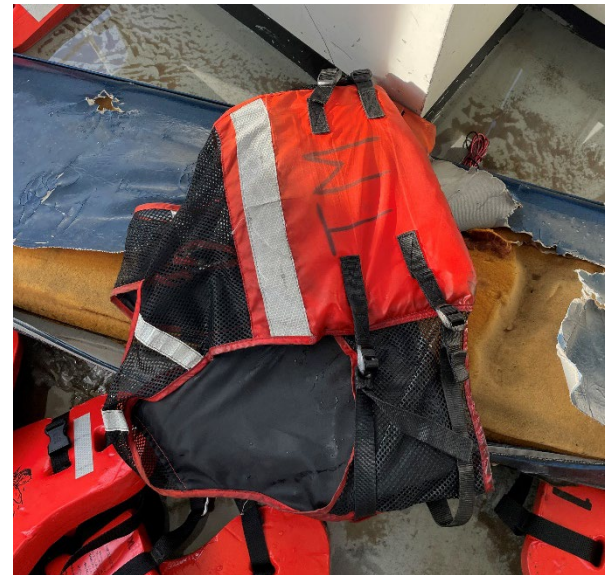
Figure 6. Lifejacket with initials stenciled on the back. Taken on 3/29/2022 by the Coast Guard at Wickliffe, KY.

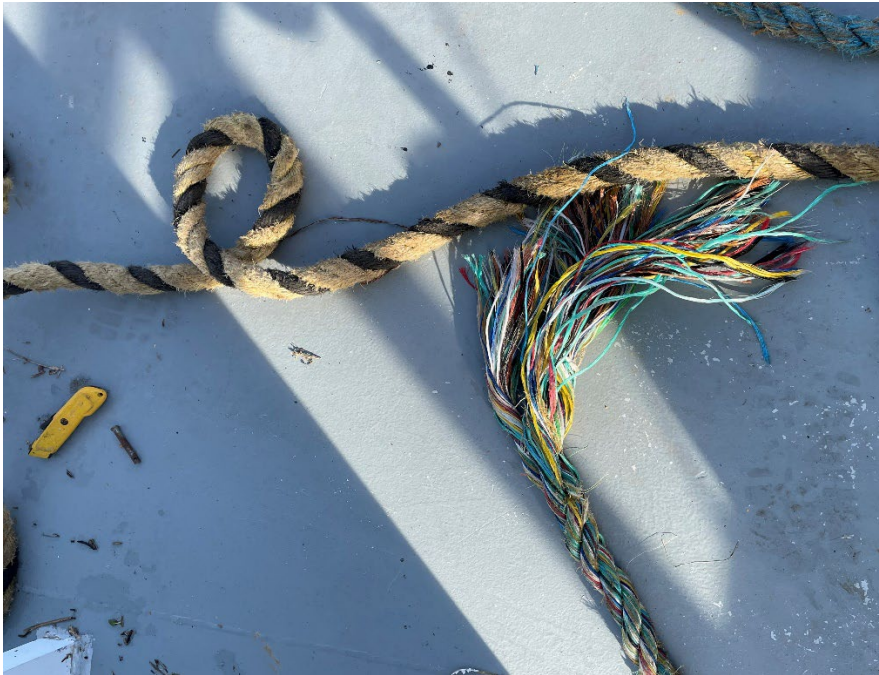
4.2.10. The deck line that was used to tie the boats together was from the WICKLIFFE CREWBOAT. It was 1.5-inch synthetic mooring line. There were no records of when the line was purchased or maintenance records.

Figure 7. Broken deck line from the WICKLIFFE CREWBOAT used to tie the vessels on the day of the incident. Taken on 3/29/2022 by the Coast Guard at Wickliffe, KY.

5.8. Inadequate Deck Lines. There was only one line tying the vessels together and once the crew boat began to become unstable against the side of the towing vessel this one line was not adequate to help control the rolling of the crew boat in the current river conditions. After the stern became awash the line parted soon after. Deckhand 1 most likely thought one line was adequate to keep the crew boat stable while alongside the towing vessel. Deckhand 1 may have performed this operation many times in the past without anything bad happening and thought it would be sufficient. Once the vessel began being unstable it is possible there was not enough time to add additional lines before the deck line parted. The line was not strong enough to take the full weight of the vessel while tied underway in the current river conditions. It is reasonable to assume that if Deckhand 1 had added additional lines when tying alongside the towing vessel, this may have provided adequate stability, and the stern deck may not have become awash and prevented the line from breaking.

6.6.4. The deck line that was used on the day of the incident had no records of purchase or maintenance. It is good marine practice to track and change out lines as needed to avoid wear and tear of old lines. Although the line had no records it is unclear that a new line that would meet general requirements for a small vessel would have been able to sustain the forces and tension placed on the deck line the day of the incident. It could not be concluded that the deck line used that day was somehow a contributing factor in this incident.

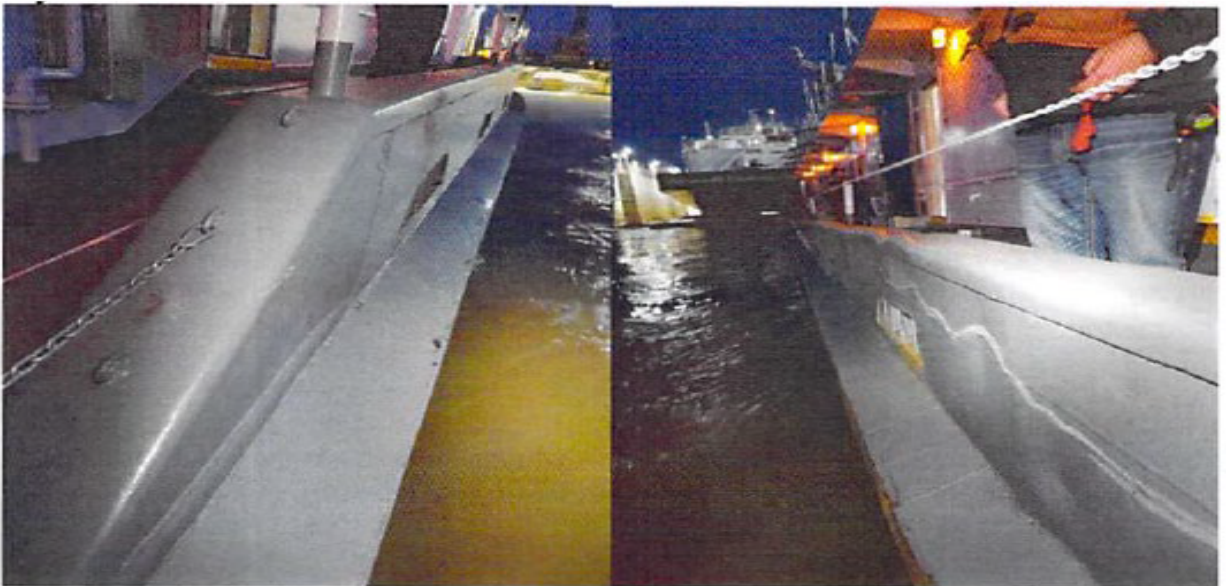
4.2.12. Post casualty assessment of both vessels showed damage from a hard collision, with the WICKLIFFE CREWBOAT suffering structural damage and the LUKE BURTON suffering superficial damage on the port side.

Figure 8. LUKE BURTON damage port side. Obtained from the General Condition Survey completed on 3/5/2022, by [REDACTED]

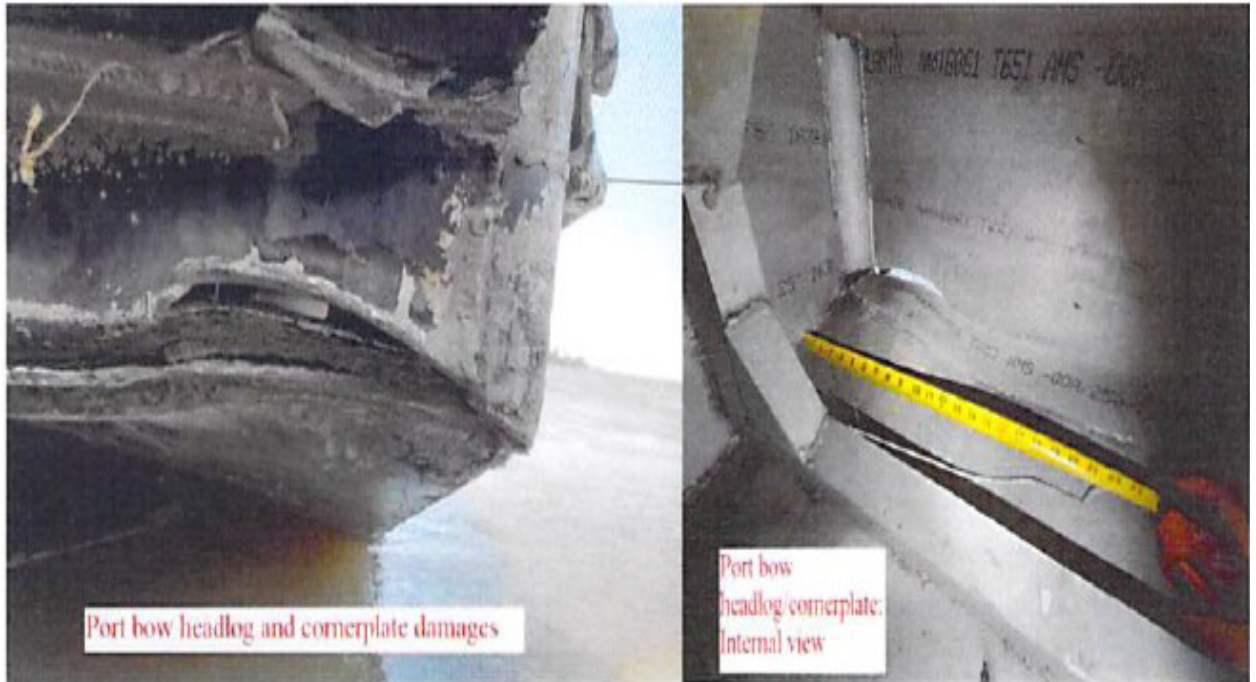
Figure 9. WICKLIFFE CREW BOAT hull damage. Obtained from the General Condition Survey completed on 3/5/2022, by [REDACTED]

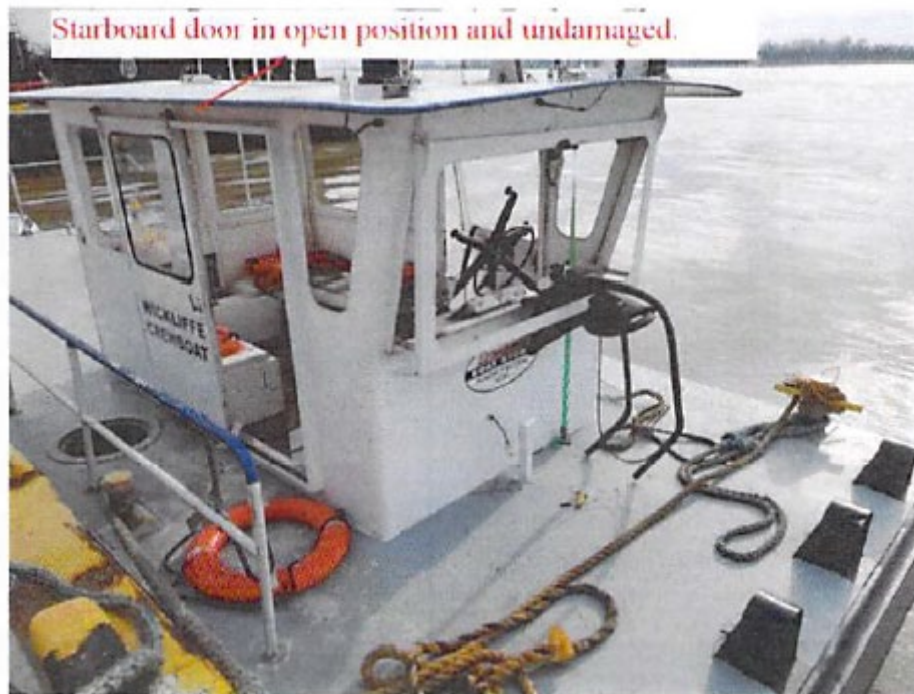
Figure 10. WICKLIFFE CREW BOAT cabin and deck. Obtained from the General Condition Survey completed on 3/5/2022, by [REDACTED]
