**REPORT OF THE INVESTIGATION
INTO THE
ALLISION OF THE TANK VESSEL BOW
TRIUMPH (IMO 9669902) WITH JOINT BASE
CHARLESTON PIER BRAVO IN THE COOPER
RIVER ON SEPTEMBER 5, 2022**

**MISLE ACTIVITY NUMBER: 7568095
MISLE CASE NUMBER: 1320684**

**THE ALLISION OF THE NORWEGIAN FLAGGED TANK SHIP BOW TRIUMPH
(IMO 9669902) WITH JOINT BASE CHARLESTON PIER BRAVO IN THE
COOPER RIVER, SOUTH CAROLINA ON SEPTEMBER 5, 2022**

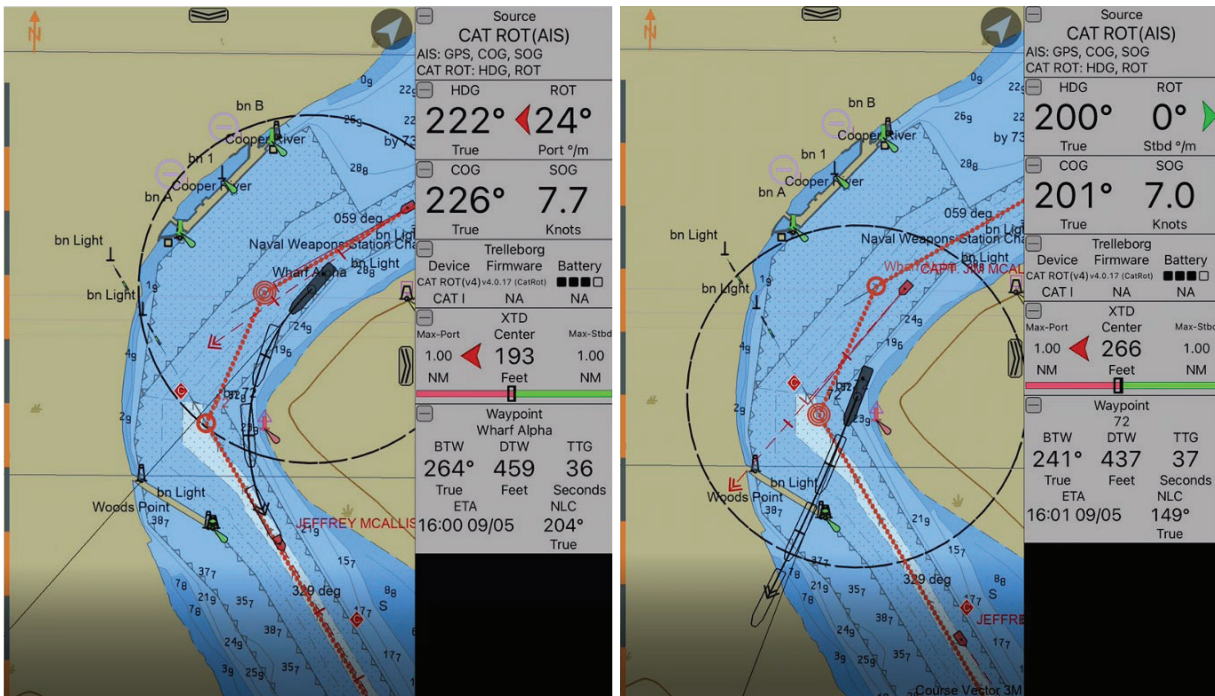
Figure 3 The Harbor Pilot's PPU recordings, showing a significant rate of turn calculated during initial approach with Port 20 degrees rudder (left), followed by no rate of turn, after the rudder had already been at Port 35 degrees for several seconds (right). Images: Harbor Pilot PPU.

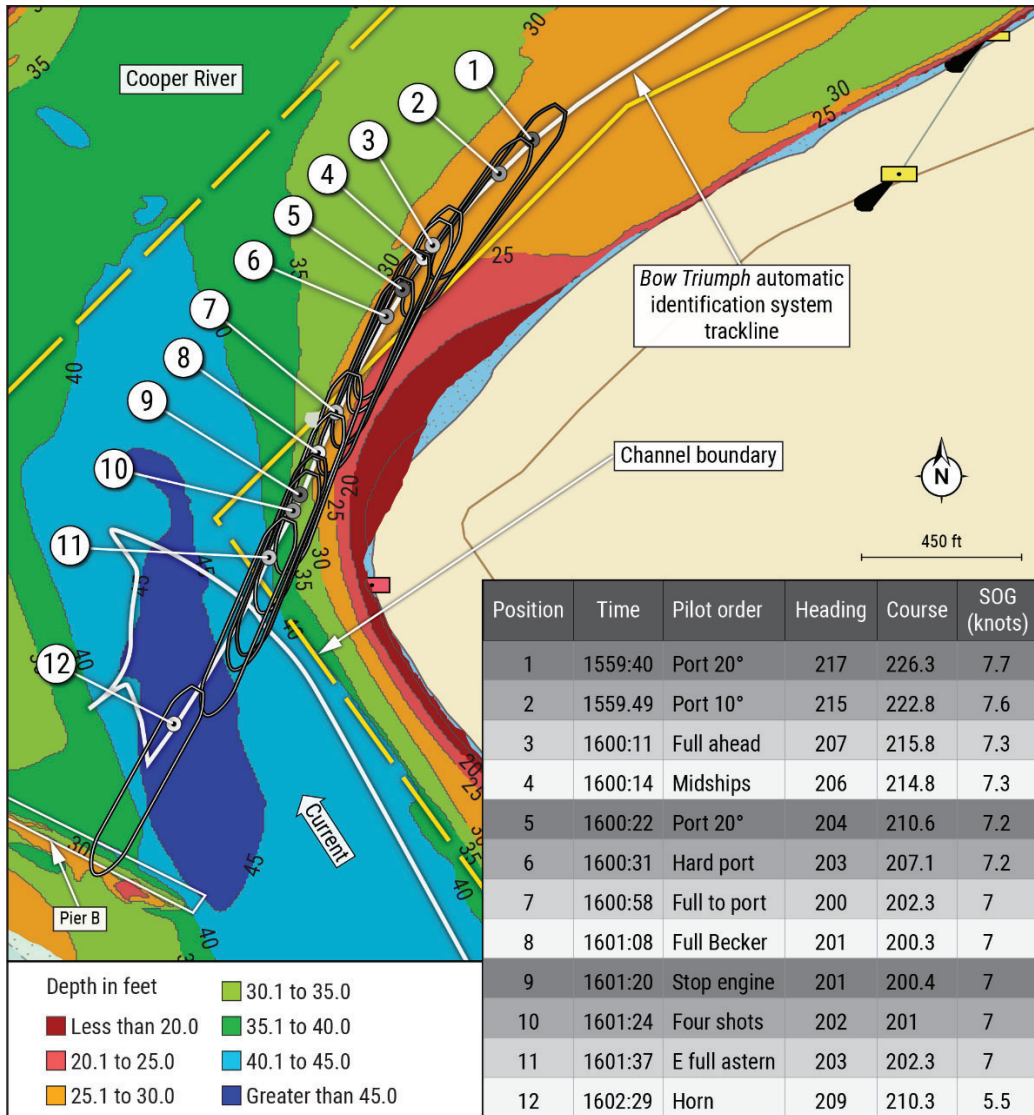
Figure 4 Positions of BOW TRIUMPH (scale approximate) approaching and alliding with Pier Bravo and helm commands, based on Automatic Identification System and Voyage Data Recorder data, overlaid with soundings (in feet, at MLLW) from a 06 September 2022 USACE survey. Image: NTSB/USACE.

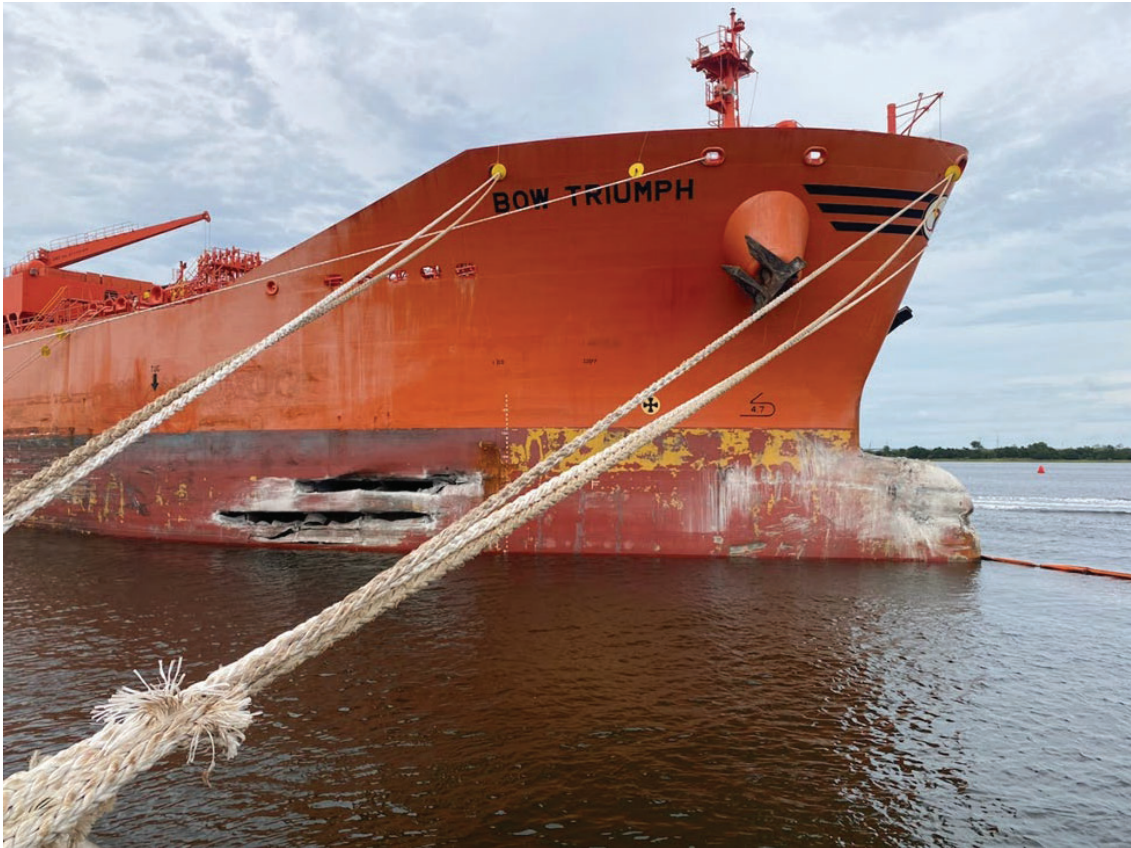
4.1.22. BOW TRIUMPH suffered a hull laceration above the waterline, 13' 11" above the keel on the starboard side, to the forepeak ballast tank and No. 1 starboard ballast tank, damaging the hull from frames 81-87 and No. 2 & 3 stringer in No. 1 starboard ballast tank including internal stiffeners. The starboard hull plating was scraped and exposed at frames 84-103. The bulbous bow was punctured and damaged at frames 103-107. A dive survey revealed the bottom hull coating near the bow was scraped in an area slightly port of centerline approximately 7.5" wide x 19.5" tall. The anchor was fouled in the pier debris. Resultant damage was initially estimated at \$300,000, but actual costs for repairs were approximately \$2.3 million. See Figure 5.

Figure 5 BOW TRIUMPH's damaged starboard bow while moored at Odjell Terminal in North Charleston on 08 September 2022. Photo: U.S. Coast Guard.

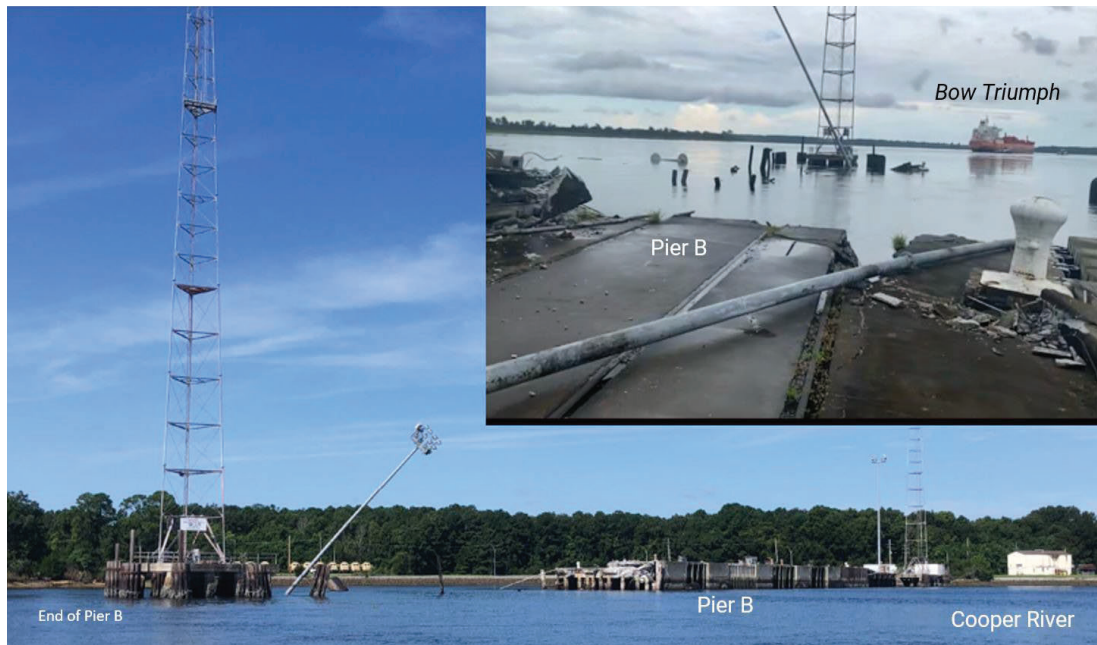
4.1.23. A section of Pier Bravo, approximately 300 ft in length, collapsed due to the impact, including a light pole and several support pilings. The end of the pier, which held the lightning tower, remained undamaged. The total cost to demolish and rebuild the damaged segment was estimated at approximately \$27.9 million by the Naval Facilities Engineering Command. This estimate did not include the design costs or Supervision, Inspection, and Overhead (SIOH), which would increase the estimated costs to \$32.3 million. See Figures 6 and 7.

Figure 6 Joint Base Charleston Pier Bravo damage facing west. Inset: Witness photograph taken shortly after the contact facing east. (Photo: USACE, Inset: Jacob Wall)

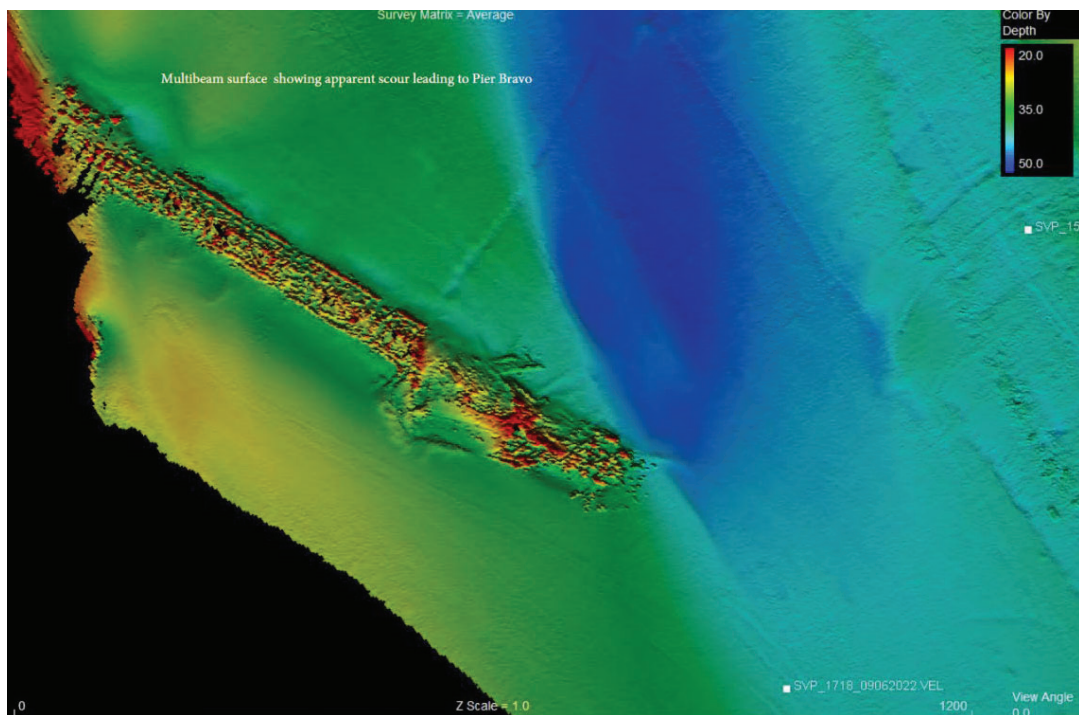
Figure 7 Multibeam survey on 06 September 2022 (one day post-casualty) showing damaged Pier Bravo and evidence of anchor/chain contact with the river bottom. Image: USACE.

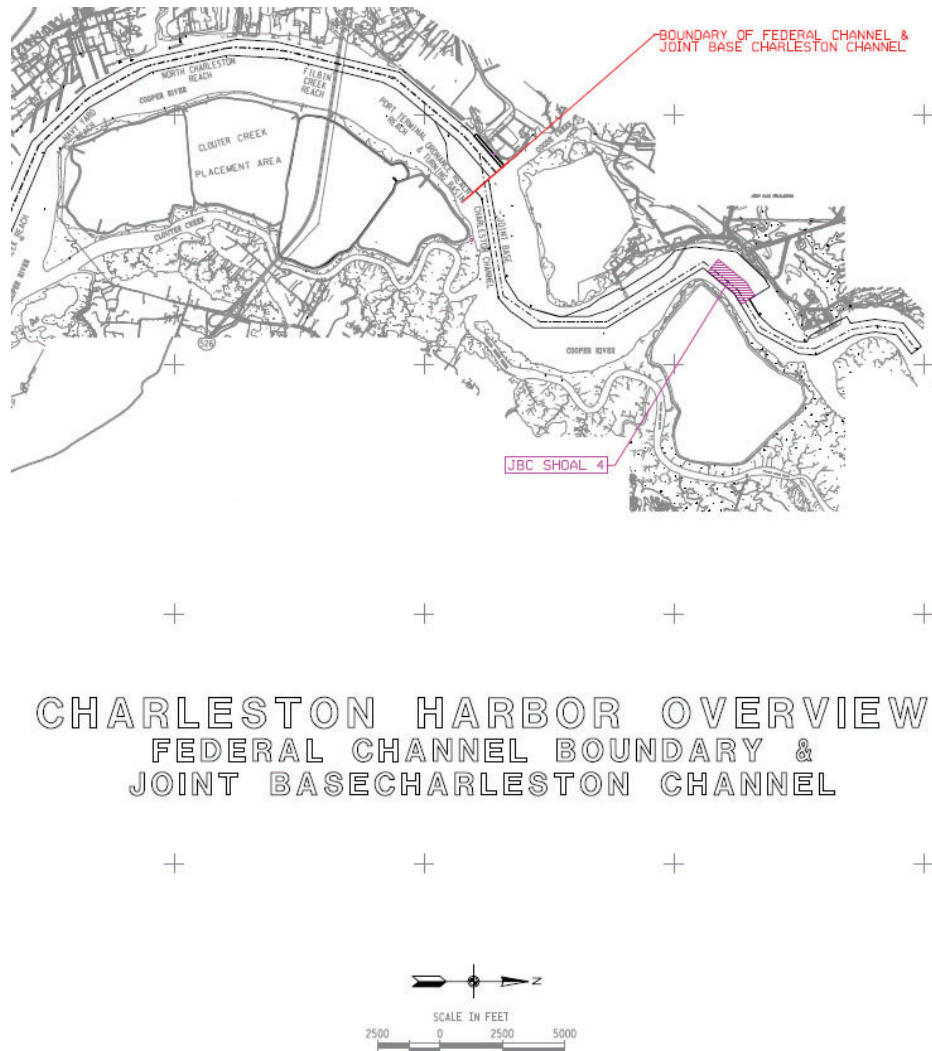
4.2.4.1. The upper Cooper River, including the channel adjacent to JBC, while considered “navigable waters of the United States⁴” is not part of a “federally maintained channel,” which is the authority and funding mechanism under which USACE maintains a particular waterway to its published controlling depth. Navigable waters that are outside a federally maintained channel are dredged, as necessary, at the discretion and cost of other waterway users. The JBC channel extends from Red Bank Landing near the Nuclear Power Training Unit down to the northern edge of North Charleston Terminal (see Figure 10). The federally maintained channel initiates offshore at the Charleston sea buoy, extends through Charleston harbor, and terminates in the Cooper River at North Charleston Terminal. It is maintained by the USACE and surveyed on a quarterly basis.

Figure 10 Boundary between the federally maintained channel and JBC channel (red line), and Shoal 4 (pink shade), where the BOW TRIUMPH experienced a loss of turning ability. Image: USACE.

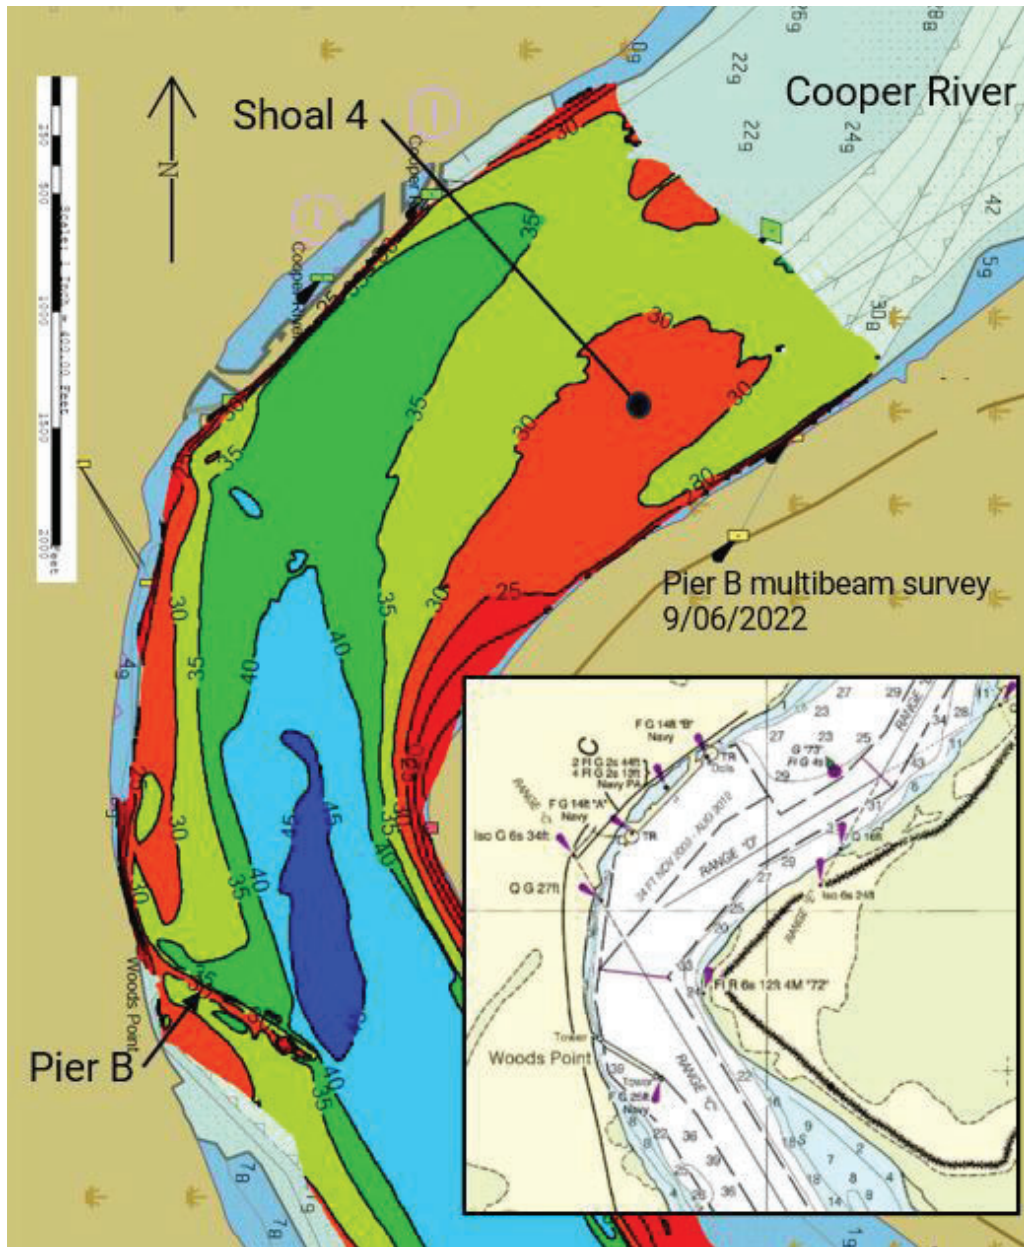
Figure 11 Results from the 06 September 2022 multi-beam survey in vicinity of Joint Base Charleston and Pier Bravo, showing shoal of 30 ft and under in the channel, one day post-casualty. Image: USACE. Inset: NOAA Chart 11527.

4.2.4.6. One day after the BOW TRIUMPH incident, USACE conducted a condition survey of Shoal 4, followed by a pre-dredge multibeam survey on 28 September 2022. Figures 4, 8, & 11 display data from the 06 September 2022 survey, showing that silting in the area of Shoal 4, over a period 17 months, had reduced the depth by more than 10 feet in portions of the JBC channel.

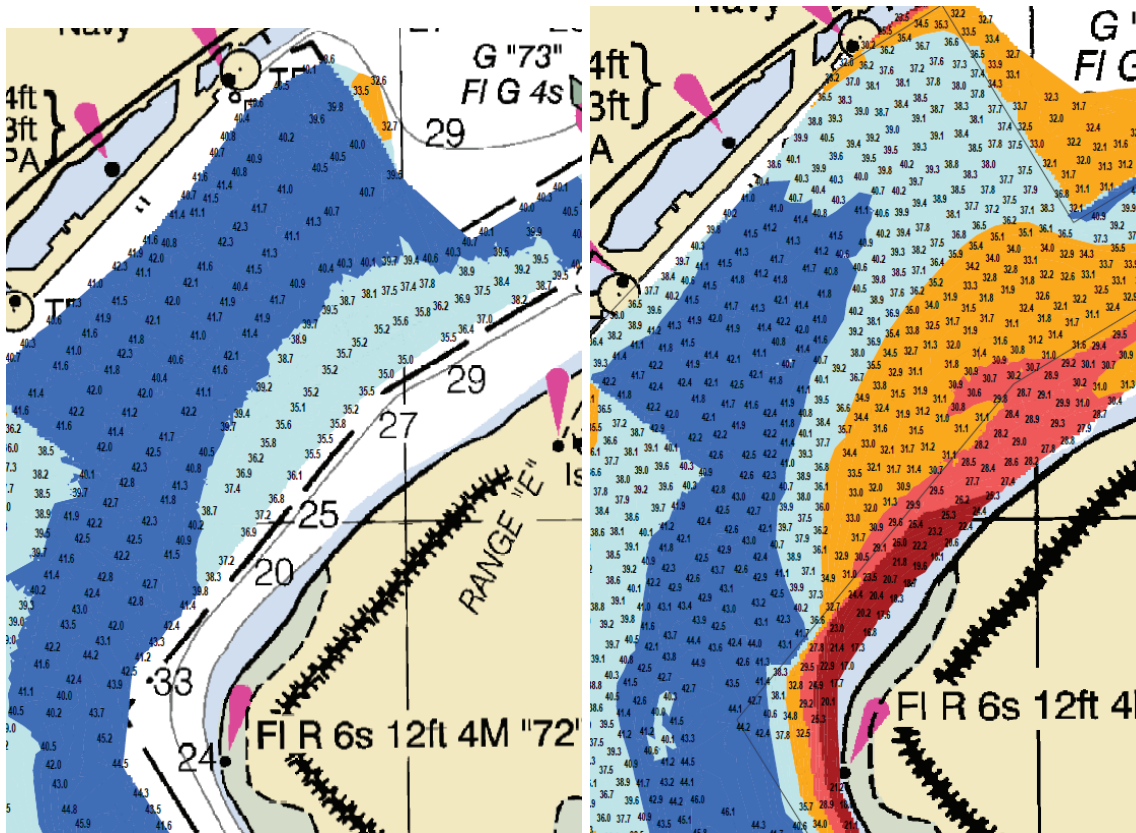
4.2.4.7. An 11 January 2023 singlebeam condition survey indicated that the JBC channel on Range D had shoaled to depths of 35-39 ft. A 16 May 2023 singlebeam condition survey showed that depths within the channel boundary had decreased to as little as 29 ft (see Figure 12).

Figure 12 Survey data from January 2023 (left) and May 2023 (right) showing a rapid rate of shoaling on the eastern bank of JBC Channel on Range D following the November 2022 dredge work. Images: USACE.

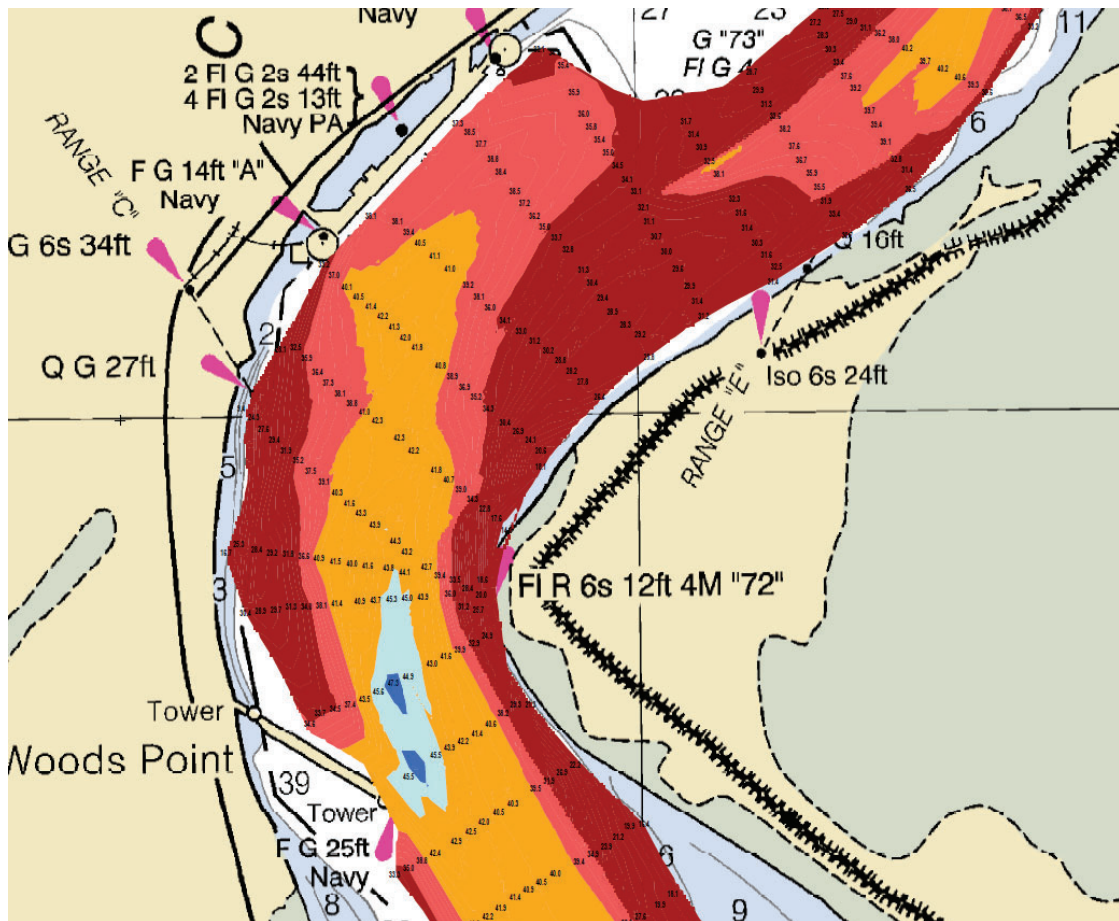
4.2.4.8. Each Pilot is responsible for routinely updating survey data in their PPUs. The CBPA occasionally requests JBC channel surveys from USACE to make available for the Pilots. On the date of the BOW TRIUMPH incident, CBPA Pilots were referencing USACE sounding data from a 15 November 2021 survey. This data had been uploaded into the Harbor Pilot's PPU. As displayed in Figure 13, this survey indicated significant shoaling on Range D, with depths as low as 30 ft near Shoal 4. Soundings under 40 ft are shown in light and dark red.

Figure 13 November 2021 soundings, depicting <40 ft in the channel (light red) and <35 ft (dark red) in the channel and along Shoal 4, with depths as low as 27 ft along the eastern edge of the channel. Image: USACE.

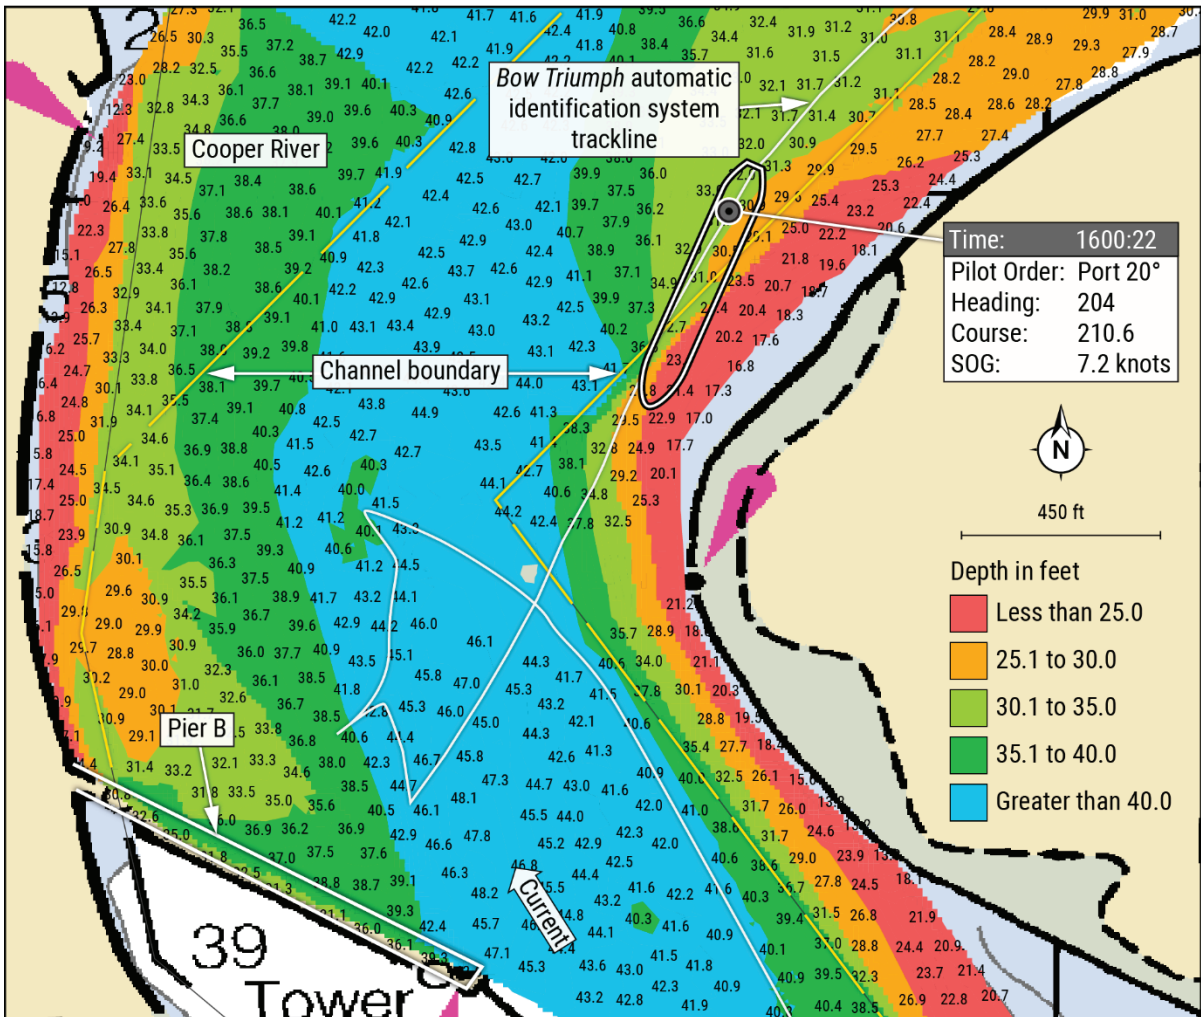
Figure 14 Position of the Bow Triumph (approximate scale) at 1600:22, based on AIS data, about the time the Harbor Pilot noticed that the rate of turn was not increasing. Pilot order is from the ship's VDR. Soundings (in feet, at MLLW) were recorded during the 06 September 2022 USACE survey. Image: NTSB

5.2. *Hydrodynamic effects.* Based on the BOW TRIUMPH's proximity to Shoal 4 and the 6 ft HoT, the ship likely began its turn where the channel was as shallow as 34 ft, causing a UKC of 5 ft or less. CBPA's policy for minimum water depth ($1.15T < h$) was marginally met, as $1.15(28.96) = 33.3$ ft. Applying the commonly accepted principle that shallow water affects maneuverability when $h/T < 1.5$, it is clear that the BOW TRIUMPH ($h/T = 34/28.96 = 1.17$) could have lost turning capability due to its path over Shoal 4. Once the ship sailed even closer to the eastern riverbank, the UKC may have been as low as 1 ft.

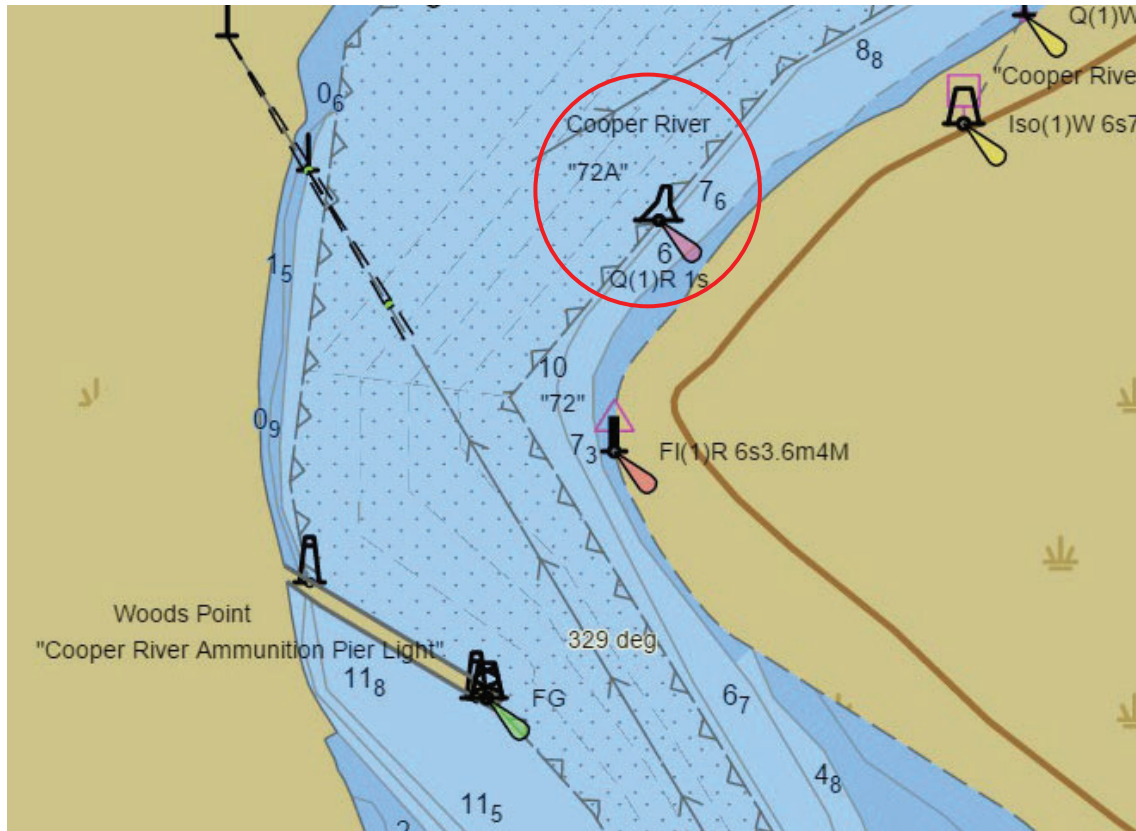
Figure 15 Excerpt from ENC US5SC1LO with the newly established buoy Cooper River “72A” circled in red.
Image: NOAA/U.S. Coast Guard

(ANT) Charleston set this buoy in position as requested on 20 September 2022. After dredging began in October 2022, the temporary buoy was removed. A permanent buoy was requested on 29 March 2023 by CBPA and accordingly processed for approval through the Coast Guard Seventh District. On 03 January 2024, Local Notice to Mariners 04/24 formally established “Cooper River Lighted Buoy 72A,” and ANT Charleston placed the buoy on 17 January 2024 (see Figure 15).
