THE CAPSIZING & LOSS OF LIFE ON THE UNINSPECTED PASSENGER VESSEL GET WET IN THE VICINITY OF MOLASSES REEF, FLORIDA ON DECEMBER 18, 2011 RESULTING IN LOSS OF LIFE

16732/IIA # 4210580
28 October 2024

**THE CAPSIZING OF THE UNINSPECTED PASSENGER VESSEL GET WET
(O.N. 627133) RESULTING IN THE LOSS OF ONE LIFE WHILE SUPPORTING
A RECREATIONAL DIVE AT MOLASSES REEF OFF KEY LARGO, FLORIDA
ON DECEMBER 11, 2011**

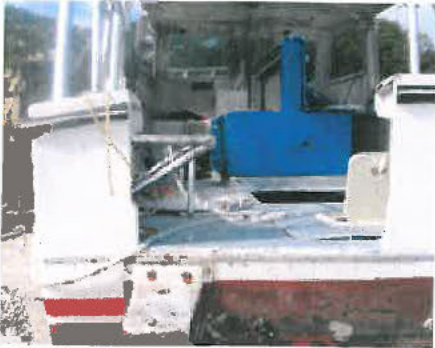
(1) *Main Deck Flooding:* It was common for the main deck of the vessel to flood with ¼ inch of standing water, covering the stern, up to the forward edge of the lazarette deck plate. GET WET had a six inch stern freeboard, which was further decreased by the addition of crew, passengers and dive gear. Water would flood the main deck, by splashing over the gunnels or passing easily through the 2 ½ foot section that was cut-out of the transom to provide passengers easy access to the dive platform.

A section of the transom removed for divers' access to the swim platform

(a) Main deck flooding: GET WET was operated in a condition in which it was common for the main deck of the vessel to flood with ¼ inch of standing water, covering the stern, up to the forward edge of the lazarette deck plate. The flooding of GET WET's main deck was caused by a combination of weather conditions, dangerous modifications to the transom and the addition of weight to the stern, from passengers with dive gear, reducing the vessel's six inch stern freeboard. Operating GET WET in a condition, in which the stern is partially sunk, significantly increased the chance of this casualty occurring.

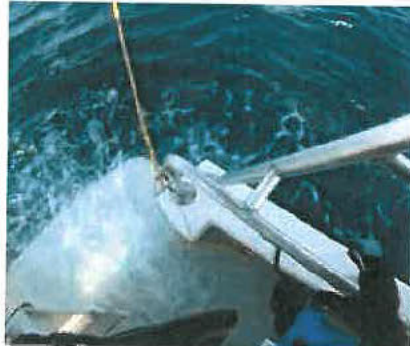
Water freely passing through the transom opening onto the main deck.

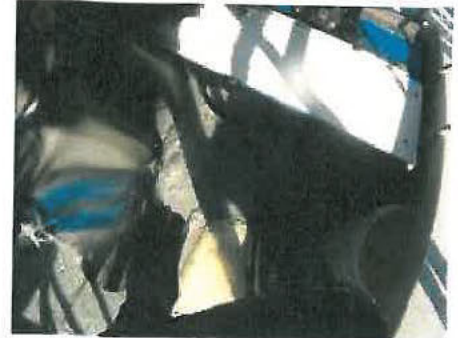
Water flooding the main deck covering the lazarette deck plate.

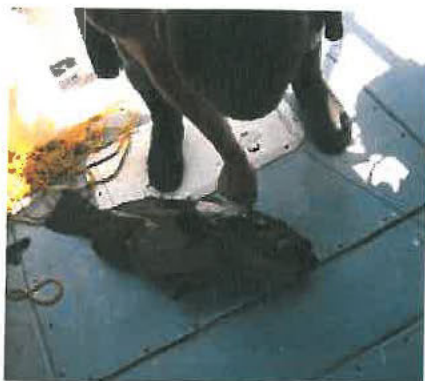
(2) *Down Flooding:* While [REDACTED] was diving with the passengers, GET WET was taking on water at the stern, flooding stern part of the main deck. Once water was on deck, it would downflood into the engine room and lazarette compartments by passing through open bolt holes and underneath the ungasketed edges of the deck plates, if they had been properly in place they would have secured openings to those compartments. Each deck plate, measured roughly 32-inches by 32-inches, had 30-bolt holes drilled around the perimeter and was intended to be installed water tight, with a gasket. To accomplish this, an operator would insert a fabricated gasket between the deck plate and meeting edge of the main deck, thread a bolt through the bolt hole and secure that bolt with a washer and nut, from the underside of the main deck. This process required the operator to either climb into an extremely tight space and hold the nut and washer in place, while someone on deck tightened the nut, or utilize the removable hatch / inspection ports on each deck plate to bolt them down. Either method required a significant amount of time and effort, making it difficult to freely remove the deck plates for general maintenance. The deck plates were initially removed after Key Largo Scuba Shack, LLC purchased GET WET (TROPICAL DAZE) from Eagle Ray Divers, LLC for painting, maintenance and engine repair, but the deck plates were replaced without gaskets or bolts. Instead, screws were dropped into some of the corner bolt holes on each plate, to prevent the deck plates from sliding, while GET WET was underway. It was easier for the Crew to frequently check for flooding in these compartments with only 3 screws. As water on deck downflooded the engine and lazarette compartments, the vessel's stern freeboard would decrease, allowing even more water on deck, causing further downflooding.

Unsecured deck plates. A single screw is visible on the lazarette deck plate.

(b) Downflooding through non-watertight deck plates: GET WET was operated in a condition in which compartments below the main deck were susceptible to downflooding, jeopardizing the vessel's stability and causing the potential for capsizing. The standing water on

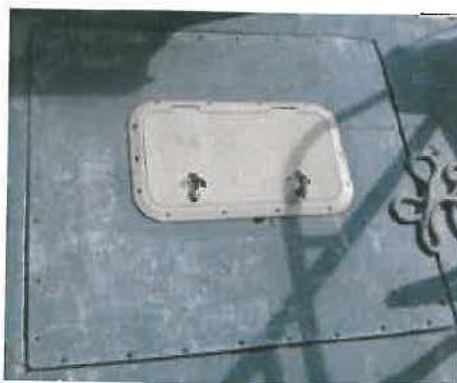
Lazarette deck plate, replaced as it had floated off after capsizing.

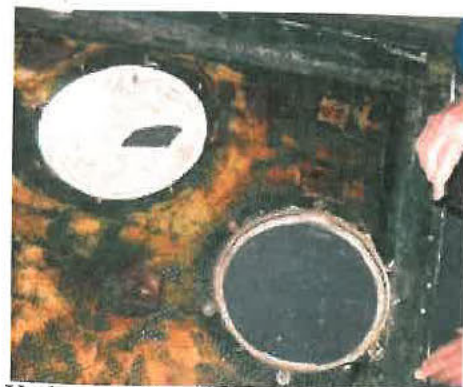
Underside of engine compartment deck plate, no gasket or sealant visible.

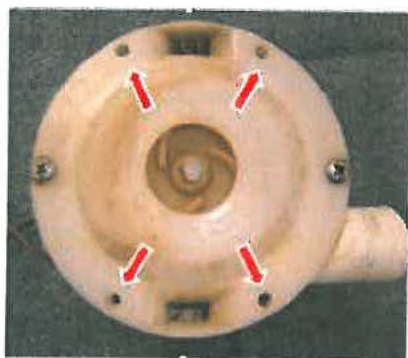
(3) *Lazarette Bilge Pump*: On December 18, 2011, as [REDACTED] went to check the lazarette compartment, discovering a large volume of water had filled the lazarette. [REDACTED] checked the lazarette's bilge pump and discovered it had not been operating. GET WET's lazarette compartment was fitted with a Rule, 2,000 gallon per hour electric submersible bilge pump. That pump had been previously disassembled and incorrectly reassembled, compromising the watertight integrity of the pump. Water intrusion into the pump housing and motor caused the pump to cease and fail presumably before the date of the incident. Without the pump, the lazarette compartment could not be dewatered and continued to fill from downflooding. As the lazarette compartment filled, the stern freeboard decreased and the water on deck increased, subsequently downflooding the engine compartment. After [REDACTED] and the passengers completed their first scheduled dive and reboarded GET WET at the stern, they began removing their dive gear. This added weight, combined with the weight of the water already on deck and in the partially flooded lazarette compartment, further decreased the freeboard. This allowed even more water to flood the deck, amplifying the effects of the continuous downflooding.

Missing screws from incorrectly reassembling lazarette bilge pump.

(c) Lazarette Bilge Pump Failure: GET WET's lazarette compartment was fitted with a Rule, electric submersible bilge pump that had been disassembled and incorrectly reassembled, compromising the watertight integrity of the pump, rendering it inoperable. It was not of the design type to be repaired, but rather was required by design to be completely replaced if faulty. Without the pump, the lazarette compartment could not be dewatered and continued to fill from downflooding. As the lazarette compartment filled, the stern freeboard decreased, the water on deck increased and the engine compartment began downflooding. While a properly installed, fully functional bilge pump would not have prevented the downflooding it could have provided adequate dewatering for the vessel to return to port safely.

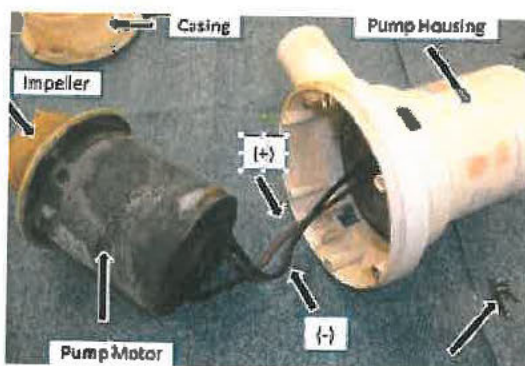
Water intrusion and corrosion visible. Improperly compressed o-ring resulted during reassembly.

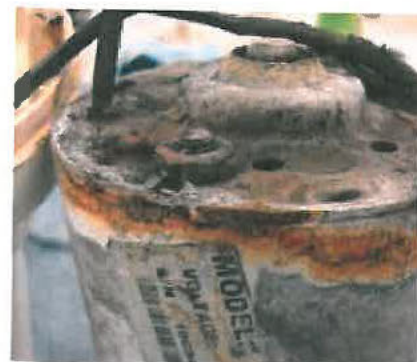
Visible corrosion. Making it likely that the pump had been inoperable for some time, possibly after the failed attempted self repair.

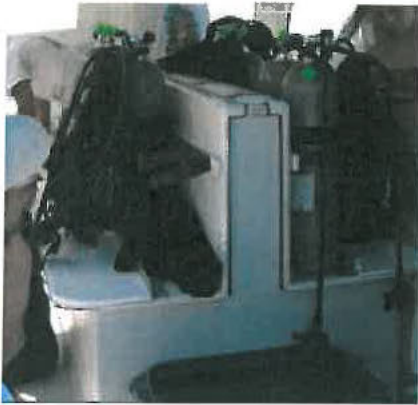
inch wide by 66-inch long access opening in the main deck. This opening was secured with an engine hatch cover, which sat on a small coaming. The original engine hatch cover was modified throughout the years, turning it into bench seats with tank storage racks. The modified engine hatch cover weighed over 300 pounds, without SCUBA tanks attached, and measured an approximate 66-inches long, 36-inches wide and 41-inches high.

Hatch cover with tanks mounted, photo taken October 9, 2010.

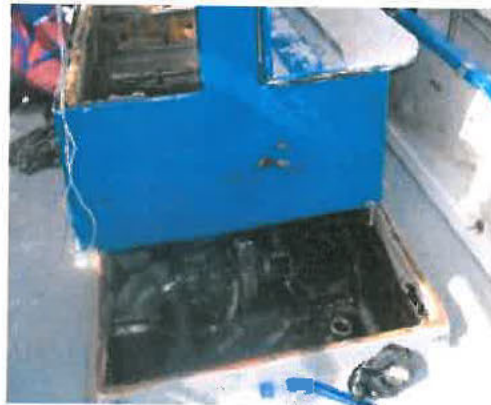
Hatch cover coaming.

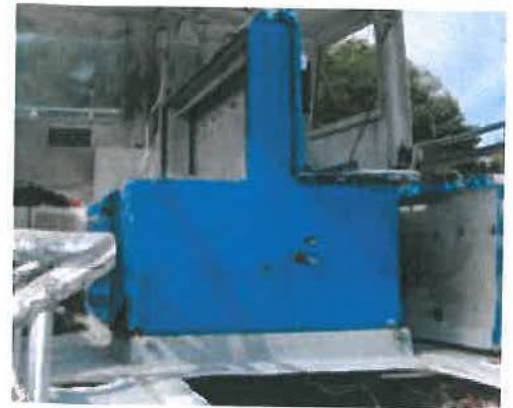
Hatch cover reassembled post casualty.

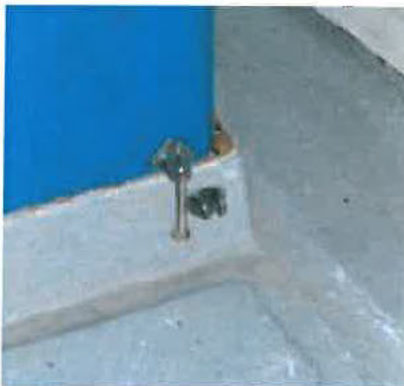
This hatch cover sat on top of the small coaming, secured with four lag bolts, fed through brackets, and tightened with wing nuts. The brackets were attached to the hatch cover and coaming utilizing one inch wood screws.

Securing device in place.

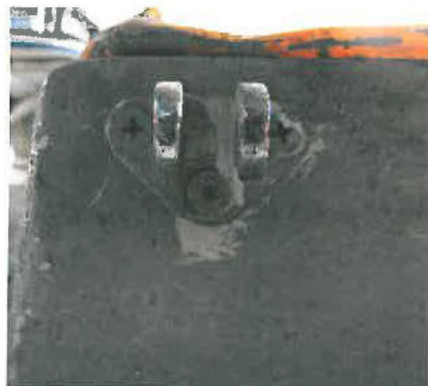
Coaming bracket installed.

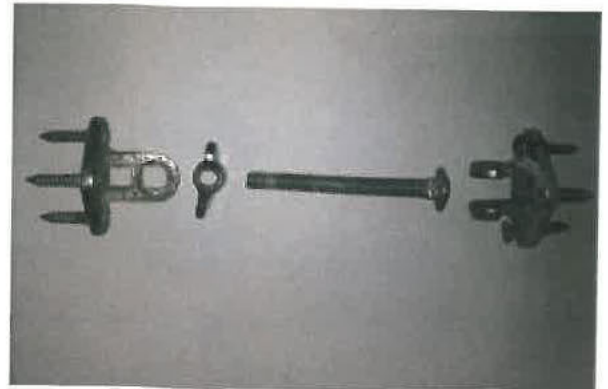
Bracket, carriage bolts and wingnut.

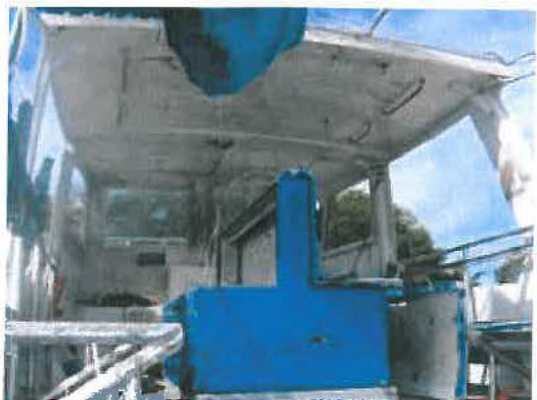
The engine hatch cover broke free as sea and stability conditions caused the GET WET to rock violently and capsize. As GET WET began to sink stern down, the buoyancy of the hatch cover forced it towards the passengers, entrapping them within the fiberglass bimini. [REDACTED] became entrapped under the engine hatch cover and [REDACTED] leg was pinned to the bulkhead; both were unable to escape the sinking vessel. The combined weight of the 300 pound hatch cover, and six tanks that were secured to it, would have made it nearly impossible for them to free themselves. The causal factors that caused the engine hatch cover to break free are design

modification, condition and the capsizing of the vessel. The hatch cover modification significantly increased the cover's weight and size considering that SCUBA tanks were attached to the back of the bench seat area. The cover also sat on a small thin coaming, secured with four removable lag bolts and brackets, hand tightened. The brackets used were secured with three 1-inch wood screws drilled directly into the cover and coaming. The wood on the hatch cover suffered from wet rot, enabling the screws to easily pull out. Finally, the motion of the vessel, combined with the weight and condition of the hatch cover, allowed it to break free and become a significant hazard.

View of engine hatch cover. The hatch cover moved forward, under the bimini as the vessel sank.

(f) Engine Hatch Cover: The engine hatch cover had been modified from its original construction. The modifications to the hatch cover and its poor condition were latent unsafe conditions. As GET WET rocked violently from side-to-side, the 300 plus pound hatch cover broke free, pinning [REDACTED] leg against the starboard bulkhead, causing her to drown, and entrapping and injuring [REDACTED]. Had the hatch cover remained secured, [REDACTED] and [REDACTED] chances of escaping the sinking vessel would have significantly increased.

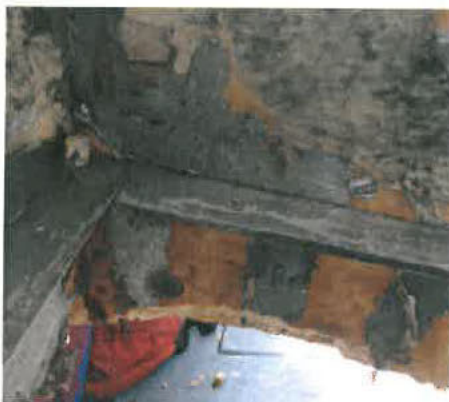
Interior wet rot and decay of the engine hatch cover.

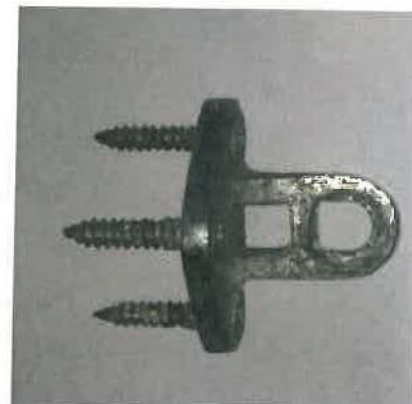
one inch wood screws used to secure the brackets for the hatch cover.
