**REPORT OF THE INVESTIGATION  
INTO THE  
LOSS OF LIFE ON BOARD THE PASSENGER VESSEL  
GOL MAKER (O.N. 1065056) IN THE GULF OF  
MEXICO ON NOVEMBER 26, 2022**

**EXECUTIVE SUMMARY**

**INVESTIGATING OFFICER'S REPORT**

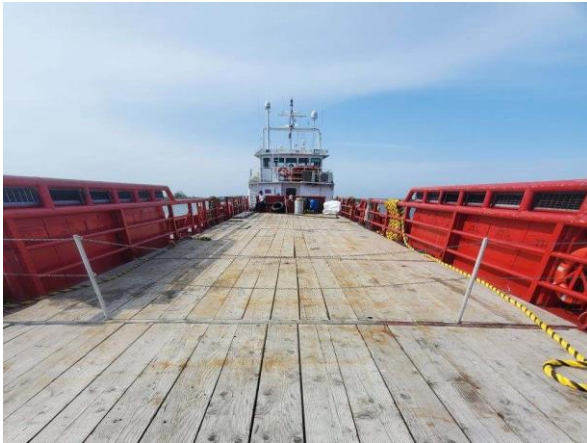
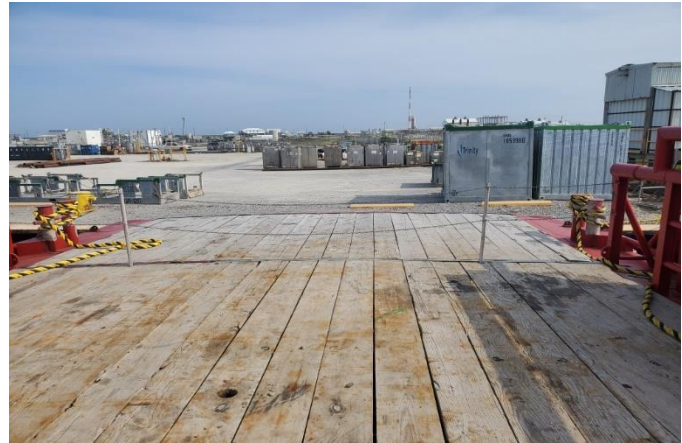
Figures 3 & 4. GOL MAKER Aft chain and stanchion arrangement looking forward and aft. Source: Rec Marine Logistics.

4.2.4. At the time of the mooring evolution on the GOL MAKER, the aft chain arrangement was down, as it would have prevented Deckhand 1 from egressing to the forward portion of the vessel in case of an emergency. There is no bulwark or chain that protects personnel from falling in the vicinity of the aft port or starboard bitts once they go beyond the stern chain arrangement.

- 5.2. **Ineffective aft railing arrangement.** The aft railing arrangement provided no protection for crewmembers line handling in the vicinity of the transom of the vessel. In order to effectively moor the vessel using the aft bitts, crew members were required to pass beyond the stanchion and chain arrangement to an area of the vessel with no railing or bulwark. If there had been railing or bulwark around the deck area where the crewmember was line handling, it is reasonable to assume they may have been able to catch themselves upon slipping and prevented them from falling overboard.

6.1.1.2. The approved, ineffective railing arrangement for protecting individuals operating in the vicinity of the GOL MAKER's aft bitts.

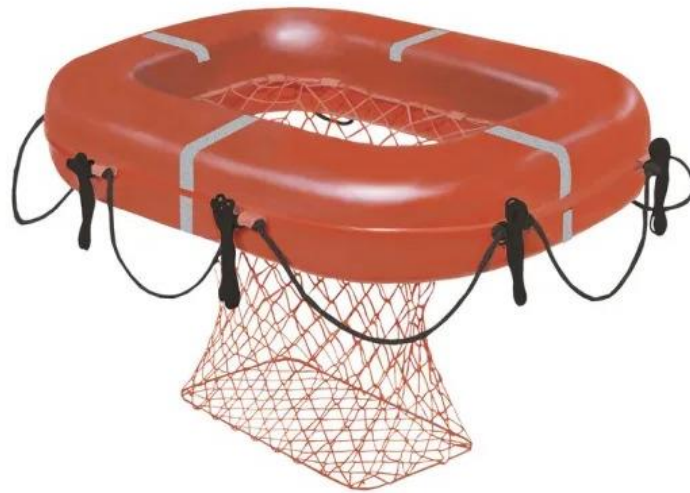
4.2.6. Per 46 CFR § 160.027-2(a), “Each life float must meet the requirements in subpart 160.010 of this chapter for a peripheral body type buoyant apparatus designed so that persons supported are only partially immersed (180 N (40 lb.) of buoyancy per person required)”. Life floats are designed to be held on to along the periphery and are not designed to support personnel within the inner ring of the life float. The life float deployed by SMI 99A was a Jim-Buoy 1200 series, 12 person life float.

Figure 5. Jim-Buoy life float, 1200 Series. Source: Fisheries Supply.

approximately 5 months. According to witness statements, the crew member attempted to climb into the life float deployed by the platform. If the crewmember had known that life floats are designed for personnel to hang off the side, it is reasonable to assume that he may have only held on to the side of the life float, not lost control of it, and conserved his energy, allowing him to hold on longer.
