**REPORT OF THE INVESTIGATION
INTO THE
FIRE ON BOARD THE NORWEGIAN
FLAGGED RO-RO CARGO SHIP
HOEGH XIAMEN (O.N. 9431848) WHILE
MOORED AT BLOUNT ISLAND
IN JACKSONVILLE, FLORIDA ON JUNE 4,
2020**

16732/IIA #6968687
January 21, 2025

**FIRE ON BOARD THE NORWEGIAN FLAGGED RO-RO CARGO SHIP
HOEGH XIAMEN (O.N. 9431848) WHILE MOORED AT BLOUNT ISLAND
IN JACKSONVILLE, FLORIDA ON JUNE 4, 2020**

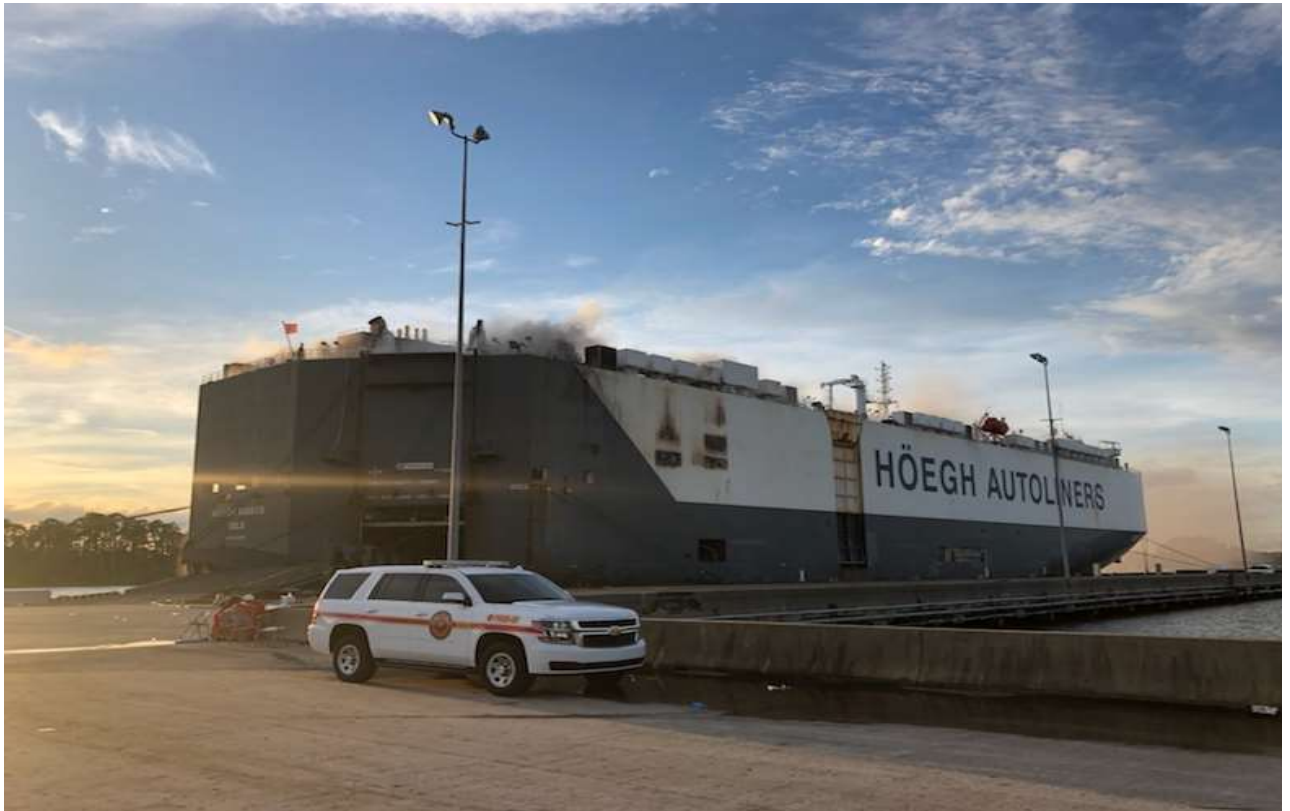
Figure 1. Photograph of *HOEGH XIAMEN* provided by Coast Guard, taken on June 4, 2020

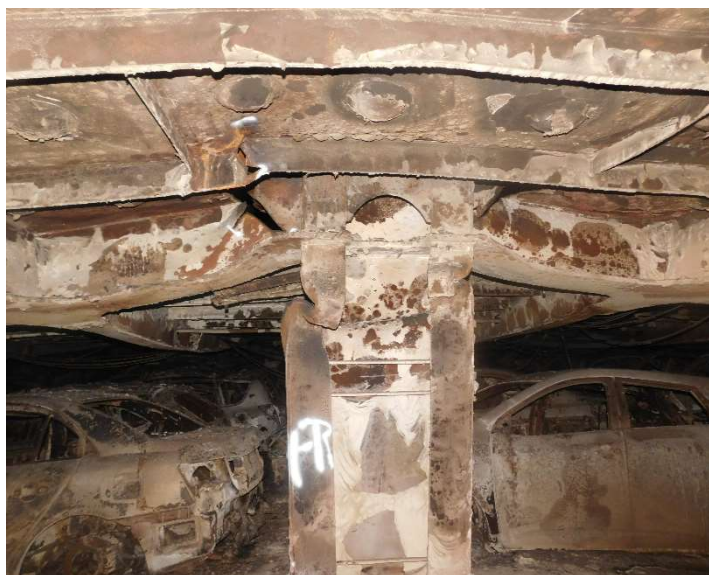
Figure 3. Deck 9 of the *HOEGH XIAMEN* taken on June 26, 2020, provided by the Coast Guard.

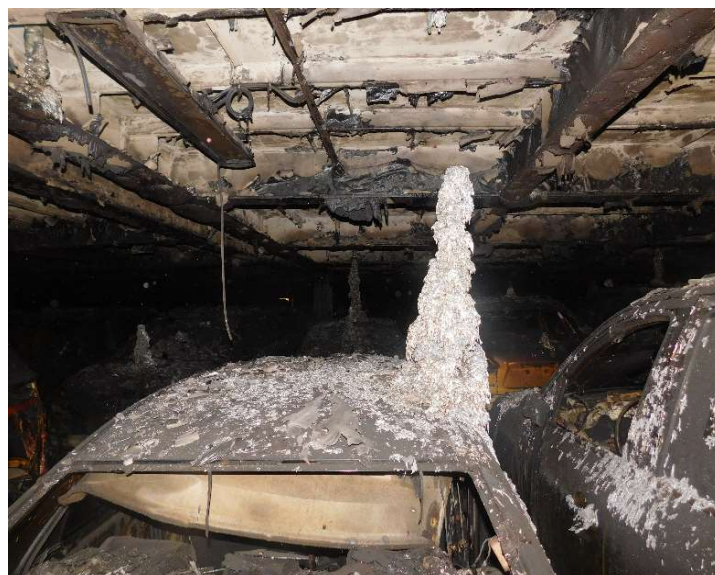
Figure 4. Deck 7 of the *HOEGH XIAMEN* taken on June 26, 2020, provided by the Coast Guard.

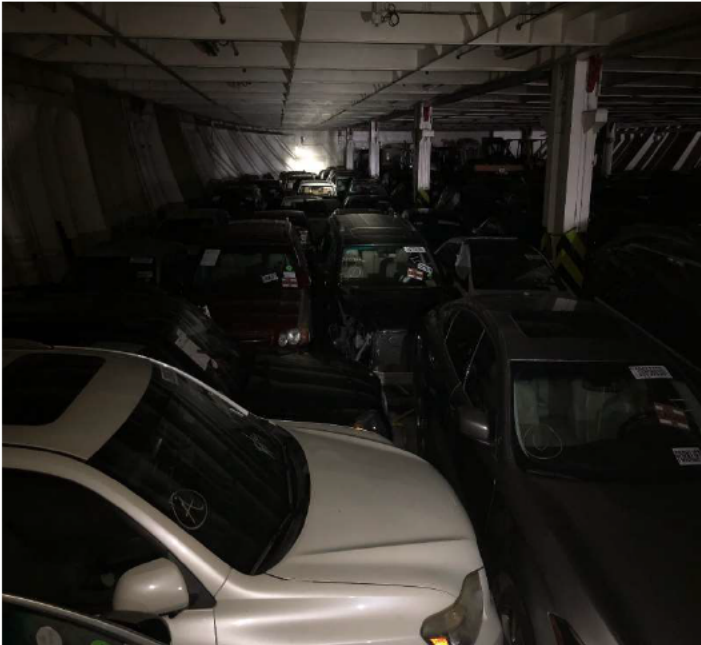
4.2.4. Grimaldi Deepsea S.p.A had a policy in place providing instructions to the terminal and stevedore company on how to prepare cars for loading onto the vessel. The policy required vehicles to have at least 1/8 tank of gas. The policy also required vehicles to be spaced with 4 inches between side rear view mirrors and 12 inches bumper to bumper.

Figure 5. Spacing of vehicles on deck 5 of the *HOEGH XIAMEN* taken on June 11, 2020, provided by the Coast Guard.

- 5.2. **Failure of the crew to prevent vehicles from leaking fluids excessively.** A policy was in place to load vehicles onto the vessel four inches apart between side mirrors, and twelve inches from front to rear bumper. This policy was communicated by the charterer (Grimaldi Deepsea S.p.A) to the stevedores in order to maximize the amount of cargo loaded. Investigators observed many vehicles placed closer than the requirements provided by Grimaldi Deepsea S.p.A. This loading arrangement created several rows of vehicles loaded onto the vessel that investigators could not walk through or inspect easily. It is likely that because the cars were so tightly packed together, crewmembers could not walk

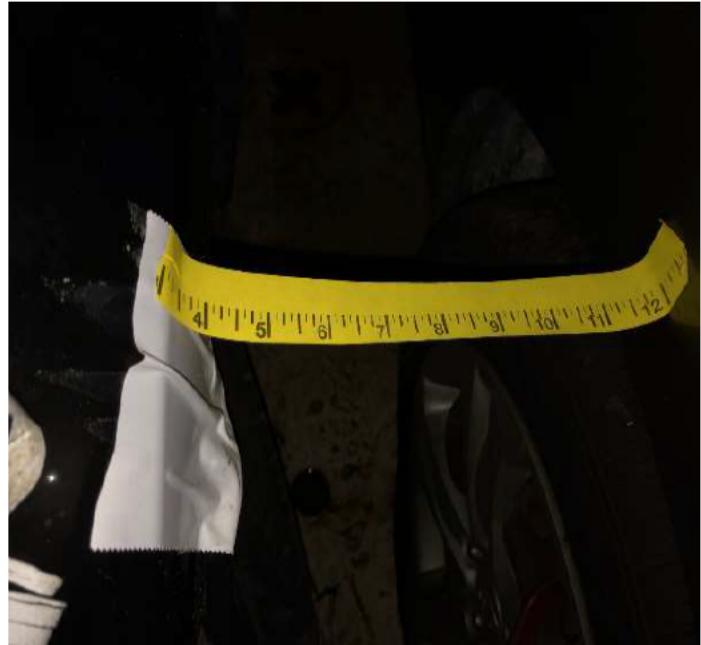
Figure 6. Spacing between vehicles on deck 5 of the *HOEGH XIAMEN* taken on June 11, 2020, provided by the Coast Guard.

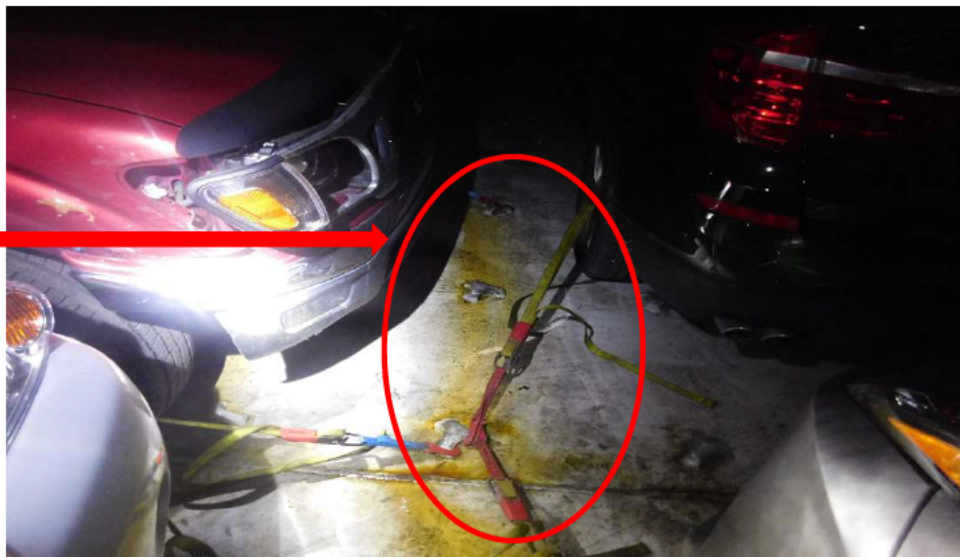
Fluid leaking from loaded vehicles

Figure 7. Vehicles loaded on deck 1 of the *HOEGH XIAMEN* taken on June 21, 2020, provided by the Coast Guard.

to be towed, and vehicles that were transported by trailer and forklift onto the vessel. The crewmembers stated that the cars loaded onto the vessel as cargo often leak fluid during loading and that the crew could smell gasoline fumes.

between vehicles, and not all vehicles were checked for leaking fluids. Upon boarding the vessel, investigators observed leaking fluids of various colors and smells on each deck unaffected by fire. During interviews, both the crew and stevedores stated that no vehicles were rejected for loading due to vehicle condition on either June 3 or 4. During interviews the crew of the vessel stated that the “vehicles always leak fluids”. Investigators observed numerous bags of saw dust on board, which the crew stated were used to clean leaking fluids from vehicles. According to the special provisions of the IMDG Code 961 and 962, when a motor vehicle is leaking fluid it must be classified as Class 9 Hazardous Material. The cargo manifest for the *HOEGH XIAMEN* did not have any vehicles labeled as hazardous material. It is likely that fluids from leaking vehicles provided a fuel source for the fire and allowed it to easily spread.

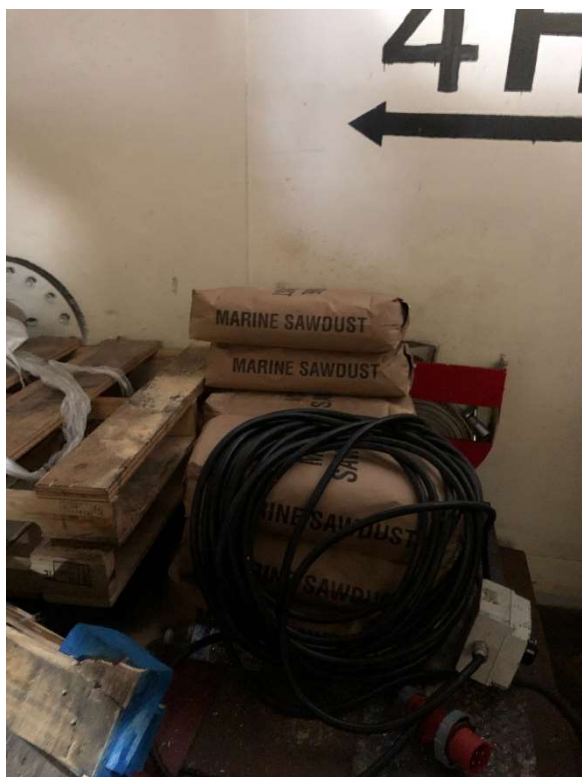
4.2.9. Investigating officers observed debris in vehicles loaded onto the vessel, including flammable materials. Investigating officers observed numerous 50 pound bags of marine sawdust on multiple cargo decks.

Figure 8. Bags of Marine Sawdust on deck 5 of the *HOEGH XIAMEN* taken on June 11, 2020, provided by the Coast Guard.

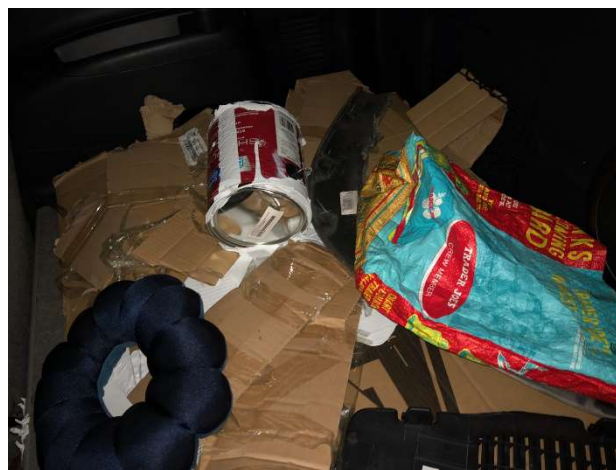
Figure 9. Paint and cardboard in a vehicle on deck 5 of the *HOEGH XIAMEN* taken on June 11, 2020, provided by the Coast Guard.

Investigators observed numerous vehicles loaded onboard the *HOEGH XIAMEN* that contained items such as cardboard, personal effects, ammunition, and paint cans. The presence of these additional items increased the fire load in the vessel's cargo hold, and could have presented an additional fire source.

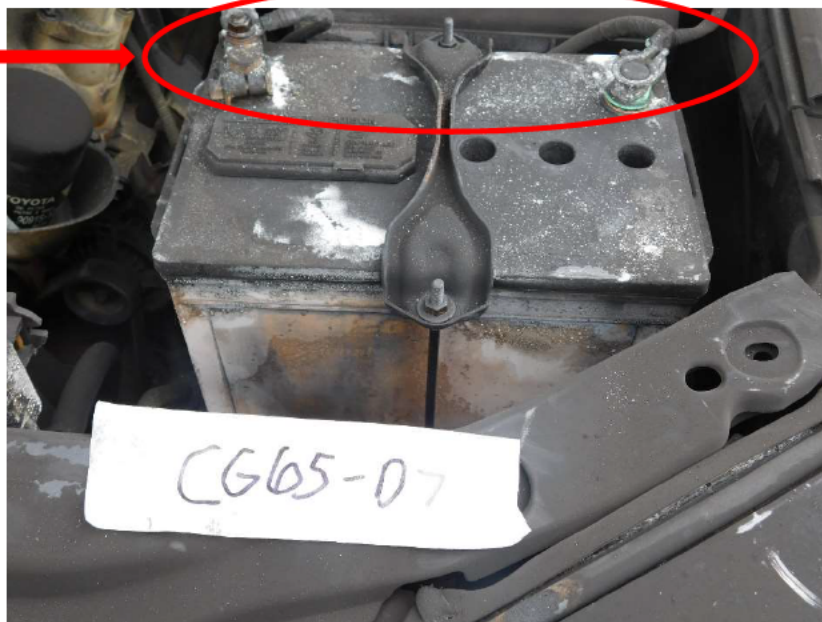
4.2.11. Stevedores stated that not all batteries were disconnected for vehicles on board. At least 58 batteries were not disconnected, as the Master or Chief Engineer signed a form from stevedores stating that 58 batteries were left connected.

Battery terminals
found connected.

Figure 10. A connected battery on a vehicle from deck 7 of the *HOEGH XIAMEN* taken on July 12, 2020, provided by the Coast Guard. The vehicle was originally towed onto the vessel by stevedores.

- 5.1. **Failure to disconnect and protect all car batteries loaded onto the vessel.** The stevedores documented that a total of 58 vehicles loaded onto the vessel in Jacksonville did not have their batteries disconnected prior to being lashed and stowed for sea. During interviews stevedores stated that they were given instructions by Grimaldi Deepsea S.p.A, who was the vessel charterer at the time of loading, to disconnect all “tow and runner” car batteries when loaded. The instructions provided by Grimaldi to the stevedore company (Atlantic SSA) stated that there should be no exceptions to the battery disconnect policy. The acknowledgment by the vessel’s Master and Chief Officer that 58 vehicles did not have their battery disconnected is in violation of the policy provided by Grimaldi to the stevedores, as well as special provisions 961 and 962 of the IMDG Code because vehicles were also known by the crew to be leaking fluids. Coast Guard investigators observed leaking vehicles on non-fire affected decks during their investigation. The vessel’s crew knew the vehicles leaked fluid, therefore the exceptions to the IMDG Code for vehicle stowage as cargo did not apply to the vessel for this voyage. The failure to disconnect or prevent these batteries from short circuiting created a potential ignition source for the fire.

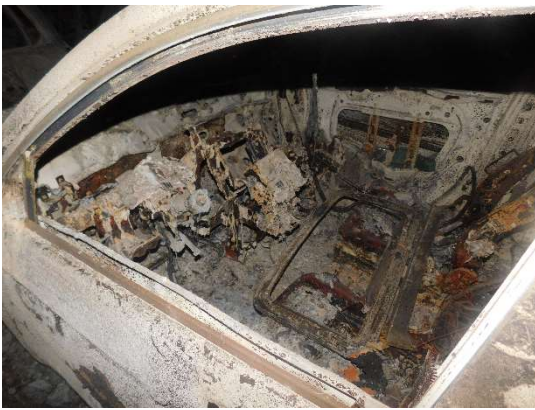
The condition of the cars loaded on the vessel was used; many of which had clearly been in accidents and sustained high levels of damage. Damage to vehicles can result in the

Figure 11. A vehicle on deck 8 of the *HOEGH XIAMEN* taken on June 26, 2020, provided by the Coast Guard.

vehicle's wiring and electrical harnesses sustaining damage. Wires in contact with metallic surfaces creates a ground when energized. This electrical ground results in heat being generated at the point of the ground. It is likely that a damaged vehicle loaded onto the vessel had an electrical ground, short, or other similar condition. If the battery was not disconnected, this could have allowed current to flow through the damaged electrical system, and subsequently could have produced enough heat to start a fire. Because the fire burned in excess of seven days and at temperatures exceeding 1000° F, no specific source of the fire was able to be identified by the Coast Guard. However, it is likely the fire was ignited from an electrical short within a damaged vehicle with its battery still connected. Another possible source of ignition was that battery cable lugs resting on or near unprotected battery terminals could have provided a source of electrical arcing. This demonstrates a failure to protect car batteries against short circuiting in accordance with the IMDG Code special provisions 961 and 962, which mandates motor vehicle batteries be prevented against short circuiting, could have provided the source of the vessel fire.

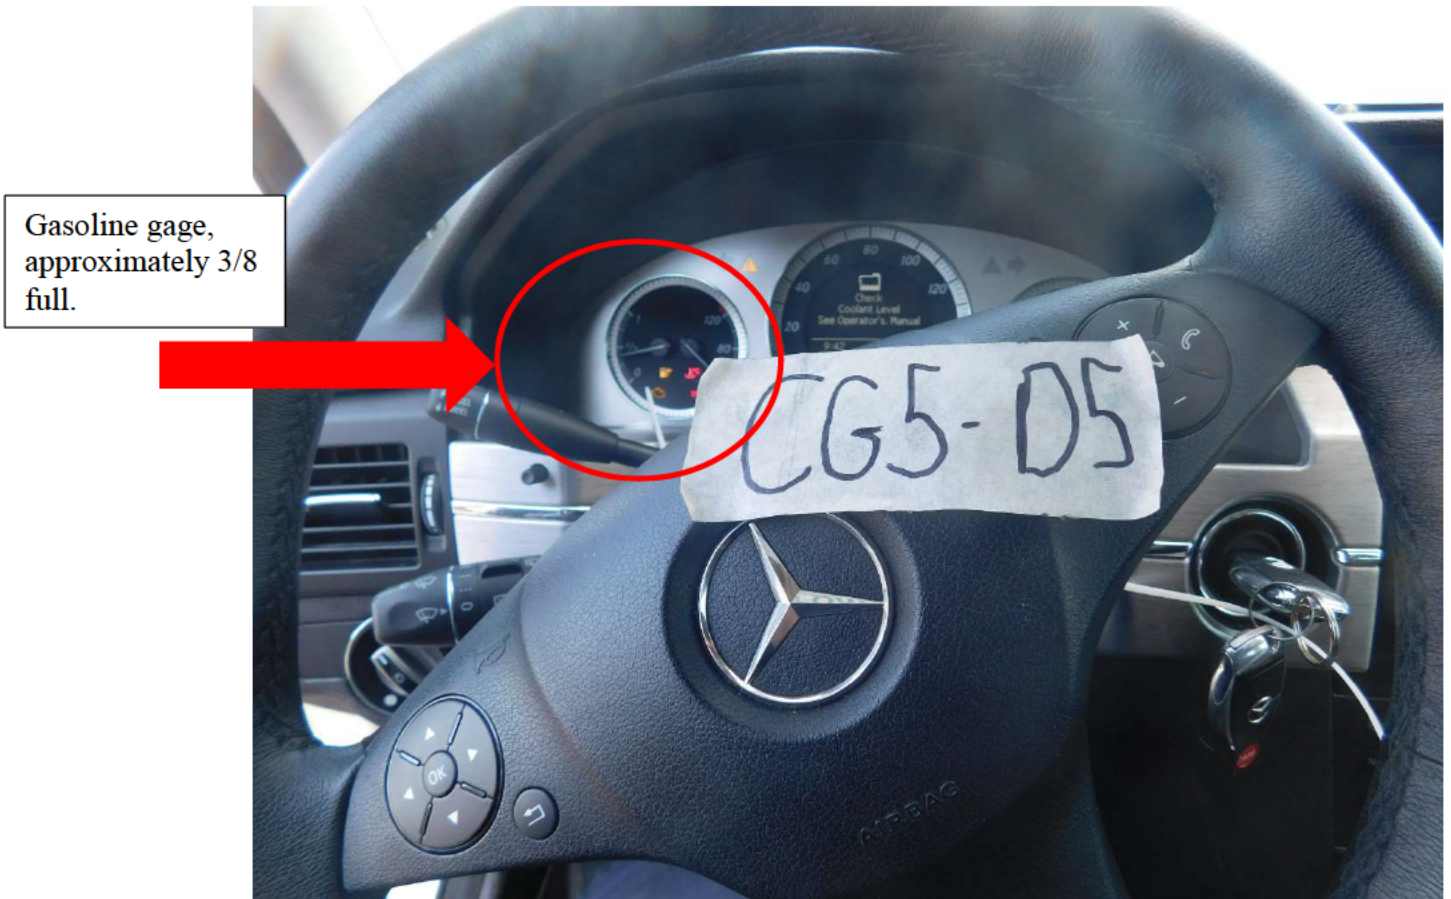
consistent with IMDG Code requirements, all units must have at least 1/8 tank of gas. During the interview of the terminal manager conducted by the Coast Guard, the terminal manager stated that vehicles that arrive with more than 1/8 tank of gas are allowed to be loaded onto the vessel as they have gasoline in excess of the minimum level required by Grimaldi. The terminal manager further stated that the tows and forklift vehicles are not checked for gasoline levels, as the vehicles cannot be started. Additionally, during the offload of the unaffected cargo, investigators were able to determine that gasoline was present in two of the “forklift” vehicles, one of which had 3/8 tank of gas.

Figure 12. A vehicle from deck 5 of the *HOEGH XIAMEN* taken on July 9, 2020. The car was designated a forklift and has approximately 3/8 tank of gas, provided by the Coast Guard.

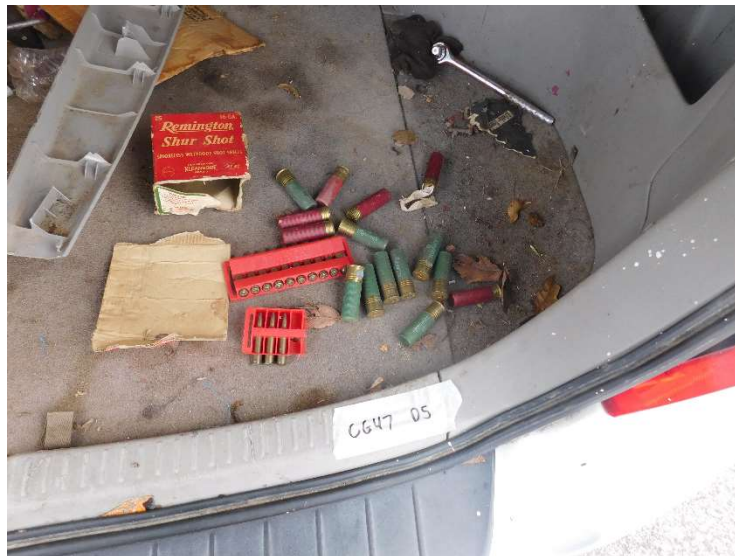
Figure 13. A vehicle from deck 5 of the *HOEGH XIAMEN* taken on July 9, 2020. The car was loaded with personal effects and ammunition, provided by the Coast Guard.

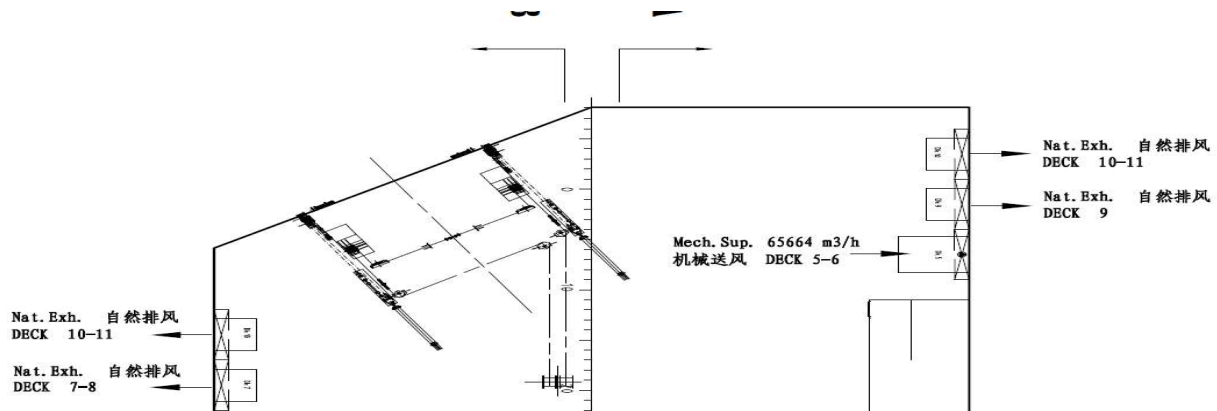
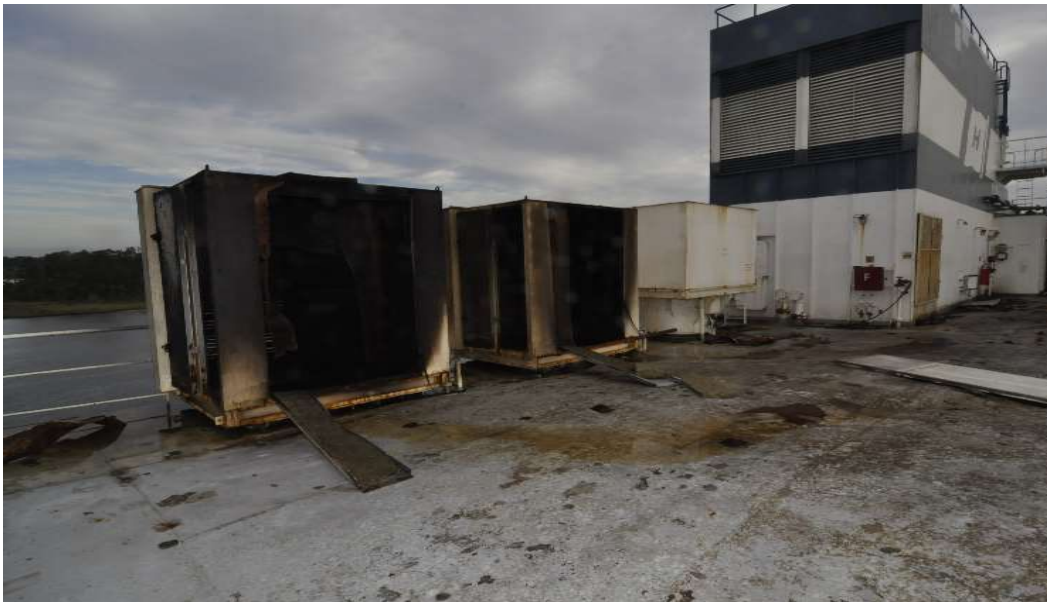
6.1.3. Following the fire, the vessel's crew turned over firefighting efforts to Jacksonville Fire Rescue Department (JFRD). The fire fighters boarded the vessel and opened ventilation to decks 9, 10, and 11 which caused the first re-flash. Causal factors leading to this event were:

sought to increase ventilation to the vessel decks, opening up ventilation ducts that ventilated decks 9, 10, and 11, which had previously been closed by the vessel's crew. Once the vents were opened, air could flow into the upper decks, which caused the fire to spread and become out of control. If the firefighters from JFRD had been trained in shipboard firefighting, they likely would not have opened ventilation to the additional decks, minimizing the potential for the fire to spread.

Figure 14. Vents for decks 9, 10, and 11 of the *HOEGH XIAMEN*'s excerpt from the vessels ventilation drawing provided by HEOGH Technical Management INC. Note deck 10 and 11 have a common vent. Below: photo of top deck vents taken on July 13, 2020, provided by Resolve.
