**REPORT OF THE INVESTIGATION
INTO THE
TANK SHIP MTM DUBLIN (IMO NO. 9335824)
CREWMEMBER LOSS OF LIFE IN MASSACHUSETTS
BAY, APPROXIMATELY 6 NMI EAST OF NAHANT, MA
ON SEPTEMBER 26, 2023**

MISLE ACTIVITY NUMBER: 7798704

INVESTIGATING OFFICER'S REPORT

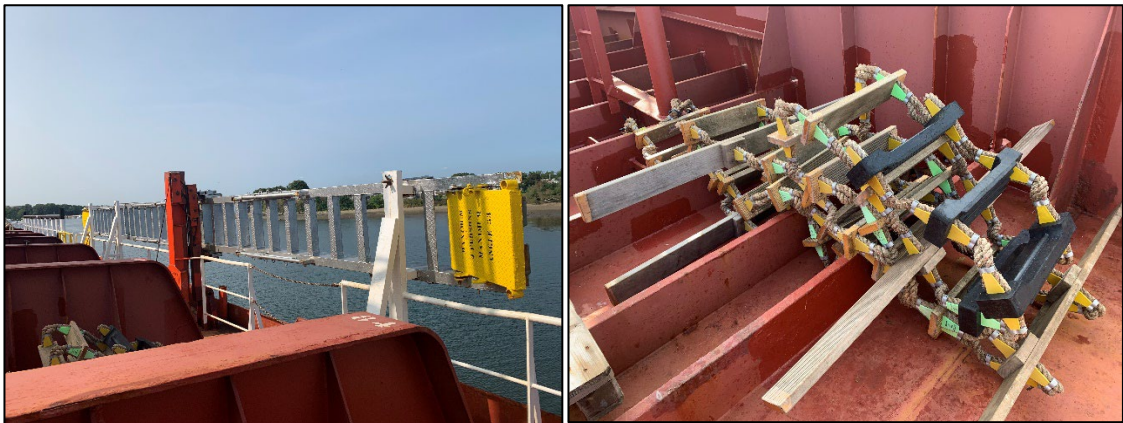
Figure 3. Photos of accommodation ladder (left) and pilot ladder (right) in stowed position, onboard the MTM DUBLIN taken September 27, 2023 (Source: USCG).

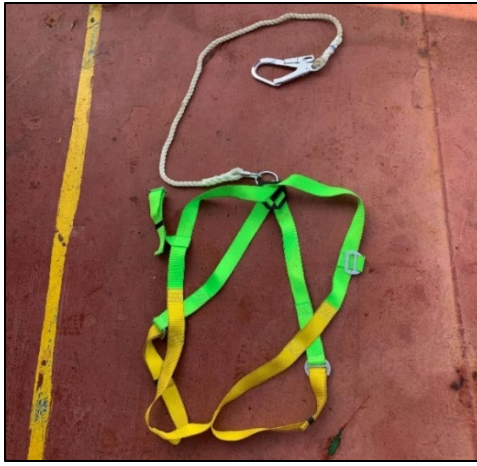
4.1.4. The pumpman donned a hard hat, inflatable lifejacket, safety harness and a safety line with an attached clip (Figure 4) in preparation for working over the side. The AB donned a hard hat and an inflatable lifejacket over his orange coveralls.

Figure 4. Photo of safety harness with clip similar to the one worn by the pumpman on the MTM DUBLIN, taken September 27, 2023 (Source: USCG).

8.2.1.1. Conduct refamiliarization with crews focused on the PPE requirements related to working near ship's side and over the side in accordance with SMS procedures. The refamiliarization should reinforce the need for safety harnesses to be worn at all times for both of these operations and emphasize the need to reassess safety risks if there are changes in the operational parameters such as a change in work assignments or change in environmental conditions.

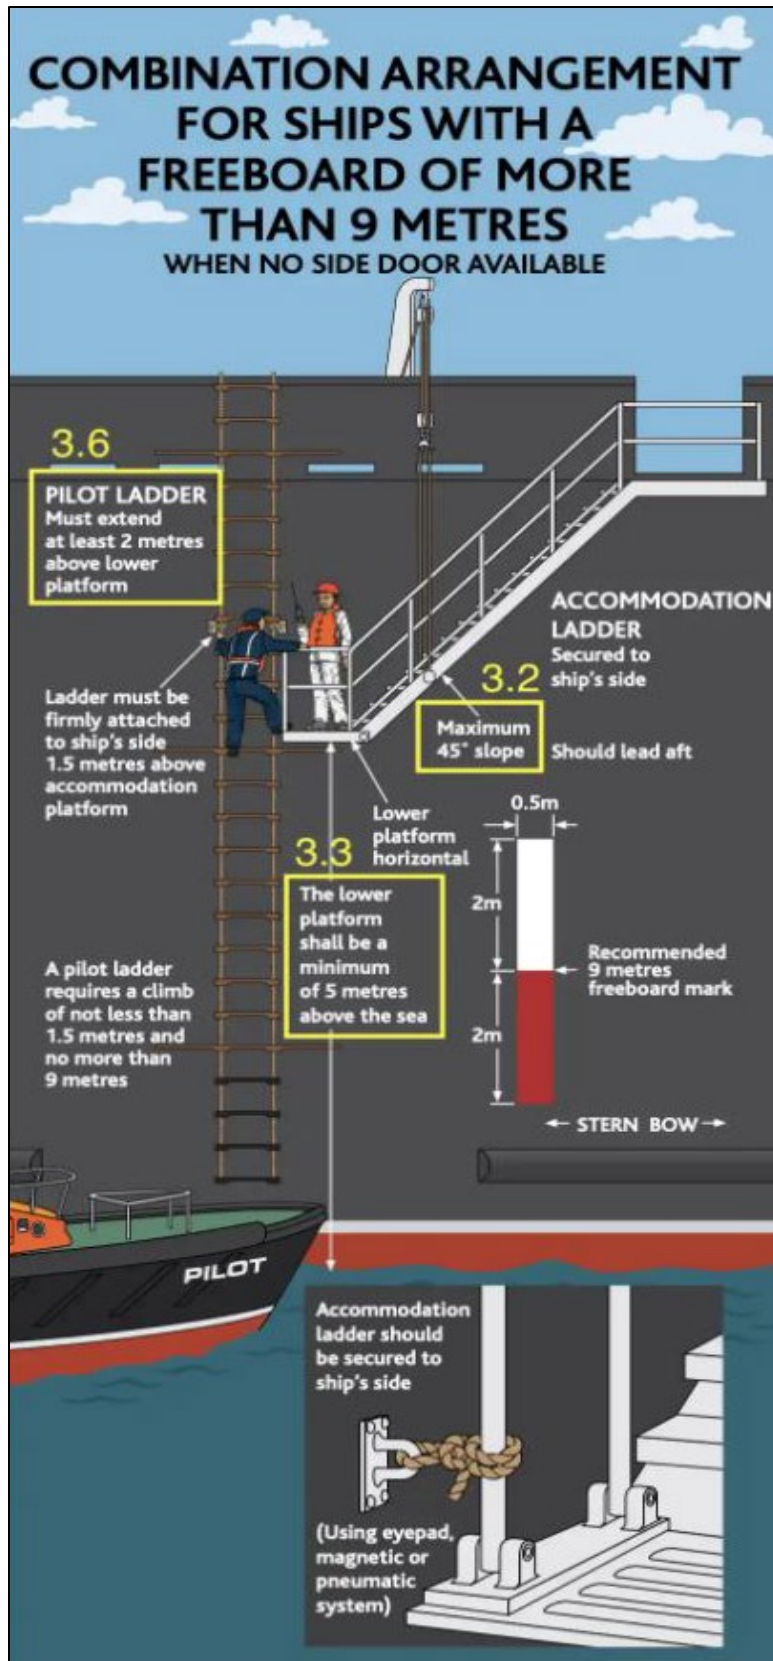
4.1.6. At 0425, the pumpman walked down the accommodation ladder to the lower platform to attach magnets to the pilot ladder and accommodation ladder which functioned secure the ladders to the side of the vessel. The lower platform was approximately 2 to 3 meters above the waterline (Figure 5).

Figure 5. Diagram showing accommodation ladder and pilot ladder arrangement for pilot boarding in accordance with SOLAS Regulation V/23 and International Maritime Organization (IMO) Resolution A.1045(27) (Source: IMO/International Maritime Pilots' Association).

5.4. Lower Platform of Accommodation Ladder Below Recommended Height: The MTM DUBLIN utilized a combination arrangement for pilot embarkation, rigging the accommodation ladder and the pilot ladder together, in accordance with SOLAS Regulation V/23 and IMO Resolution A.1045(27). This arrangement is required if a vessel’s freeboard is more than 9 meters, which applied to the MTM DUBLIN due their freeboard measuring at 9.2 meters. Section 3.3 of IMO Resolution A.1045(27) states that the lower platform of the accommodation ladder should be a minimum of 5 meters above the waterline. The lower platform of the accommodation ladder on the MTM DUBLIN was approximately 2 to 3 meters above the waterline when this incident occurred. The wave that swept the AB off the accommodation ladder was observed by the pumpman to be over his head, which indicates the wave exceeded the height of the lower platform. Although the minimum height is only a recommendation and vessels may have different arrangements, this placement made the accommodation ladder more susceptible to being hit by waves exceeding the height of the lower platform. Had the lower platform been at the recommended 5 meters above the waterline, it is possible the surrounding waves may not have affected the lower platform.

6.1.1.4. The lower platform of the accommodation ladder was 2 to 3 meters above the waterline, lower than the IMO's recommended minimum height of 5 meters.

8.2.1.2. Assess the possibility for reconfiguring the combination arrangement for pilot embarkation to meet the recommended minimum 5 meters height of the accommodation ladder's lower platform in accordance with SOLAS Regulation V/23 and IMO Resolution A.1045(27).

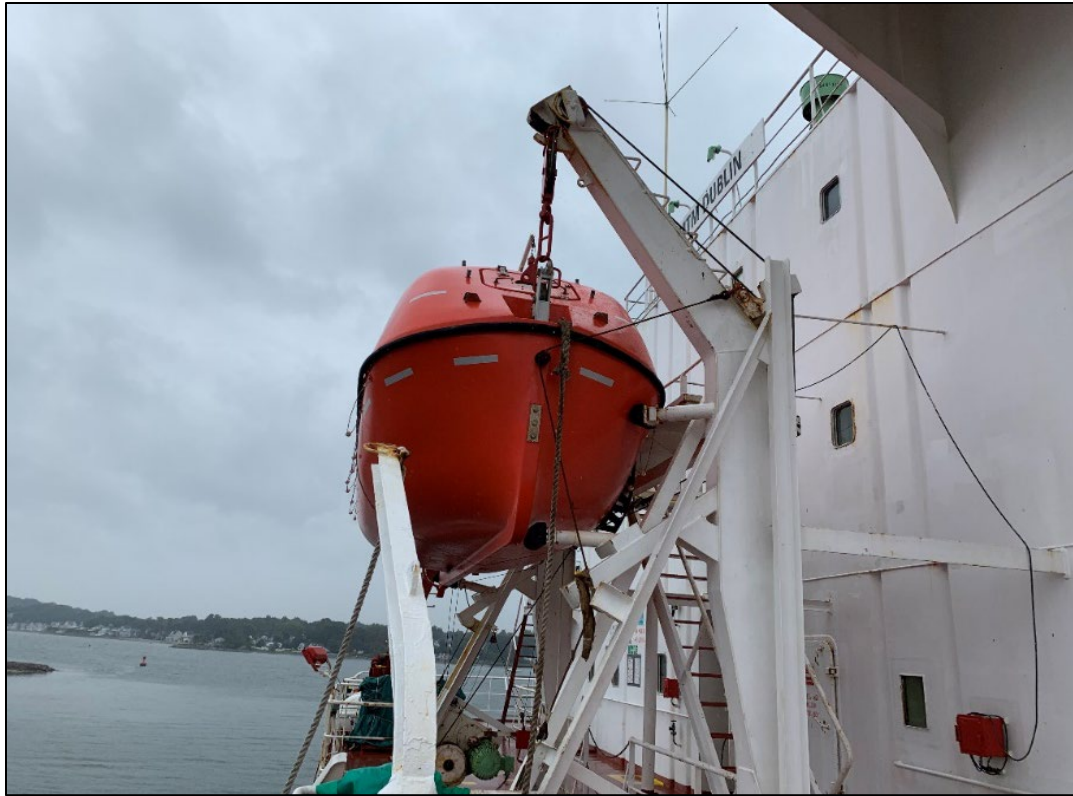
4.1.23. The deck crew on the MTM DUBLIN attempted to launch the starboard rescue boat to recover the AB on two separate occasions (Figure 7). The first attempt was at 0450 and the second attempt was at 0458, but weather conditions were too rough to lower the rescue boat safely.

Figure 7. Photo of starboard rescue boat onboard the MTM DUBLIN taken September 29, 2023 (Source: USCG).

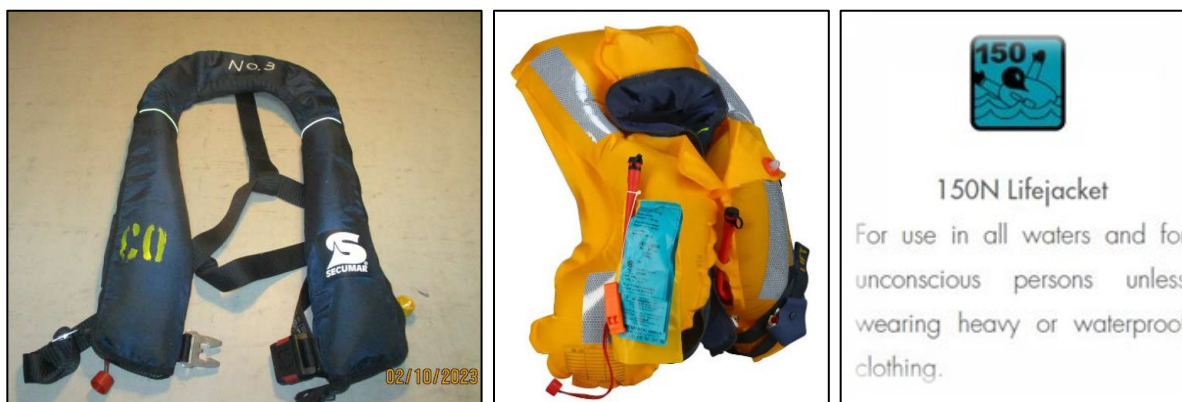
4.2.8. The inflatable lifejacket donned by the AB was a Secumar Golf 150 SOLAS inflatable lifejacket, designed with a dual CO2 inflation system for both automatic and manual inflation (Figure 9). The lifejacket had a dark blue protective cover with a yellow buoyancy bladder that is secured inside the protective cover when not inflated, and black straps which came down from the back of the lifejacket and snapped with a buckle around the waist. The lifejacket was designed to turn an unconscious wearer face-up. Service and inspections had been performed on the lifejacket in accordance with manufacturer's recommendations with no issues noted.

Figure 9. Particulars of the same type of lifejacket the AB donned the day of the incident, Secumar Golf 150 SOLAS. (Left) Photo of the lifejacket with the buoyancy bladder stowed (Source: C/O, MTM DUBLIN). (Center) Photo of the lifejacket when inflated (Source: Secumar.com). (Right) The buoyancy rating of the lifejacket (Source: Secumar.com).

6.1.2.1. Failure or malfunction of the AB's lifejacket inflation mechanism or buoyancy chamber, as the lifejacket was designed to fully inflate automatically and turn an unconscious wearer face-up.

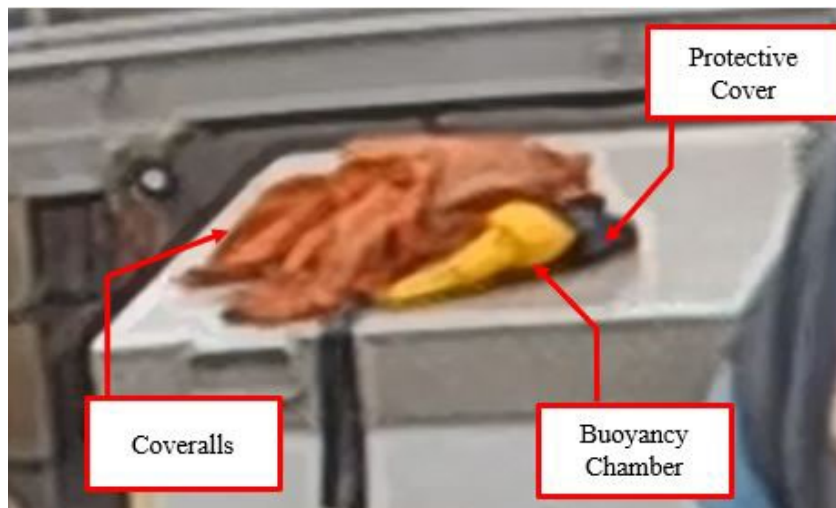
5.5. Lifejacket Failed to Fully Inflate: The lifejacket that the AB was wearing, a Secumar Golf 150 SOLAS, had a dual CO2 inflation system capable of manual and automatic

inflation. With automatic inflation, the lifejacket is designed to fully inflate in the water and turn an unconscious wearer face-up. The AB was never observed as being conscious by the deck crew, so it was unlikely that he attempted to manually inflate the lifejacket. From the MTM DUBLIN deck crew's observations, the lifejacket was inflated; however, the AB was face-down when they observed him in the water indicating it hadn't fully inflated. When the crew onboard the AMERICA located the AB in the water, he was reported as face-down and they observed, both when he was in the water and after recovering him, that his lifejacket was only partially inflated. The lifejacket was thrown away by a crewmember on the AMERICA later that morning and unable to be recovered for examination by the marine casualty investigators. Based on witness observations of the AB in the water and body camera footage of the lifejacket obtained from the Massachusetts State Police, it is highly possible the lifejacket failed or malfunctioned impacting the lifejacket's capability to fully inflate (Figure 11). Had the lifejacket properly inflated, it is likely the AB would have remained face-up as designed.

Figure 11. Screen capture from Massachusetts State Police body camera footage taken after the AMERICA arrived at Boston Fish Pier and AB had been transported via ambulance to the hospital, showing AB's orange coveralls and lifejacket (Source: Massachusetts State Police).
