**REPORT OF THE INVESTIGATION
INTO THE
PRESIDENT EISENHOWER (IMO No. 9295220),
MAIN ENGINE SPACE FIRE WHILE UNDERWAY
IN THE SANTA BARBARA CHANNEL ON APRIL
28, 2021.**

MISLE ACTIVITY NUMBER: 7184564

INVESTIGATING OFFICER'S REPORT

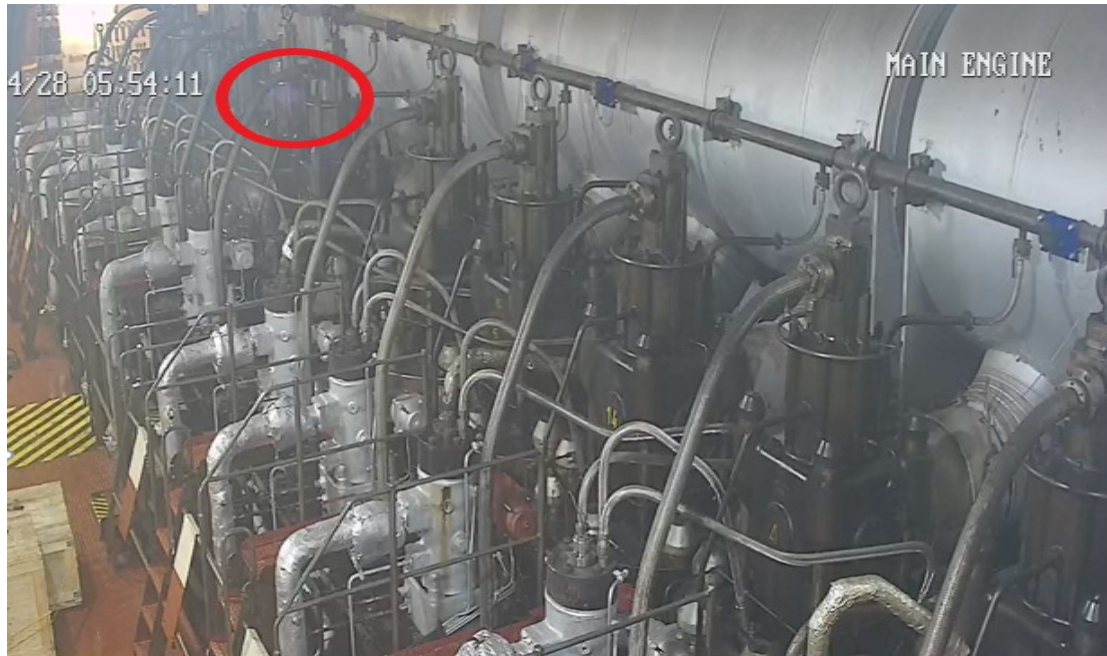
4.1.6. At 0124, a leak of atomized fuel was captured on the ship's internal video recording device in the vicinity of the No. 4 and No. 5 main engine cylinders.

Figure 3. Screen shot of the main engine feed ships internal video recording device showing oil mist cloud accumulating near cylinder No. 5. (Source: APL)

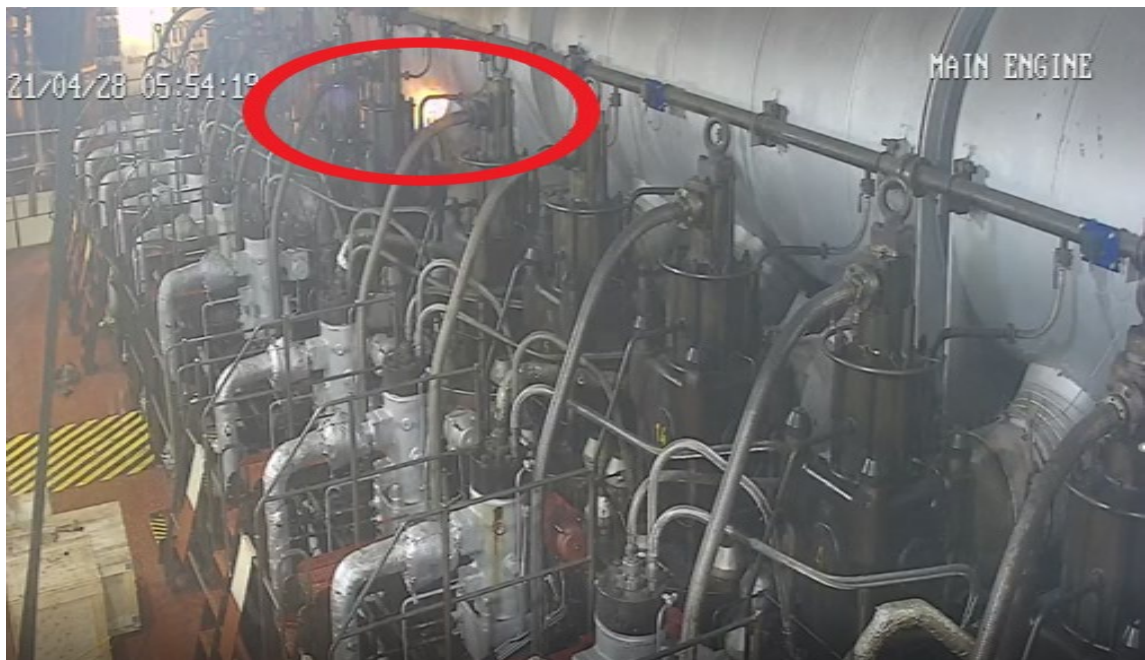
4.1.7. At 0154, when the vessel was approximately 17 miles southwest of Santa Barbara, CA; the main engine leak reached the engine exhaust lines and caused the fuel oil fumes to ignite on the flange of the exposed exhaust valve bellows. At the time the fire began, the machinery space was in an unattended status. The fire was then recorded spreading from the No. 5 cylinder head to two adjacent cylinder heads (No. 4 and 6). The flames from the fire on the main engine eventually reached the boiler flat more than 30 feet above. This caused nearby spare part boxes and ship stores to ignite.

Figure 4. Screen shot of the main engine feed ships internal video recording device showing the moment the first explosion occurred at cylinder No. 5 exhaust bellows. (Source: APL)

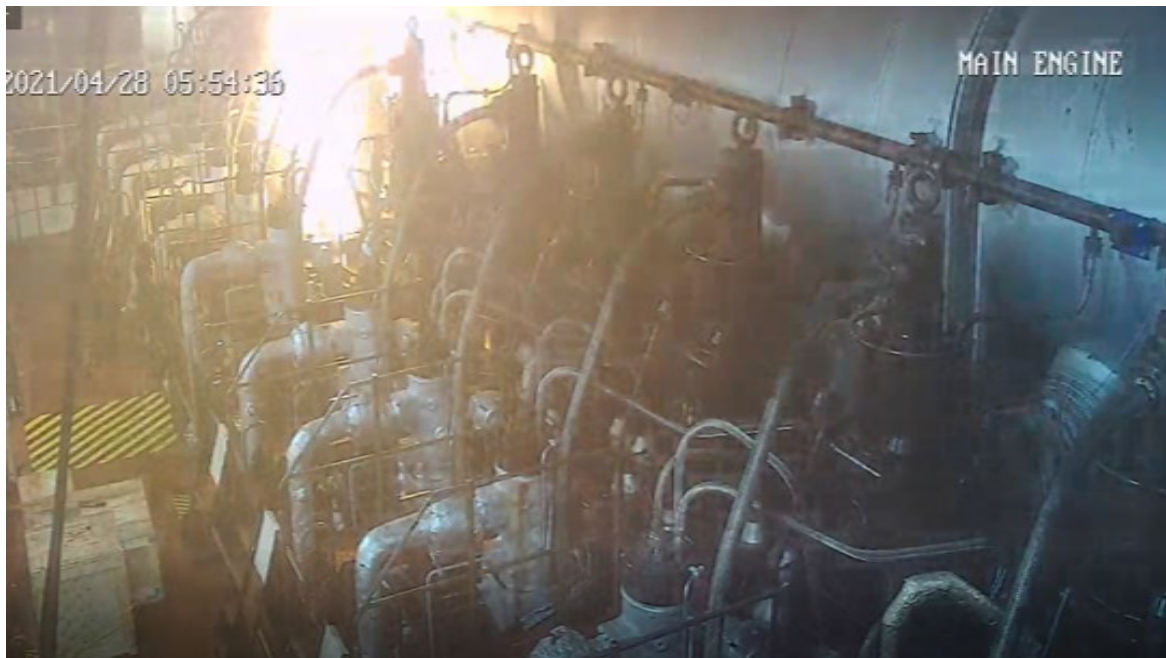
Figure 5. Screen shot of the main engine feed ships internal video recording device showing the flames spreading to cylinders 4 and 6. (Source: APL)

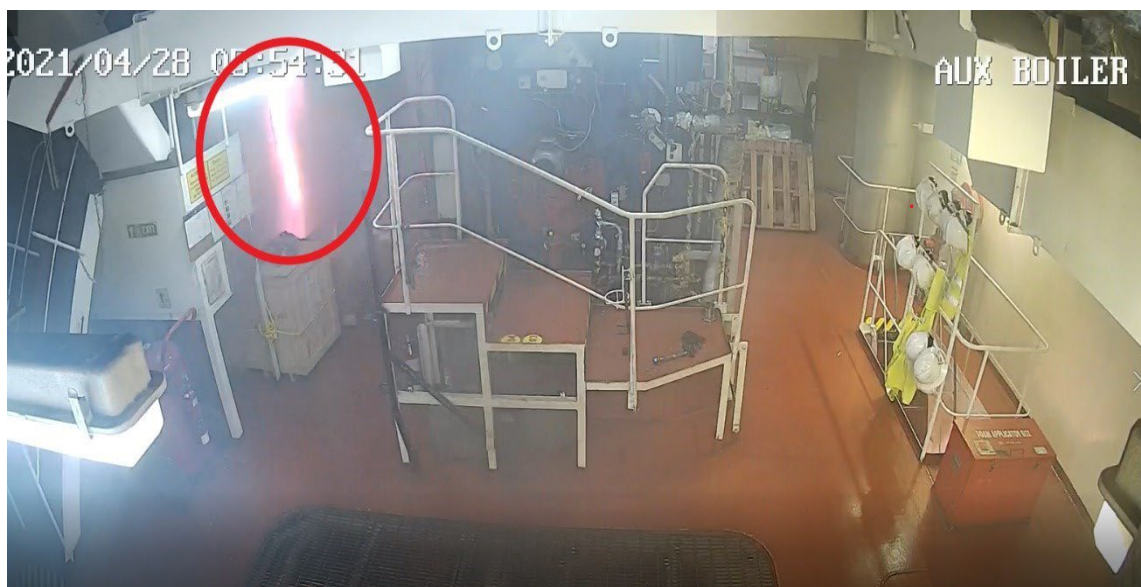
Figure 6. Ships camera video showing the flames from the main engine reaching the boiler flat. (Source: APL)

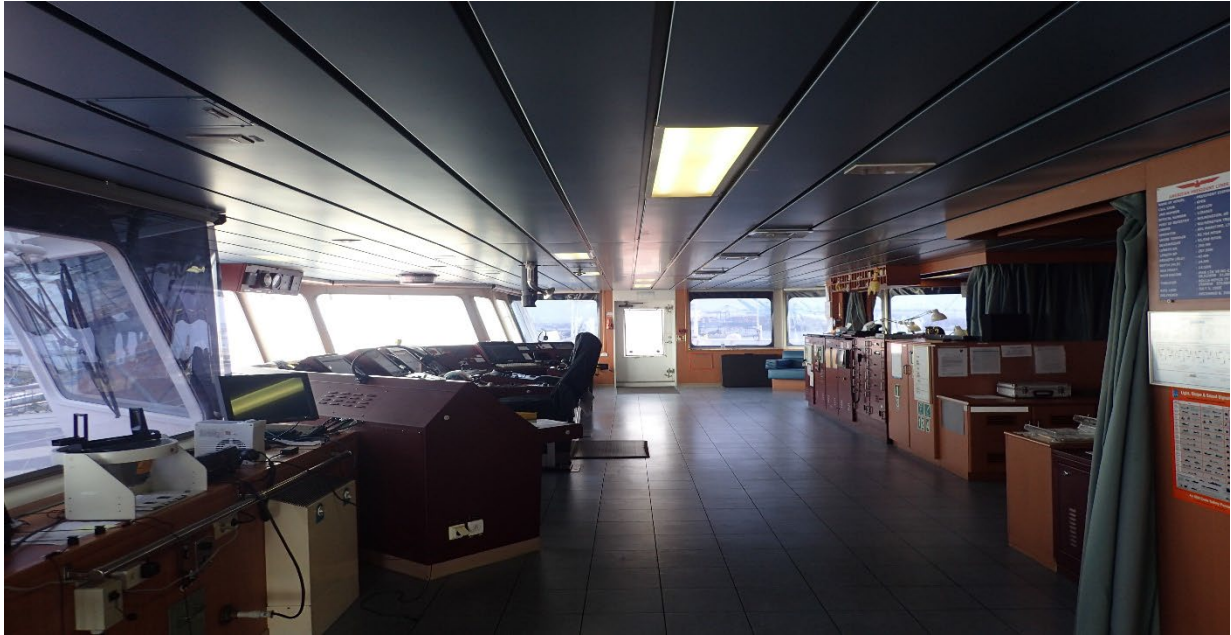
4.1.11. At 0202, smoke from the fire started to collect inside the bridge and obscure visibility for the bridge team. The Master transferred steering and throttle control to the starboard bridge wing to maintain control of the vessel. The bridge wing doors were opened to promote ventilation. The Master also began reducing engine rpm to slow the vessel and decrease the amount of fuel flowing to the main engine.

Figure 7. Photograph of the bridge as seen from the port bridge wing door (Source: U.S. Coast Guard)

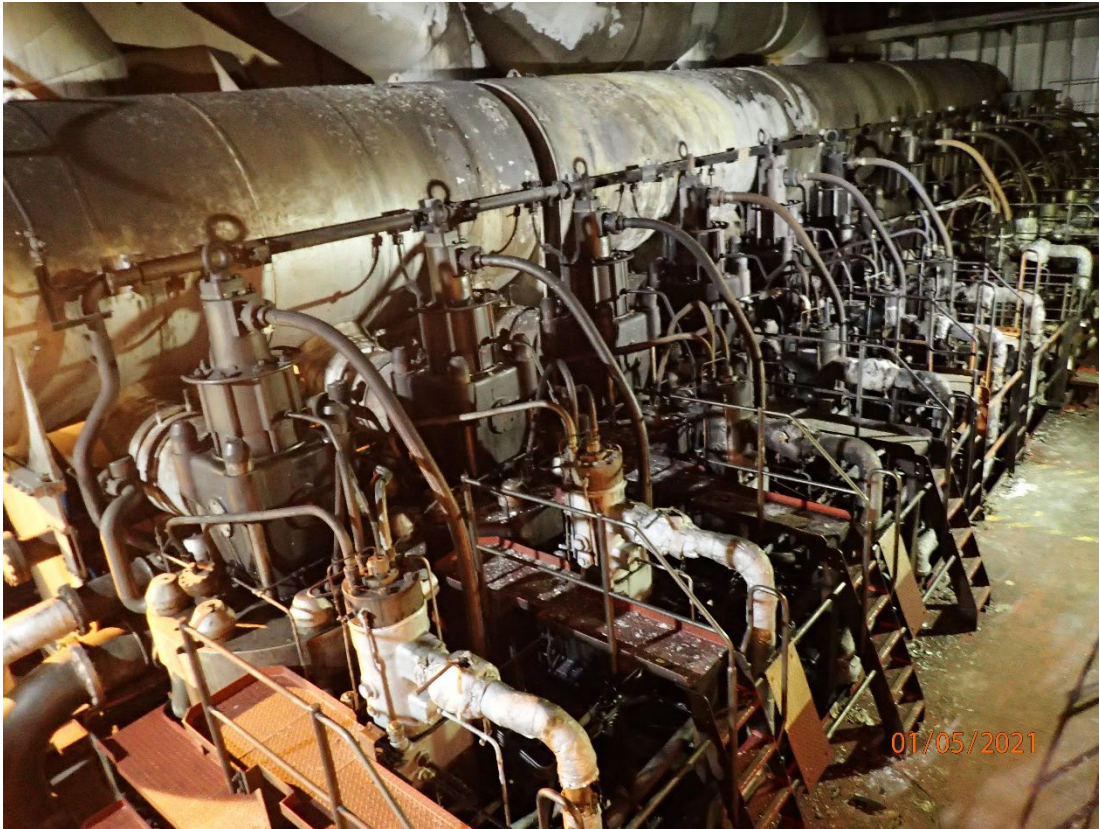
Figure 8. Photo taken on April 30, 2021 showing the fire damage to the port side of the main engine. (Source: U.S. Coast Guard)

7.1.1. Overhaul of the main engine with repair or replacement of all components affected by the fire.

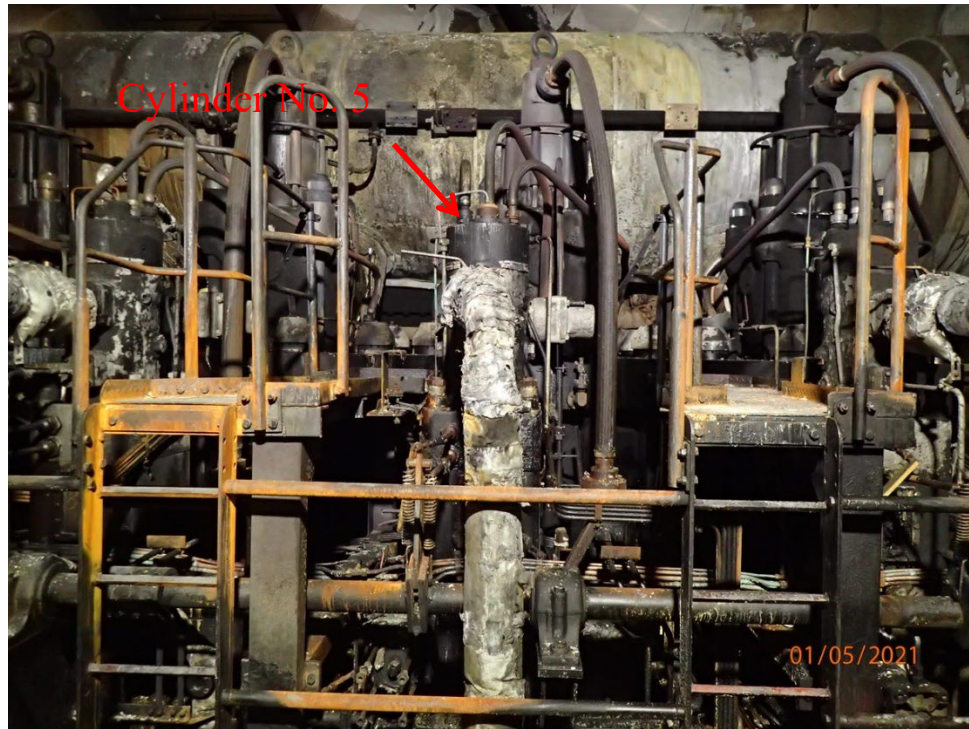
Figure 9. Side view of main engine and the initial location of the fire. (Source: U.S. Coast Guard)

5.3. *Insufficient insulation of the cylinder cover and exhaust system surfaces.* After the fuel oil return line detached from the fuel system, oil droplets began spraying onto the cylinder covers and exhaust system. Under normal operating conditions, the surface temperature of an uninsulated cylinder cover and/or exhaust piping can reach 600° F. Fuel spraying onto these surfaces quickly ignited and allowed the fire to spread rapidly. Had the surfaces been insulated or shielded, the spraying oil droplets may not have ignited so quickly.

8.1.4. M-25-04: Recommend that APL install insulation and shielding for high temperature engine room components.

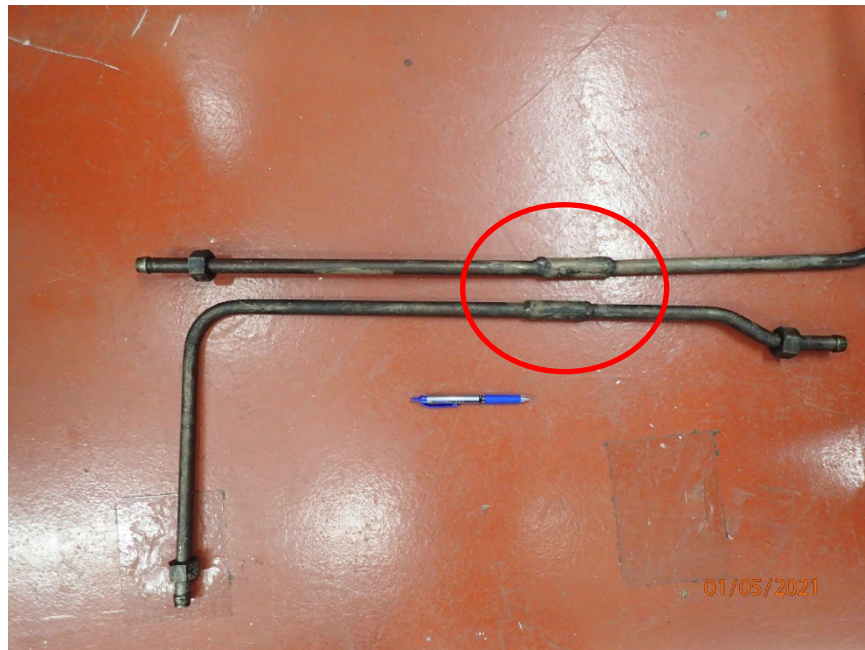
4.1.53. On Feb 13, 2021, while enroute to Los Angeles and approximately two months prior to the fire, the crew noted the No. 5 cylinder fuel oil return line had developed a pinhole leak. The ship stopped its main engine to complete a temporary welded repair of the fuel oil return line. The repair was documented in the ship's log and NS5 maintenance system. Neither the USCG nor the class society was notified of the repair.

Figure 11. Picture of the tubing repaired by the crew with an emergency weld. (Source: U.S. Coast Guard)

5.2. *Failure to report the material defect of the No. 5 fuel oil return line.* The pinhole leak in the No. 5 cylinder fuel oil return line was not reported to the vessel's classification society, DNV. DNV Rules state that this type of material defect is required to be reported in accordance with the Rules for Classification: Ships Pt. 1 Ch. 1 Section 3 Paragraph 1.2.2: The rule states: “

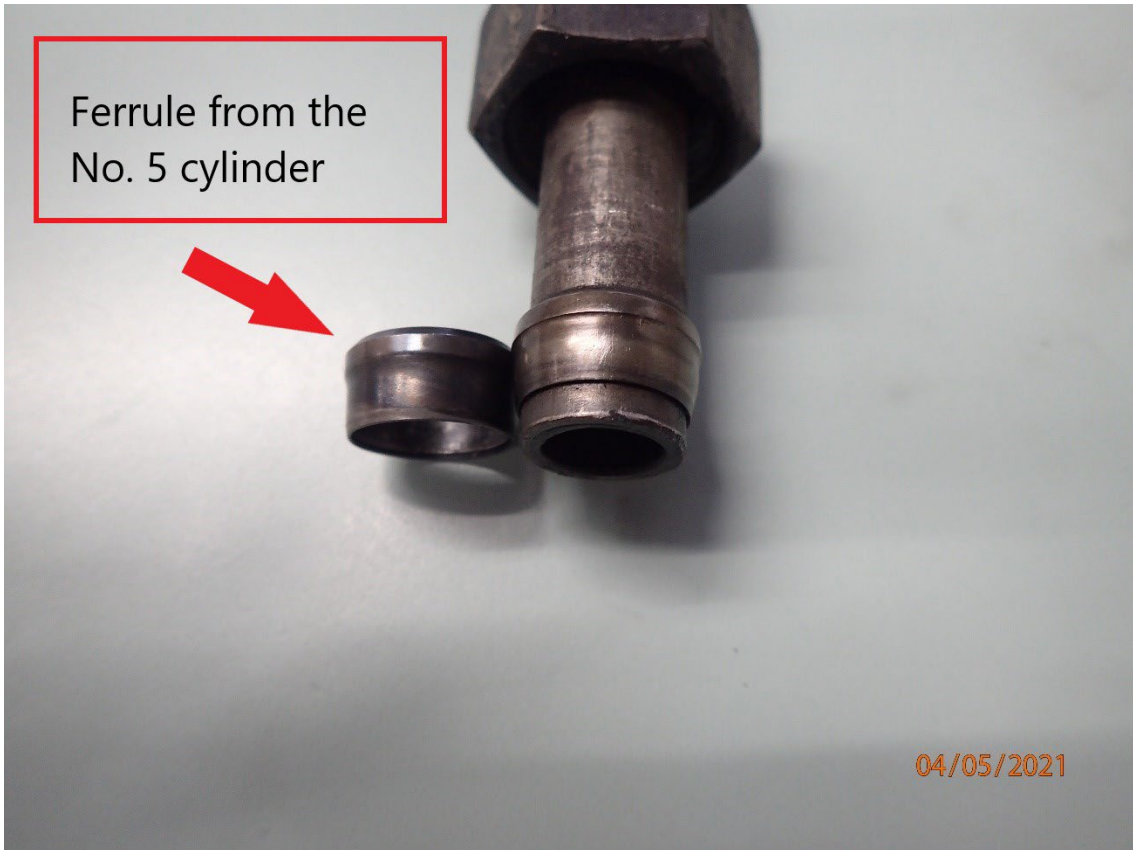
4.1.56. On April 23, 2021, the 2nd A/E was instructed to replace the fuel oil return line. This was his second time performing such a task and he stated he was unfamiliar with a key step in the process which involved crimping or "swaging" the fuel line ferrule. A properly swaged ferrule provides increased strength and leak resistance for compression fittings. Swaging is a procedure by which the end of a ferrule is deformed to fit around a connection point. While conducting the task, the 2nd A/E failed to properly swage the ferrule at the T-joint between the fuel oil return line and the No. 5 cylinder. Failure to properly crimp the ferrule reduced the connection point's strength and ability to prevent leakage. A post fire inspection revealed that the fuel line had separated from the T-joint.

Figure 13. Left is the improperly swaged ferrule installed on the main engine cylinder No. 5 fuel oil return line. On the right is a properly swaged ferrule. (Source: U.S. Coast Guard)

5.1. *Improper installation of the No. 5 cylinder fuel oil return line.* The fuel oil return line on cylinder No. 5 was installed one day before the fire. The 2nd A/E did not properly swage the ferrule connecting the fuel oil line and No. 5 cylinder. Improper swaging created a weak point and left the connection vulnerable to separation. A post casualty inspection revealed that the fuel oil return separated from the T-joint and sprayed fuel oil onto the cylinder cover and exhaust valve.

8.1.3. M-24-03: Recommend that APL implement additional training and oversight requirements within their SMS on the requirements for installing and testing fuel oil piping.

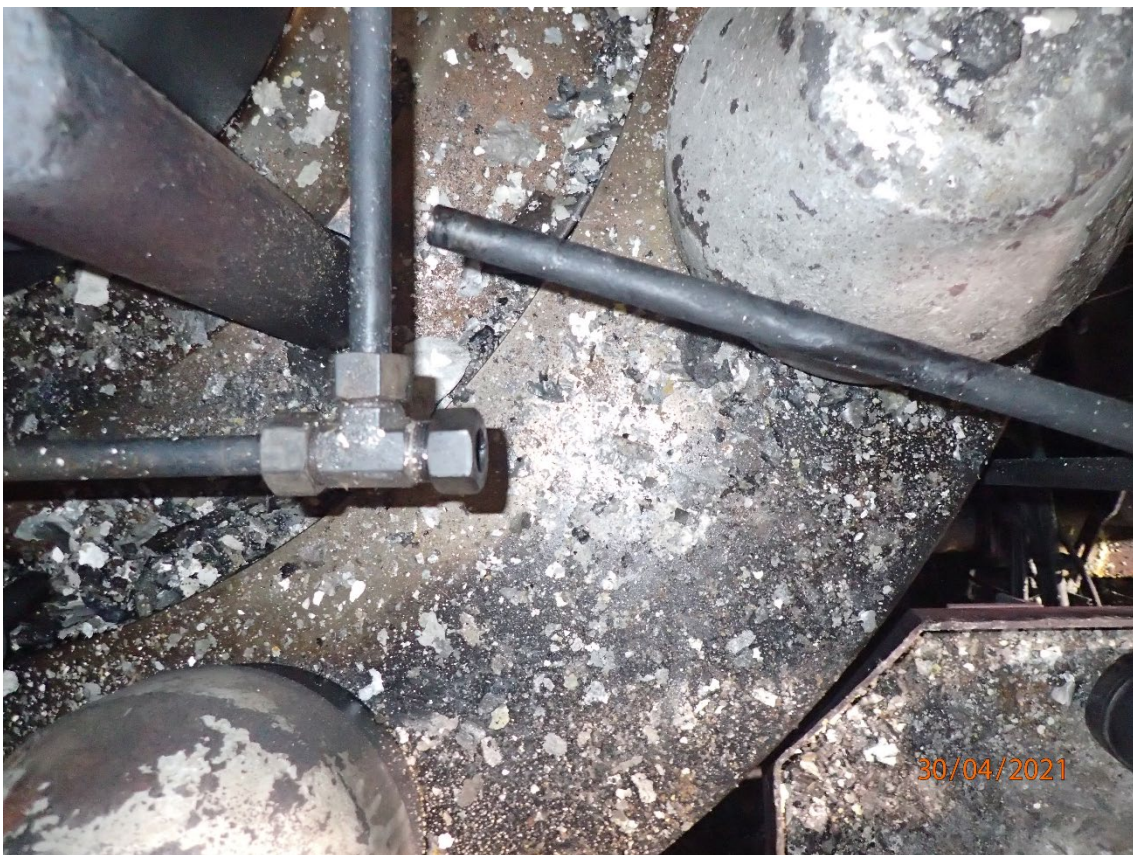
Figure 14. The fuel oil return line found separated from the T-joint. (Source: U.S. Coast Guard)

6.1.1.1. Improper installation of the No. 5 cylinder fuel oil return line.

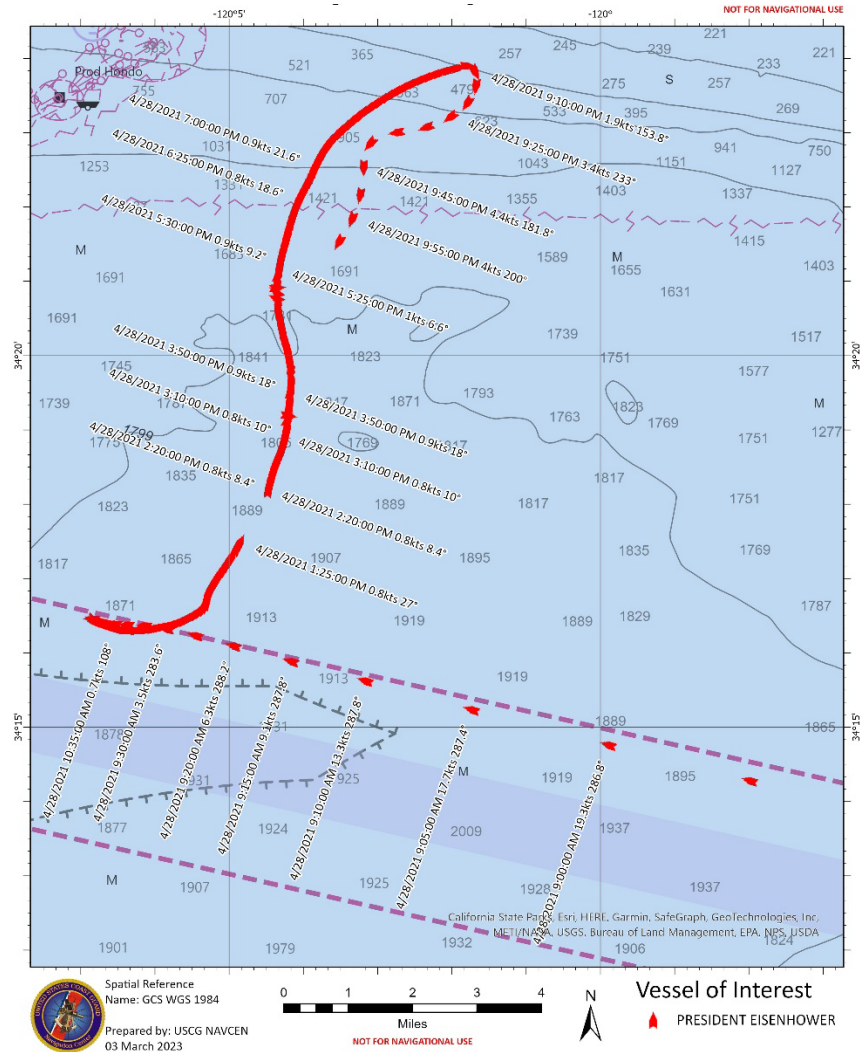
6.7.1. *Proximity of the drifting vessel to fixed platforms HOLLY and HONDO.* Assist tugs from the Port of Los Angeles were faced with a transit of more than 10 hours to the disabled PRESIDENT EISENHOWER. At its closest point of approach, the vessel drifted within 4 miles of HONDO, an active production platform. A tug dispatched from

the Port of Hueneme was able to push the vessel back toward the TSS and avoided a potential grounding or collision with HONDO. A collision with HONDO would have resulted in a pollution event and additional property damage.

Figure 15. Zoomed in AIS track of PRESIDENT EISENHOWER during the incident timeframe. Times listed in GMT. (Source: U.S. Coast Guard)

8.1.1. M-23-01: Recommend the USCG Office of Marine Environmental Response Policy (CG-MER) and the Office of Waterways and Ocean Policy (CG-WWM) establish or amend USCG policy to address oversight and analysis of the procedures and operations related to having a tug at each deep-water port that is on standby with the appropriate size, horsepower, and towing equipment to assist a large commercial vessel in case of emergency. The first towing vessels on scene after the fire came from the Port of Hueneme. After arriving and providing station keeping for a short while, the vessels had to be recalled by the Port of Hueneme to resume their normal escort duties as the port was limited in its inventory of towing vessels.
