REPORT OF THE INVESTIGATION INTO THE PASSENGER VESSEL SANDY GROUND (O.N. 1299657) ENGINE ROOM FIRE IN UPPER NEW YORK BAY ON DECEMBER 22, 2022

**ENGINE ROOM FIRE ONBOARD THE PASSENGER FERRY SANDY GROUND
(O.N. 1299657) IN THE BAY RIDGE CHANNEL NEAR MANHATTAN, NEW YORK
ON DECEMBER 22, 2022**

INVESTIGATING OFFICER'S REPORT

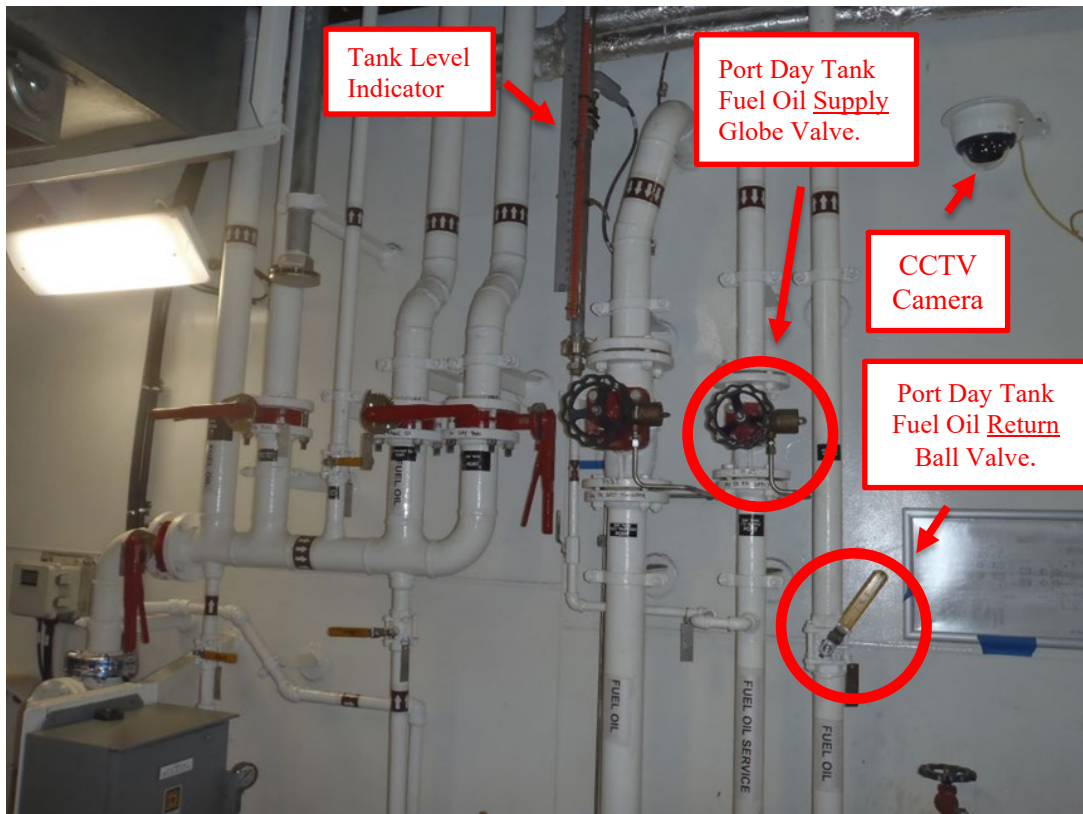
Figure 5. Photograph of the Staten Island end (port) fuel oil station onboard the SANDY GROUND's sister vessel, the SSG MICHAEL H OLLIS, showing the port fuel oil day tank supply and return valves, taken on January 10, 2023. Photograph provided by the U.S. Coast Guard.

5.1.1. The SANDY GROUND has two 15,000-gallon fuel tanks and two 2,500-gallon day tanks, which supply fuel to all of the ship's engines. The fuel oil is pumped from the day tanks to the engine through the filters and excess fuel that is not used, leaves the injectors through the fuel return lines and back to the day tanks. The fuel oil return lines are essential because not all of the fuel that is pumped to the engine is used for combustion, and the excess fuel that leaves the engine is returned to the day tanks via the fuel return lines. Fundamentally, there are two ways to level the day tanks in a system using multiple tanks. Option one is to manipulate supply to an engine, which either limits or exaggerates the amount of unused fuel being returned to the tank. Option two is to close or limit the return valves to one tank, which will divert some or all of the unused fuel to the other tank. Although not explicitly required, the SANDY GROUND did not have an established written procedure for leveling the port and starboard fuel oil day tanks. Many crewmembers work on different classes of vessels within the Staten Island Ferry fleet which have dissimilar engine room layouts and configurations. The various arrangements along with the ability of double ended symmetrical vessels to travel in both directions, may make it easy to become disoriented and confuse port and starboard piping systems.

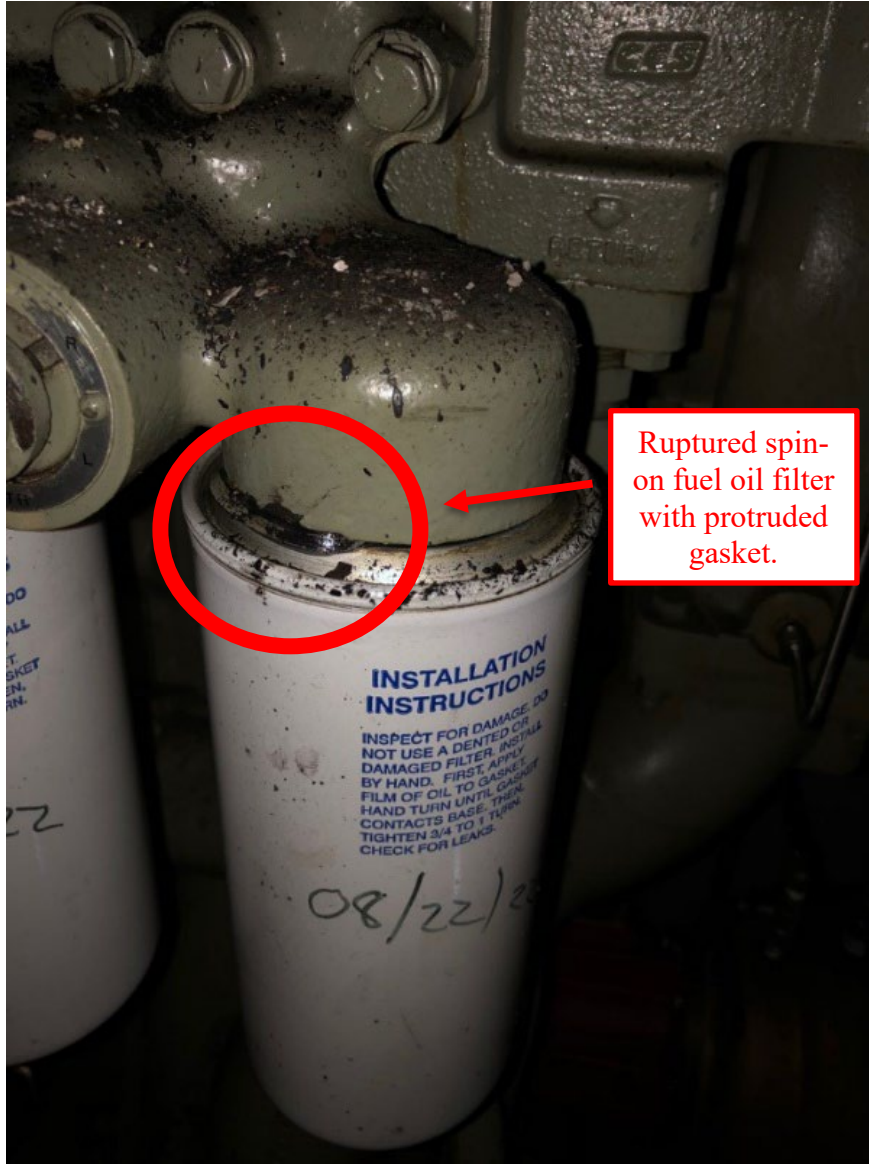
Figure 6. Photograph of the ruptured #1 main diesel engine online spin-on fuel oil filter with protruding gasket taken on December 23, 2022. Provided by the U.S. Coast Guard.

5.3.1. The over-pressurization of the fuel oil return system led to the failure of the spin-on fuel filters on all four main diesel engines, resulting in fuel oil spraying from these engines. Post-casualty images of the SANDY GROUND's engine room depict signs of material failure due to over-pressurization, including gasket failures, deformation, and depressurization. According to the EMS-Marcon Alarm and Monitoring System Log dated December 22, 2022, the maximum recorded fuel system pressures on all four main diesel engines during the over-pressurization event were as follows: 148 psi on the #1 main diesel engine, 124 psi on the #2 main diesel engine, and 148 psi on both the #3 and #4 main diesel engines. The computer also showed that over the previous several hours, the normal operating pressure was between 87 and 92 psi. If the bypass relief valves had functioned as intended or if there was an additional relief valve further downstream in the fuel system, the high-pressure fuel would not have reached the fuel filters, preventing their subsequent failure.

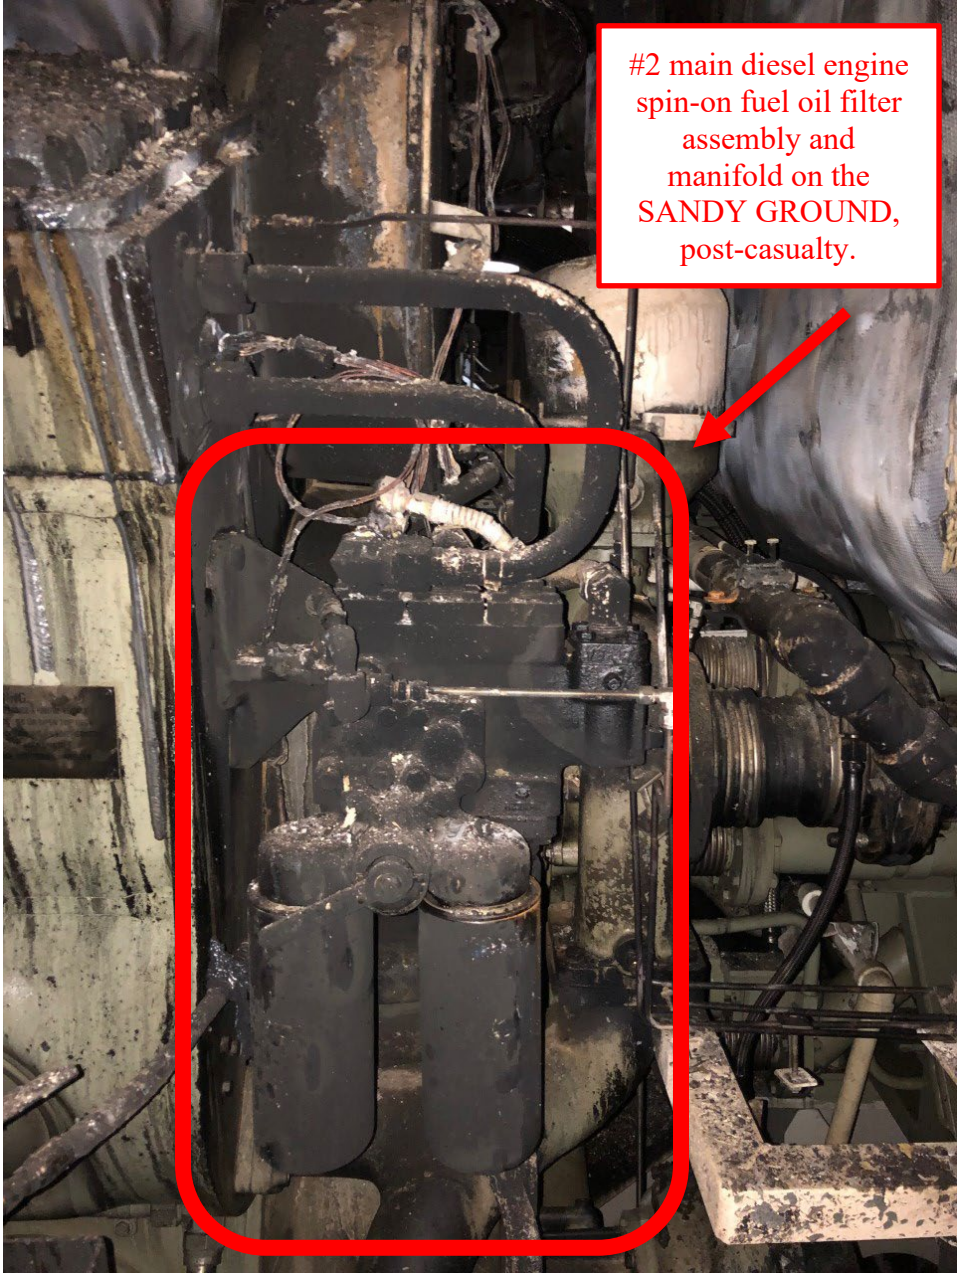
4.1.7. At 1649, MO1 and MO2 observed fuel oil spraying from the fuel oil filters on the #3 and #4 main diesel engines. The CME observed fuel oil spraying from the spin-on fuel filter assembly on the #2 main diesel engine, then alerted the Master that the fuel oil was leaking and that a loss of propulsion and steering was imminent.

Figure 7. Photograph of the #2 main diesel engine spin-on fuel oil filter assembly and manifold (block) post-casualty taken on December 23, 2022. Provided by the U.S. Coast Guard.

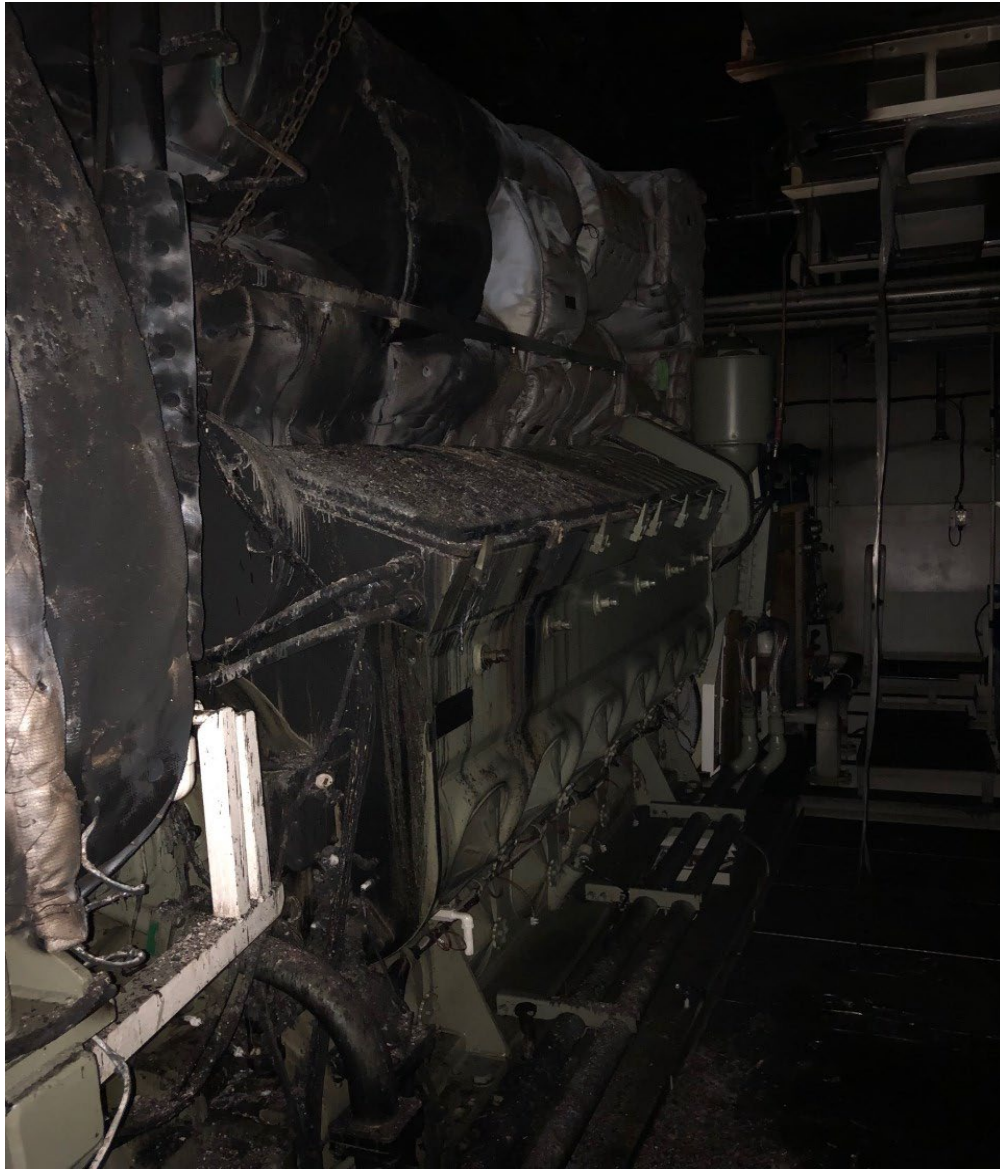
4.1.12. At 1654, MO2 proceeded to the port fuel oil station to retrieve additional absorbent pads. During this time a fire erupted near the exhaust manifold on the #2 main diesel engine. After observing the fire, MO1 and MO2 ran back to the EOS to inform the CME of the fire. MO1's clothes had been soaked in fuel oil from attempting to hinder the fuel oil spraying from the fuel oil filter assembly. The CME informed the Master of the fire and that he intended to secure all four main diesel engines from the MCS. The CME then observed multiple alarms, including low fuel pressure alarms, on the MCS displays for all

Figure 8. Photograph of the #2 main diesel engine (inboard) post-casualty, facing the New York End of the SANDY GROUND taken on December 23, 2022. Provided by the U.S. Coast Guard.

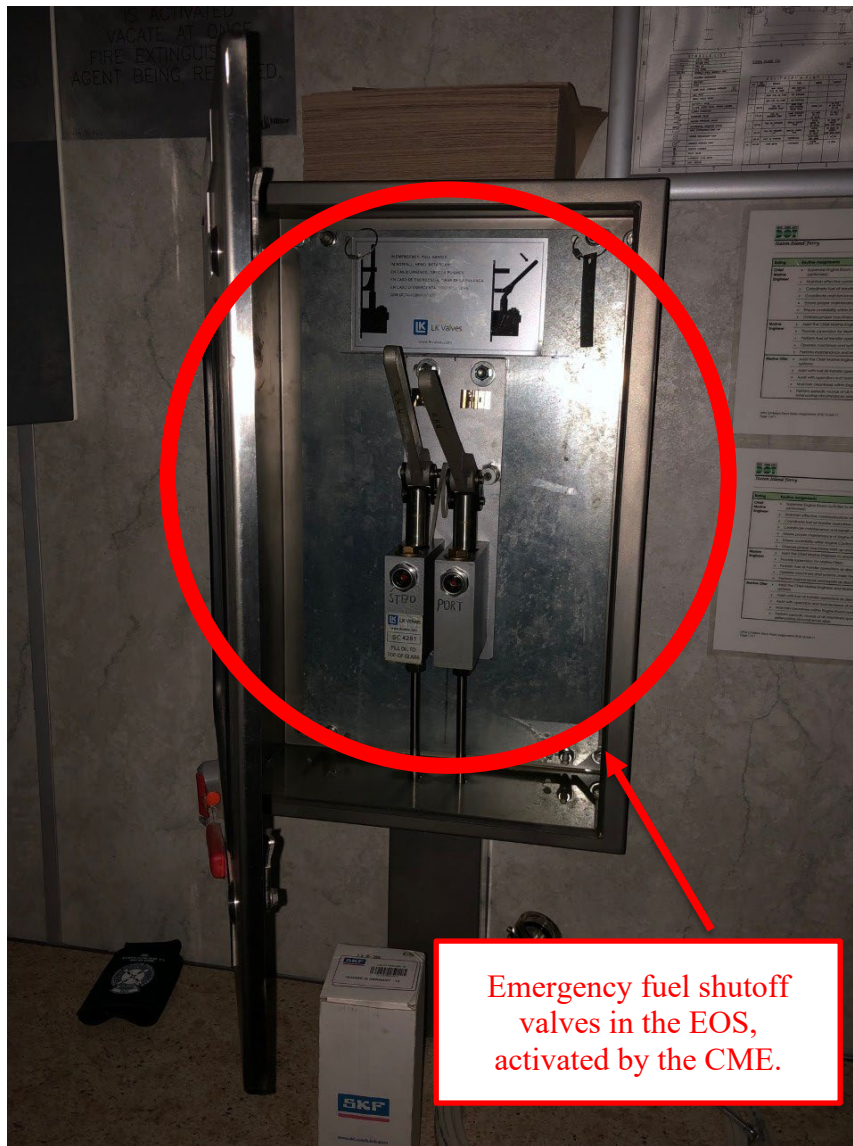
Figure 9. Photograph of the emergency fuel shutoff valves located in the EOS taken on December 27, 2022. Provided by the U.S. Coast Guard.

5.4.1. The vessel's Operating Manual defined an emergency condition as severe damage to one of the main propulsion diesel engines, warranting an immediate shutdown, and includes instances such as an engine room fire. The emergency condition checklist stipulated that the crew must cut off power and/or fuel to the affected machinery. On the SANDY GROUND, this could be achieved by pressing the emergency stop buttons on the EOS panel, at the local engine control panels, or in either pilothouse. However, the hydraulic emergency fuel shutoff switch was considered a last resort because using it would also result in the loss of all ship boilers and ship service generators. The fuel oil sprayed onto the engine room lagging and components for approximately seven minutes before the engine fire ignited. If the fuel had been shut off to the affected machinery and the emergency fuel pull shutoff valves had been activated earlier, it might have prevented the ignition of the fuel oil spray, potentially averting the engine room fire altogether.

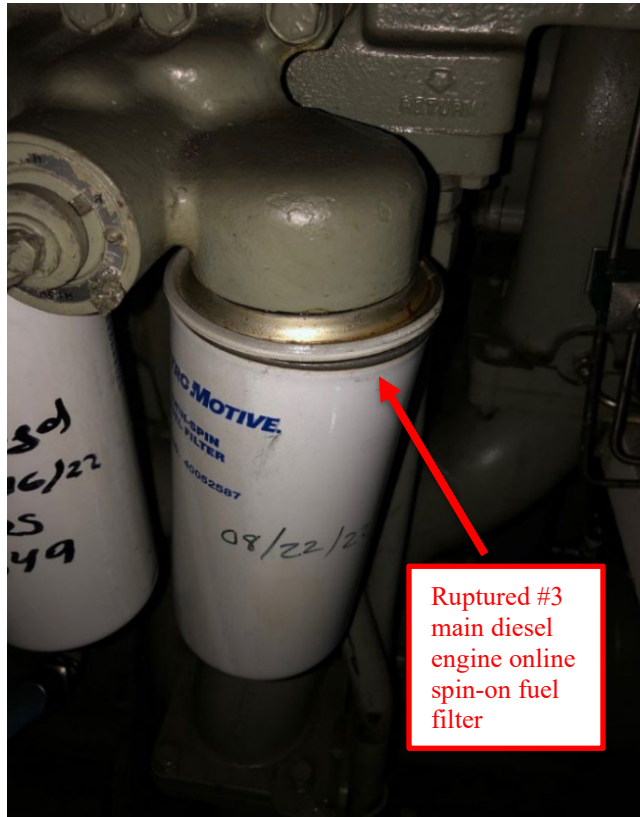
Figure 12. Photograph of the ruptured fuel oil filter on the #3 main diesel engine taken on December 23, 2022. Provided by the U.S. Coast Guard.

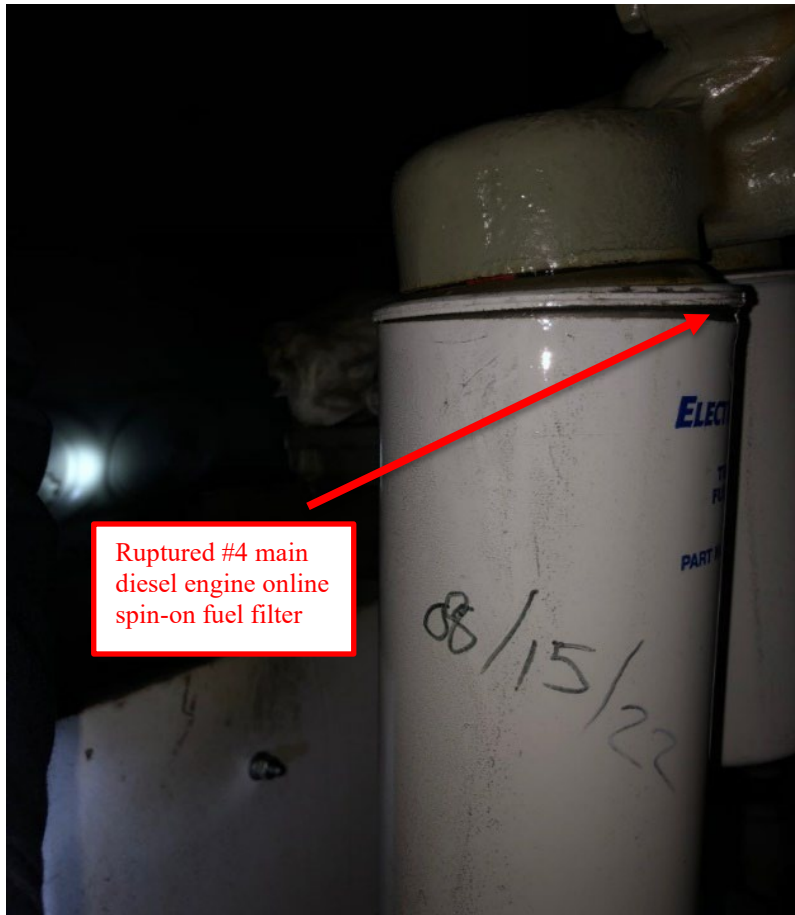
Figure 13. Photograph of the ruptured fuel oil filter on the #4 main diesel engine taken on December 23, 2022. Provided by the U.S. Coast Guard.

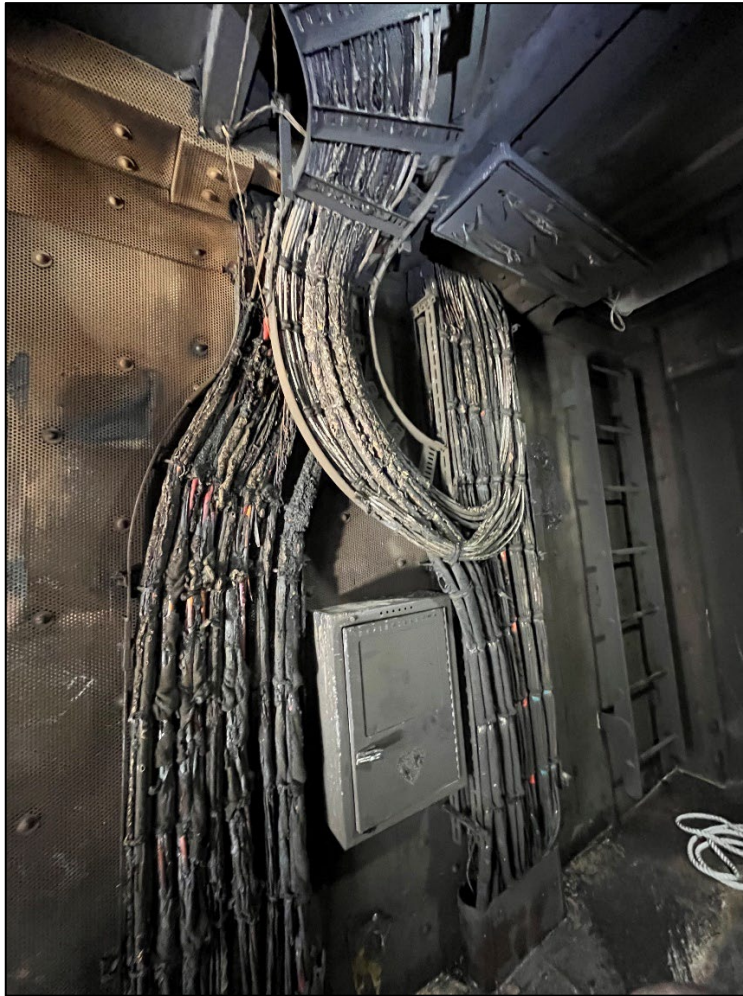
5.6.1. Emergency power was automatically activated after the ships service diesel generators located in the engine room had shutdown. However, unexpectedly, it went offline about a minute later due to a system failure. Despite efforts, the crew couldn't restore emergency power, leaving the vessel in darkness, except for battery-powered emergency lighting. Upon closer examination, it became clear that the fire had caused extensive damage to the overhead cables in the engine room and the adjacent main deck machinery casing. Among the damaged cables was the Emergency Diesel Generator (EDG) run status indicator cable, which extended from the emergency switchboard to the main switchboard located in the EOS. The cable sheathing had melted, resulting in a short circuit that triggered a critical system failure and led to an immediate and irreversible shutdown of the EDG. If the NOVEC 1230 fire suppression system had been activated earlier, the engine room fire might have been extinguished more rapidly, potentially preventing damage to the vital cables.

5.6.2. Upon further investigation into the EDG shutdown and the short circuit in the run status cable, it was revealed that the cable had caused an over-current fuse failure in the emergency generator panel. This, in turn, was interpreted as a phase loss by the Woodward Easygen Controller located at the emergency switchboard. The vessel's Operating Manual specified that the EDG supplies 395 KW, 480 VAC, 3-phase, 60 Hz power to the emergency switchboard. It provides power to essential systems needed for safe vessel navigation. The Woodward Easygen Controller monitors and manages bus voltage, 3-phase generator voltage, current, engine start/stop, parallel generator operation on the bus, and load sharing between generators. When the engine controller detects what it believes to be a loss of phase, it automatically and irreversibly shuts down the engine to prevent potential damage to the system. Furthermore, Staten Island Ferry maintenance personnel discovered missing terminal connections for the emergency generator run status cable from the emergency switchboard compared to the "as-built" electrical diagram drawings. As a response to this incident, the Staten Island Ferry Division developed an engineering modification to provide overcurrent protection and isolate cables routed outside of the emergency switchboard in order to prevent them from affecting the generator Controller. If there had been a means to prevent the phase loss caused by the damaged cable, the generator shutdown and lockout might not have occurred, potentially allowing the vessel to maintain its emergency power generation capability including the emergency fire pump.

Figure 14. Photograph of damaged cables located in the main deck machinery casing above the engine room. Provided by the NTSB.
