REPORT OF THE INVESTIGATION INTO THE ILLEGAL SMALL PASSENGER VESSEL STIMULUS MONEY (NJ 8563HN), CAPSIZING WITH LOSS OF LIFE ON JULY 12, 2022

**CAPSIZING OF THE MOTOR VESSEL STIMULUS MONEY RESULTING IN
THE LOSS OF TWO LIVES WHILE OPERATING ON THE HUDSON RIVER
IN THE VICINITY OF INTREPID PIER 90, MANHATTAN, NEW YORK
ON JULY 12, 2022**

ILLEGAL SMALL PASSENGER VESSEL STIMULUS MONEY (NJ 8563HN), CAPSIZING WITH LOSS OF LIFE ON JULY 12, 2022

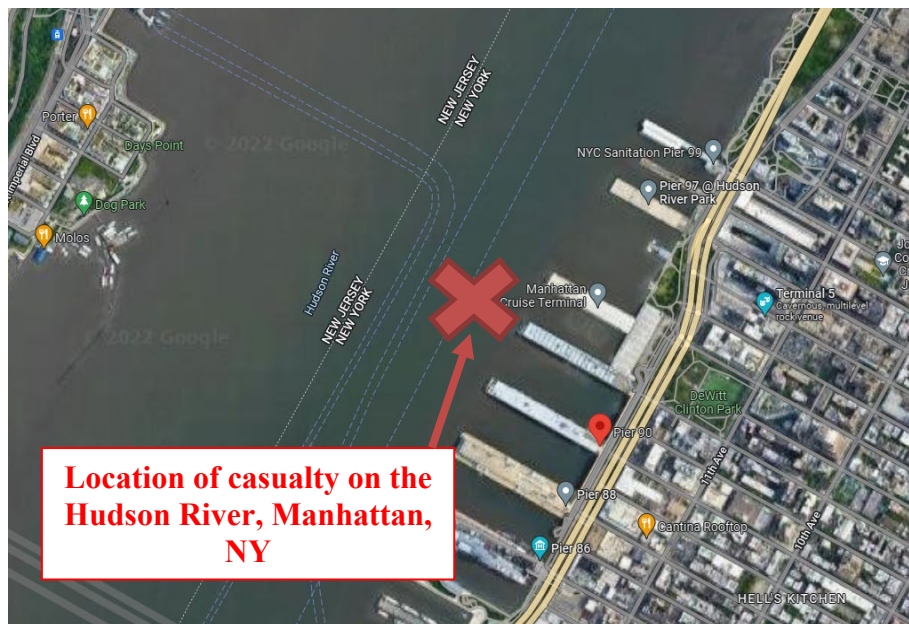
Figure 3. Photograph of casualty location in front of the Manhattan Cruise Terminal, Hudson River, Manhattan, NY, source Google Maps.

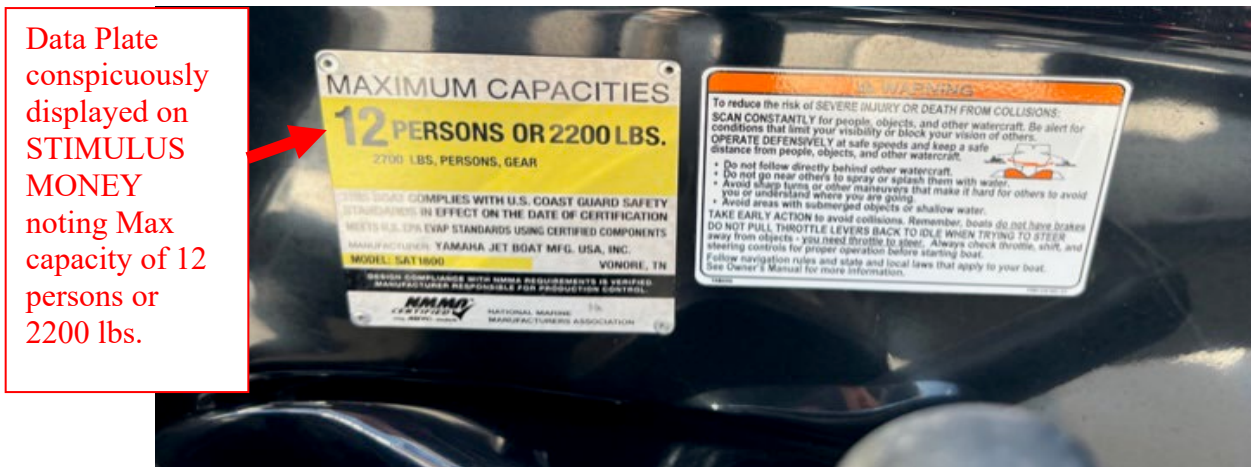
5.2. **Excessive Passenger Count Onboard Vessel Exceeding Vessel Data Plate:** The STIMULUS MONEY was loaded with 13 total persons at the time of the incident, consisting of 12 passengers and one operator. This exceeded the maximum capacity for the vessel as indicated on the manufacturer's data plate (fig. 5). Investigators were unable to obtain the weight of each person onboard, but using the assumed average weight per passenger of 185 pounds in accordance with 46 CFR 170.090(d)(1), the vessel also exceeded the weight limit.

Figure 5. Photograph of STIMULUS MONEY Data Plate taken at NYPD Harbor Unit, Marshall's Island, NY post casualty taken July 12th, 2022, Provided by USCG.

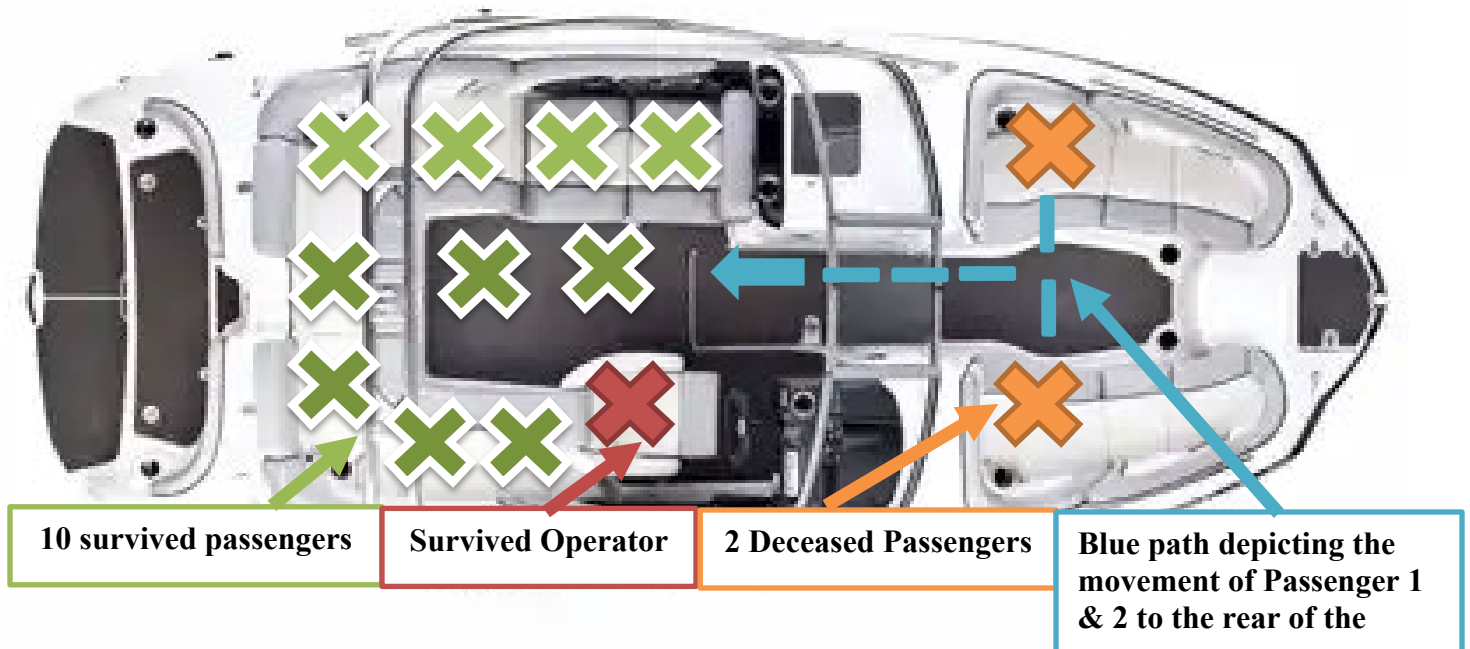
The passengers were unevenly distributed throughout the vessel (fig. 6), in contrast with manufacturer's direction outlined in (fig. 8) about even weight distribution. (fig. 7) depicts even weight distribution and the vessel being operated beneath maximum capacity.

Figure 6. Stock photograph of Yamaha AR240 Seating arrangement and the positions of the passengers/operator when the series of swells were encountered, Provided by Google Images.

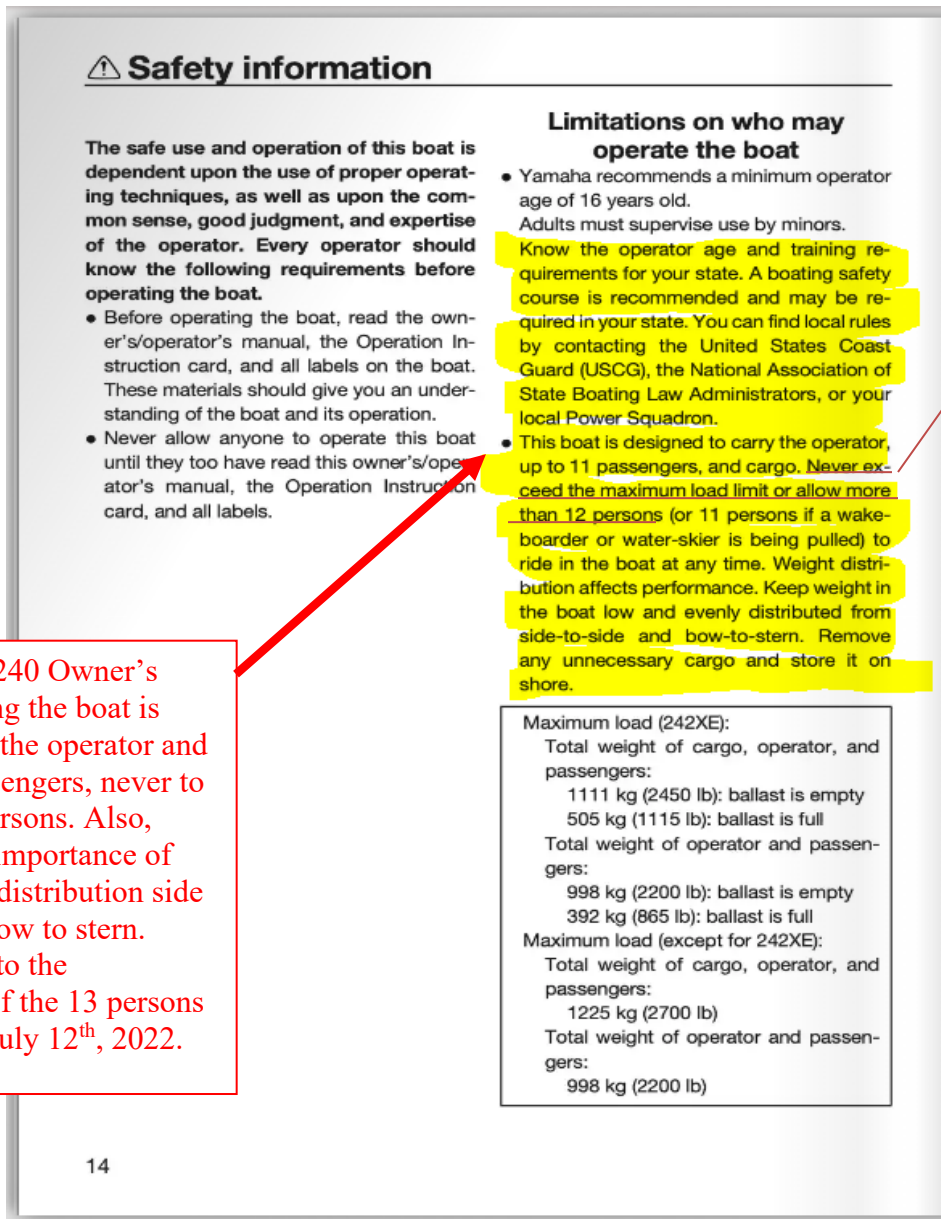
Maximum Capacity standards are outlined by the manufacturer in the Yamaha AR240 owner’s manual (fig. 8). Small Passenger Vessels carrying more than six passengers, with at least one for hire, require a stability letter, or stability test to prevent a compromise in stability that could result in the capsizing of the vessel. Small Passenger Vessels require a USCG Certificate of Inspection (COI) during which stability standards are reviewed by a qualified CG Marine Inspector. Furthermore, COIs are required to be posted showing the total allowed passenger count. If the Owner had acquired a COI for the STIMULUS MONEY as required, the total passenger count and stability standards may have been adhered to and prevented this casualty.

Figure 8. Photograph of Yamaha AR240 Owner's Manual Page 14 showing maximum load limit for passengers and weight distribution instructions.

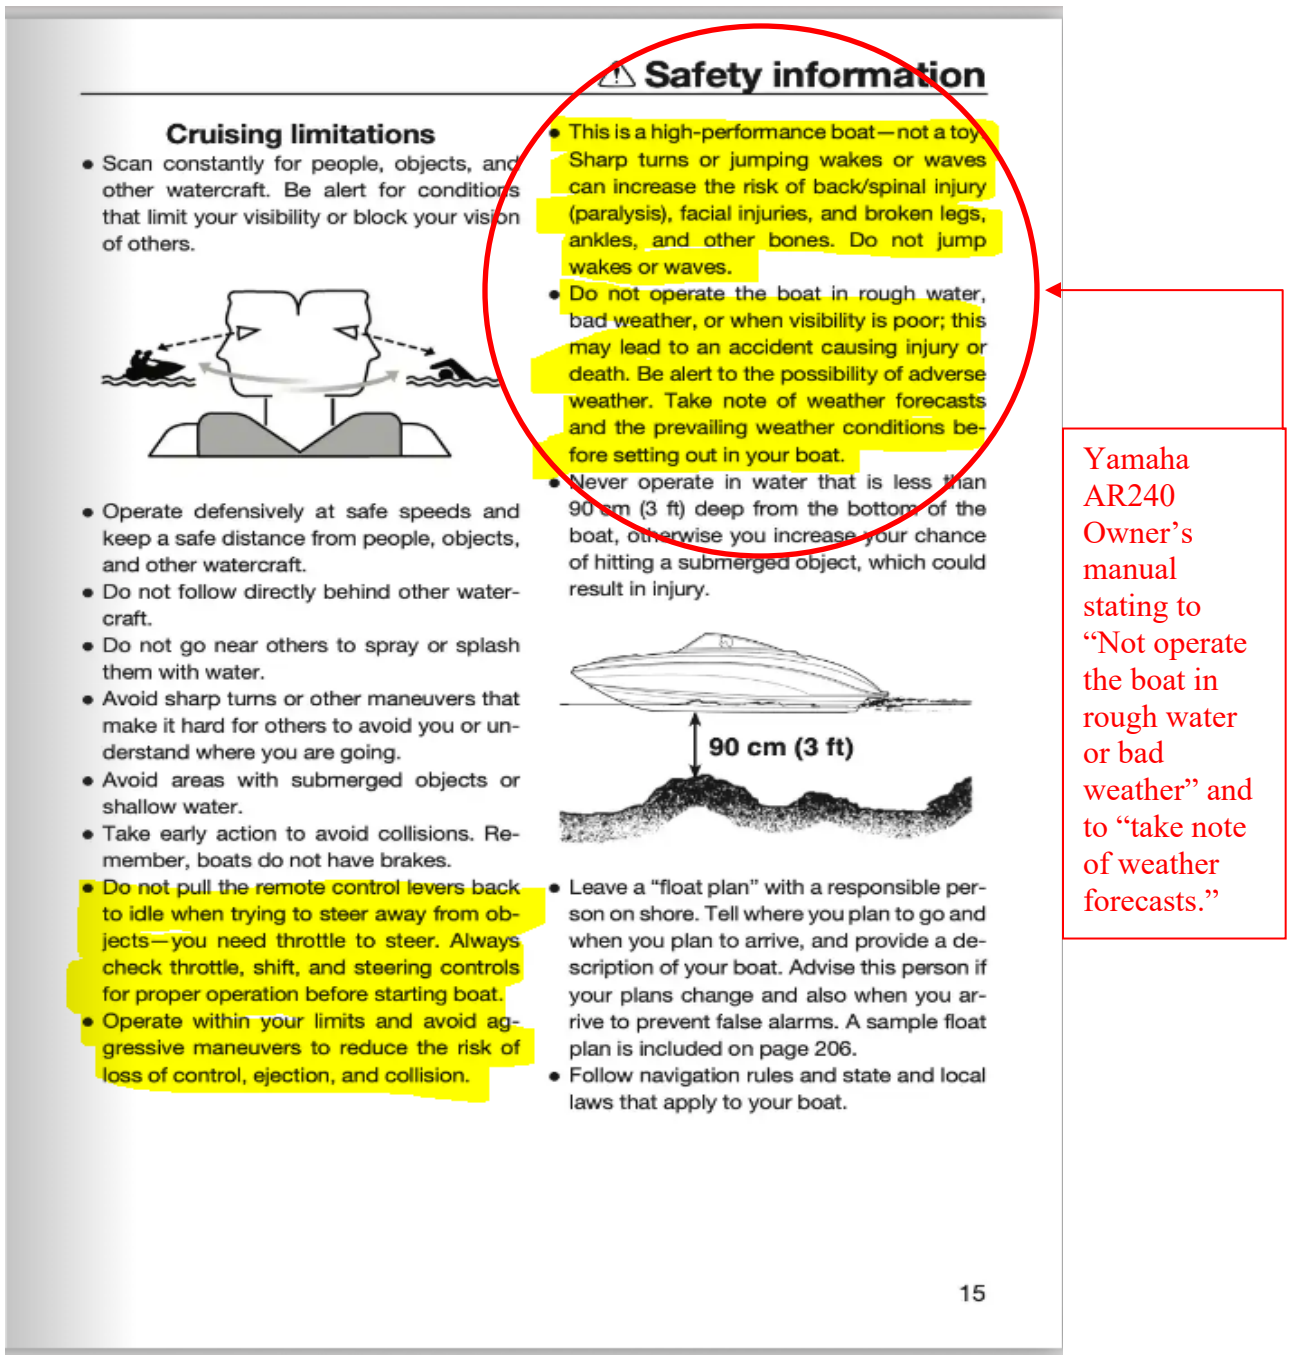
5.3. **Failure to Heed NOAA Small Craft Advisory:** The National Oceanic and Atmospheric Administration (NOAA) Weather Service issued an Urgent Marine Weather Message covering New York Harbor for a Small Craft Advisory (fig. 9). The Small Craft Advisory stated, “Inexperienced mariners, especially those operating smaller vessels, should avoid navigating in hazardous conditions.” The weather conditions at the time of the incident in New York Harbor were as follows: South winds 15 to 20 knots with gusts up to 25 knots. 3-4 foot seas in and around New York Harbor. The Owner and Operator's inexperience in operating Small Passenger Vessels for hire may have contributed to them not checking for urgent weather messages. The urgent weather message was publicly posted on the USCG Broadcast Notice to Mariners page prior to the STIMULUS MONEY departing Carteret, NJ, for the sightseeing tour. If the Owner and Operator were properly trained in conducting Small Passenger Vessel operations and taking note of weather forecasts in accordance with manufacturer's direction (fig. 10), they may have checked for and heeded the NOAA Small Craft Advisory for the particular area the tour was transiting, potentially avoiding the weather conditions and the series of swells that contributed to the vessel capsizing.

Figure 10. Photograph of Yamaha AR240 Owner's Manual Page 15 warning against the operation of the vessel in bad weather conditions.

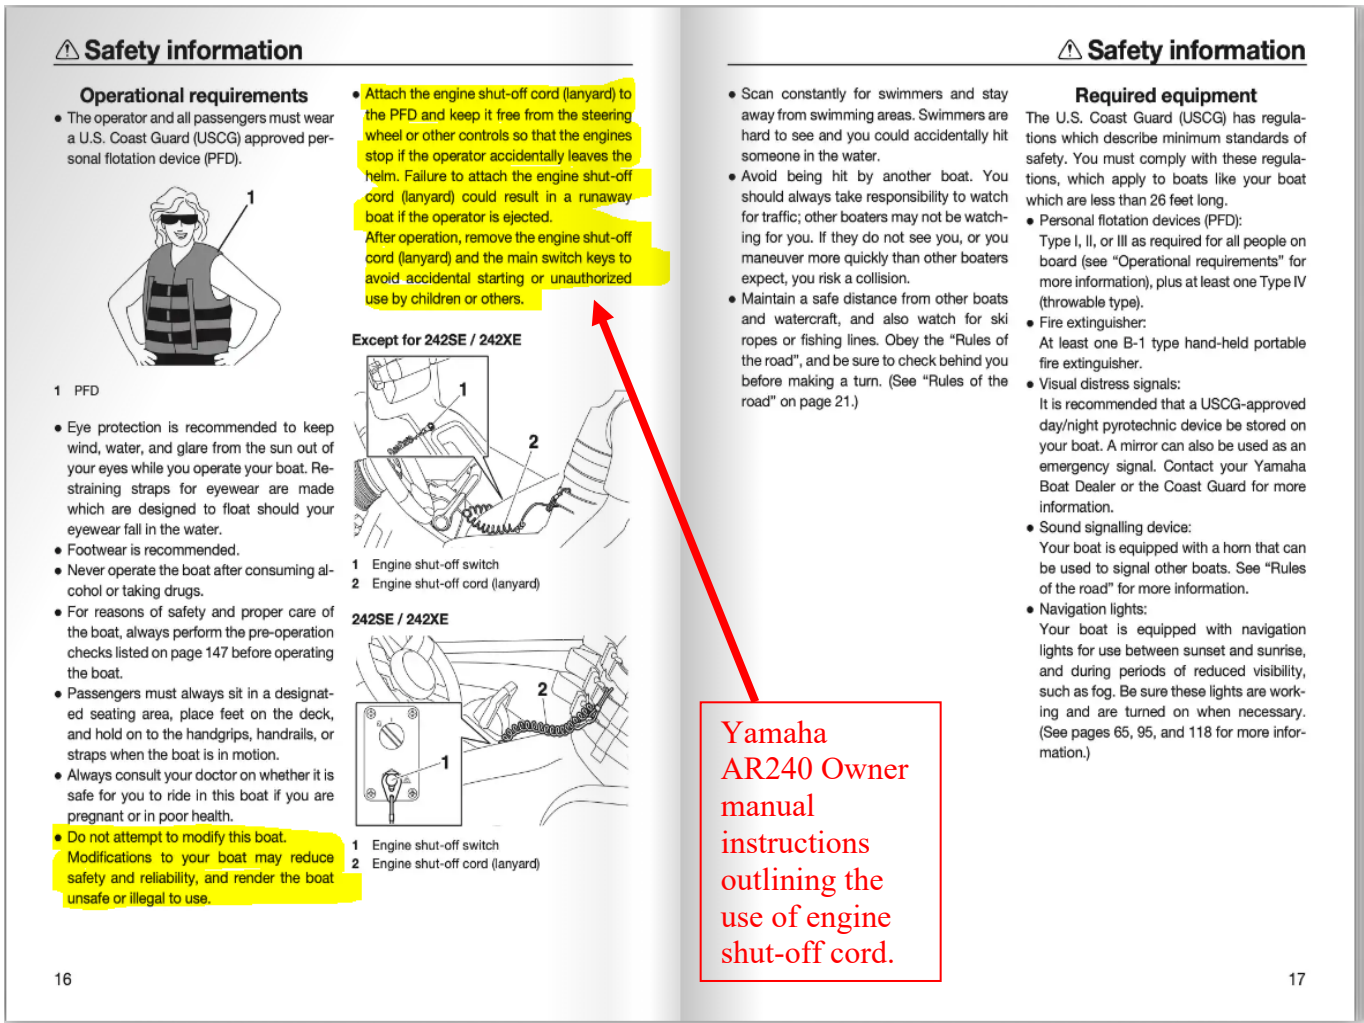
5.4.1. The Yamaha AR240 Twin Jet Drive boats, including the STIMULUS MONEY, are equipped with a safety device that is worn around the operator's wrist in the event they are abruptly moved from the operating position (fig. 11). The safety device immediately shuts down the engines, which instantaneously reduces the engine RPMs to zero. On July 19, 2022, the attending Yamaha Master Technician conducted an evaluation of the vessel post casualty, while it was in the custody of the NYPD Harbor Unit and confirmed that the lanyard was still intact and attached to the shut-off cord at

the time of the incident. This indicates that the Operator was not wearing the lanyard properly, or at all at the time of the casualty. The starboard engine reached a maximum speed of 7,800 RPMs leading up to the capsizing of the vessel. If the lanyard had been attached to the Operator properly, the engines may have been shut down as the Operator was shifted from the helm due to the vessel beginning to turn towards the port direction after encountering the series of swells. The securing of the engines by way of the engine kill switch would have dropped the RPMs immediately from approximately 7,800 to 0 RPMs, likely reducing the amount of thrust contributing to the momentum that overturned the vessel.

Figure 11. Photograph of Yamaha AR240 Owner's Manual Page 16 showing proper donning and operation of the engine shut-off lanyard.
