MARINE CASUALTY REPORT

**MOBILE OFFSHORE DRILLING
UNIT (MODU) OCEAN RANGER,
O.N. 615641,
CAPSIZING AND SINKING
IN THE ATLANTIC OCEAN,
ON 15 FEBRUARY 1982
WITH MULTIPLE LOSS OF LIFE**

REPORT NO. USCG 16732/0001 HQS 82

1. Report No. USCG 0001 HQS 82	2. Government Accession No.	3. Recipient's Catalog No.	
4. Title and Subtitle Marine Casualty Report Mobile Offshore Drilling Unit (MODU) OCEAN RANGER, O.N. 615641, Capsizing and Sinking in the Atlantic Ocean on 15 February 1982 with multiple loss of life		5. Report Date 20 May 1983	6. Performing Organization Code G-MMI-1/HQ14

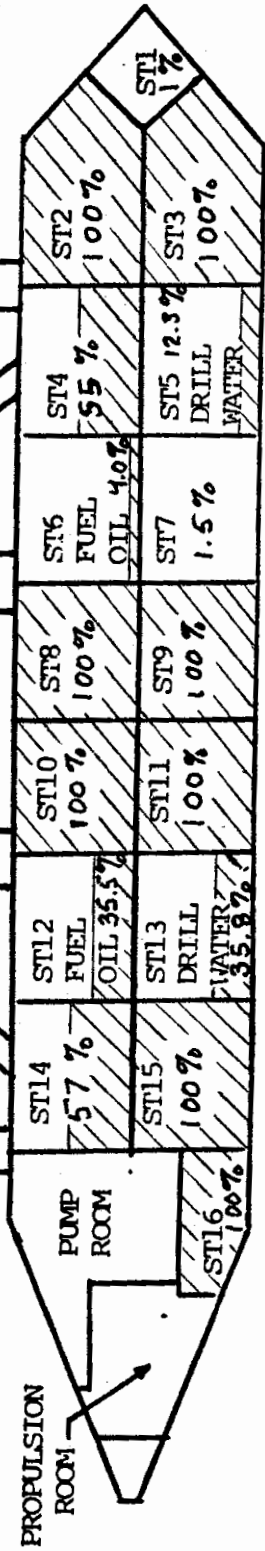
Figure 15: PERCENTAGE OF LIQUIDS IN OCEAN RANGER PONTOON TANKS, MORNING OF 14 FEBRUARY 1982

Figure 15 depicts the liquid levels in the ballast tanks on 14 February 1982 as indicated in the weekly ballast report work sheets recovered from the OCEAN RANGER. The report indicated that the after ballast tanks used for adjusting trim, PT 14 and ST 14 were respectively 67.9% and 57.0% of capacity. The ullage provided a potential moment to correct trim of 58,000 foot/long tons (F/LT). During the evening, the control panel was doused with sea water entering a broken porthole causing an actual or perceived panel malfunction. At the time of malfunction or when personnel attempted to correct the malfunction, the OCEAN RANGER either took water into the ballast tanks or water shifted to the forward tanks, or both, causing a list by the bow. At some point, the crew had taken the measure of closing the two manually operated sea inlet gate valves. Evidence indicates the rig may have had a 10 degree list for a period of time which the crew believed had stabilized. An approximate moment of 17,000 (F/LT) was required to cause a 10° trim by the bow.
