UNITED STATES COAST GUARD

REPORT OF THE INVESTIGATION INTO THE LOSS OF LIFE ONBOARD THE LIQUEFIED PETROLEUM GAS CARRIER CONCORDE (IMO #9734678), MARCUS HOOK ANCHORAGE IN THE DELAWARE RIVER, ON OCTOBER 27, 2018

INVESTIGATING OFFICER'S REPORT

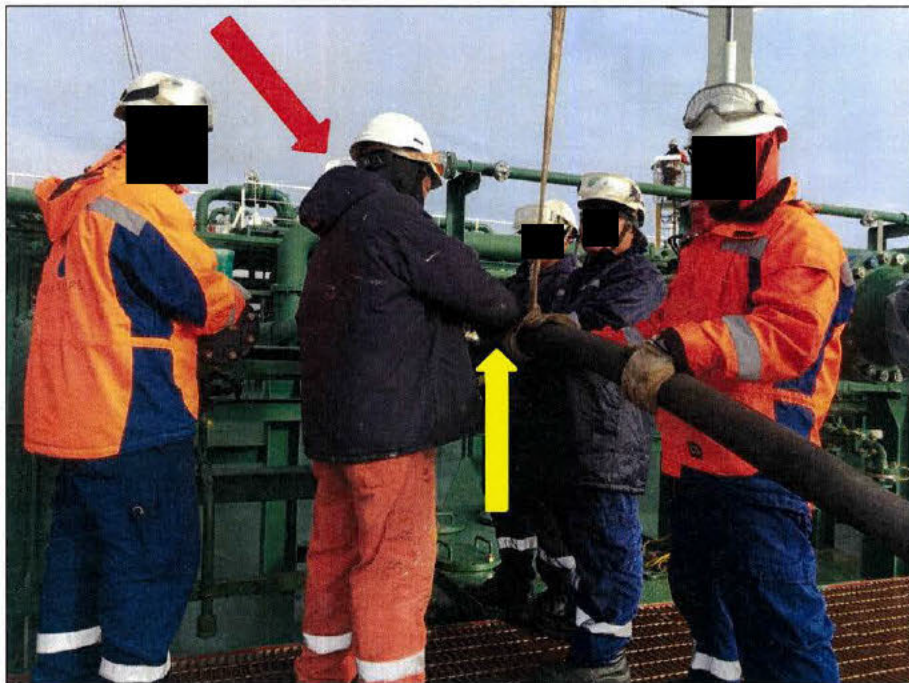
The red arrow points to the location of the Motorman. The yellow arrow points to the positioning of the Motorman's arm in relation to the bunker hose and crane sling.

Figure 3. Location of crewmembers when the bunker hose was disconnected, provided by Mr. [REDACTED]. The hose in the photo is a four-inch hose, the hose used during the incident was a six-inch hose.

4.1.6. At 2229:55, the Motorman had his arms wrapped around the bunker hose and was adjusting it so the Fitter could remove the last bolt. The crane sling was still attached to the bunker hose just behind the Motorman's right arm. The last bolt to be removed was located at the 12:00 position on the flange. When the last bolt was removed, the hose began to fall down the side of the LPG CONCORDE. The weight of the hose then shifted onto the stopper line connecting the bunker hose to the deck railing.

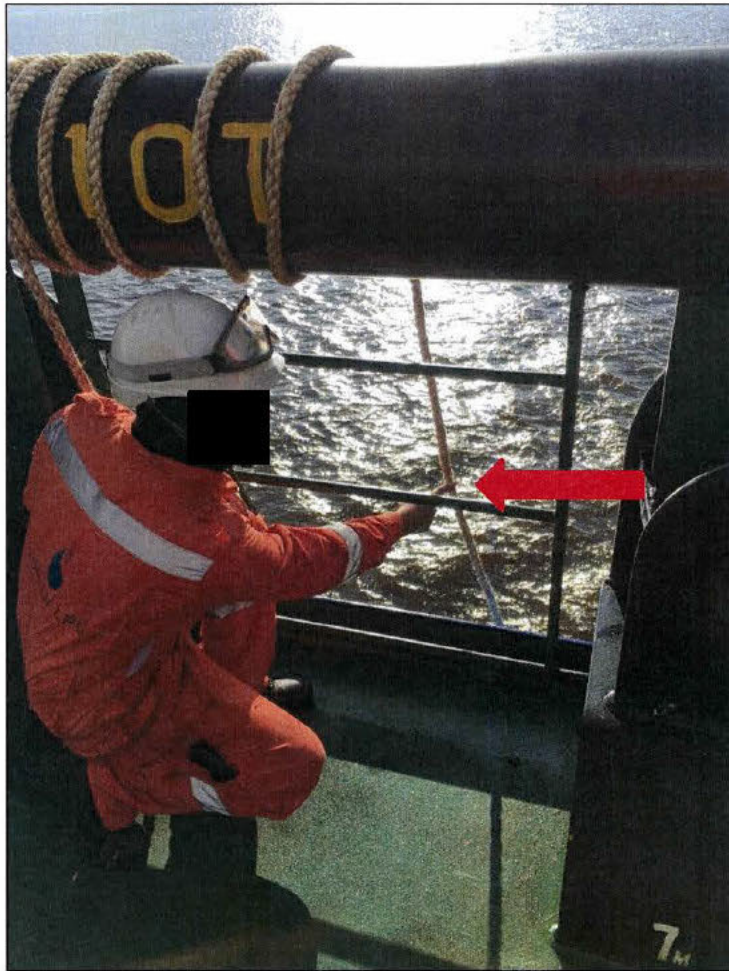
Figure 4. Crewmember pointing to where the stopper line parted. Provided by Mr. [REDACTED]

4.1.7. At 2230:00, the stopper line parted. The bunker hose then continued its slide down the side of the LPG CONCORDE causing the end of the hose to rapidly rise up into the air. The shifting bunker hose pinched the Motorman's arm between the hose and the crane sling lifting him up into the air. The crane sling then took on the load of the bunker hose, releasing the Motorman's arm. During this process, residual HFO splashed onto the Motorman making it difficult for him to hold onto anything, and he subsequently slid down the bunker hose and landed on the deck railing. A few seconds after landing on the deck railing, he slid off the side of the vessel and into the water.

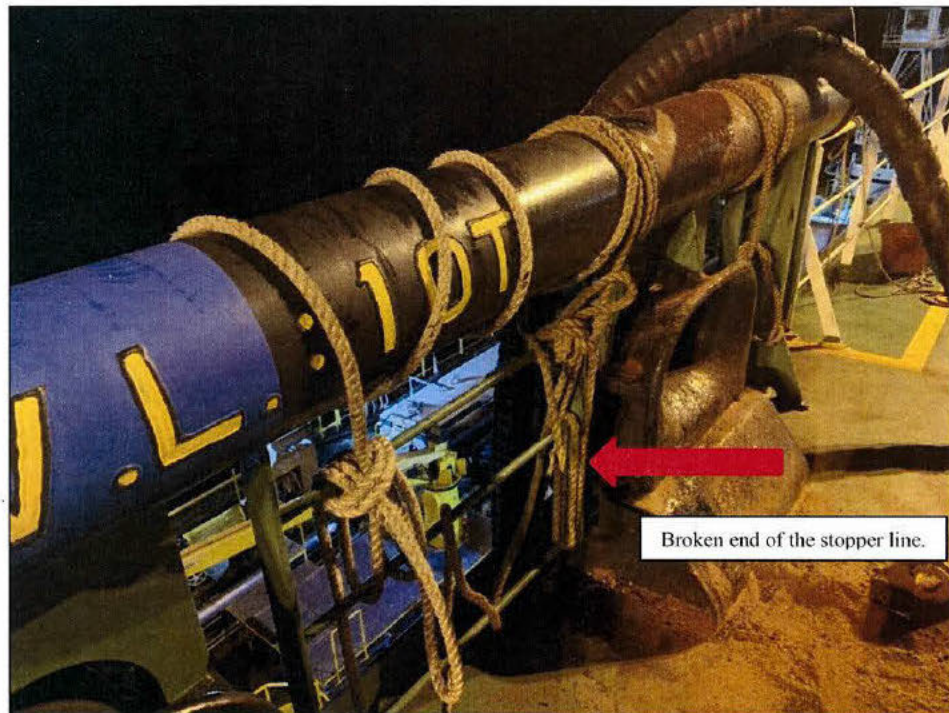
Figure 3. Location where the Motorman fell overboard, photo by Mr. [REDACTED]

4.1.8. At 2230:05, the Motorman landed in the water between the LPG CONCORDE and the BRYANT SEA. Crewmembers from the BRYANT SEA attempted to render assistance but were unable locate the Motorman from the LPG CONCORDE.

8.1.1. Recommend Commandant, Office of Commercial Vessel Compliance (CVC-2), coordinate with the International Maritime Organization to establish a standard of wear of PFD for commercial vessel crewmembers when working on deck. USCG Recreational Boating Statistics for 2017 state: "Where cause of death was known, 76% of fatal boating accident victims drowned. Of those drowning victims with reported life jacket usage, 84.5% were not wearing a life jacket." There are no readily available statistics for commercial vessels in regards to drowning deaths and life jacket usage. In the LPG CONCORDE case, had the Motorman been wearing a personal flotation device, he likely would not have drowned.

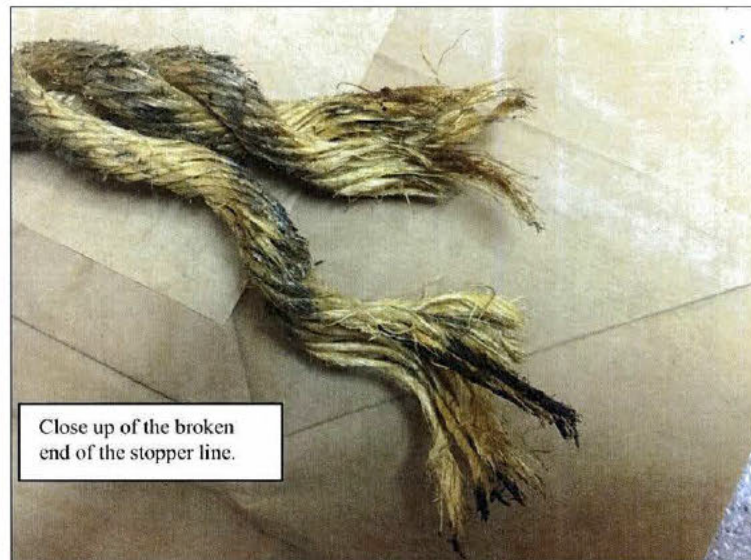
4.2.2. The crew of the LPG CONCORDE had used the same stopper line for every bunker operation since the ship was commissioned in 2015. The line was approximately three years old. In its new condition the safe working load for the stopper line was approximately 1,150 pounds. Figure 4 displays the broken end of the stopper line.

Figure 4. Stopper line broken end, provided by Mr. [REDACTED]

4.2.3. Portions of the line used onboard the LPG CONCORDE were taken as evidence and subsequently sent to be tested at Columbia University's Carleton Laboratory (see figures 4 and 5). Three destructive breaking strength tests were conducted on these samples, which resulted in the following values: test (1) 691 pounds, test (2) 735 pounds, test (3) 569 pounds, with an average breaking strength of 665 pounds.

5.1. *Failure to annually test the load bearing capacity of the stopper line.* The crew of the LPG CONCORDE used one-inch natural fiber line as a stopper for the bunker line. The stopper line was used to assist in securing the bunker hose to the vessel by connecting it to the deck railing of the vessel in way of the manifold, which would help prevent the hose from falling over the side should its flange come loose from the connection point at the fuel manifold. The stopper line was made from natural fiber, and, in new condition, it had a rated safe working load of approximately 1,150 pounds (static loading). The stopper line that failed in this case had not been tested since it was placed into service in 2015. In the United States, weight bearing equipment is required to be inspected at each use and annually in accordance with Occupational Safety and Health Administration's (OSHA) requirements outlined in 29 CFR 1926.251. We would expect that the strength of the natural fibers in this stopper line to be reduced over time due to a number of factors (exposure to the elements, wear from frequent use, etc.). In fact, three load tests of the stopper line used onboard the LPG CONCORDE were conducted after the casualty, and we found an average breaking strength of only 665 pounds under a static load; a 42% reduction in rated strength from the original safe working load.

The six-inch diameter bunker hose used for HFO was made by APPOLLOFLEX OS&D. As discussed in 4.2.4 above, the total weight of the two sections of bunker hose was approximately 927 pounds. Clearly, this load is much greater than the 665 pounds the line was likely able to support based on the testing described in 4.2.3 above. Therefore, the weight of the bunker hose exceeded the average breaking strength of the stopper line by almost 30%.

5.3. *Failure to replace the deteriorated stopper line.* The stopper line used in bunkering procedures had been onboard for approximately three years. Over time, the line deteriorated and lost approximately 42% of its original strength. In new condition, the line had a safe working load of 1,150 pounds but in its deteriorated condition it could only support an approximately 665 pound load. In the United States, OSHA standard 29 CFR 1926.251(d)(6) requires the replacement of deteriorated natural fiber line if any of the following are found during an inspection: abnormal wear, powdered fiber between strands, broken or cut fibers, and variations in the size or roundness of strands, discoloration or rotting, or distortion of hardware in the sling. The stopper line was stored in an oil spill equipment locker on deck, which exposed it to various petroleum products and chemicals. Exposure to fuels, oils, salt water and chemicals likely reduced the life span of the natural fiber line. Natural fiber line deteriorates over time. If the vessel had used a synthetic line then the stopper line may not have deteriorated at the same rate as it did being natural fiber, the reduced detrition which may have prevented the material failure of the stopper line. If the line had been stored in a more secure environment out of the elements and away from exposure to hazardous materials, it may not have deteriorated as much as it had, allowing it to support the load of the bunker hose. Lastly, replacing the line on a set schedule would have reduced the amount of time the line was able to deteriorate and may have prevented the material failure of the stopper line.

6.1.1.2. The stopper line lost approximately 42% of its original strength due to deterioration.

8.1.2. Recommend Commandant, Office of Commercial Vessel Compliance (CVC-2), coordinate with the International Maritime Organization to develop regulations to ensure that all equipment used for bunker operations is adequate for the service intended. These rules should also include specifications (material, rated load, testing frequency, etc.) for the equipment they recommend using for these types of operations.

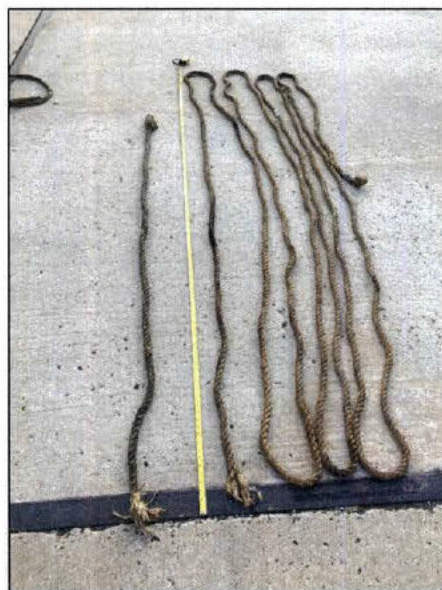
Figure 5. Stopper line displayed on the pier, approximately 83 feet, provided by Coast Guard Sector Delaware Bay Investigations.
