## REPORT OF INVESTIGATION INTO THE CIRCUMSTANCES SURROUNDING THE INCIDENT INVOLVING M/Y ELAINE G COLLISION

MISLE ACTIVITY NUMBER: 1476414  
ORIGINATING UNIT: MSO LOUISVILLE  
MISLE CASE NUMBER: 83605

**FORMAL INVESTIGATION INTO THE COLLISION BETWEEN THE TOW OF THE  
M/V ELAINE G AND A RECREATIONAL VESSEL (KENTUCKY REGISTRATION  
NUMBER KY 7808 PP) AT APPROXIMATELY MILE MARKER 568 ON THE OHIO RIVER  
ON JULY 15, 2001, WITH MULTIPLE LOSS OF LIFE**

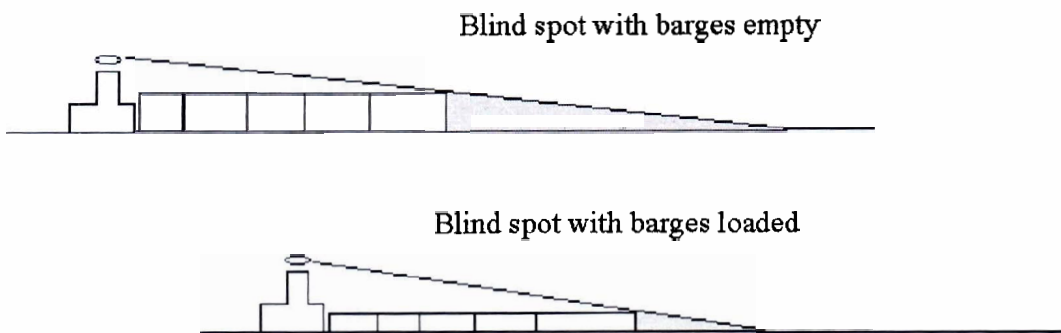
Figure 2  
BLIND SPOT DIFFERENCES UNDER LOADED AND UNLOADED CONDITIONS  
(Not to scale)

- b. All blind spot distances were significantly increased because the barge string was empty, creating minimal draft. Had the barges been fully loaded, the string would have ridden lower in the water and presented less of an obstruction between the pilothouse and the area immediately ahead of the tow (see figure 2 for example). Further, the M/V ELAINE G's pilothouse is relatively low to the waterline. This low height of eye produces a situation of obscured vision in the area ahead of its tow when pushing ahead empty strings of a similar length to that of July 15, 2001.

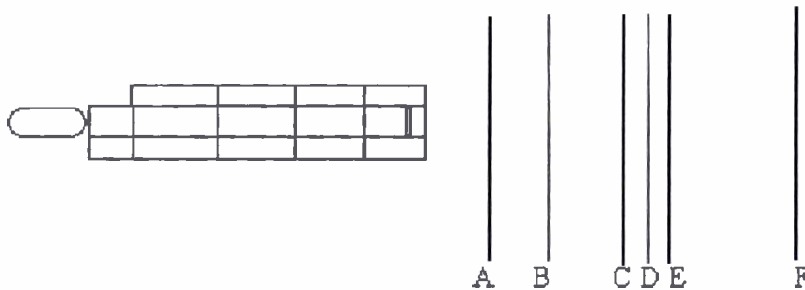
Figure 4

**BLIND SPOT DISTANCES PAST HEAD OF TOW**

426 feet	A - Highest radar to recreational boat
462 feet	B - Low radar to recreational boat
