# United States Coast Guard

## MISLE Incident Investigation Report For

GOLDEN RAY - Capsizing

Subj: FORMAL MARINE CASUALTY INVESTIGATION CONCERNING THE CAPSIZING AND  
FIRE OF THE RO/RO GOLDEN RAY WHILE TRANSITING ST. SIMONS SOUND,  
GEORGIA ON 08 SEPTEMBER 2019.

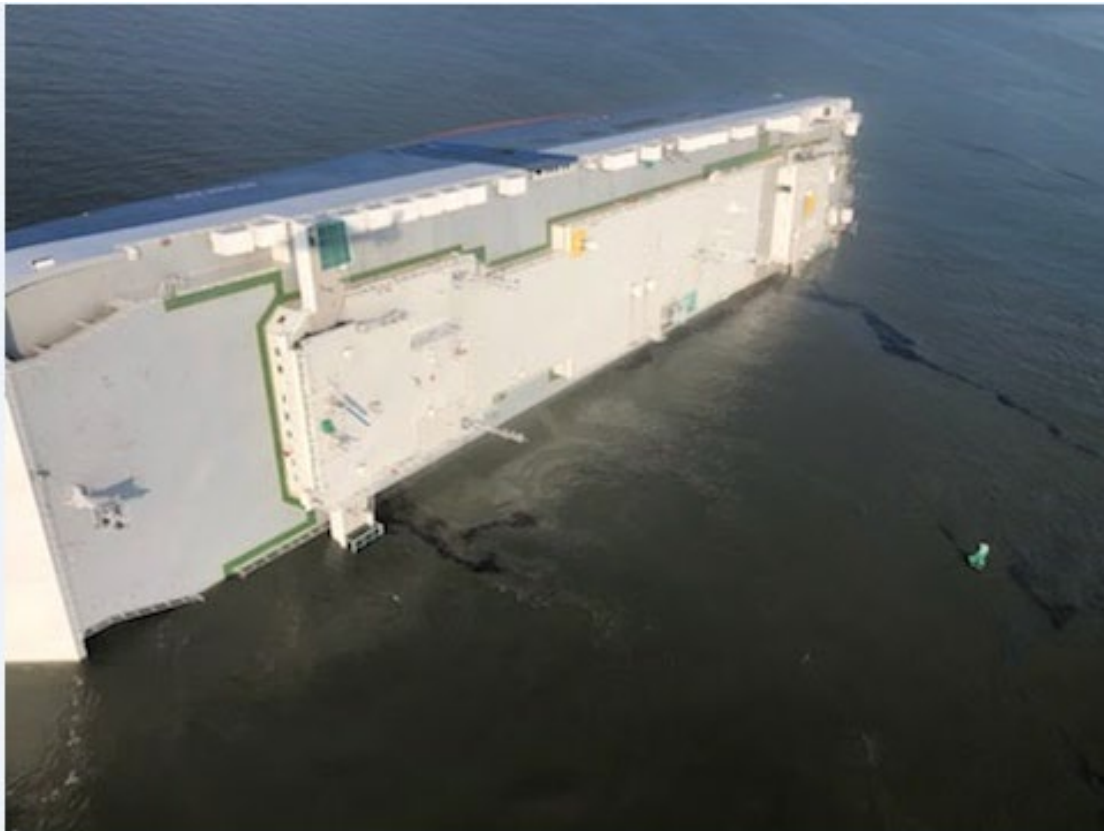
*Figure 7. Photo of sheen taken by USCG post incident*

4.1.14. After daylight, a responding airborne USCG asset observed a sheen in the vicinity of the GOLDEN RAY, captured in Figure 7.

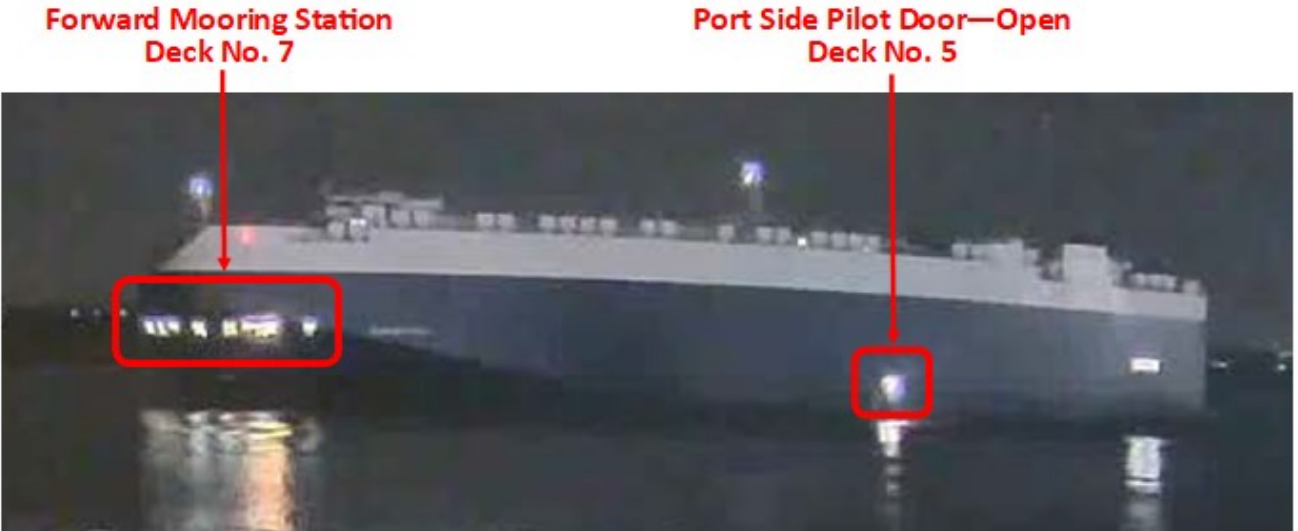
Figure 9. Pilot door condition on outbound transit from Jacksonville September 6, 2019 from JAXPORT CCTV footage

4.2.2.1.1. Upon departure from the Port of Jacksonville and until the Jacksonville Pilot disembarked the GOLDEN RAY, the Pilot Door remained open as pictured in Figure 9 below.

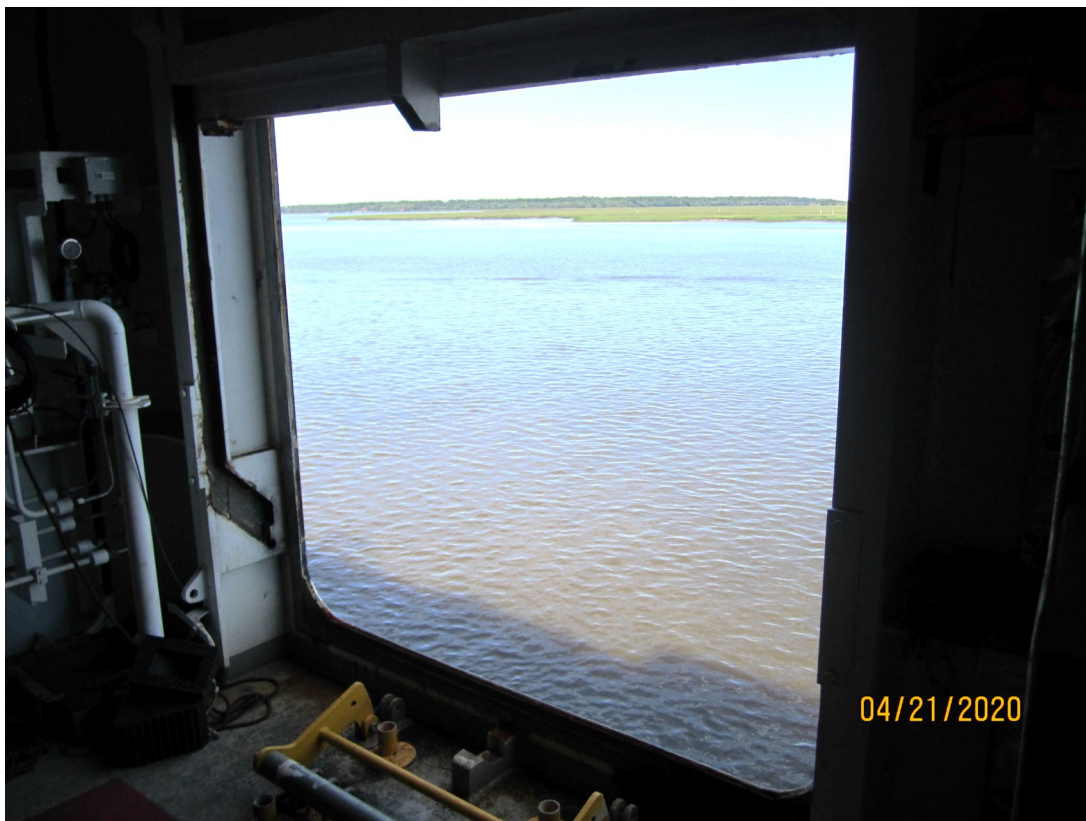
Figure 11. Photo of the SILVER RAY Pilot Door open taken from inside the vessel by USCG

transits with a pilot onboard. It is considered a watertight door completely open to Deck 5, as pictured on the SILVER RAY in Figure 11 and Figure 12. Deck 5 is considered part of the watertight envelope of the vessel and contained an aft and midship access to stairtowers noted in section 4.1.8.

The GOLDEN RAY departed port on numerous occasions with the Pilot Door open on Deck 5 during inbound and outbound transits requiring a pilot. On departure from the Port of Brunswick, the Master ordered the Pilot Door open and it remained open through the incident. SOLAS II-1/22 requires watertight doors to be closed if not in use while underway, although some discretion is left to masters in limited circumstances.<sup>6</sup>

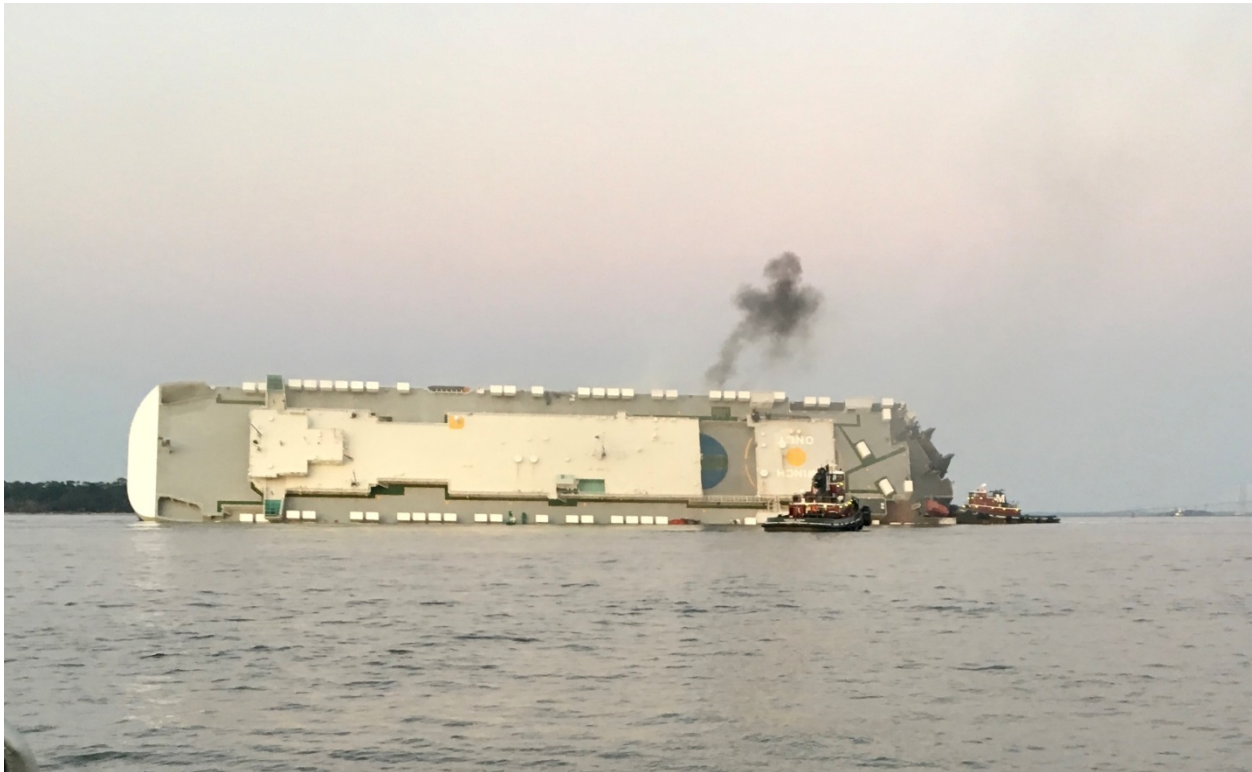
Figure 13. Photo of vessel post incident showing smoke after sunrise taken by USCG

4.2.5.2.4. *Fire Detection System.* The GOLDEN RAY was equipped with a fire detection system that alarms visually and audibly on the Bridge. Witness testimony indicated that no fire alarms were received prior to the vessel's sudden heel to port. The loss of power resulted in numerous alarms being activated on the Bridge; however, witnesses could not confirm if any originated from the fire detection system. Additionally, the history of fire alarm activations was not able to be recovered from the fire detection system panel. The only facts surrounding the fire were provided by responders, as pictured in Figure 13 and noted during their post-incident statements. No crewmembers witnessed the fire.

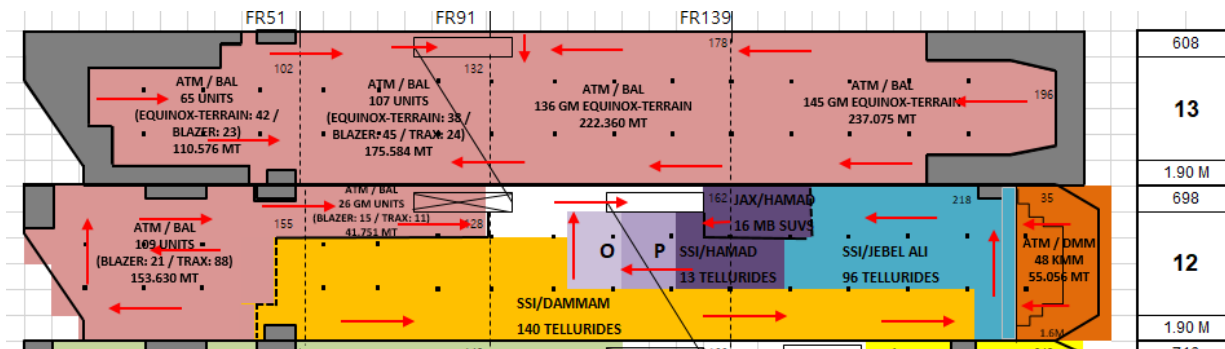
Figure 14. Snapshot of pre-stowage plan for Brunswick provided by Hyundai Glovis

Each deck was divided into "holds" and these holds were identified in the pre-stowage plan (see Figure 14). Further, the Chief Officer stated he derived individual vehicle weights by dividing the total weight by the number of

vehicles in each hold. If the GM could not be brought within parameters of the vessel's approved Trim and Stability Booklet, the Chief Officer would contact the LOM for adjustments to vehicle locations. The Chief Officer stated he entered the information into the stability instrument for Brunswick and received an acceptable stability condition. Upon arrival to Brunswick, stevedores loaded the GOLDEN RAY in accordance with the pre-stowage plan, which was subsequently verified by the Chief Officer. The Chief Officer typically would note any changes that deviated from the pre-stowage plan, but none occurred for Brunswick. Although it is a common practice in the RO-RO vessel industry, the final stowage plan was not submitted prior to departure. The Chief Officer stated he calculated the stability again using the stability instrument following the loading operations and received an acceptable stability condition, including a GM of 2.45 M, prior to departure.

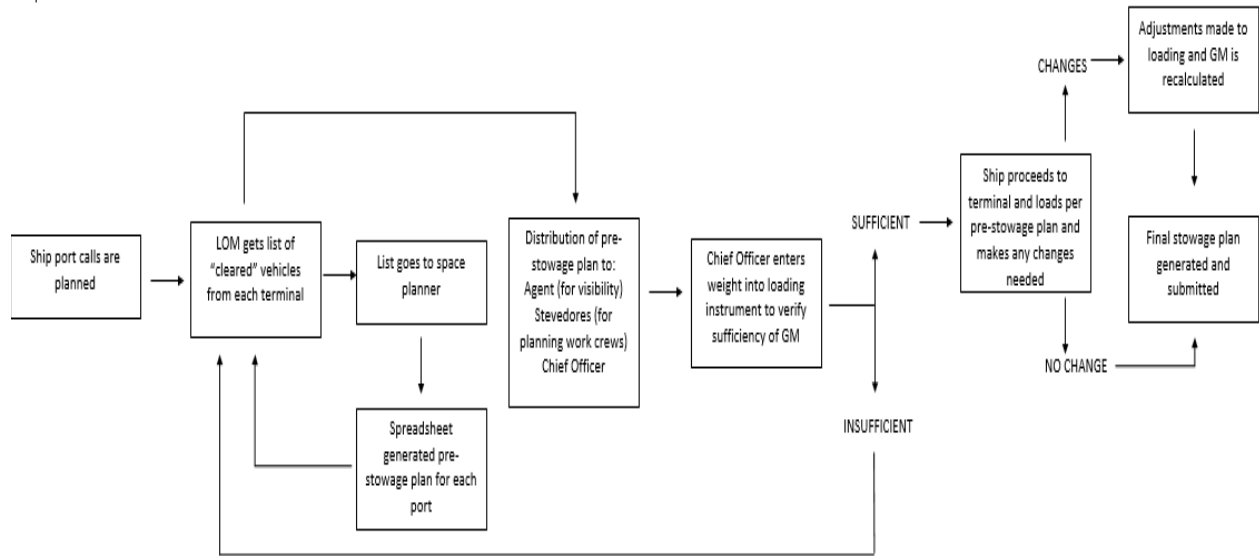
Figure 15. Cargo operations flow generated from witness testimony

While this undocumented process used for development of cargo plans for the GOLDEN RAY is efficient and utilized minimal personnel, there is a single point of failure in having multiple steps for consideration of stability in loading. The Chief Officer singularly considers and calculates stability in the process, based on decisions made by the LOM and space planner. In general, it is ideal that the vessel would receive a copy of the pre-stowage plan ahead of a port call which did happen in this case. Additionally, the Chief Officer received the pre-stowage plan with estimated total weights for each section, rather than individual vehicle weights. Due to unsuccessful attempts to retrieve information off the stability instrument, there is no way to verify the Chief Officer’s testimony that GM was calculated at the steps indicated on the flow chart using the pre-stowage plan. The process in Figure 15 had worked since its inception in the fleet and never resulted in a loss of stability for other vessels. However, this process relied solely on one person to conduct stability calculations. Had the GOLDEN RAY provided feedback to the LOM or space planner, they could have helped adjust the pre-stowage plan to achieve acceptable stability and avoided the subsequent loss of stability. No one in the process noticed visible signs of stability issues or the manner the vessel handled underway in either the Port of Jacksonville or the Port of Brunswick. Based on the departure report from Jacksonville, the LOM or space planner could have intervened at that time to set corrective measures prior to the vessel arriving in Brunswick. During the process of validating the stability based on the pre-stowage plan, if the loading instrument calculated a GM or other parameter that indicated a lack of stability, the stability instrument would have so indicated with a message of, “NOT OK”. If this message appeared, there were three options available to resolve the situation through adjustment of either cargo or ballast. First, the vehicles onboard could have been moved. However, due to limited empty cargo space, movement of vehicles would have provided little positive adjustments to the GM. Second, the vehicles could have been offloaded. In this situation, the implication of the Jones Act would have been a consideration. Lastly, and the most desirable option, the Chief Officer could have taken on ballast to achieve an

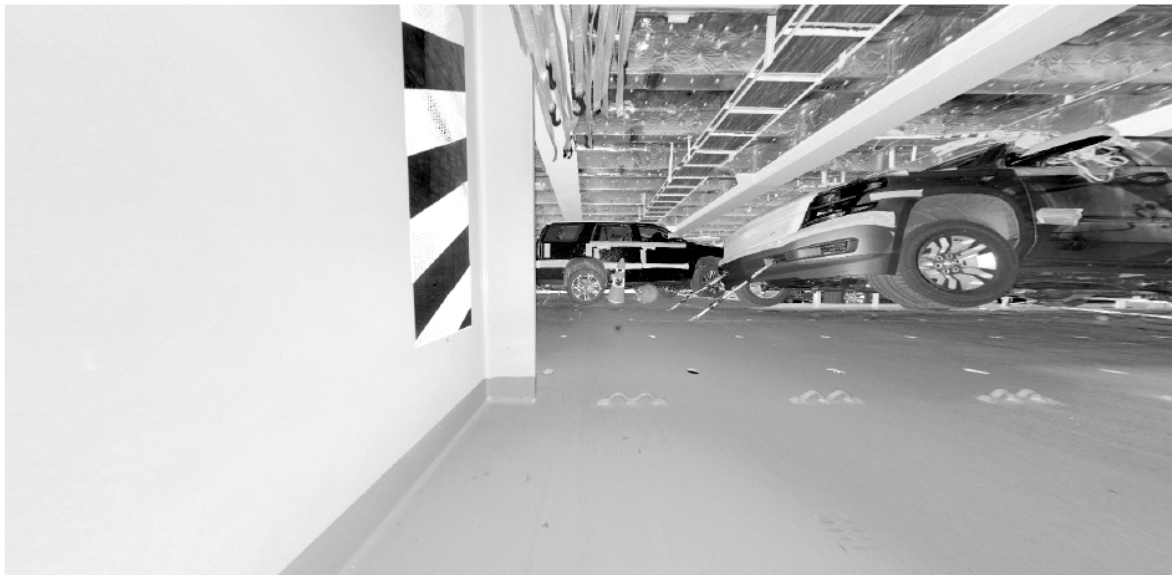
Figure 16. 3D scanning of vessel post incident by salvors

5.14. *Cargo Securing Manual (CSM).* SOLAS Chapters VI and VII require a CSM, approved by the flag Administration, to be provided on all types of vessels engaged in the carriage of cargoes other than solid and liquid bulk cargoes.<sup>19</sup> During this investigation, consideration to cargo securing was given. Evidence did not indicate there was any issue with how vehicles were secured on the GOLDEN RAY. The lashings were provided by the vessel and vehicles were lashed in accordance with the CSM. While the dangerous conditions on board prohibited investigators from confirming that all vehicles were properly secured, it is assumed based on the testimony of the stevedores and crew, that all vehicles were properly secured. Further, salvage of the vessel included 3D scanning of the cargo decks, as pictured in Figure 16. Even after the capsizing and grounding, many of the vehicles on board were held in place by their lashings. This remained the case even as the vessel was salvaged two years later, as pictured in Figure 16.
