**REPORT OF THE INVESTIGATION INTO THE
COMMERCIAL FISHING VESSEL JOHN START (O.N.
949114), LOSS OF LIFE IN THE VICINITY OF
CARPINTERIA, CALIFORNIA ON
DECEMBER 8, 2021**

MISLE ACTIVITY NUMBER: 7400259

INVESTIGATING OFFICER'S REPORT

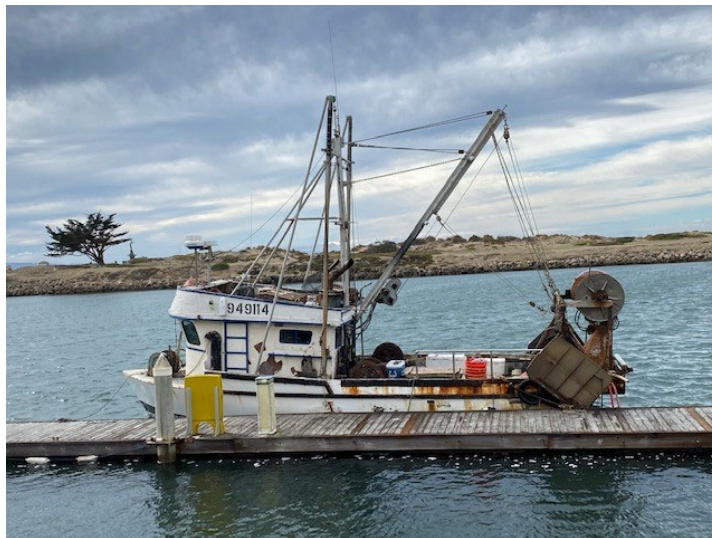
Figure 1: Port side of JOHN START moored in Ventura, CA provided by investigator from MSD Santa Barbara.

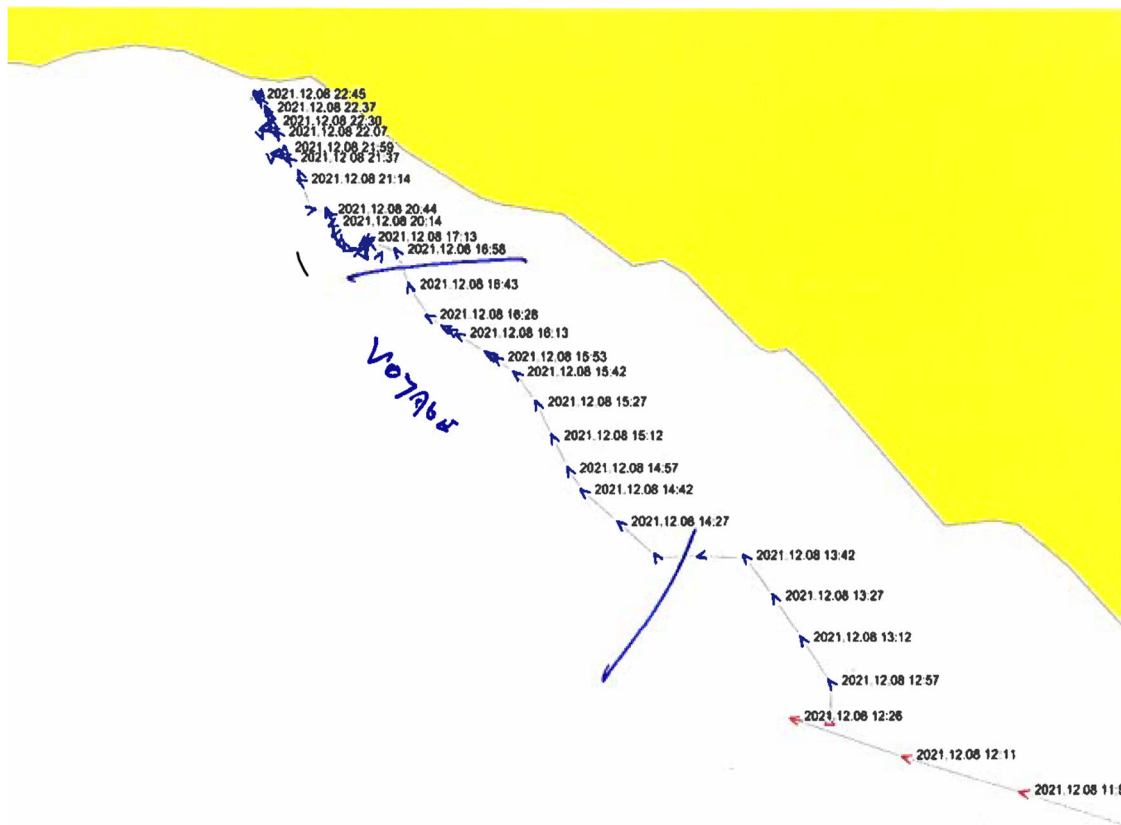
4.1.5. Between 0843 (1643 UTC) and 1445 (2245 UTC), the vessel sporadically changed course and speed as it drifted in a northwestern direction while steadily approaching the shore in the vicinity of Carpinteria, California. During this 6-hour window, it is presumed that the Master fell overboard, and the unmanned vessel continued underway with its engine engaged.

Figure 3: Map of JOHN START's VMS Tracks on 08DEC2021. Times displayed are UTC (PST +8).

5.1. *Master fished alone.* With over 20 years of experience in the fishing industry, the owner of the JOHN START was the sole operator of the vessel. As the master of the vessel, his routine operation was to fish alone unless he had a required National Oceanic and Atmospheric Administration (NOAA) observer onboard (the Magnuson Stevens Act requires trained NOAA observers to periodically go onboard Commercial Fishing Vessels to collect data on fishing activities, fishing locations, and gear used). Additionally, the master was involved in a collision with another vessel approximately 1 year prior. He failed to maintain a proper lookout on the vessel as he prepped for fishing operations at the stern (*see 4.2.4.*). The complexity of individually operating a fishing vessel imposes lapses in a sailor's ability to maintain a proper lookout while underway. The next of kin confirmed that he had departed that morning to go fishing and that he was alone. By studying the vessel's track line through the Vessel Monitoring System (VMS), it is reasonable to assume that the master could have fallen overboard at any point between 34°22.14'N, 119° 32.10'W at 0843 hours (1643 UTC) and 34° 24.38'N, 119°34.37'W at 1445 hours (2245 UTC) (*Figure 3*). Search

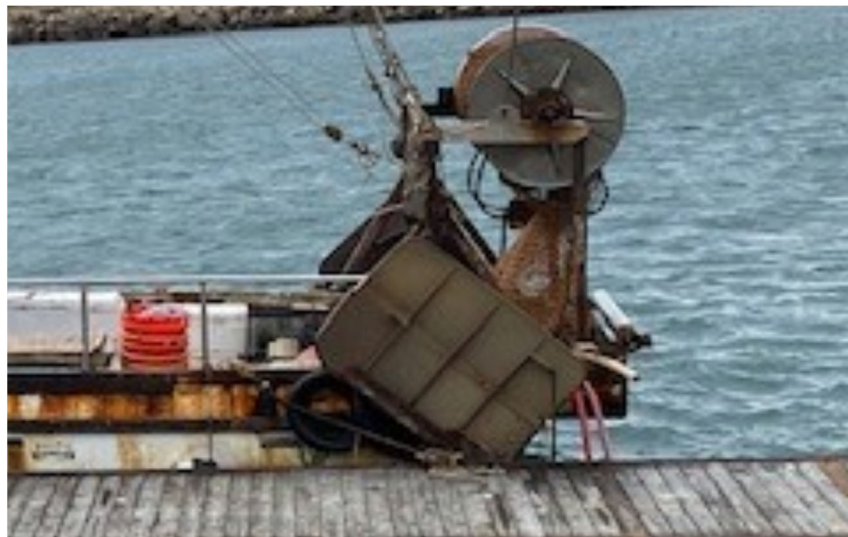
4.1.12. At 1615, Towboat U.S. vessel RETRIEVER arrived on scene. The master of the RETRIEVER observed the vessel's two metal fishing doors in their stowed position on the port and starboard sides.

Figure 4: Close-up view of stowed metal fishing doors, portside.

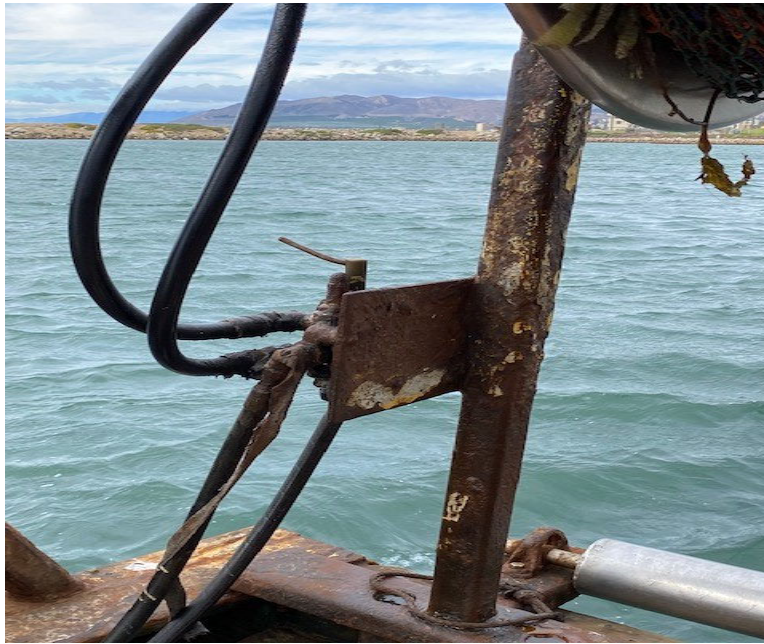
4.1.13. The RETRIEVER maneuvered alongside, and a crewmember boarded the JOHN START. He assessed the vessel and confirmed that the JOHN START was anchored to the sea floor by its entangled fishing net at a depth of approximately 20 feet of water. He attempted to raise the net using the hydraulic winch located on the stern of the vessel, but it held fast.

Figure 5: Hydraulic lever operating the fishing net drum.

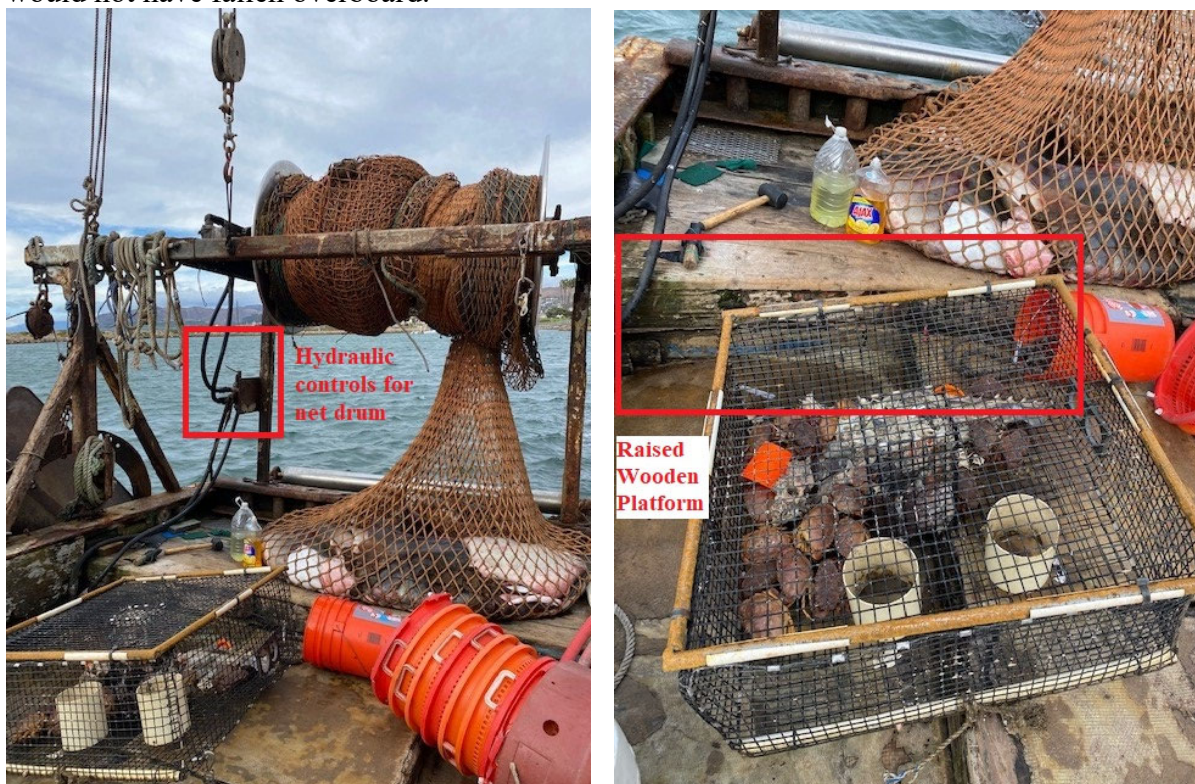
5.2. *Vessel arrangement.* It is reasonable to assume that the master's last position prior to falling overboard was at the stern, attempting to maneuver the net using the hydraulic controls or directly manipulating the net by hand when he fell overboard. When search and rescue crews arrived on scene, they observed both port and starboard metal doors (also known as plows) were in the stowed position (*Figure 4*), and the vessel was anchored to the sea floor by the entangled fishing net. The position of the doors indicated the vessel had completed initial fishing operations and the master was preparing to retrieve the fishing net. Crewmembers from Towboat U.S. made several attempts to retrieve the net onboard using the hydraulic controls. The outboard position of the hydraulic control station located at the stern of the vessel required the operator to step onto a wood platform in order for it to be operated. The construction of the wood platform was susceptible to becoming slippery in wet conditions, which would have always been present during fishing operations. The location and height of the platform reduced the effective height of the safety rails and increased the potential for tripping hazards to exist. It is reasonable to assume that if the vessel was configured to a higher degree of overboard safety during hydraulic operations, he would not have fallen overboard.

Figures 6 & 7: Hydraulic control location / raised wooden platform (vessel's last known configuration).
