REPORT OF INVESTIGATION INTO THE SINKING AND LOSS OF TWO CREW MEMBERS ABOARD THE COMMERCIAL FISHING VESSEL LADY LUCK

IN THE GULF OF MAINE
ON 01/31/2007

MISLE ACTIVITY NUMBER: 2865282

INVESTIGATING OFFICER'S SUPPLEMENTAL REPORT
REGARDING THE SINKING AND LOSS OF TWO CREW MEMEBERS
ABOARD THE COMMERCIAL FISHING VESSEL

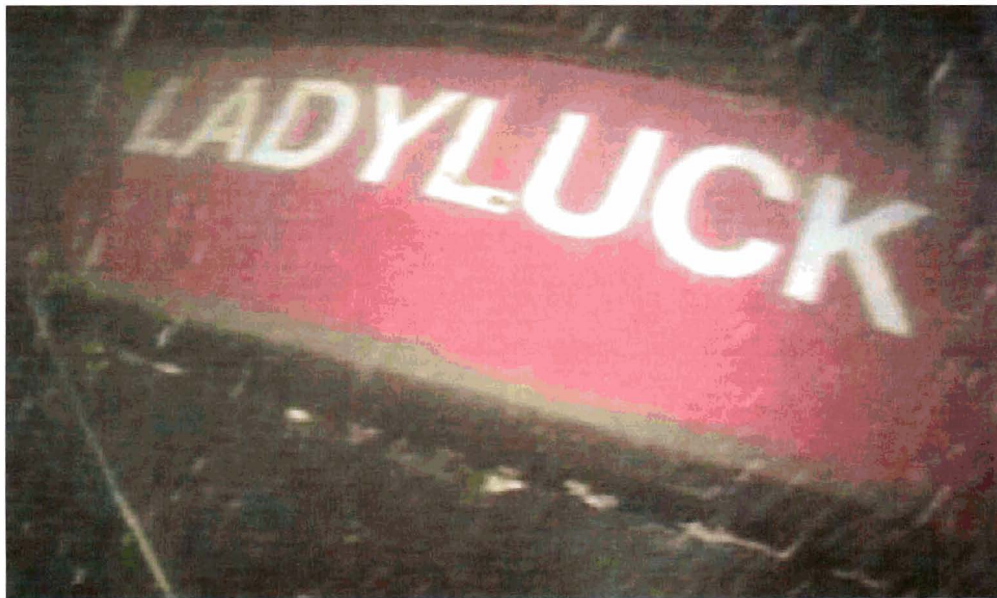
Starboard bow of LADY LUCK

The ROV operation showed all windows intact. The hull appeared to be in the same condition as shown in available pictures with no breaches. The entire rail around the port to starboard bow is also intact. There is one small inset on the starboard quarter but it is not apparently catastrophic.

The ROV operation conducted on March 13, 2007 revealed the vessel resting on its port side, however, the entire structure of the bow can be seen clearly. Based on the video produced from the ROV operation, there is no indication of damage to LADY LUCK that would be consistent with a collision at sea, *however, over 40 feet of the port side could not be viewed with the ROV*. All windows are intact and the hull appears to be in the same condition as shown in available pictures taken before the accident. The entire rail around the port to starboard bow is intact. Although the mast itself is not shown clearly, it is not seen lying on or near LADY LUCK and appears to be in place. During the viewing of the ROV video, the manager of Leslie Ann Fisheries, LLC questioned a small dent in the starboard quarter of the vessel. The inset had no obvious tears, holes, fractures or scrapes that would be consistent with a catastrophic high impact collision. Therefore, the Coast Guard does not consider this inset to be associated with the sinking (see photo on pg 13).

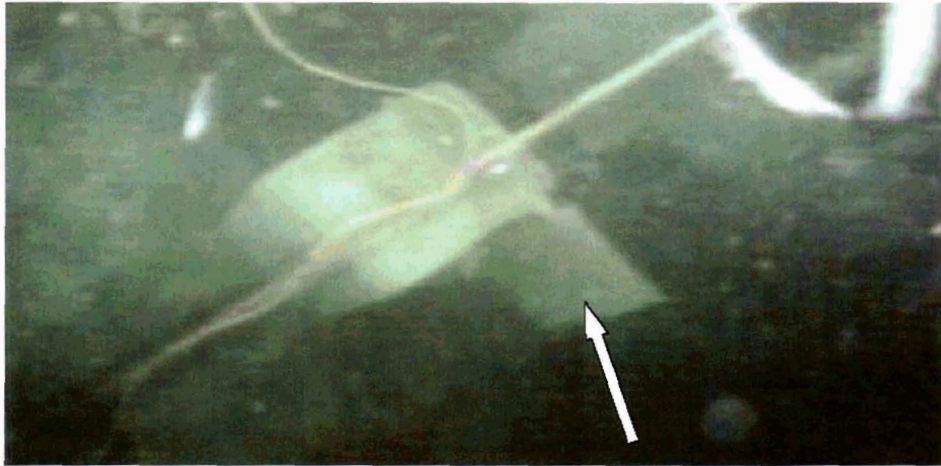
Photo of open door

ROV video shows the forward watertight door that leads to the forward berthing of LADY LUCK open. The owner of the vessel stated that the door is normally kept closed while underway.

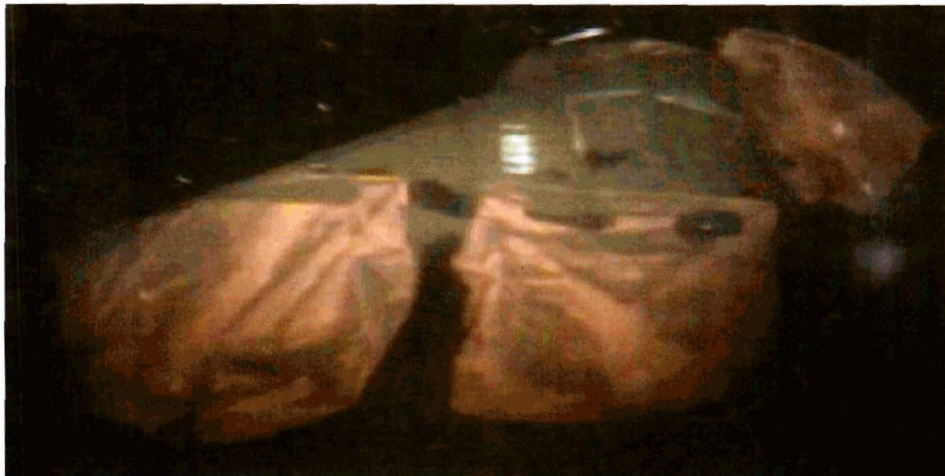
Photo of life raft

During the ROV operation, the life raft was observed deployed and inflated with the sea painter still attached to the cradle. The life raft had deployed and was lying on the bottom of the ocean floor approximately 40 feet in front of the bow of LADY LUCK. *ROV video could not determine the weak link configuration or if an appropriate weak link was installed and/or installed properly or whether the painter fouled.* Investigators can only ascertain from the video that the life raft deployed as designed but the sea painter never separated from the cradle.

LADY LUCK's life raft deployed properly; however, the sea painter *appears to be* attached to the cradle which prevented the raft from separating from the sinking vessel. During the ROV operation, the life raft was found approximately 40 feet forward of the bow of LADY LUCK still attached to the location of the weak link. ROV video could not determine the weak link configuration or if an appropriate weak link was installed (or installed properly). Investigators can only ascertain from the video that the life raft deployed as designed but the sea painter never separated from the cradle. It is unknown if the life raft surfaced at any time, only that the life raft was not released from the vessel. The life raft's sea painter suggests how the vessel may have sunk because of its positioning between the forward day shape (which is located on top of the pilot house). At this position it is possible that the vessel could have sunk by the stern. As it sank, the life raft deployed through the day shape on the pilot house structure over the bow of the vessel. *It is possible that the weak link was improperly installed which could have led to its not performing as designed; however, it cannot be conclusively determined from the available evidence whether the weak link did in fact fail, whether improper connections were made, or if the painter was otherwise fouled during the sinking. The December 15, 2006 boarding by CGC JEFFERSON ISLAND did not reference any weak link discrepancies.*

Opinion: ***Deployment of Lifesaving Equipment:*** The life raft floated free and deployed as designed. The weak link either failed, was improperly installed, or installed in a way that prohibited the life raft from separating from the sinking vessel. *Investigators cannot rule out that the painter may have been fouled as the vessel sank, which may also explain the painter's non-release.* Likewise, the EPIRB also deployed and transmitted.

The life raft deployed as designed but the weak link assembly failed to release the raft from the vessel bringing it to the ocean floor. *Investigators cannot rule out that the painter may have been fouled as the vessel sank, which may also explain the painter's non-release.* While investigators could not ascertain the cause of this failure, it raises visibility of the criticality of liferaft and buoyant apparatus weak links and their proper installation.

Coast Guard recommends continued outreach to fishing communities, highlighting marine casualty evidence of the proper and improper installation of safety gear on fishing vessels. It is *possible* that the connection of the sea painter to the cradle was improperly made, *the weak link did not function properly, or that the painter somehow fouled during the sinking*. The Coast Guard should emphasize the importance of proper weak link installation and educate life raft owners of the weak link's purpose and life raft deployment theories. Based on interviews with fishermen, there may also be a false sense of security with some VMS providers. Some fishermen may be under the impression that VMS is monitored for Search and Rescue purposes when it is really a Living Marine Resources tool.

We recommend that the Coast Guard (CG-5214) study the feasibility of re-engineering weak link locations from the raft cradle to be located inside the life raft's tamper proof canister for Coast Guard approved life rafts. Conceptually, trained technicians would install the weak link during servicing and leave the painter to be secured to the vessel by the crew. This proposal could simplify the installation process and better protect the weak link.

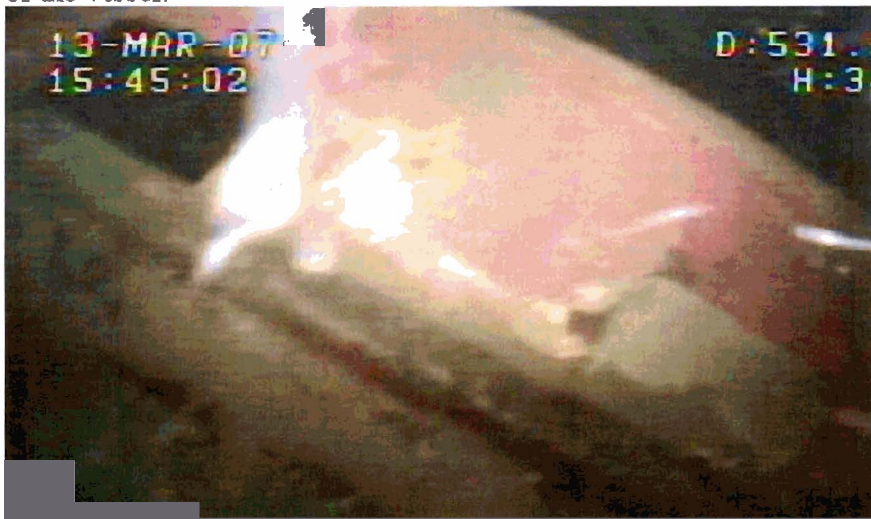
Photo of Open/Closed Freeing Ports

Freeing ports are openings in the bulwarks that allow water to quickly drain from the deck. The vessel was equipped with three freeing ports on each side of the work deck. *The bulwarks also had other smaller openings which could have also allowed water to drain. The other openings, however, appear not to be solely positioned or designed to drain large volumes of water, as freeing ports are.* It is common practice for freeing ports to be intentionally closed to retain fish on deck or to prevent water from entering the deck from the sea. The Coast Guard obtained several recent photographs of LADY LUCK on separate occasions which show multiple freeing ports closed. The Remote Operated Vehicle video also showed *two* of three freeing ports closed on the starboard side. Closed freeing ports may have prevented water on deck from quickly draining and may have impacted stability.

on deck. Based on their modeling, only limited amounts of water was needed to negatively affect stability. The vessel's course exposed the vessel to a quartering sea which would make it susceptible to shipping seas from the stern. If any (if not most) of the freeing ports were closed (as the Coast Guard suspects) then water on deck would cause a free surface effect causing the vessel to further lose stability. *The altered forward net reel arrangement may have affected the overall intact stability characteristics of the vessel but without a stability test or inclining experiment, it is impossible to know to what extent.*

Opinion: *Capsize:* With the available evidence (ROV video and pre-casualty photographs) of the net reel arrangement along with the closed freeing ports, the Coast Guard feels that capsizing due to a rapid loss of stability is the most likely cause of the sinking. This opinion is supported by the lack of distress or mayday calls, or the recovery of survivors or bodies. The Coast Guard remains convinced that the sinking happened so rapidly that the crew had no time to react or access lifesaving equipment. The MSC evaluation supports this position as capsizing due to water on deck or a combination of water on deck with a flooding lazarette proved to leave their model highly prone to rapid capsizing.
