UNITED STATES COAST GUARD

TUG VALOUR

40 MILES OFF THE COAST OF WILMINGTON, NORTH
CAROLINA ON JANUARY 18, 2006 WITH MULTIPLE
LOSS OF LIFE

Subj: TUG VALOUR REPORT OF INVESTIGATION

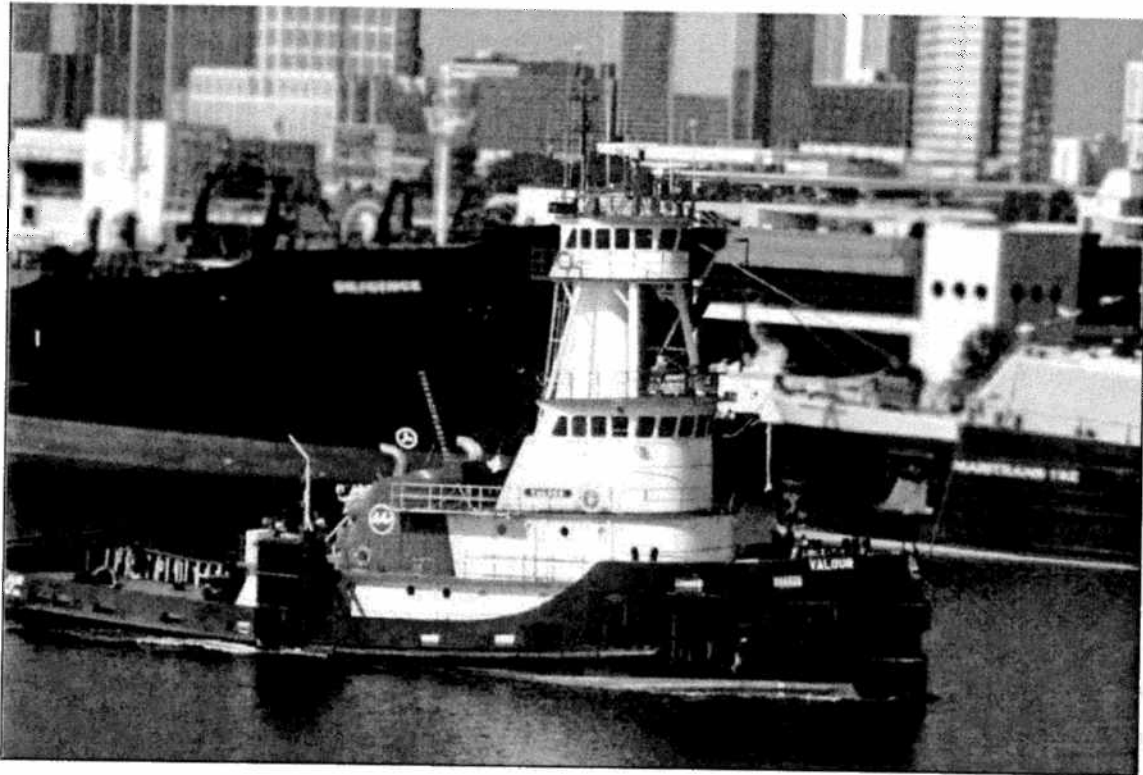
Photograph of the VALOUR prior to the incident

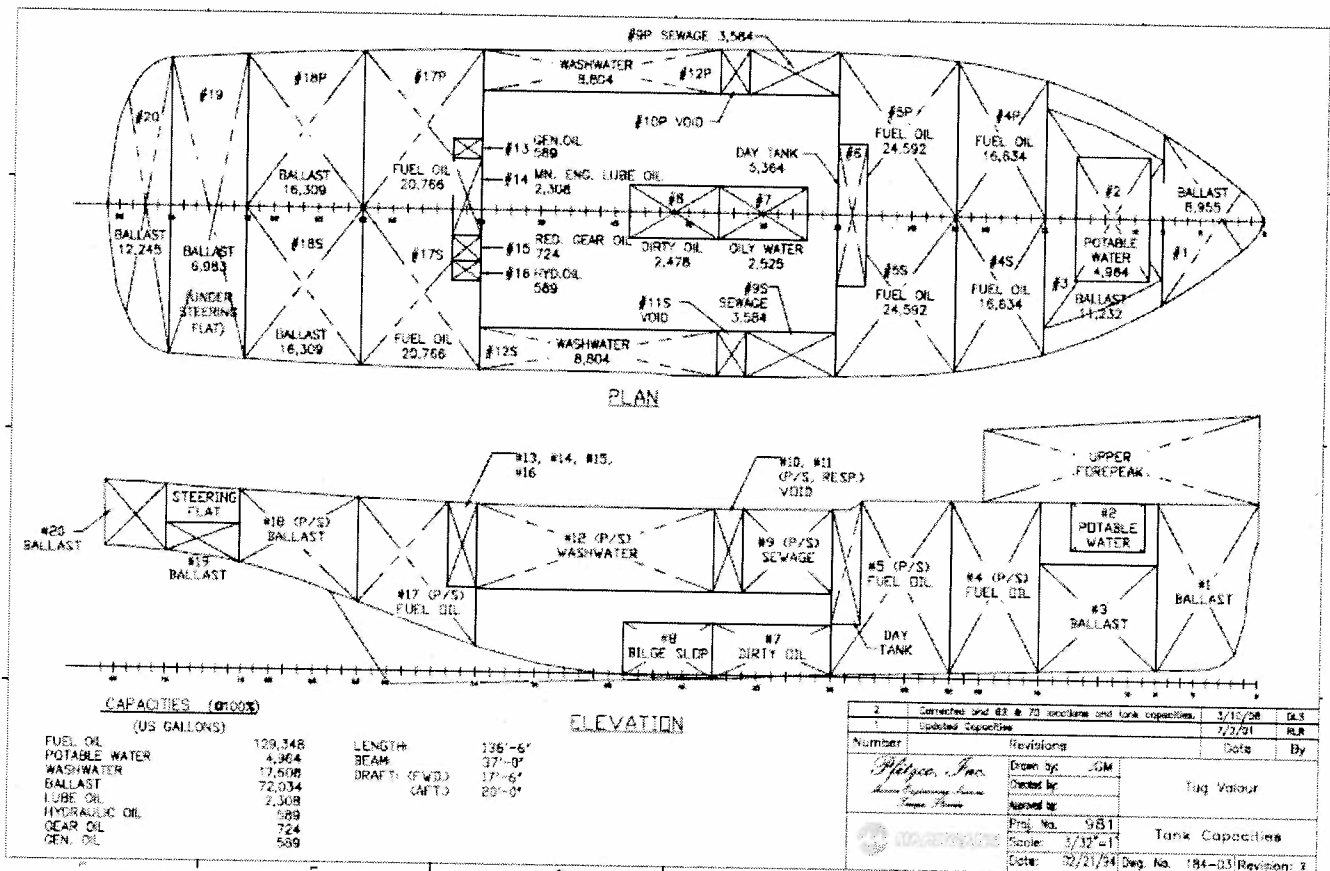
Corrected Tank Capacities Plan

5. The master and crew of the VALOUR relied on an incorrect tank capacity plan provided by Maritrans Operating Company, LP, the operating company of the VALOUR, for referencing tank capacities for ballasting and fueling. This plan dated February 21, 1994, had the #17 port and starboard fuel tank capacities at 15,683 gallons each and the #18 port and starboard ballast tank capacities at 8,483 gallons each. The Coast Guard received a corrected tank capacity plan after the VALOUR sank. The corrected capacities for the #17 fuel tanks were 20,766 gallons each and the #18 ballast tanks were 16,309 gallons each.

10. It is recommended that OSG – Maritrans conduct an internal review to ensure that all of their vessels' plans are accurate and up to date.
11. It is recommended that OSG – Maritrans revise their crew changeout checklist to ensure each crewmember verifies that they have a survival suit that fits him or her in a logical location such as in their stateroom, workplace or the emergency gear locker.

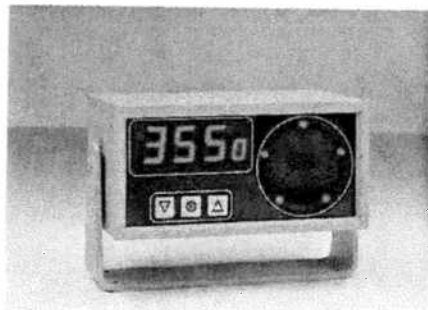
3. *Loss of Gyro / Maneuvering:* The wind was at least 40-50 knots gusting up to 70 knots and the seas ranged from 12 to 20 feet. Both were coming from approximately 180 degrees true. At 2320, Capt █████ slowed the VALOUR to 3 knots and shifted from autopilot to manual steering. At 2347, Capt █████ reported that he lost his gyro and that he was steering 103 degrees true according to the digital display. In his testimony he restated that the gyro did not fail. The digital display for the gyro was what he was referring to when he said he lost his gyro. Technical representatives for the gyro digital display (the LR40 shown below) stated that it has two alarm modes; the "Signal Alarm from Gyro Compass" and the "Power On Alarm." With the "Signal Alarm from Gyro Compass," the LR40 senses something wrong with the gyro signal and starts flashing the display, but it does not re-set the numbers to zero. The ships heading will be accurately displayed; however, it has most likely lost a "decimal" update. This means that it only loses or gains 1/6 of a degree. With the "Power On Alarm," the LR40 must lose power completely. In this case, once the unit regains power, the display will flash, but the numbers reset to 000.0 and begin counting up or down with the gyro signal. Meaning, if the unit lost power and then regained power when the vessel is on a gyro heading of 090 degrees true, then 090 degrees true is displayed as 000.0, 095 degrees true would be displayed as 005.0, 085 degrees true would be displayed as 355.0, and so on. When Capt █████ stated that the gyro display read 103 degrees; if this had been a "Power On Alarm," and Capt █████ was heading into the wind and seas (approximately 180 degrees true), then the VALOUR's gyro heading would have had to have been approximately 077 degrees true when the unit regained power in order for it to read 103. This is unlikely, as a course of 077 degrees true with a strong wind and sea coming from due south would have likely pushed the VALOUR much farther north.

LR40 (same gyro digital display unit found on the VALOUR)

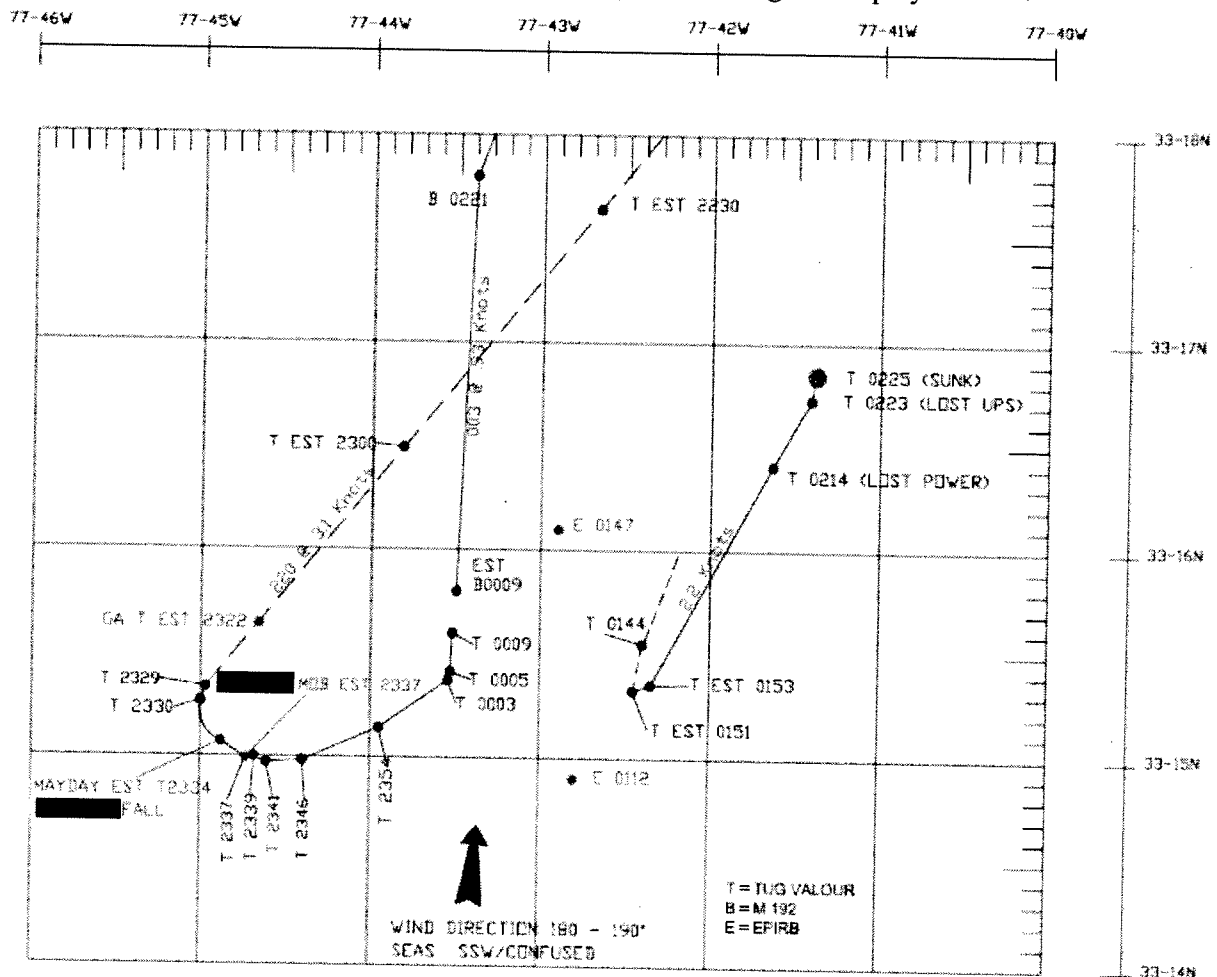
The VALOUR's trackline shows that it began tracking to the east shortly after 2330, and from 2337 to 2346, was on a course made good of 093 degrees true. There is speculation as to what the VALOUR's heading was as Capt █████ stated that he was heading into the wind and seas. From 2330 to 2354, the VALOUR went a distance of approximately 1 nautical mile during the

24 minute timeframe on a course made good of 102 degrees true which could easily be accounted for on a course of 103 degrees true at 3 knots. It is however very unlikely that the VALOUR would drift 1 nautical mile east when she was heading into winds and seas coming from due south. The winds and seas coming from the south could not have had such an eastward effect on the VALOUR without a significant port heading change. Additionally, barge M 192 was being towed 500 yards behind the VALOUR and was subject to the same winds and seas. Once the tow was released, from 0009 to 0221, with only winds and seas exerting force upon it, the barge drifted on a course of 003 degrees true at approximately 1 knot.

Therefore, regardless of whether this is the result of maneuvering to locate the man overboard or a loss of spatial awareness, it is likely that the VALOUR was transiting on a course of 103 degrees true with a "Signal Alarm from Gyro Compass" causing the display to flash.

Tracklines of the VALOUR and Barge M192 (via transponders on each vessel)
