**REPORT OF THE INVESTIGATION
INTO THE
FOREIGN PASSENGER VESSEL
WORLD EXPLORER (IMO# 9835719)
PASSENGER DEATHS ON NOVEMBER 15, 2022**

MISLE ACTIVITY NUMBER: 7597646

**LOSS OF LIFE ON AN EXCURSION VESSEL OPERATING FROM
THE FOREIGN CRUISE SHIP WORLD EXPLORER (IMO# 9835719)
ON NOVEMBER 15, 2022**

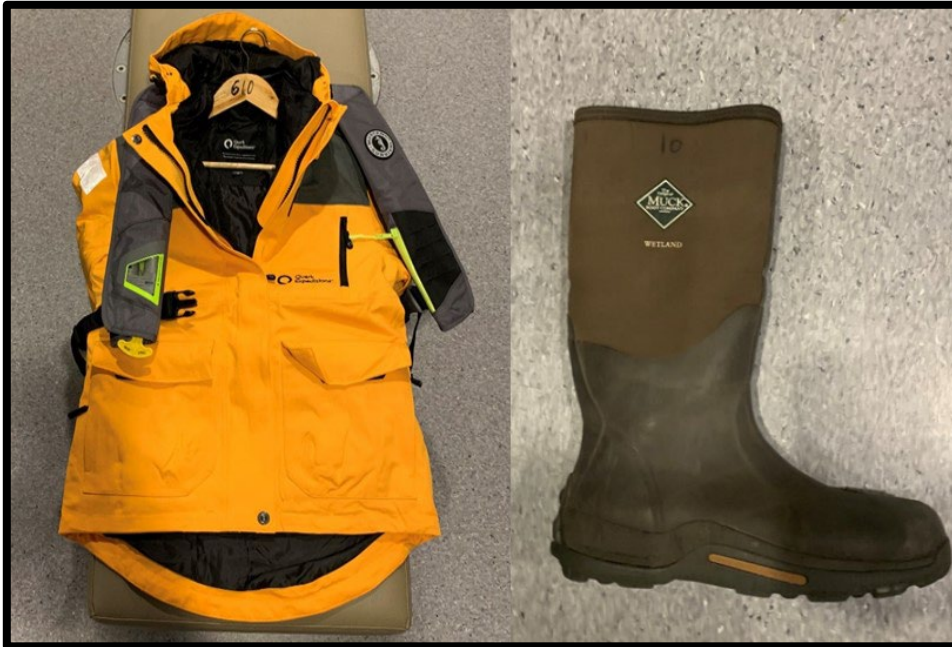
4.1.5. The WORLD EXPLORER crew prepared and lowered eight excursion Zodiacs into the water to conduct wildlife sightseeing excursions away from the shoreline without any planned landings. Prior to boarding the Zodiacs, all passengers were wearing the Quark-issued waterproof outerwear and inflatable PFDs. No passengers were wearing immersion PPE (i.e., dry suits or immersion suits).

Figure 4 - Quark provided standard PPE for excursion operations (taken by USCG on 30Nov2022)

5.5.1. All passengers onboard Zodiac #4 were wearing waterproof outerwear to protect against atmospheric elements. None of the passengers wore protective outerwear to insulate against cold water immersion (i.e., dry suits or immersion suits). The recorded water temperature on the day of the incident was -1 degree Celsius (30.2°F), which can dramatically reduce the survival time of persons in the water. This is because immersion into cold water causes rapid hypothermia and reduces the ability to hold breath, increasing the chance of aspiration and drowning.

- 8.2.2. It is highly recommended that Quark Expeditions and all other IAATO members consider amending their current operating procedures to separate the role of vessel operator (operator and lookout) and tour guide until international regulations are established to capture excursion operations in the Polar regions. In this incident, Quark Expeditions' most senior and experienced operator was not able to maintain complete situational awareness while fulfilling both roles. It is also recommended that these same parties consider the use of additional PPE to protect against cold-water immersion while on Zodiac excursions.

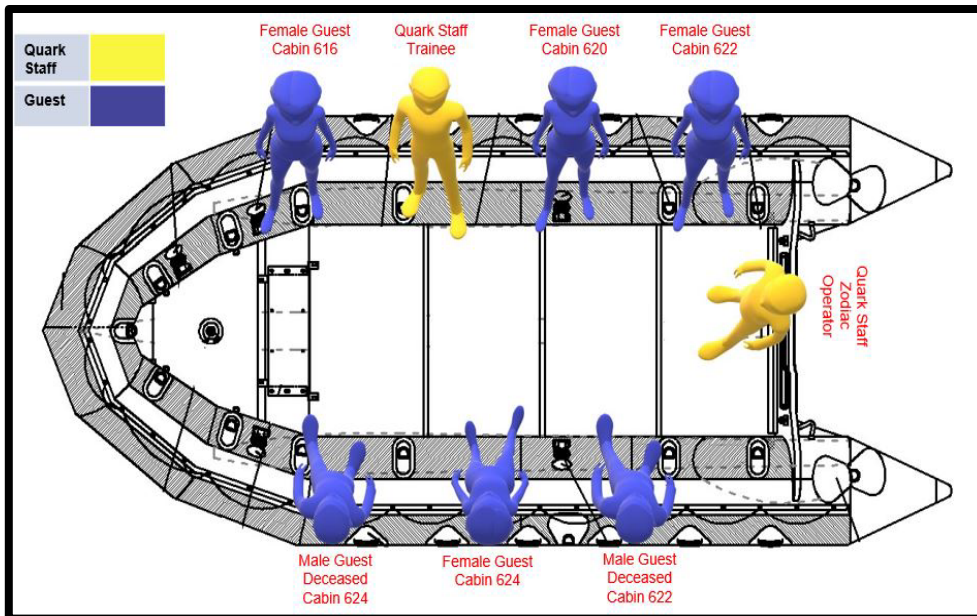
- One Zodiac operator (Quark team lead), who was in charge of the excursion and the safety of the vessel,
- One ornithologist (Quark staff) who was there as an operator trainee and to help spot wildlife,
- And six passengers.
- Three of the passengers were seated on port side buoyancy tube, and the other three passengers along with the ornithologist were sitting on the starboard buoyancy tube. The operator was standing in the stern of the Zodiac manning the tiller with his left hand. See figure 5 below.

Figure 5 - Depiction of the location of the Quark staff and passengers on Zodiac #4 (created by USCG)

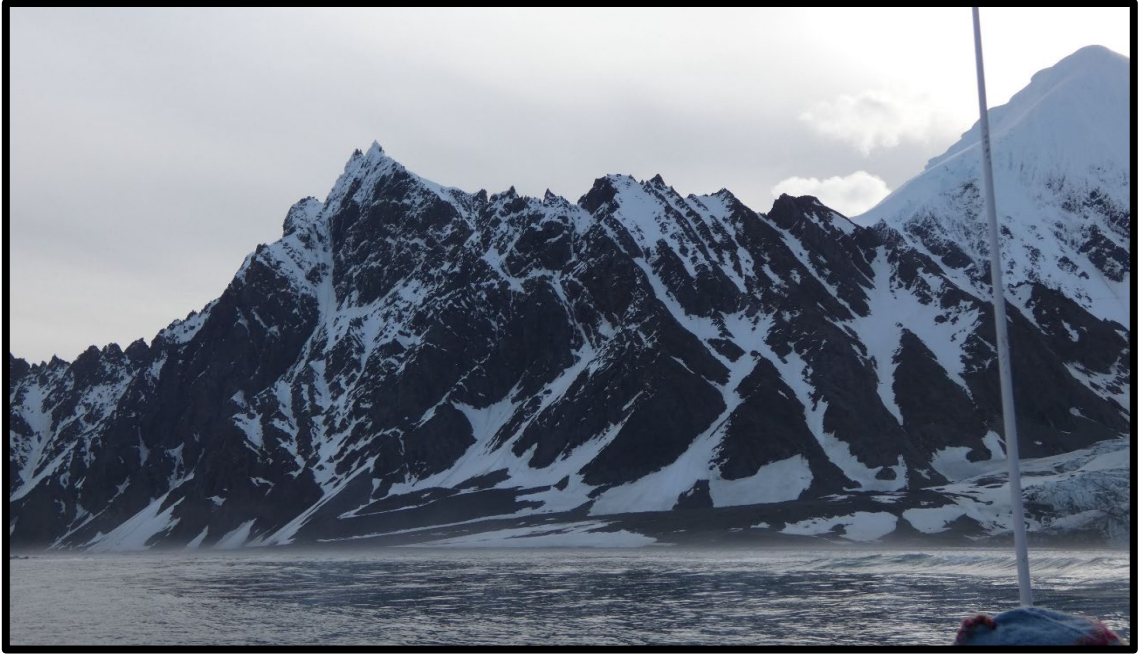
- 4.1.8. At approximately 1830, Zodiac #4 was away from the ship and travelling west in the direction of Cape Lookout. As required by Quark policy, Zodiac #4 was travelling with another Zodiac, “buddy boat”, who was approximately 50 to 70 meters away. The Zodiac #4 was parallel to the shoreline and approximately 50 meters from the observed surf zone (see figure 6 below). The speed of the Zodiac was approximately 2 knots.

Figure 6 – Picture provided by passenger showing the shoreline during excursion (taken by passenger on 15Nov2022)

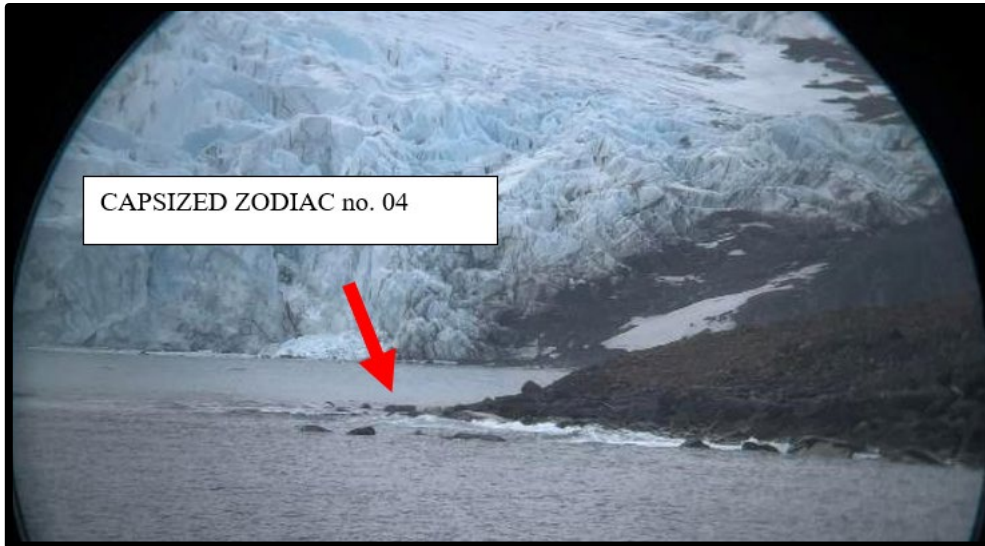
- 4.1.16. The location of the capsize was approximately 100 meters from the shore and near the mouth of a glacial bay (see figure 7 below). Due to the location of the capsize, emergency response Zodiacs could not directly approach Zodiac #4 and had to transit through the mouth of the glacial bay to a separate landing point. This extended the length of time for rescue personnel to reach the Zodiac to provide emergency medical attention.

Figure 7 – Area where Zodiac #4 capsized showing glacial bay (provided by Quark Expeditions)

5.4.1. The Antarctic region had limited and outdated near-shore charts for identifying bottom contours and potentially hazardous areas. Additionally, bottom contours and hazardous areas shift over time based on glacial activity and prevailing currents. The area where Zodiac #4 capsized had an uncharted underwater feature that caused a breaking wave to occur away from the prevailing surf zone at Elephant Island. Quark's Zodiac operators had to rely on experience-based knowledge of excursion areas for safe operations. However, the wave that caused Zodiac #4 to capsize was not part of a wave set or normally reoccurring pattern, so experience-based knowledge was insufficient to identify the hazard. If the area in which Zodiac #4 had been recently charted, it is possible that the Zodiac operators could have identified the potential hazard before the wave occurred. This would have allowed all the Zodiacs to avoid the immediate area and keep the excursions in safer water.

- 8.2.1. It is recommended that IAATO and IHO focus hydrographic efforts on commonly visited cruise ship locations to better identify potential hazard areas and provide operators with amplifying subsurface information. Experience-based knowledge can be an effective tool to determine potential waterway hazards in excursion routes. However, the weather and sea conditions in the Antarctic region are highly variable, and it is impossible to experience every excursion route under all possible operating conditions. Thus, amplifying hydrographic information is needed so Zodiac operators can increase their knowledge and awareness of potential hazards in commonly visited excursion routes.

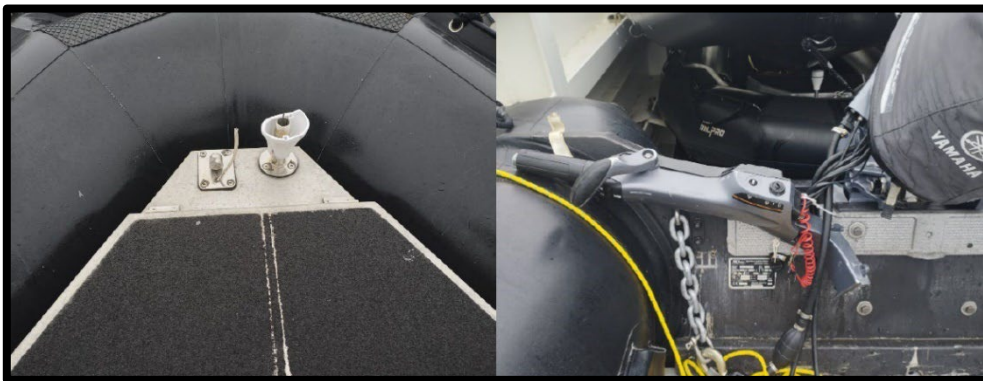
- 4.1.30. At approximately 2155, the capsized Zodiac #4 was towed off the rocks and brought back on board the WORLD EXPLORER. During that evolution, the Zodiac sustained extensive damage to the skeg, propeller, and engine body.

Figure 8 – Photos of damaged Zodiac #4 showing broken antenna and tiller (provided by Quark Expeditions)

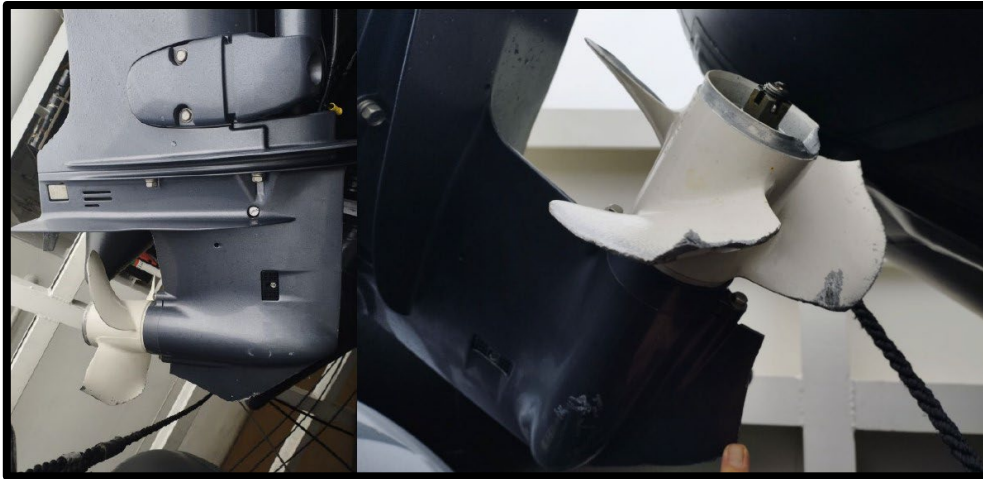
Figure 9 – Photos of damaged propeller on Zodiac #4 (provided by Quark Expeditions)
