UNITED STATES COAST GUARD

REPORT OF INVESTIGATION INTO THE COLLISION AND FIVE FATALITIES ONBOARD THE **M/V ZIM MEXICO III AND THE OSV LEE III**

IN THE SOUTHWEST PASS OF THE MISSISSIPPI RIVER
ON 02/21/2004

FORMAL INVESTIGATION INTO THE COLLISION OF THE M/V ZIM MEXICO III (IMO #9063988) AND THE OSV LEE III (O/N 542918) AT MILE MARKER 8 ON THE SOUTHWEST PASSAGE OF THE MISSISSIPPI RIVER ON 21 FEBRUARY 2004, RESULTING IN THE SINKING OF THE LEE III AND LOSS OF FIVE LIVES.

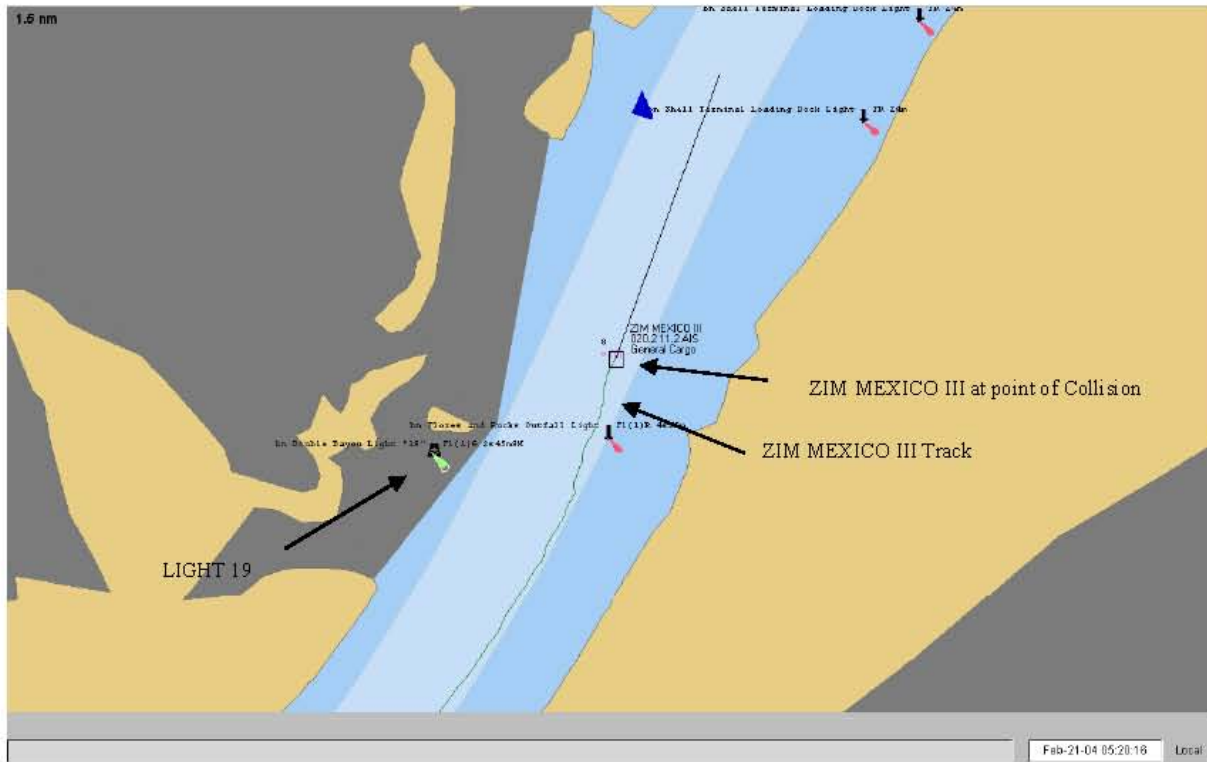
Figure 2: ZIM MEXICO III AIS Track at Moment of Collision (05:20:16)

41. The AIS position for the collision, 29-02.96N and 089-18.94 W, is based on the location where the vessel made a dramatic reduction in speed—from 11.2 knots to 8.4 knots in a matter of seconds. The data also shows that the 2.8 knot speed reduction was followed 20 seconds later by a 40-degree heading change and a further speed reduction to 1.6 knots. Clearly, the AIS data accurately fixes the time and position of the collision. It also matches the position the Chief Mate wrote down in the Bell Log of 29-02.97N, 089-18.92W immediately after the accident.

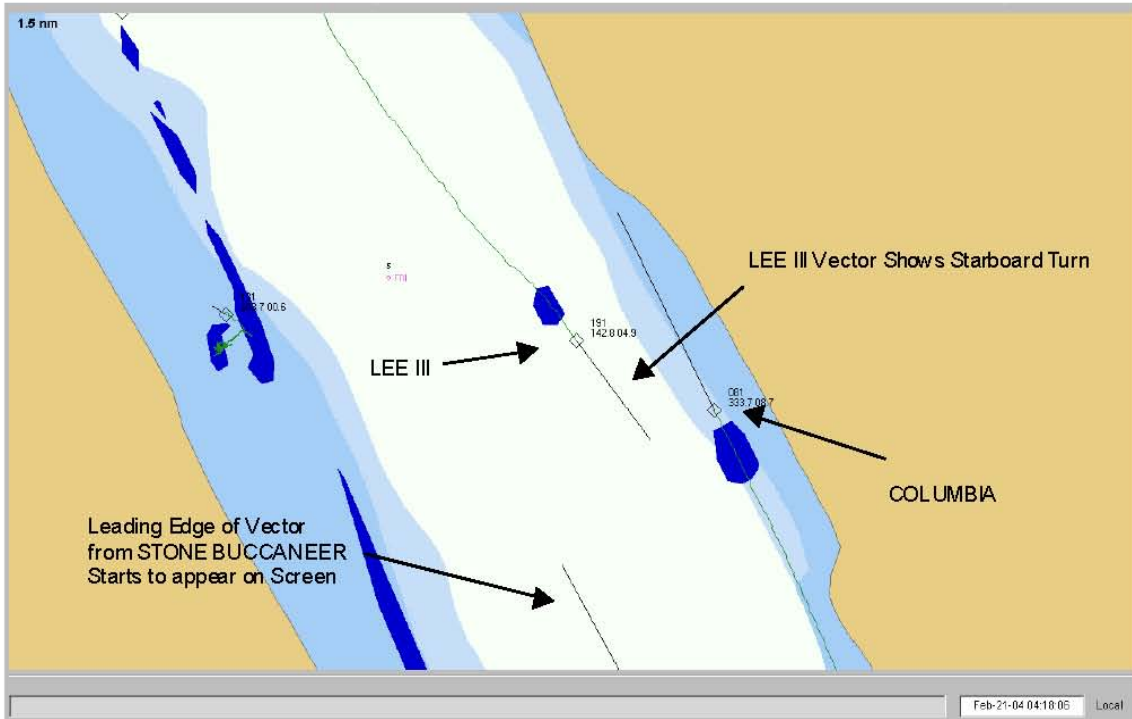
Figure 6: LEE III at 04:18:06; Turning to Starboard

18. At 04:18:06, the LEE III called on the VHF, “LEE III calling both these northbound.” At that time the LEE III had continued to turn slowly to the right as shown in Figure 6.

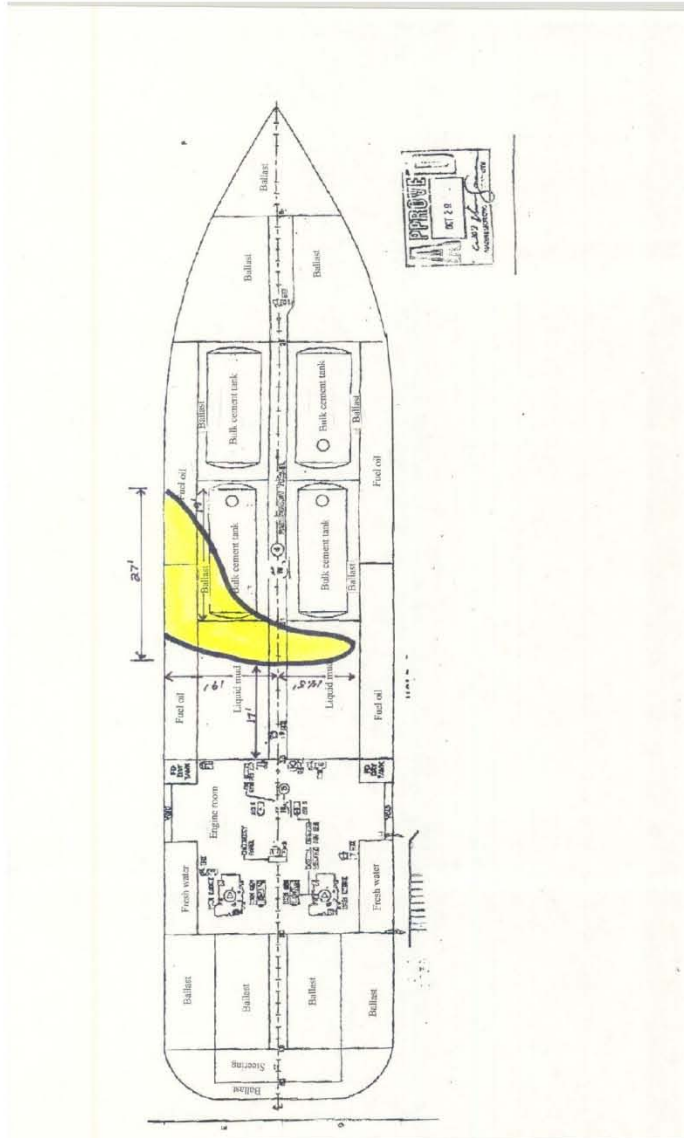
Figure 10: Schematic Showing Location of Damage to LEE III

3. The Coast Guard hired United Marine Surveying, out of Destrehan, LA, to complete a damage survey on the LEE III (Enclosure # 12). The surveyor found that the vessel's port side and bottom were split open starting at approximately 80 feet from the bow stem. The split moved aft 27 feet, centered on the Plimsoll mark, going inboard approximately 33.5 feet to within six feet of the starboard side. The split in the hull is V-shaped, is 27 feet wide on the port side and tapers down to three feet wide on the starboard side. The centerline passageway and longitudinal bulkheads were heavily distorted and/or crushed. The internal framing in way of the port #1 and #2 fuel oil tanks, port bulk cement tank compartment, centerline passageway, and port and starboard liquid mud tanks are crushed and distorted. The collision breached or destroyed the port # 2 fuel tank, port liquid mud tank, and port #2 cement tank bulkheads, the centerline passageway longitudinal bulkheads on each side of the liquid mud tanks, and the forward port and starboard liquid mud tank bulkheads. The main deck was split open centered at the Plimsoll mark over a 10 foot long area going inboard approximately 16 feet. See Figure 10.
