REPORT OF INVESTIGATION INTO THE CAPSIZING OF THE SMALL PASSENGER VESSEL LADY D RESULTING IN THE LOSS OF FIVE LIVES AND MULTIPLE SERIOUS INJURIES

MISLE ACTIVITY NUMBER: 2029161

**REPORT OF INVESTIGATION INTO THE
CIRCUMSTANCES SURROUNDING THE
CAPSIZING OF THE
LADY D
RESULTING IN FIVE LOSSES OF LIFE
AND MULTIPLE SERIOUS INJURIES
ON MARCH 6TH, 2004**

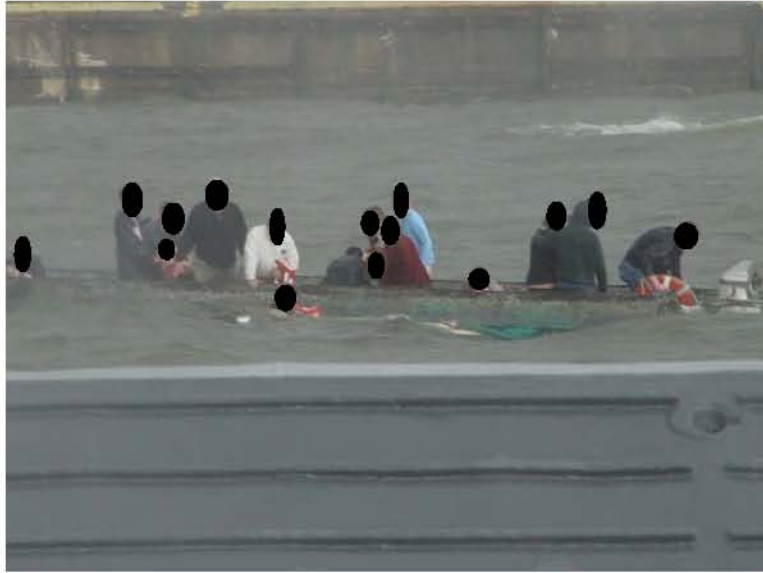
Figure 1: The *Lady D* survivors aboard the capsized hull.

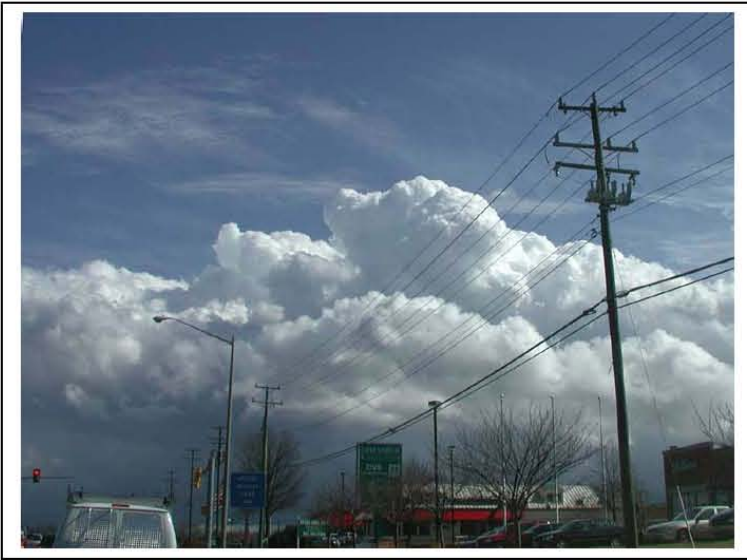
Figure 3: The March 6, 2004, squall line of showers and strong winds photographed in Washington D.C.
