**Sector Los Angeles/Long Beach**

Findings of Concern 001-25

**RISKS ASSOCIATED WITH USING SHIPPING PALLETS FOR  
CRANE LOADING OPERATIONS**

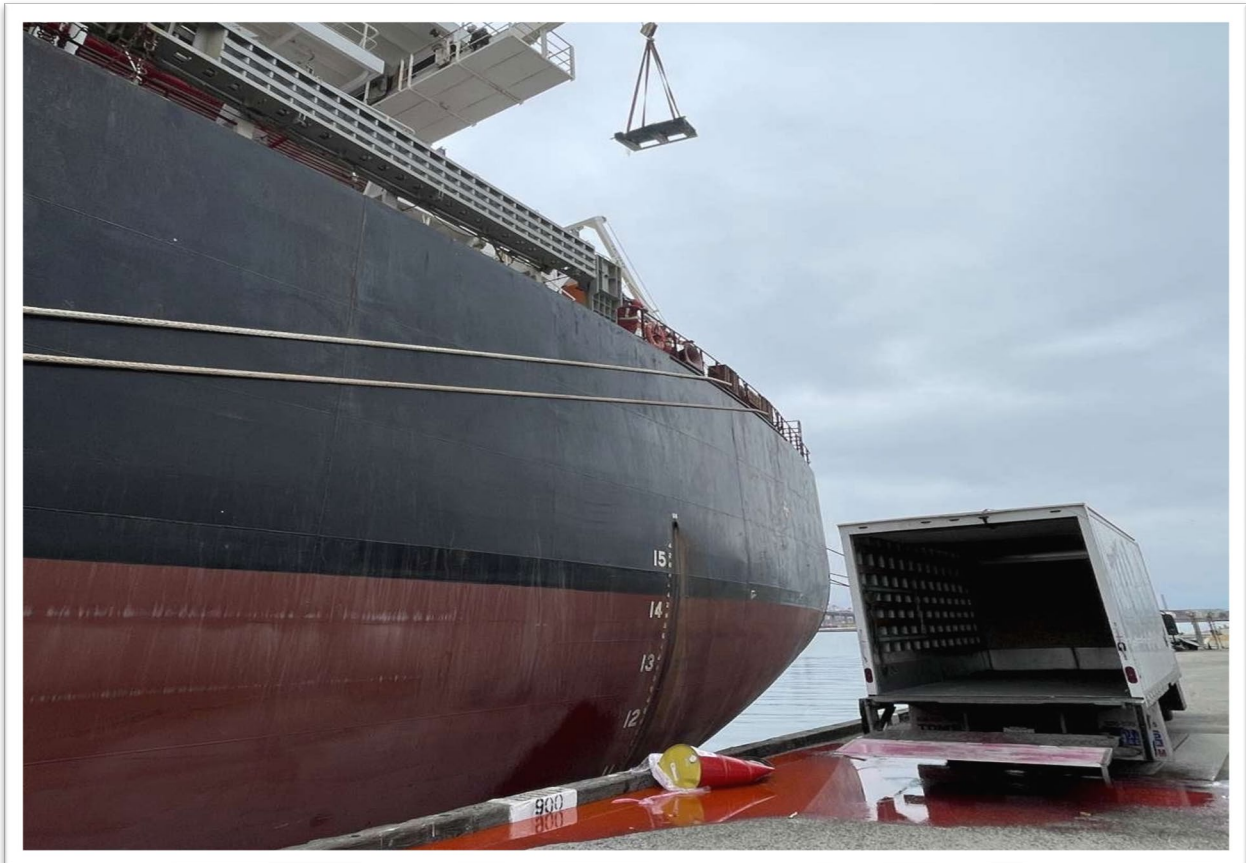
Post incident photo depicting the broken pallet suspended by the ship's crane and a damaged hydraulic oil barrel. Approximately 50 gallons of hydraulic oil was subsequently released into the harbor after the pallet failed during loading operations. Photo provided by U.S. Coast Guard.

Contributing Factors and Analysis. During onloading operation, two barrels of hydraulic oil fell when the wooden shipping pallet being used to lift them broke. One barrel landed on the pier while the other entered the water, resulting in an estimated 50 gallons of oil being discharged into the harbor. The primary contributing factor was the failure of the wooden shipping pallet used to transport the hydraulic oil barrels, which was unable to withstand the weight of the load, coupled with excessive force tension due to the single point attachment rigging configuration. Secondary contributing factors included the vessel's loading procedures and potential absence of additional safety measures to secure heavy barrels during transfer by crane.

- **Ship's Responsibility:** Vessels should implement a pre-loading quality assurance inspection protocol for all equipment and materials used in support of onloading and offloading operations, especially pallets used for heavy loads or hazardous materials. Crewmembers should verify that pallets are structurally sound and suitable for the weight they are intended to carry. Regular crew training on safe load-handling procedures, including the proper assessment of loading materials, will also enhance safety and prevent incidents.

- **Facility Responsibility:** Facilities providing materials to support vessel loading operations, such as pallets, should ensure all supplied equipment meets sufficient load-bearing criteria for the intended cargo. Facilities should inspect pallets for structural integrity and certify them for safe use with specified weight limits. Clear communication of pallet capacity and intended use to vessel personnel is recommended to avoid misuse and enhance overall safety during onloading operations.
