## **FINDINGS OF CONCERN**

### **Sector San Francisco**

Findings of Concern 002-25

## **UNSAFE LINE HANDLING OPERATIONS**

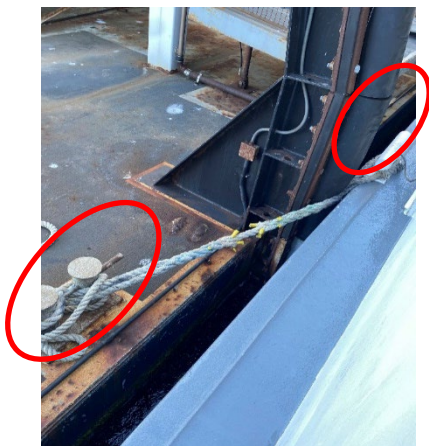
Contributing Factors and Analysis. The investigation identified multiple causal factors related to unsafe line handling operations including use of fixed length mooring lines, cleats positioned outboard of the railing, and the company's failure to adequately identify and assess risk. The fixed mooring line was approximately 3' in length with the bitter end permanently made to a pier-side bit and soft eye used on the vessel's cleat. The soft eye was connected to a small tag line to add length which allowed the line to be hung from a pier side affixed hook during departure. This was designed to speed up the mooring and unmooring process and eliminate the need for pier-side or vessel crew to manually tend the line. However, to hang the line on the hook, crewmembers were forced to position themselves on a 9-12" wide gunwale outboard of the railing. To maintain footing, they stood sideways and held the vessel railing with one hand and the line with the other to reach the hook while simultaneously avoiding falling overboard. The company failed to adequately identify, assess, and mitigate the risk of line handling outboard of the railing with a fixed length line, an inherently unsafe practice with the potential for man overboard or critical injury/death outcomes.

Crew stood sideways on this outboard gunwale to handle the aft spring line. The cleat was hard to access and outboard of the railing. The hook used is also pictured.

- Review current company or vessel safety procedures and Safety Management System (SMS) documentation, related to line handling operations, if applicable. Ensure procedures adequately assess and identify the safety risks associated with line handling, including, but not limited to mooring line arrangements, basic line handling safety, and instances where crewmembers may be positioned outboard of the vessel's railing due to the location of cleats, bits, or similar apparatuses. If high risk activities are identified, implement safety measures and risk mitigation measures.

- Avoid use of fixed length or pre-made mooring lines (those that are secured to the vessel or pier/terminal at pre-determined lengths and are not tended by crewmembers during mooring evolutions). Although use of fixed lines may expedite mooring evolutions, particularly for onboard ferries and other vessels that frequently run the same route, they inherently introduce additional risks. The utilization of spring-loaded lines or employing additional line handlers, when possible, may limit risk to personnel.

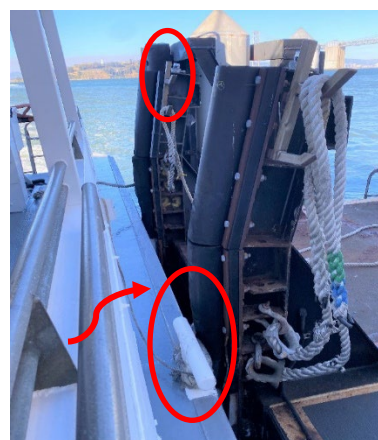
The line was pre-made to a bit on the pier and of a fixed length. Crew removed the eye and hung it on a pier-side hook for ease of access.
