FINDINGS OF CONCERN

Marine Safety Unit Lake Charles

Findings of Concern 009-19

CORROSION CAUSED CASUALTIES

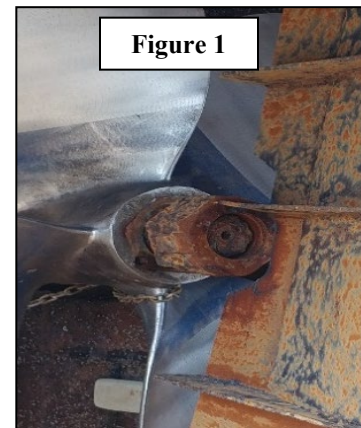
The Incident. On September 25, 2018, an Inspected Towing Vessel (ITV), pushing a loaded tank barge, experienced a loss of steering and subsequently ran aground. The marine casualty investigation determined the initiating event to be the port shaft propeller nut wedged into the rudder, which prevented the free and full movement of the steering gear. (Figure 1)

- Review company corrosion prevention systems/programs. If necessary, engage with a corrosion specialist from the American Boat and Yacht Council (ABYC) and/or National Association of Corrosion Engineers (NACE).

- Ensure adequate primary and secondary propeller shaft securing devices (cotter pins, double nut, locking strap, etc.) are in place at all times, with consideration given to vessel operations and environmental conditions.
- Ensure propeller fasteners are inspected routinely/during every dry-docking and recommend replacing IAW manufacture's instructions.

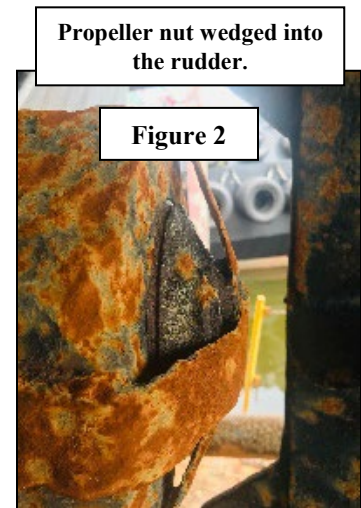
Contributing Factors and Analysis. The investigation identified the initiating event causal factors to be a material failure of the port shaft propeller nuts locking strap (missing), the lack of a secondary securing mechanism (second nut/cotter pin) on the port propeller nut, and an inadequate corrosion mitigation preventative maintenance program. Visual analysis of the starboard shaft locking strap noted significant deterioration of the locking mechanism (Figure 2), requiring immediate replacement. Based on the analysis of this casualty, Marine Inspectors inspected the locking nuts straps of several other ITV's during scheduled dry-dock exams which showed similar corrosion issues.
