### **Sector Boston**

Findings of Concern 010-19

## **RECREATIONAL SCALLOP DIVING HAZARDS**

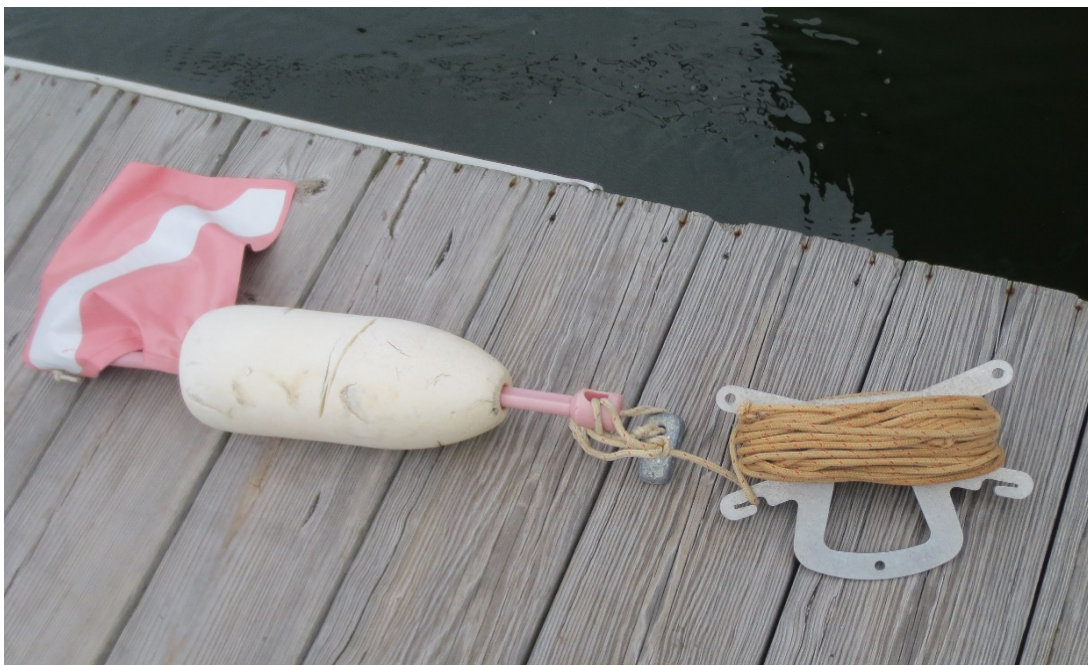
Dive flags are required by Massachusetts law and serve to alert boaters of divers in the area. When scallop diving, divers use an individual dive flag buoy attached to a line on a reel (see Figure 1). The dive flag buoy floats on the surface and the diver pays out the line from the reel while descending. Once on the ocean floor, the diver uses a mesh catch bag to collect scallops while keeping the dive flag reel in hand and towing the buoy to mark their location. When finished collecting scallops, the diver ties off the catch bag to the dive line and ascends along the line to the surface. The dive flag line and catch bag are hauled up using the vessel's pot hauler after the diver has returned to the vessel. Although dive flags are used for diver safety, they can also present risks, particularly to divers that are inexperienced with their use. Towing the flag while collecting scallops can lead to overexertion. The scallop bags become heavier as they fill up which can make it challenging to maintain neutral buoyancy and may lead to increased fatigue. The dive line can also present an entanglement hazard, particularly in strong currents.

Figure 1. Dive flag buoy and reel with line used by divers on scallop dive charter

- **Dive Flag Buoys:** The entanglement risk posed by dive flag buoys can be mitigated by carriage of a dive knife. In addition to carrying a dive knife, it is also recommended that divers have experience using a dive flag buoy prior to scallop diving.
