Office of Investigations and Casualty

August 13, 2019
Wilmington, North Carolina

Findings of Concern 012-19

**COMMERCIAL ASSIST TOWING OPERATION RISK
MANAGEMENT**

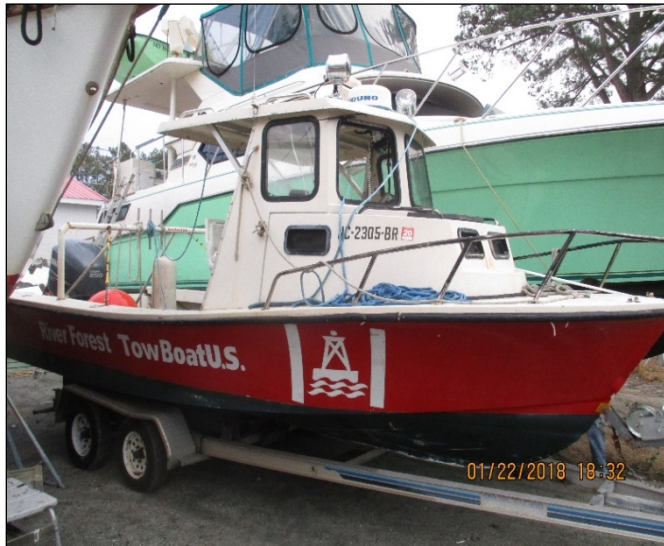
The Incident. On the evening of January 17, 2018, the 21-ft. Towboat US state-numbered commercial assist towing vessel NC2305BR (TOWBOAT US) departed Moss Landing Marina, NC with the 44-ft state numbered recreational vessel NC8373DY in tow. One master operated the TOWBOAT US and one deckhand was placed aboard the NC8373DY in tow. The planned voyage was to conduct a non-essential dock-to-dock estimated 40-mile towing operation from Moss Landing Marina in Washington, NC to Belhaven Shipyard, NC via the Pamlico River and Pungo River. Prior to departure, the National Weather Service (NWS) issued a Gale Warning Alert and Coastal Winter

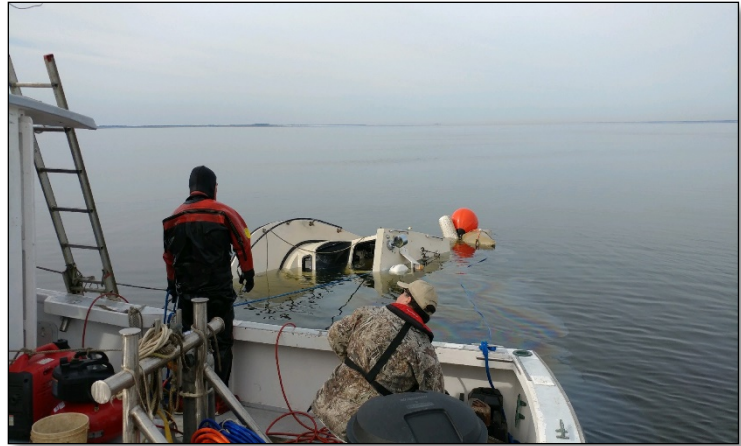
In the early morning hours of January 18, 2019, the starboard aft mooring line aboard the TOWBOAT US fell overboard, dragged behind the vessel, submerged in the water, and fouled the single engine propeller. The TOWBOAT US lost propulsion and drifted dead in the water while still attached to the NC8373DY in tow. Subsequently, sea waves crested the TOWBOAT US and progressively flooded the open deck. The vessel became unstable and capsized on its portside. The master entered the water without a Personal Flotation Device (PFD) and grasped to the cabin superstructure. The deckhand immediately moved to the flying bridge aboard the NC8373DY in tow and radioed the Coast Guard. However, the deckhand did not attempt to provide the master with available lifesaving equipment carried onboard. Within minutes of entering the water, the master let go of the TOWBOAT US cabin, drifted away, submerged and drowned.
