BERMUDA SAFETY BULLETIN

EUSABI WATER MIST HEADS FAILING TO ACTIVATE AT SYSTEM PRESSURE

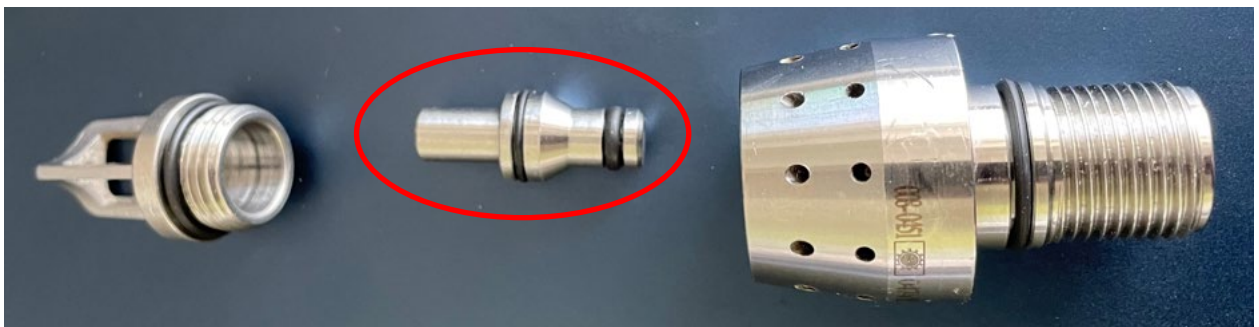
- (1) On disassembly of the heads, no corrosion, significant mineral deposits or other issues were identified as causal factors. However, it was noted that the activating piston which slides out of the body when the head is activated, to allow water to flow, was very stiff. This piston is retained by 2 rubber O-Rings.

- (2) Comparison between the watermist heads that activated and those heads that failed to activate at the system standby pressure showed signs of insufficient lubricant on the heads that failed.
- (3) A selection of both failed heads and those that functioned correctly were sent to the OEM for a detailed failure analysis.

- (4) Chemical analysis of the O-Rings did not indicate any issues with the rubber chemistry or degradation of their physical properties.
- (5) On review of manufacturing records for the period when the failed heads were produced, it was noted that they were all of the same batch and showed signs of insufficient lubrication. The OEM has reported that this is the likely root cause of the failures experienced.
- (6) Water samples were taken from the ship's watermist system and chemically tested. These showed no issues with water quality in the system.

- (7) The vessel engaged in refurbishment of the heads onboard, with the participation of the OEM. Heads were fully disassembled, cleaned, lubricated and re-assembled according to procedures agreed by the OEM. Subsequent bench tests of the refurbished heads show a 100% success rate for activation at normal standby pressure.
