MEMORANDUM

Subj: STEAMER DELTA QUEEN, O.N. 225875; SPECIAL INSPECTION

STEAMER DELTA QUEEN – SPECIAL INSPECTION

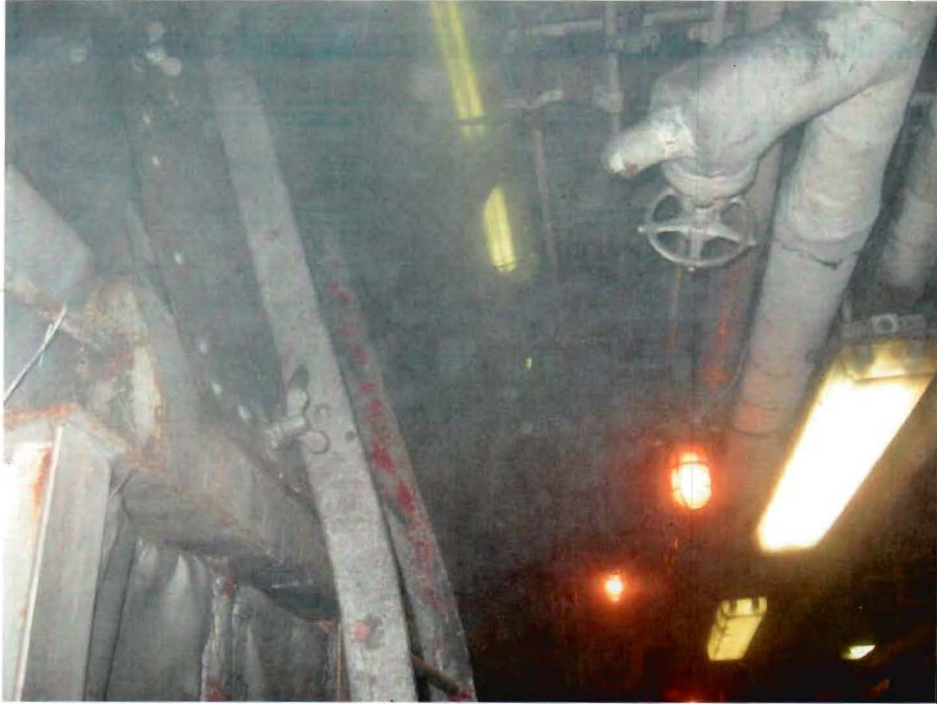
1. Soot accumulation in the fire room: With the vessel only steaming for a month, there was an obvious excess accumulation of soot over recently painted parts of the boilers. The fire room watch indicated the cause was casing leaks when blowing tubes. Accompanied by Mr. Gordon (V-Ships), we proceeded to the fire room that evening to find the fireman dressed out in Tyvek's coveralls and a dust mask. The soot blowing arrangement is primitive. It is stationary and uses existing hollow staybolts that are then drilled in all directions at the firebox end. Leakage where the staybolt exits the plate waterwall tube headers is where the leakage occurs, further exacerbated by boiler doors that are warped, ungasketed and do not fit any more. The result during routine soot blowing was the introduction of clouds of soot into the fire room settling everywhere, instead of up and out the stack. The aft boiler is leaking the worst and the primary source of soot. See enclosure 5.

Above - Typical Soot Cloud When Blowing Tubes – 5/2008

Note: This constitutes an unnecessary and unacceptable accumulation of combustible fire load. This has probably been this way a long time, but is an issue that needs a focused plan, attention at lay-up and can be managed. Since identified and before repairs can be made, the vessel has instituted boiler washdown after blowing tubes to keep the accumulation in check.

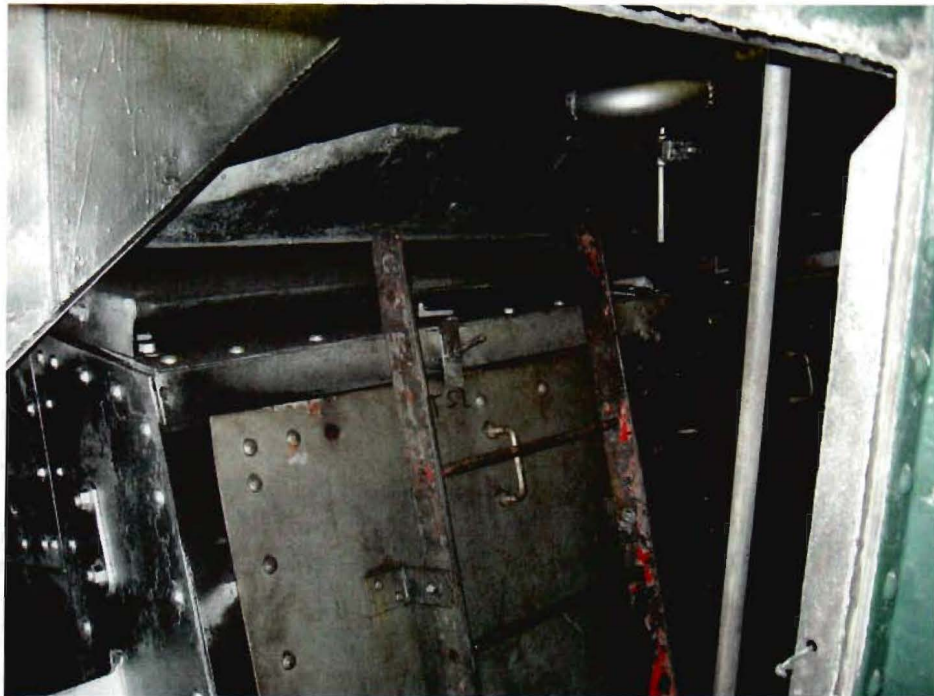
Below - Resultant soot accumulation – 5/2008

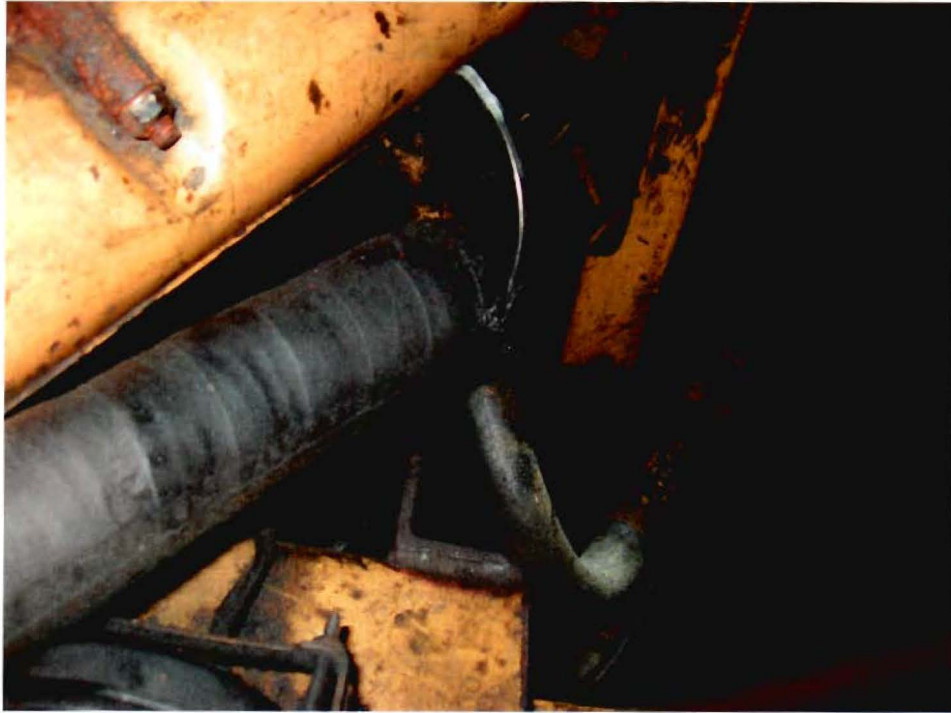
2. Oily residue in Generator Enclosures: Considering a fire tripped the CO2 system on this enclosure at the end of lay-up while testing engine safety shutdowns and there is an extensive narrative written during lay-up about cleanliness in the generator enclosures, a closer look was in order. The source was crankcase vents exhausting engine blowby uncontrolled into the space. See enclosure 6.

Steamer DELTA QUEEN – Crankcase Vents Pumping Blowby in Generator Enclosures – 5/2008

Note: This is another unnecessary/unacceptable accumulation of combustible fire load that can be managed. Since identification, a CG-835 was issued during the first quarterly inspection in Cincinnati on 6/19/08 and filter separators have been ordered.

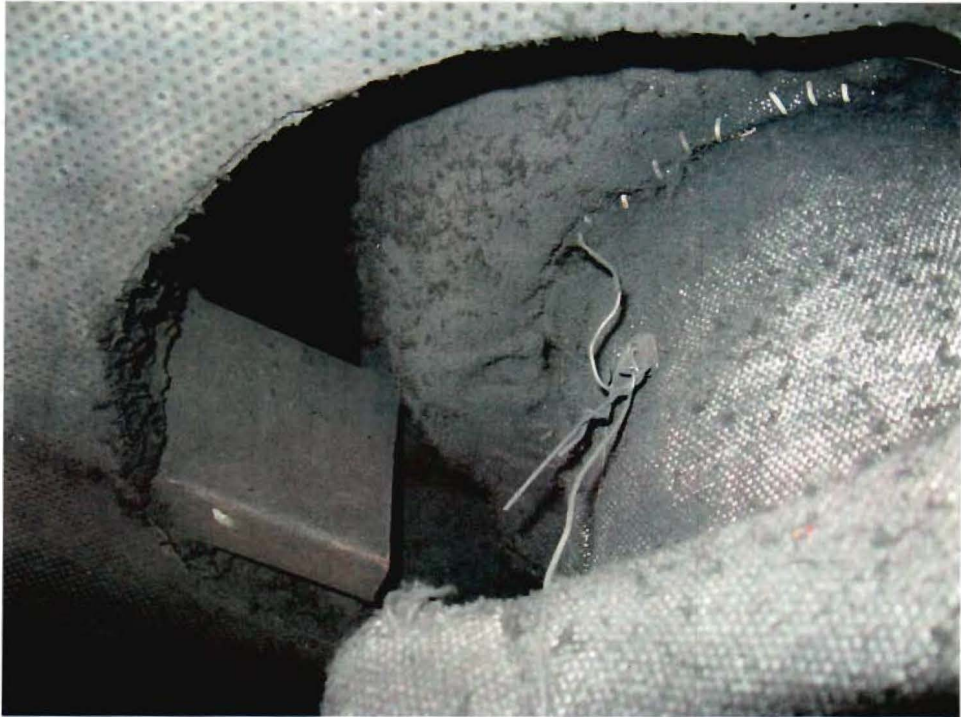
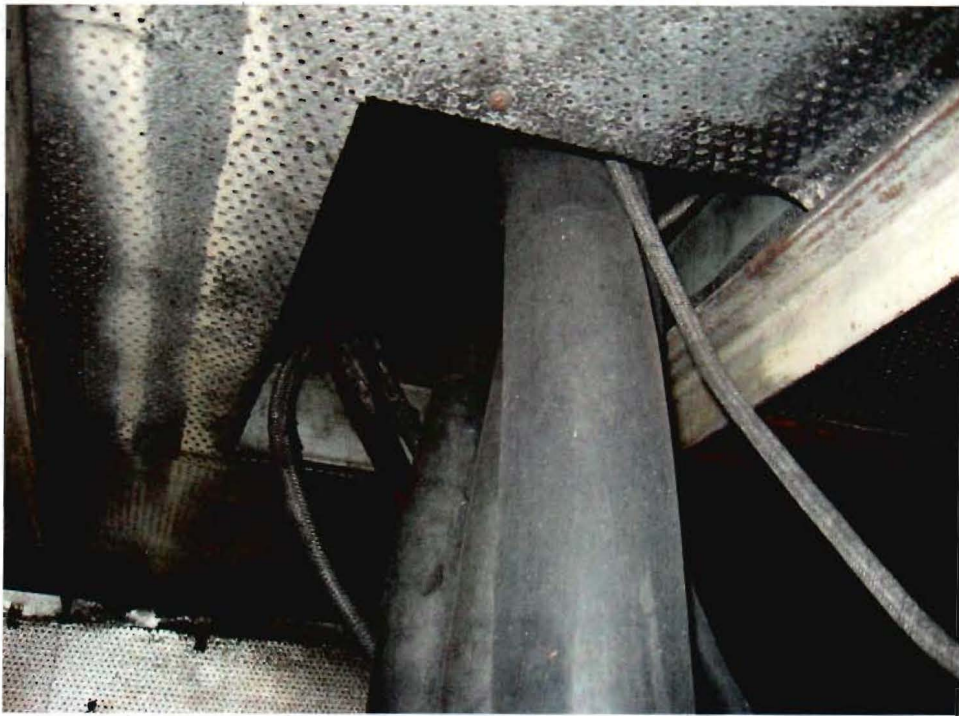
3. Generator Enclosures not Fume-tight: The above is further exacerbated by finding penetrations in the CO2 protected enclosure not fume tight (missing) in way of the engine exhaust piping and generator end electrical cables. There was also evidence that insulation installed to the wood underdeck of the fire room was not replaced over the enclosure after the generator end was rebuilt incident to the CO2 tripping event. See enclosures 7 and 8.

Steamer DELTA QUEEN
CO2 Protected Generator Enclosures not Fume-tight -- 5/2008

Note: Since this was identified, the Chief Engineer is taking steps to close openings and reinstall insulation. CO2 calculations were verified as being 150% of required, so no CG-835 was issued during the subsequent quarterly inspection.

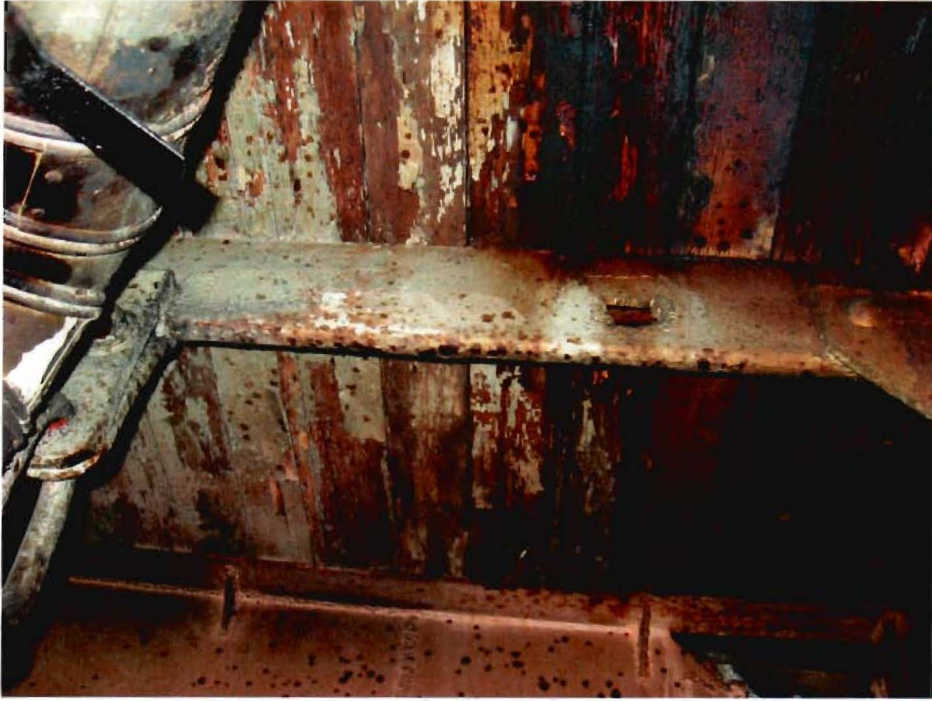
Above - Wood Underdeck over Port Generator Box without insulation

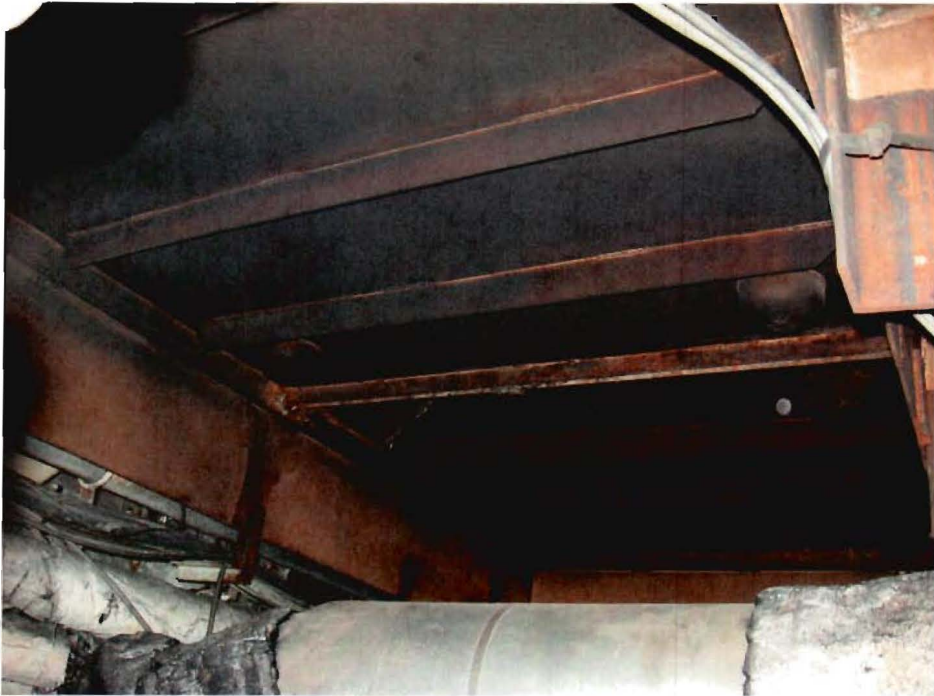
Below - Wood Underdeck over Starboard Generator Box with insulation

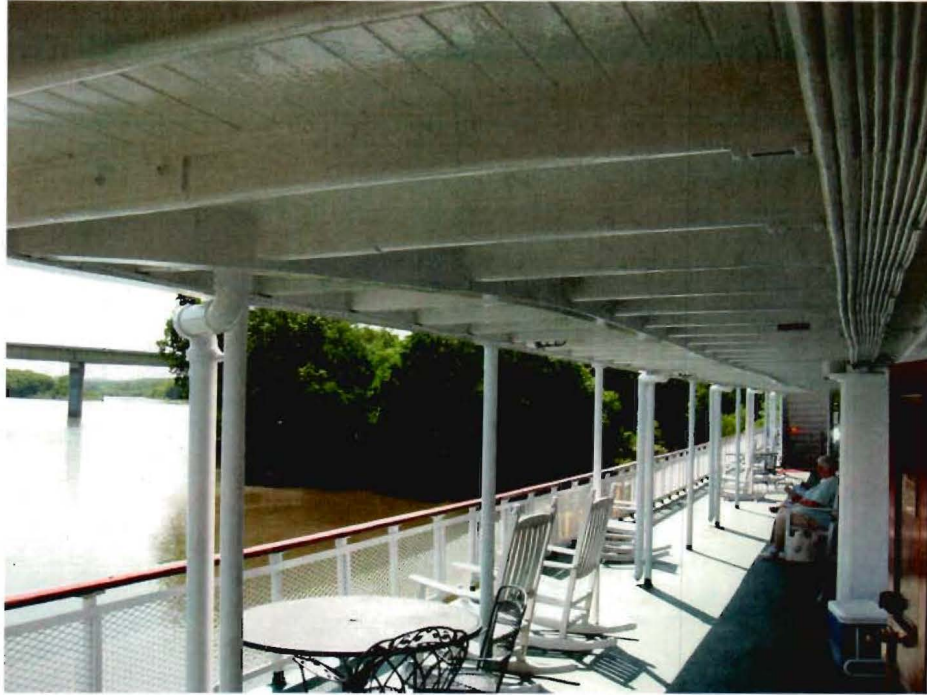
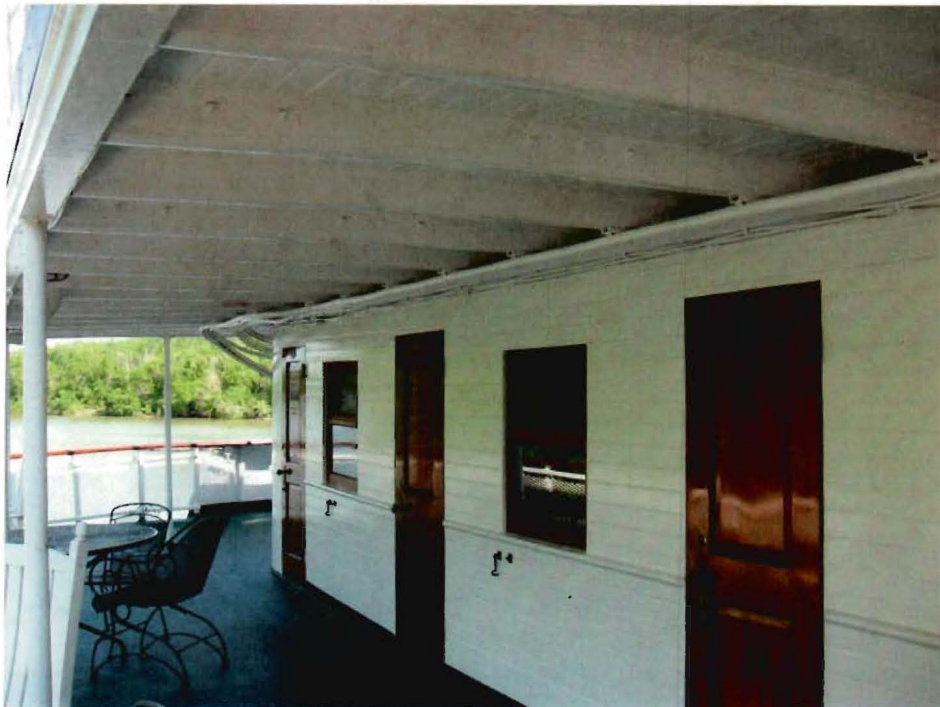
1. Deck: The fit, finish and maintenance of the topside and public spaces was found to be consistent with maintaining the vessel's status as a national historic landmark and promoting a unique passenger/consumer product. In the opinion of the undersigned, a major reason for the conditions found is the company's decision to employ a full time skilled carpenter as a daily 12 hour dayworker. This is another area somewhat outside the scope of minimum regulatory requirements, but important to the continuous upkeep of a wood vessel. As part of crew interviews, toured the vessel in its entirety with the carpenter to get his perspective. The wood superstructure combined with the passenger vessel arrangement would be a maintenance nightmare without someone devoted full time to its upkeep. Inherent in this upkeep and directly contributing to passenger and crew safety are ensuring the wood and things fastened to that wood are not deteriorated and firmly anchored. Small but important items that come to mind are hand rails, grab rails, chairs, tables, banisters and staircases as well as the proper operation, alignment and adjustment of doors, windows and associated latches. During the trip, it was a regular occurrence to see the carpenter all over the vessel attending to repairs or making them before they became larger and more complex issues. The carpenter, like much of the crew, was passionate about his job and keeping the DELTA QUEEN in the best condition he could structurally and cosmetically. Topsides were properly prepared and painted out with modern high gloss polyurethane. Decks were treated with non-skid and the brightwork both inside and out showed the depth of preparation and maintenance in its obvious luster and final appearance. See enclosure 9. Long term maintenance and repair of the wood structure should be included in the annual lay-up plan. Not of immediate concern, but repairs over time will be needed to steel vertical columns where they pass through wood cap rails on each deck. Varying degrees of corrosion and or deterioration are taking place to these structural members.

Condition of Wood Topsides – Typical - 5/2008

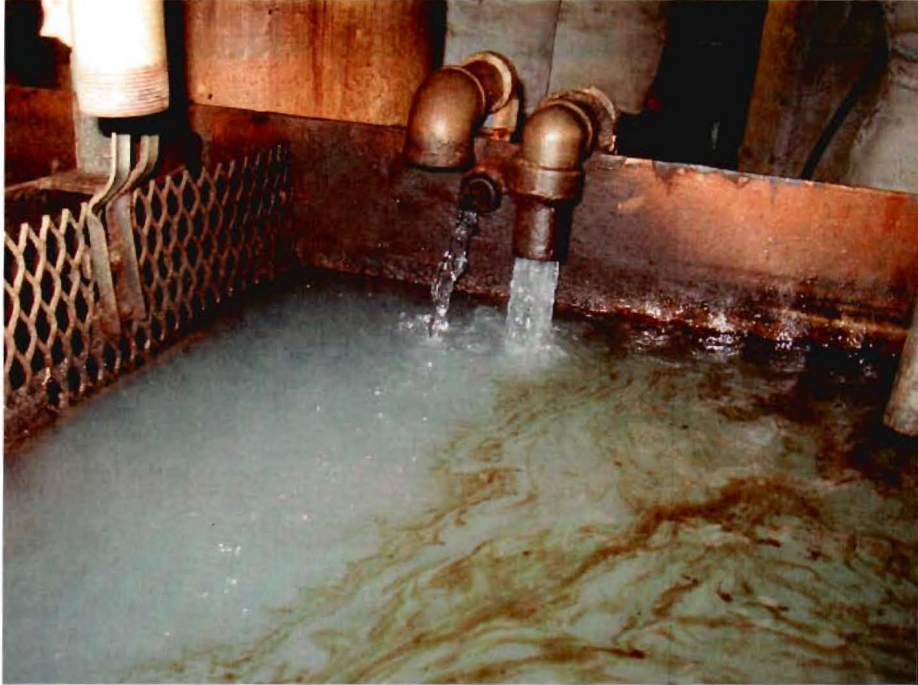
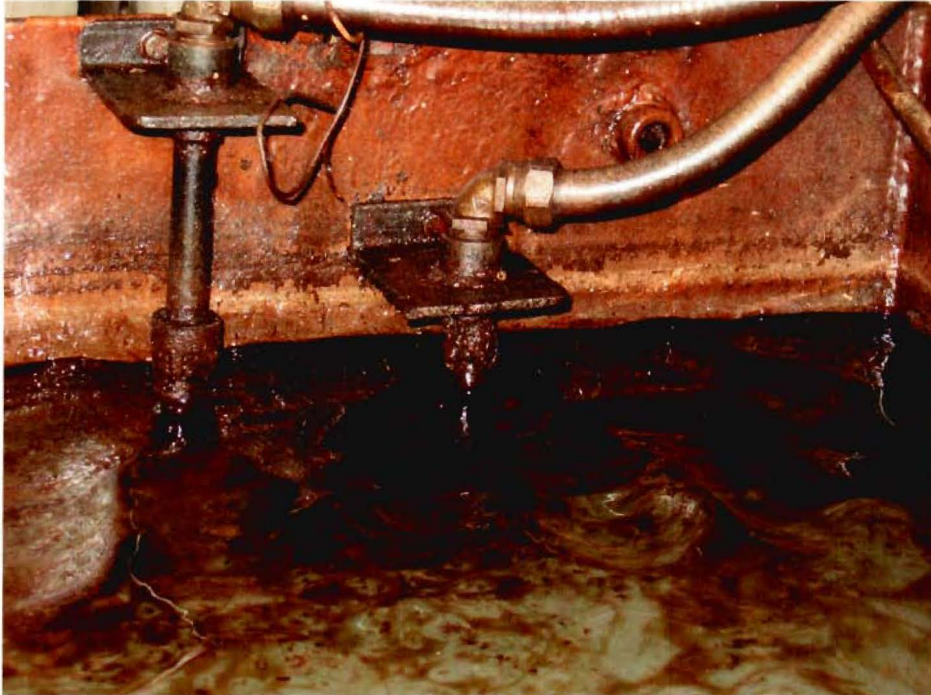
2. Engineering: In addition to items in paragraph 4(e) above, the following were noted:
a. *oil in the condensate*: There is a dedicated lubricator injecting oil just ahead of the throttle valve, but this is cylinder oil, not black oil, so the source of black oil is still not certain and may contribute to premature tube replacement due to ineffective heat transfer. Although there is a chronic history of this oil in the condensate and boiler as evidenced by a 1987 report

found onboard, it is simply not good boiler operating practice and an effort should be made to mitigate or proactively manage this problem. See enclosure 10. As previously noted, annual chemical cleaning was part of routine maintenance but not conducted due to budgetary constraints this past lay-up.

Oil in Condensate at the Hot Well – 5/2008
