N-CFSAC

Supporting Documentation Package 2

MISLE Incident Investigation Report For FV RANDI - Sinking/Loss of Life

Subj: CFV CAPT JOHN REPORT OF INVESTIGATION

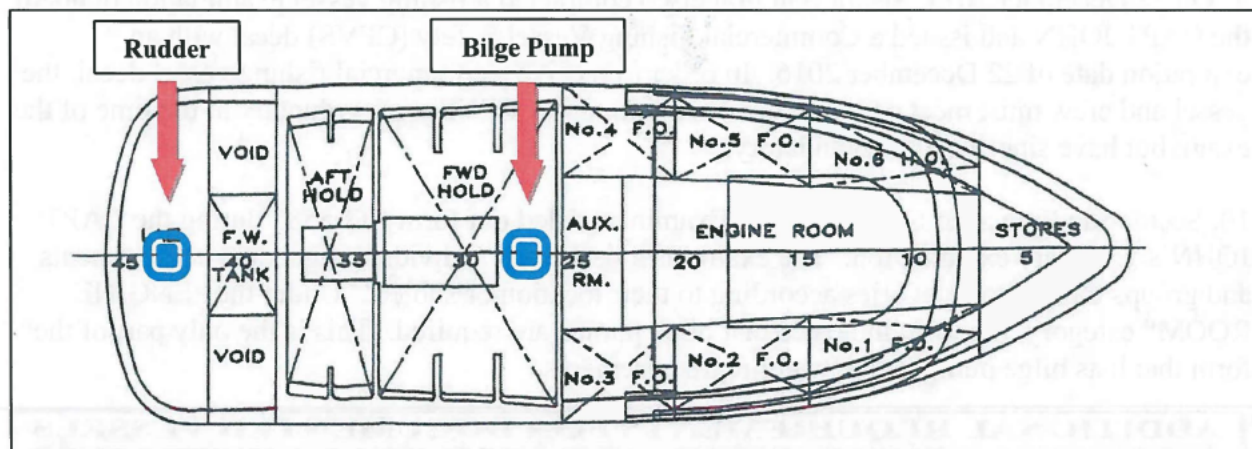
*Schematic from CAPT JOHN Sister Vessel's, GRANADA
(arrows pointing to rudderpost and bilge pump locations)*

6. The fish-hold contained the only installed bilge pump onboard the CAPT JOHN, located within the shaft-alley, below the space that also contained the propeller shaft. The bilge pump, rated at approximately 200 gallons per minute and activated manually by a switch in the pilothouse, never pumped water during the vessel's flooding.

4. *Especially Hazardous Condition:* There is no information available on why bilge piping did not extend to all spaces as installed on the sister vessel GRANADA. The CAPT JOHN crew relied on progressive flooding into the fish-hold as the primary method to dewater. The lazarette did not have dewatering capability due to inadequate bilge pumping capability. Since limber holes existed in each bulkhead, the entire interior of the vessel became a singular watertight compartment. Federal regulations did not prohibit changing CAPT JOHN in this manner, however, good marine practice would not warrant such a change. According to NVIC 12-91, an especially hazardous condition exists when a bilge system is inoperable. The CAPT JOHN lacked the ability to dewater each compartment independently. The fish-hold's installed bilge pump was the only method available to dewater the entire vessel. This method proved inadequate as obstruction to one or more limber holes prohibited dewatering capability.

4. It is recommended that Commander, Pacific Area, conduct outreach with all District Fishing Vessel Coordinators, and reiterate the requirement of bilge pumping within watertight compartments in accordance with 46 CFR §28.255. Ensuring all Coast Guard personnel are

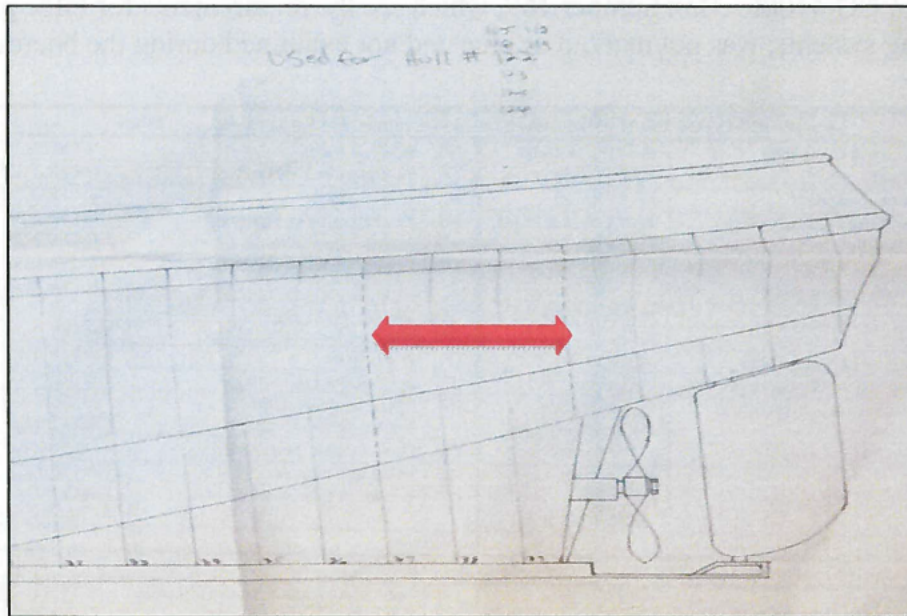
*Stern Cross Section of CAPT JOHN at Original Construction
(Dashed vertical lines indicate watertight bulkhead)*

14. The CAPT JOHN was constructed with a void space located directly forward of the lazarette that contained no thru-hull fittings. Fishnets and excess gear were stowed in the void space and accessible via a watertight hatch designed to be flush with the weather deck.

3. *Improper Modification & Progressive Flooding:* The vessel's construction consisted of several transverse bulkheads, each designed and constructed to be watertight. At some unknown point in the vessel's history, limber holes installed in each bulkhead compromised the vessel's watertight integrity by effectively removing the vessel's subdivision. Vessel subdivision prevents hazardous situations from spreading from one compartment to another. CAPT JOHN's improper modification negated the subdivision compartmentalization designed to prevent progressive flooding in an emergency, compounded by the lack of installed bilge piping, thus allowing water to flood two adjacent compartments and ultimately sink the vessel.

3. It is recommended that Sector Puget Sound Officer in Charge, Marine Inspection consider compromise of watertight bulkheads, and those designed to be watertight, as an especially hazardous condition in keeping with the intent of NVIC 12-91 and prohibit fishing vessels from proceeding beyond the boundary line until those conditions are properly addressed. Preventing commercial fishing vessels from operating beyond the boundary line with compromised watertight integrity will reduce the risk of sinking due to progressive flooding. This could potentially save lives, property, and/or the environment from irreparable harm.

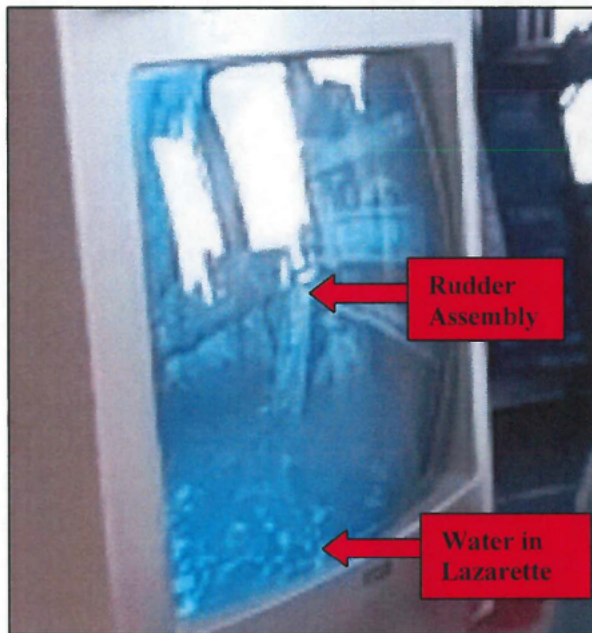
Screenshot from NOAA Observer Video of CCTV before CAPT JOHN Sinking

22. After the fourth haul-back of fish, the vessel's stern was low enough in the water that water began washing onto the weather deck from the stern ramp. Around the same time, the CCTV camera in the lazarette showed the rudderpost shaft packing was leaking again.

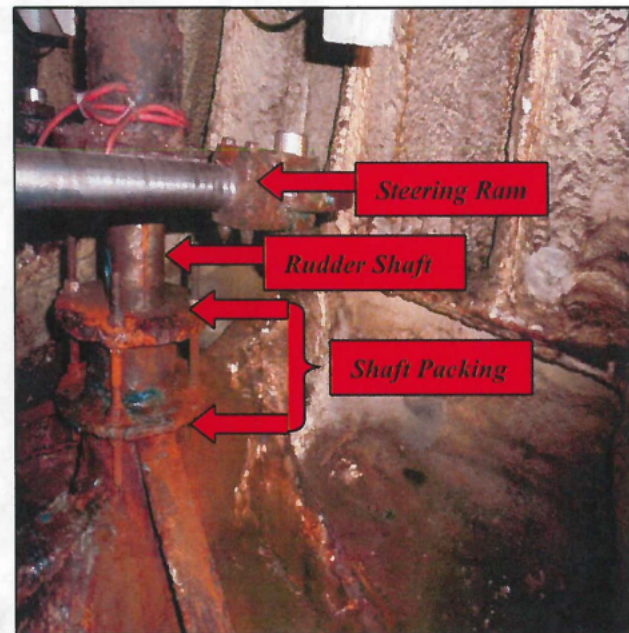
Rudderpost Assembly of Sister Vessel GRANADA

16. Immediately before departing port, a leak was found in the rudderpost shaft causing water to enter the lazarette compartment. Deckhand (1) adjusted the packing, but water continued to leak. He then added grease³ to the rudderpost shaft, which stopped the leak. The Master remained concerned with the leak and continued to monitor it while underway via the CCTV installed in the compartment.

1. *Improper Maintenance:* Rudderpost shaft packing, properly maintained, prevents water intrusion. During interviews with Investigating Officers, Deckhand (1) demonstrated knowledge regarding the proper procedure to replace the packing. However, the rudderpost shaft packing was leaking before departing port and close watch on the CCTV during the voyage indicated a lack of confidence in the adjustments made. Furthermore, the crew improperly relied on the pressure of grease to prevent water from seeping through the shaft packing and into the lazarette.

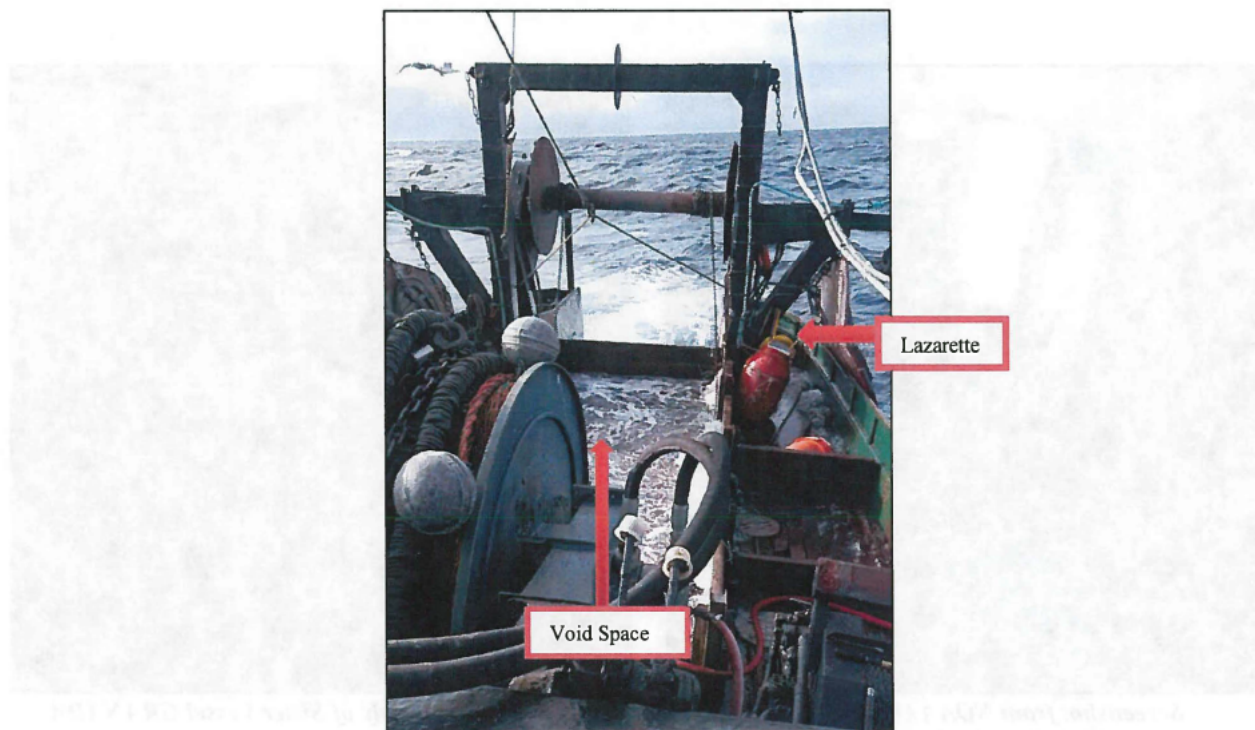
*Screenshot from NOAA Observer Video Approx. 1 Hour before Sinking
(Arrows show approximate location of access hatches to Crew Gear Locker and lazarette)*

26. At approximately 1230, water on the weather deck began obstructing access to the lazarette as it flowed over the flush deck hatch. Deckhand (1) was able to gain intermittent access to the space to continue to assess the water level being wary of down flooding concerns if the hatch remained opened too long.

27. The flush deck hatches for the void space and lazarette on the CAPT JOHN were not required to have raised coamings from the deck, nor be of the quick-acting type⁵ because the vessel was built before the regulations went into effect in 1991 and hence grandfathered from meeting the requirements.

5. *Watertight Hatch Design:* Access to the lazarette and void space were placed in locations on the weather deck that are often awash with seawater. This was especially prevalent for the CAPT JOHN on 24 January 2016 because of the approximately 90,000 pounds of fish and ice loaded into the fish-hold, which caused the vessel to sit lower in the water. Compounding the inconvenient location is the fact that the hatches were designed flush to the deck with zero coaming height. If a crewmember attempted to open one of these hatches, water would immediately down-flood into the compartment, which is what happened when Deckhand (1) attempted to enter the space.

The flush-deck hatch allowed unobstructed down flooding each time the lazarette hatch opened. This quickened the water ingress occurring within the lazarette. Coast Guard regulations for watertight hatch coaming heights do not exist for fishing vessels built before 1991. During damage control efforts, additional water entered into the lazarette, exacerbating the casualty by increasing the vessel's weight and decreasing its stability. Eventually, the standing water on-deck prevented Deckhand (1) from continued efforts to stabilize the vessel, or lower a submersible pump, had one arrived in time.
