UNITED STATES COAST GUARD

**MARINE BOARD'S REPORT
INTO THE
IMPLOSION OF THE SUBMERSIBLE TITAN
(CG 1788361) IN THE NORTH ATLANTIC OCEAN
NEAR THE WRECK SITE OF THE RMS TITANIC
RESULTING IN THE LOSS OF FIVE LIVES
ON JUNE 18, 2023**

MISLE ACTIVITY NUMBER: 7724663

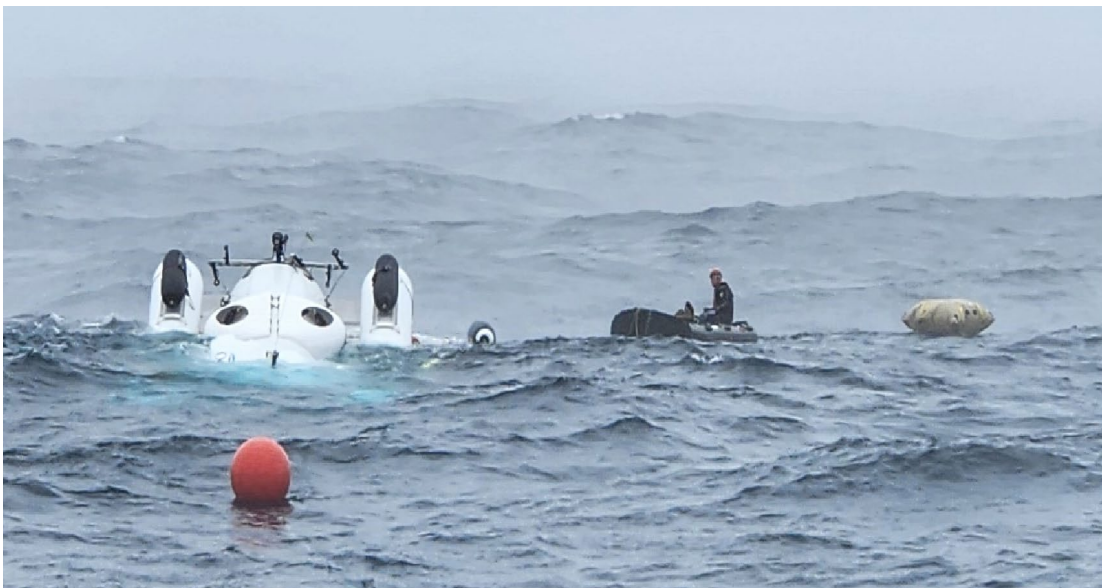
Figure 238: TITAN partially submerged due to complications with the LARS platform at 11:14 a.m. on May 24, 2024. Source: Former mission specialist.
