Final Report

Auger Lifeboat 6 Incident

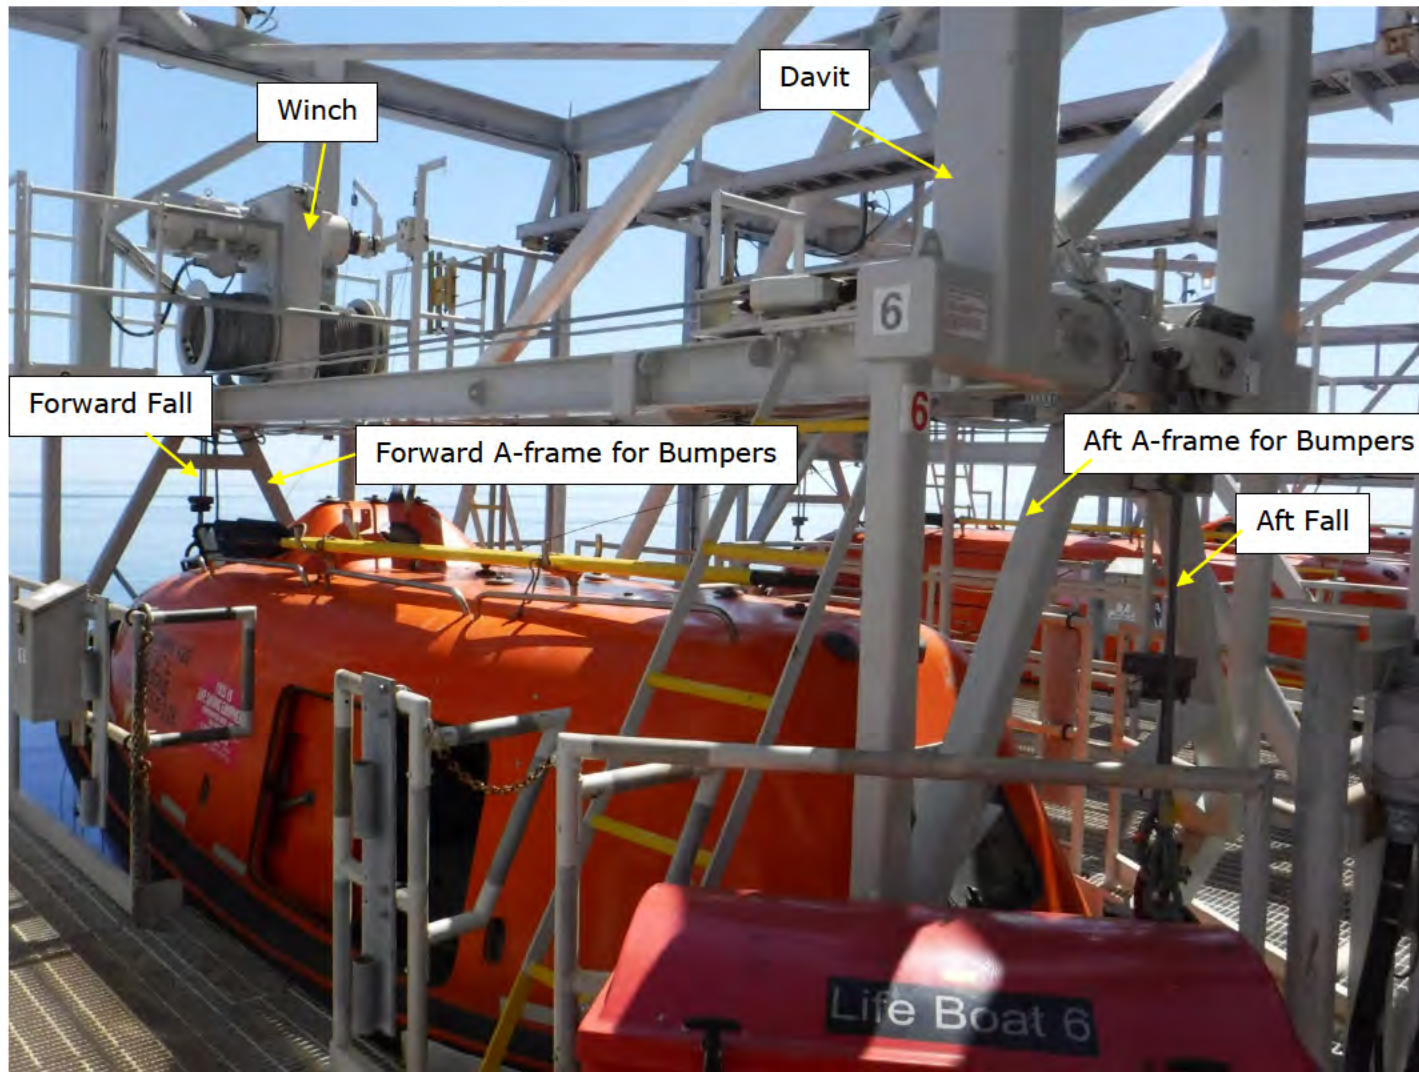
Figure 1. Photograph of Lifeboat 6 in the davit on the Auger Platform prior to the incident. Photograph provided by SOI.

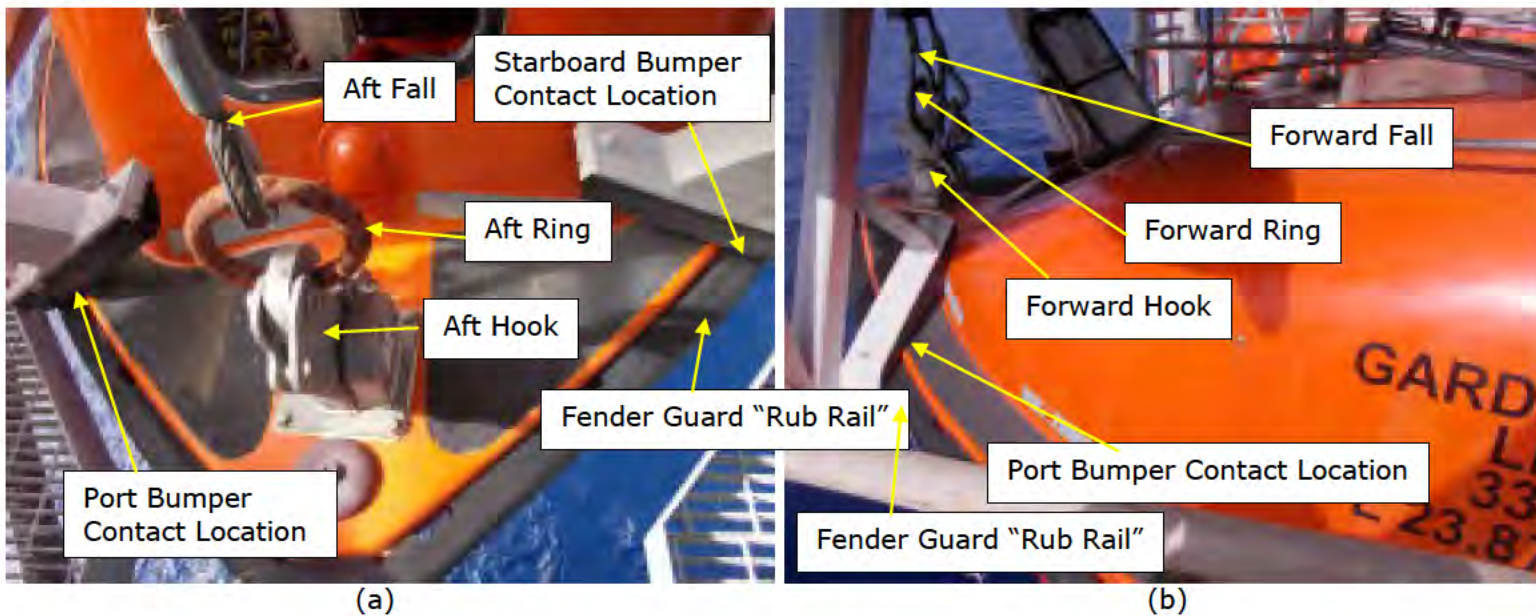
Figure 3. Photographs of the (a) aft and (b) forward ends of Lifeboat 6 in the davit on the Auger Platform before the replacement of the winch, fall cables, and rings (photograph from original equipment manufacturer [OEM] service report FS6540, approximately June 2014). Photographs provided by SOI.

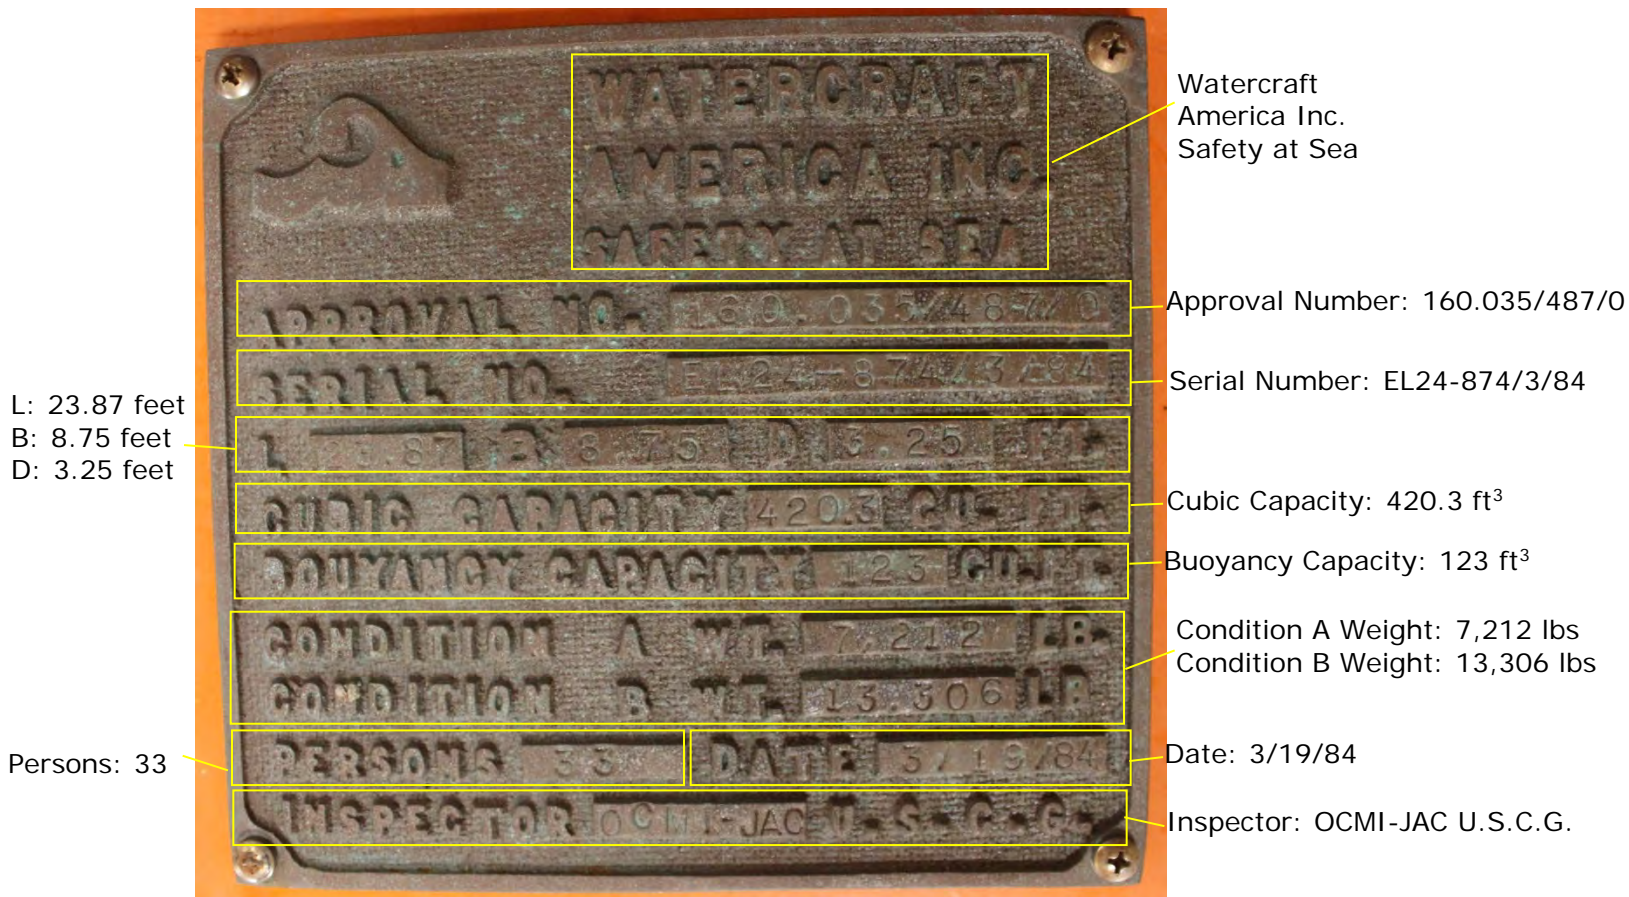
Figure 4. Photograph of the placard from Lifeboat 6 taken after the incident.

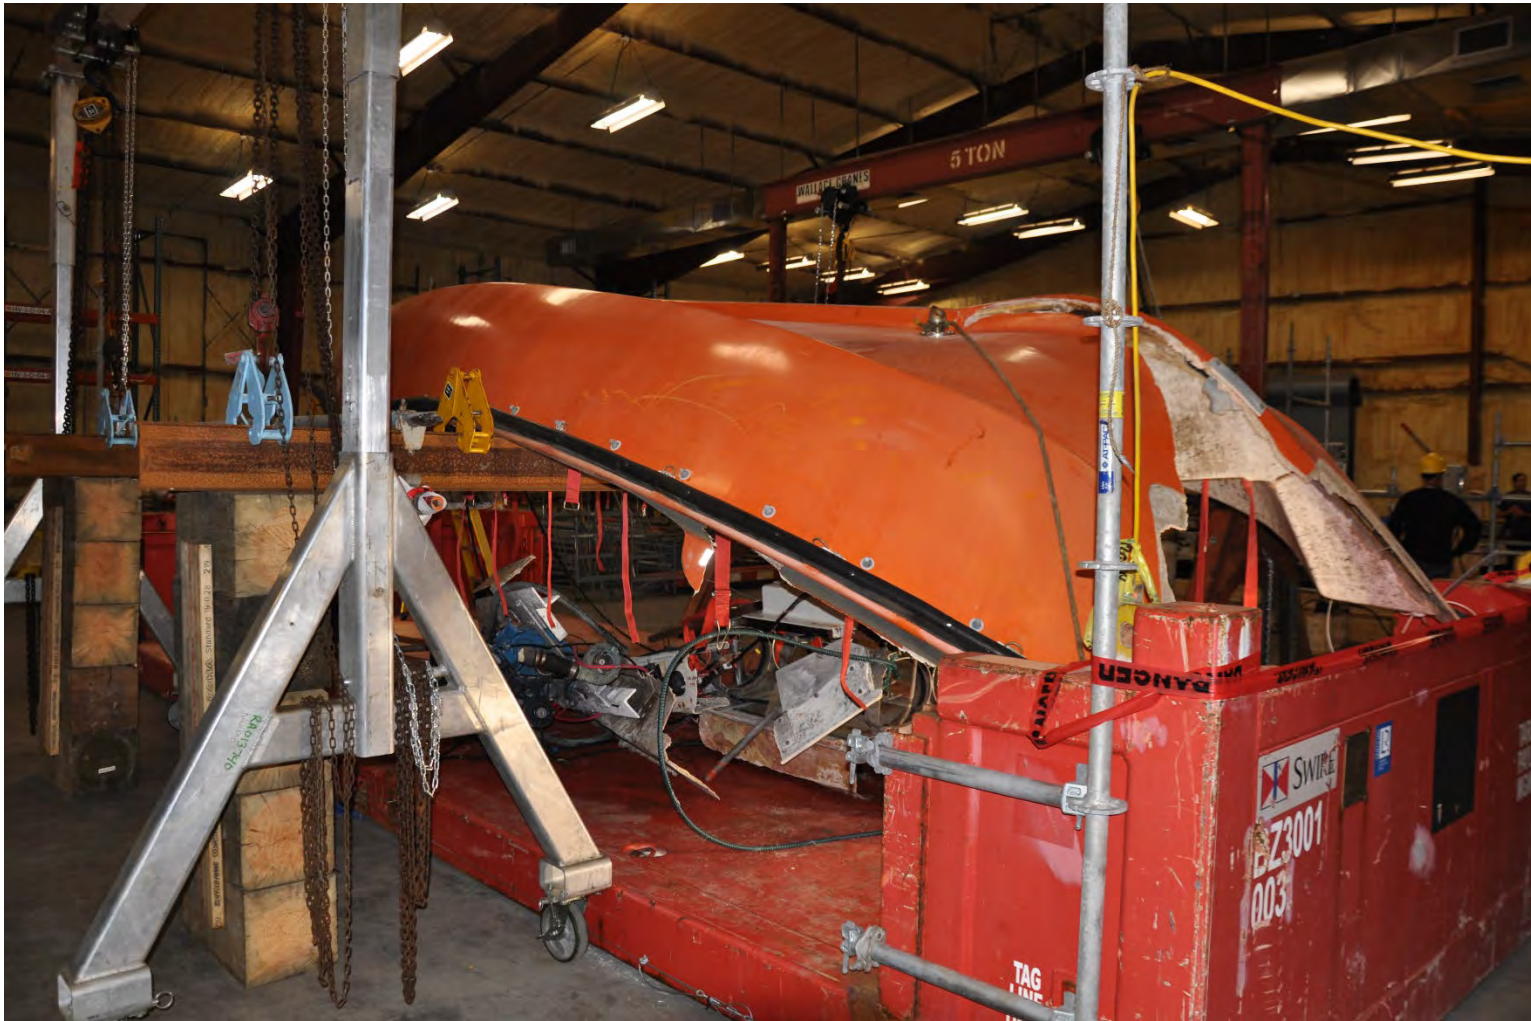
Figure 8. Photograph showing the condition of Lifeboat 6 in Harvey Terminal after the incident, as viewed from the forward, port side.

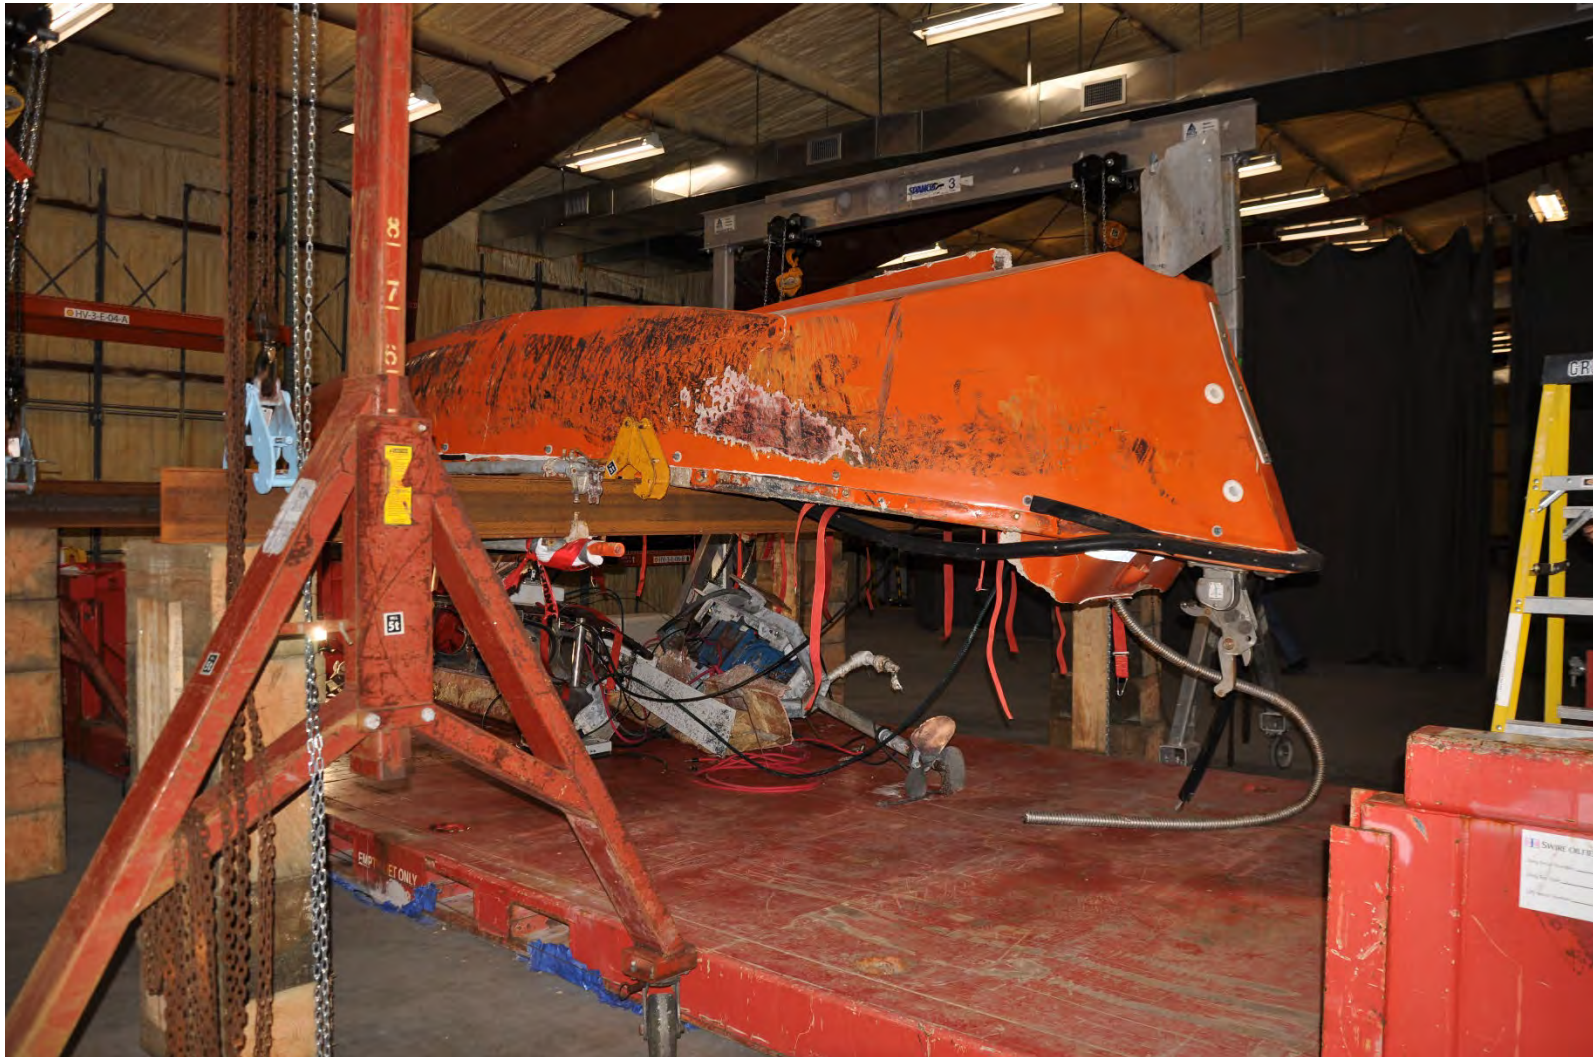
Figure 9. Photograph showing the condition of the Lifeboat 6 in Harvey Terminal after the incident, as viewed from the aft, starboard side.

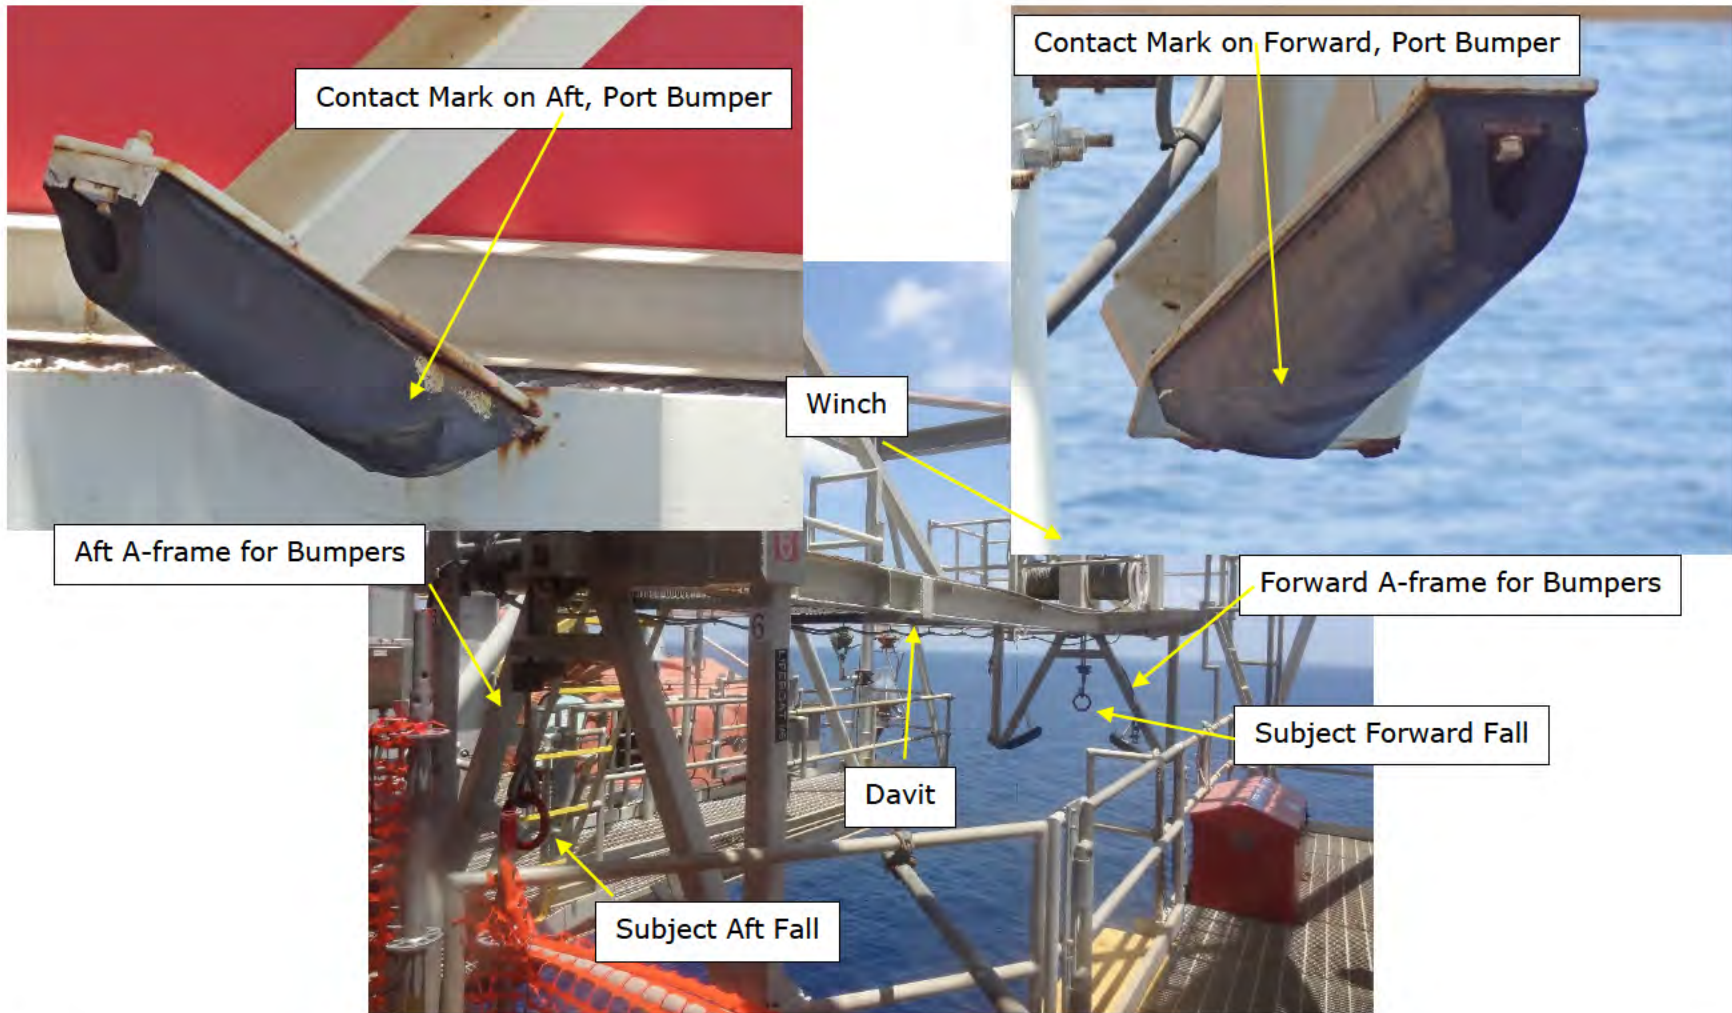
Figure 10. Photographs showing the condition of the davit and port bumpers after the incident. Photograph provided by SOI.

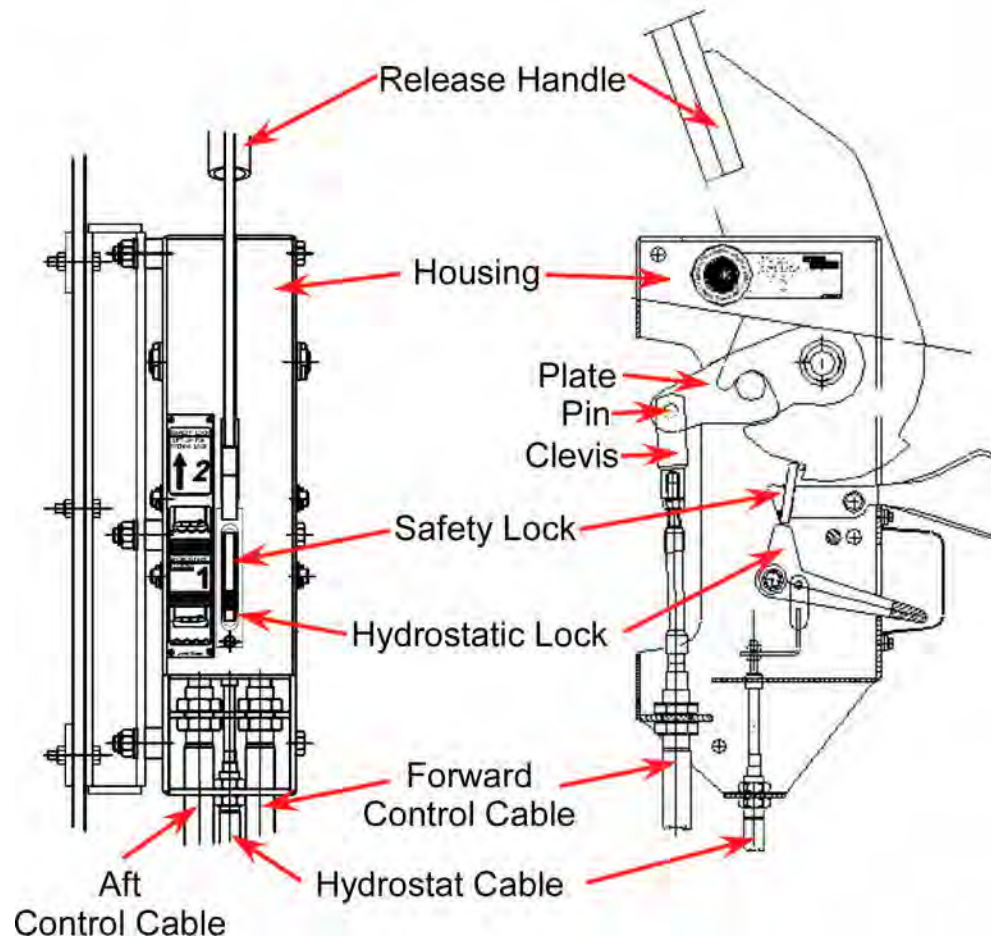
Figure 11. Drawings of the Subject Release Unit showing the different components of the release unit. The drawing on the left is from Drawing Number US10088-Rev B, Sheet 1 of 2 (front) and the drawing on the right is from Palfinger Document F10927. Drawing provided by Palfinger to SOI. Note that the drawing shown is for a hook of similar design and not the as-installed hooks.

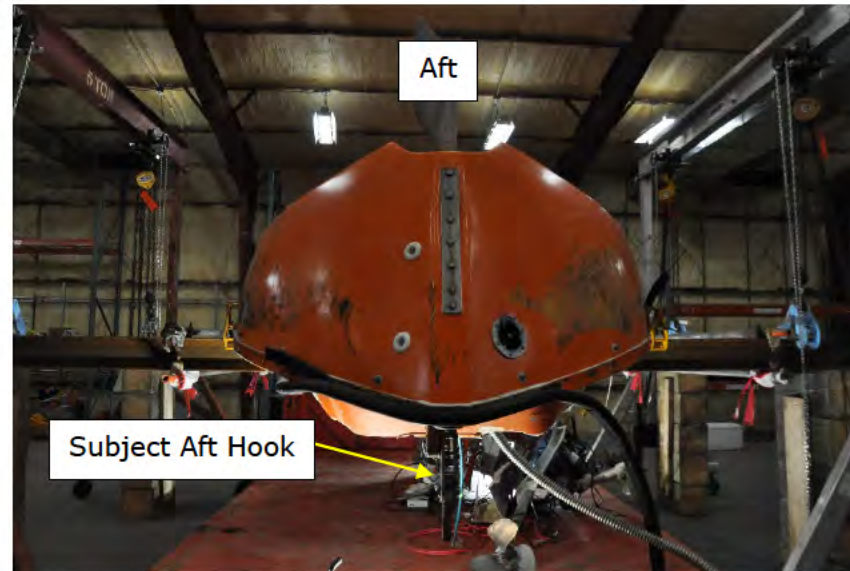
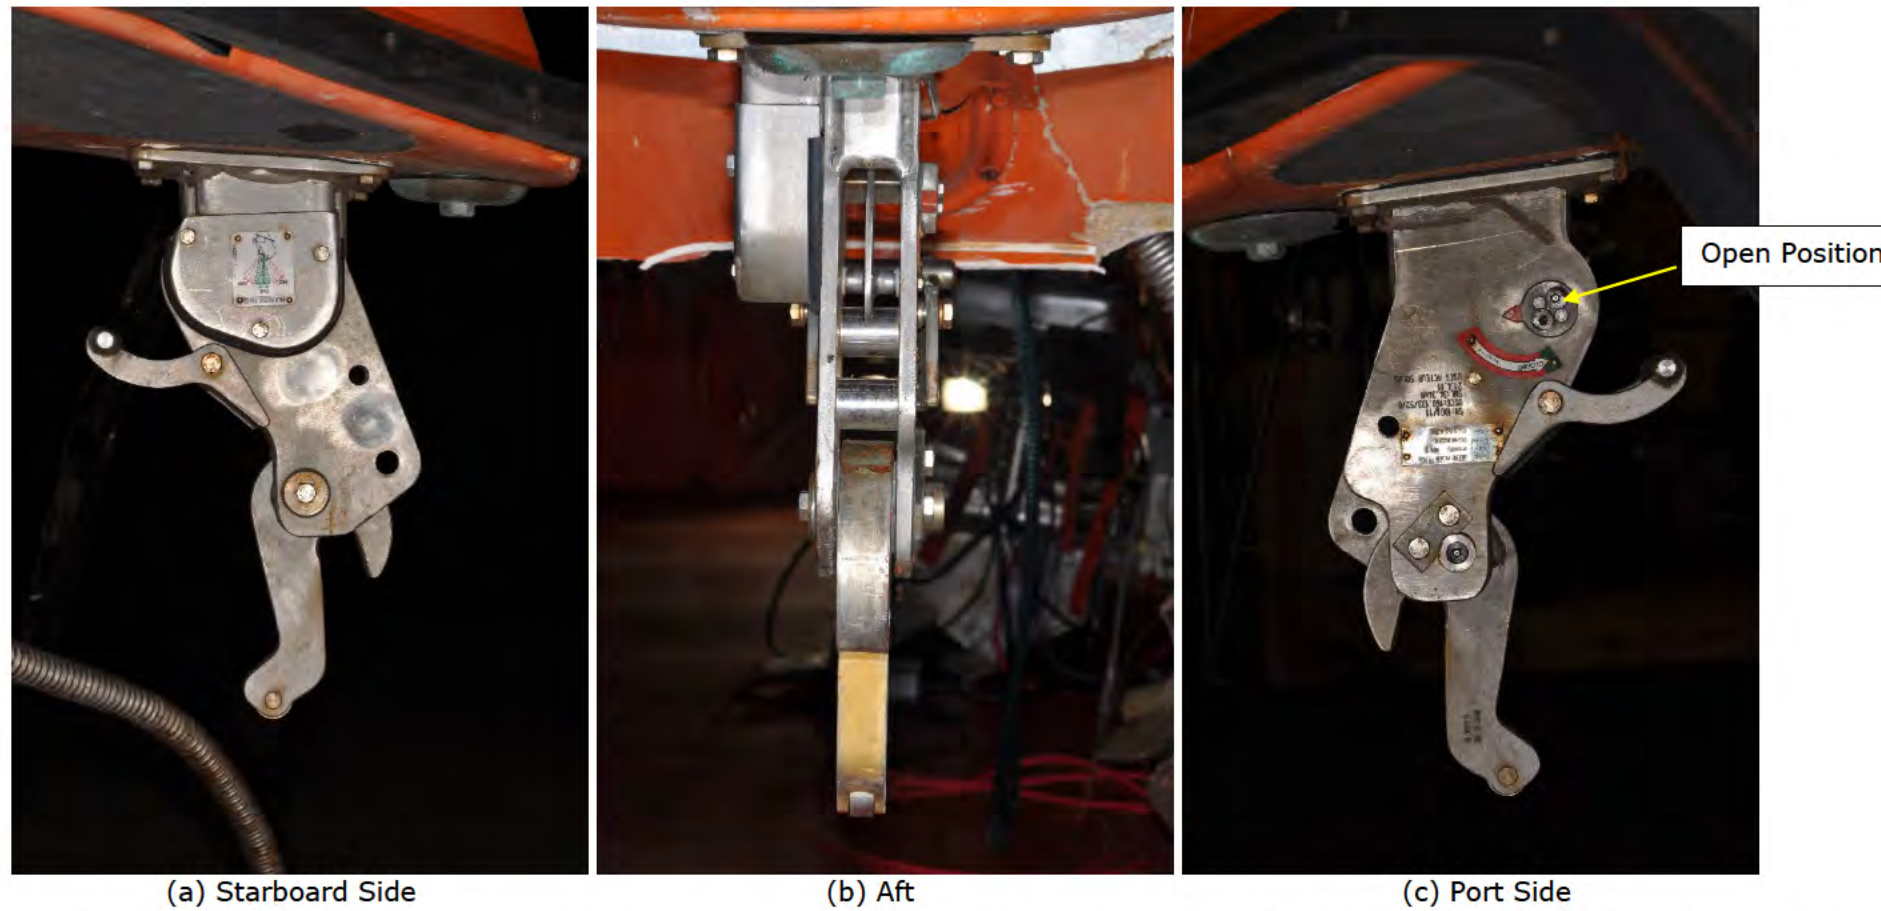
Figure 18. Photographs showing the aft of Lifeboat 6 and the as-found condition of the Subject Aft Hook as viewed from (a) the starboard side, (b) the stern, and (c) the port side.

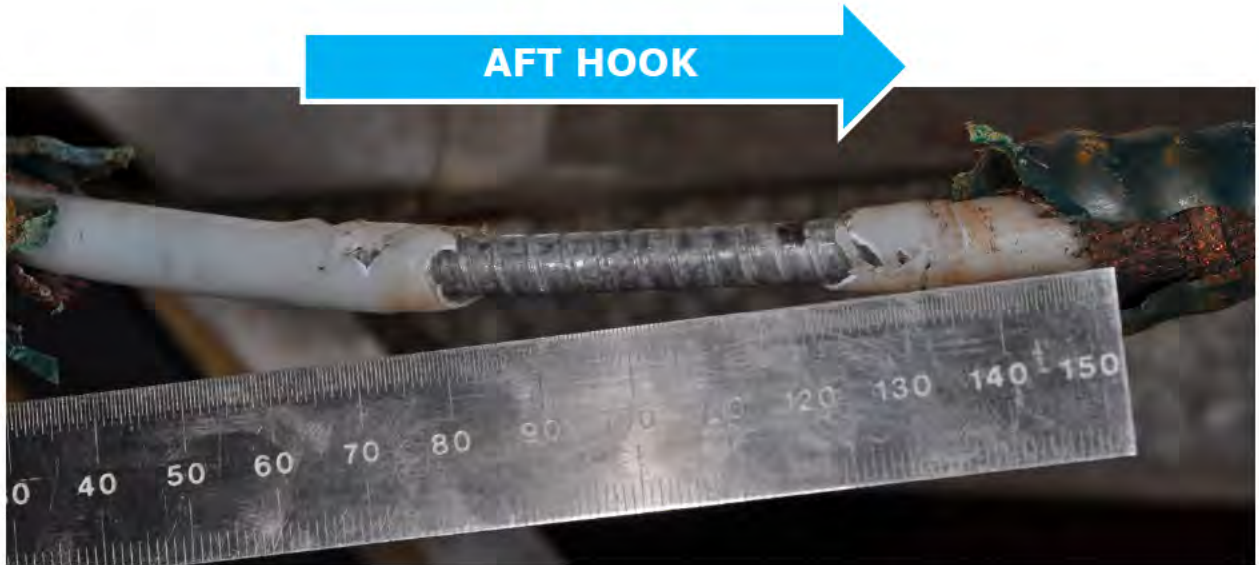
Figure 19. Photograph of the Subject Aft Cable showing a failure of the outer layers exposing the inner member. The direction of the Subject Aft Hook is noted with the blue arrow. Ruler is in mm.

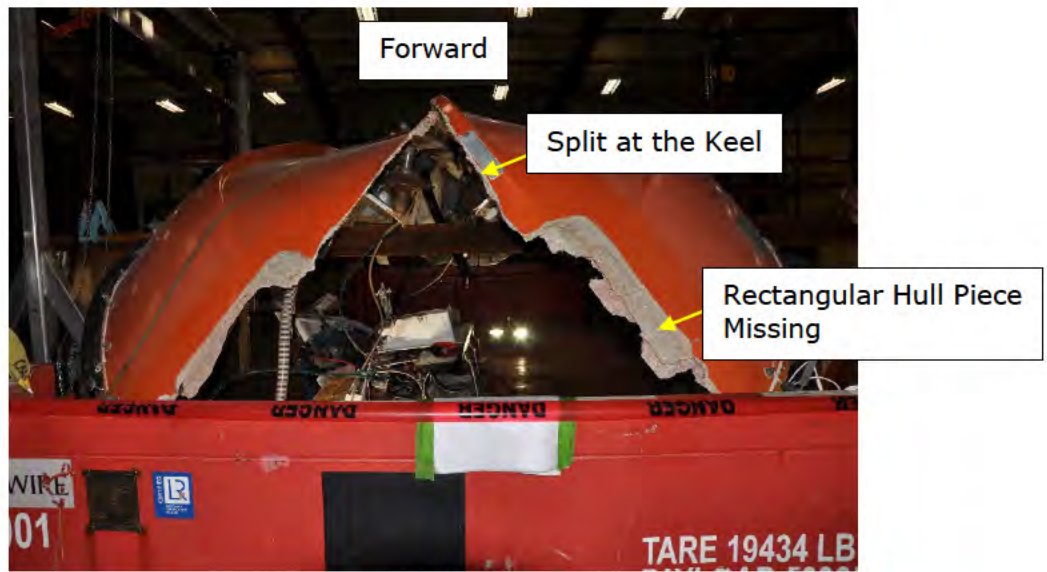
Figure 20. Photograph of the Subject Aft Hook showing the as-found condition of the threaded connections (a) at the clevis and (b) at the bulkhead nuts; the locations of the clevis and bulkhead nuts are shown in embedded schematic. Ruler in top image is in inches.

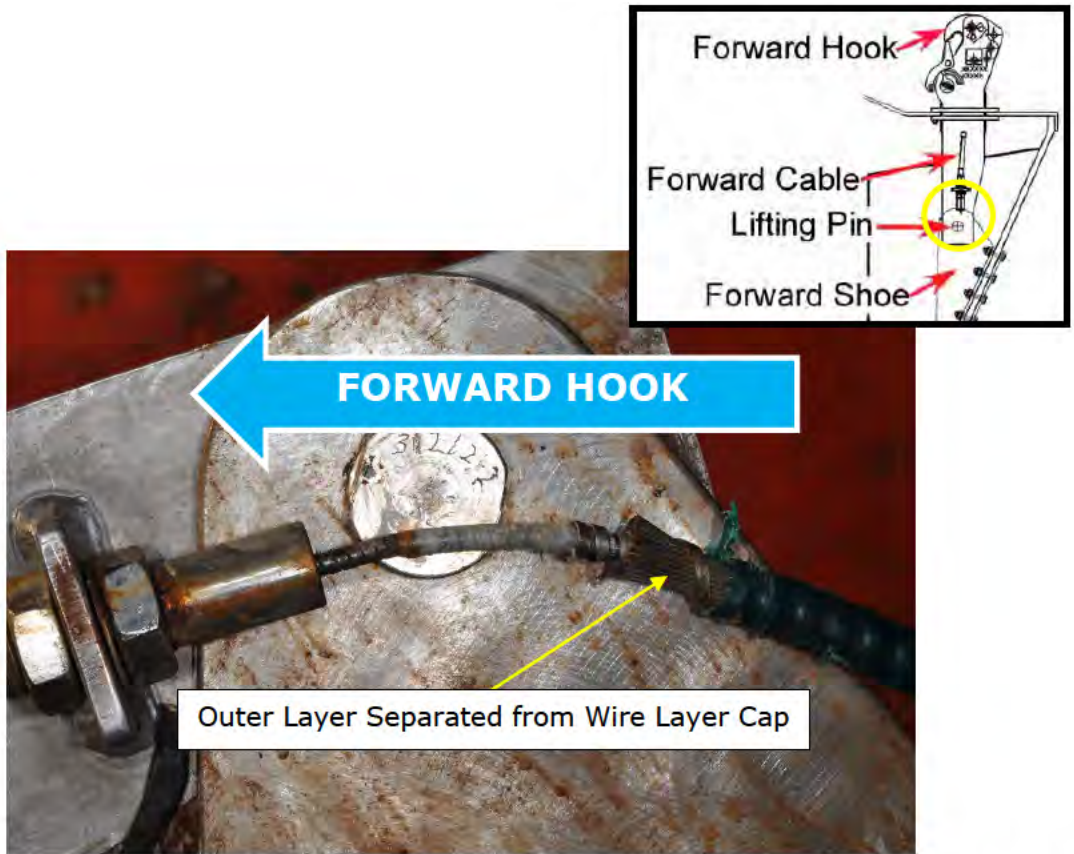
Figure 22. Photograph showing a separation of the outer layers from the conduit cap at the bulkhead nuts of the Subject Forward Cable; location shown in the embedded schematic. The direction of the Subject Forward Hook is noted with the blue arrow.

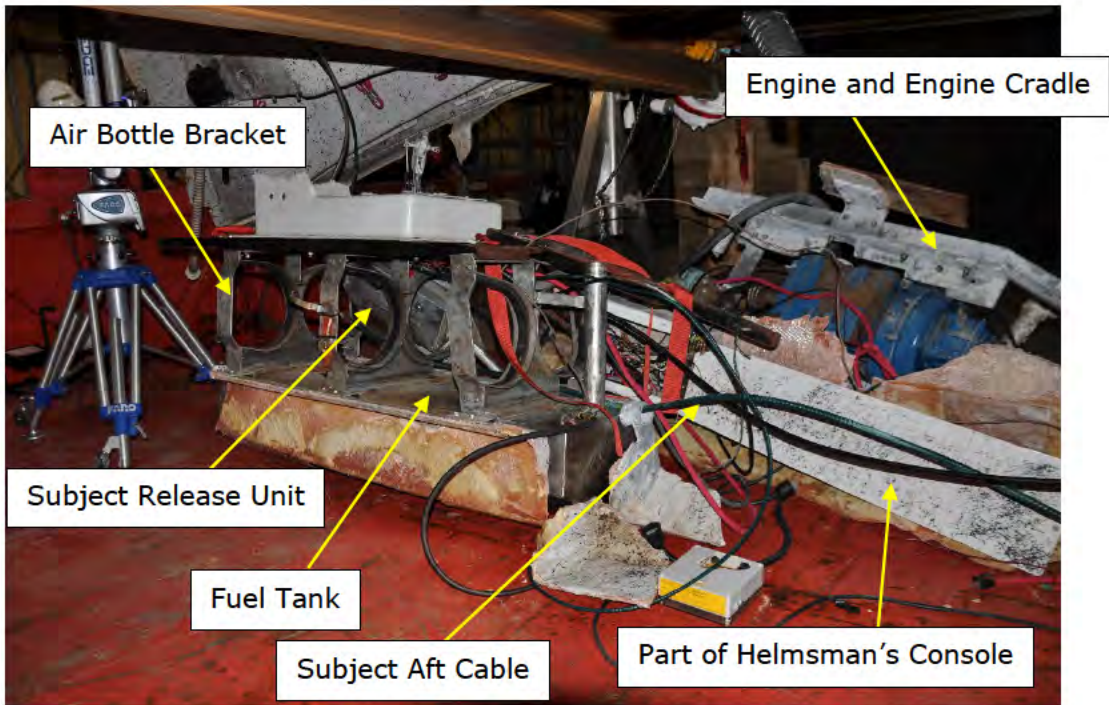
Figure 24. Photograph showing the as-found condition of the internal subject components of Lifeboat 6.

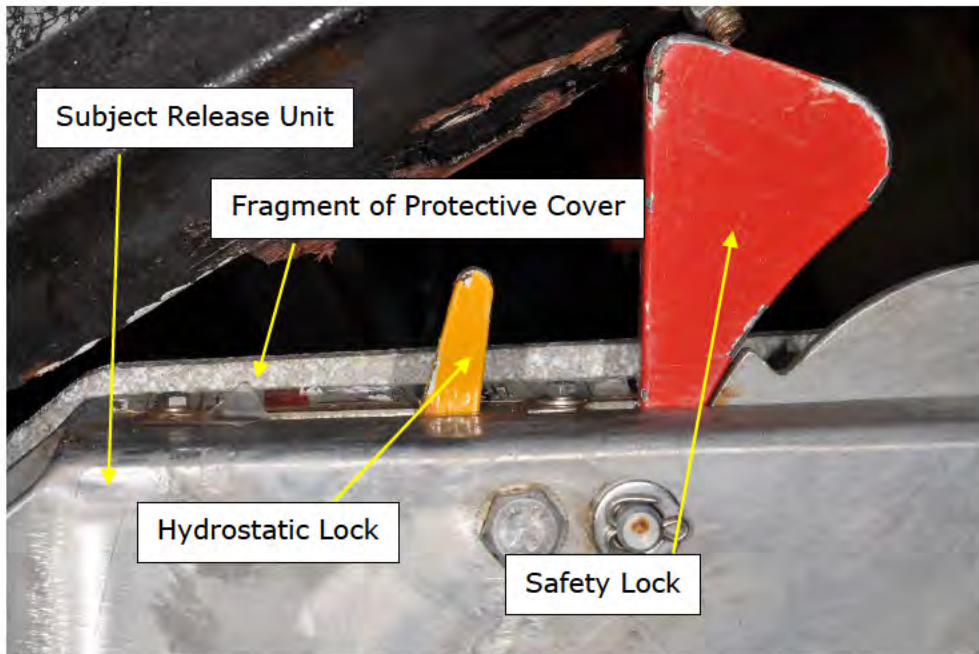
Figure 25. Photograph showing the as-found condition of the hydrostatic and safety locks on the Subject Release Unit of Lifeboat 6.

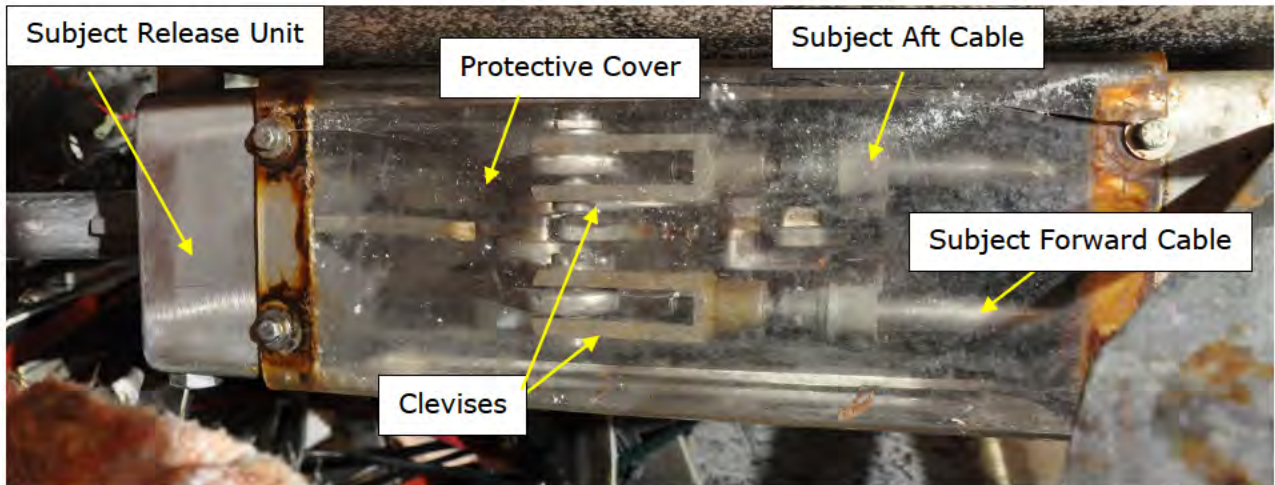
Figure 26. Photograph showing the as-found condition of the Subject Aft Cable and Subject Forward Cable clevises at the Subject Release Unit of Lifeboat 6.

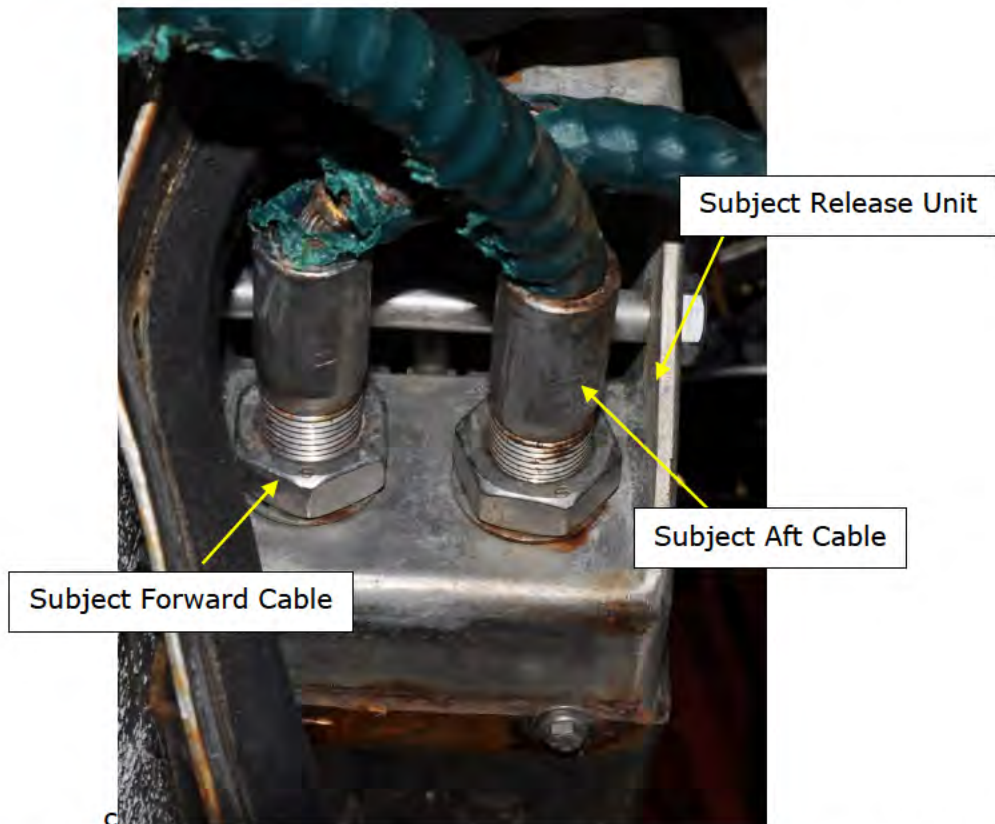
Figure 27. Photograph showing the as-found condition of the Subject Aft Cable and Subject Forward Subject at the bulkhead nuts of the Release Unit of Lifeboat 6.

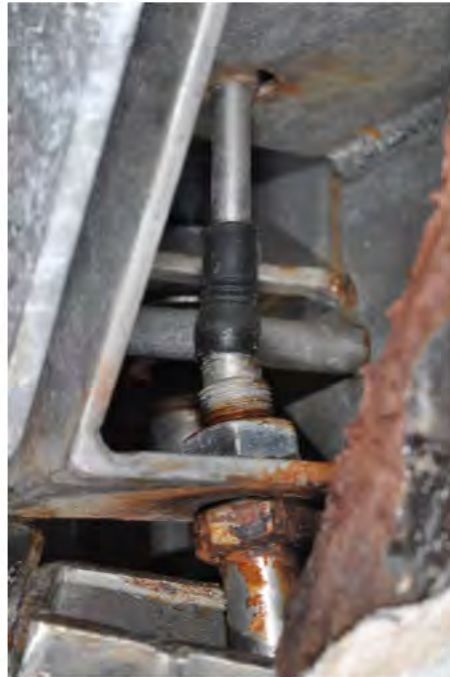
Figure 28. Photograph of the Subject Release Unit showing the as-found condition of the bulkhead nuts attaching the Subject Hydrostatic Cable to the Subject Release Unit.

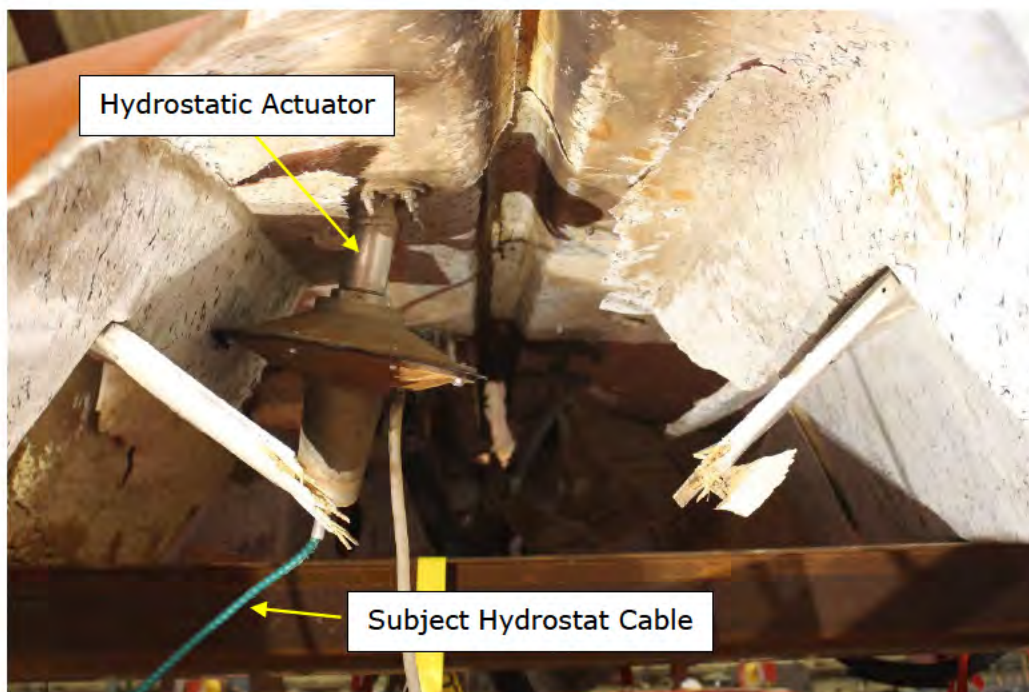
Figure 29. Photograph showing the as-found condition of the hydrostatic actuator of Lifeboat 6.

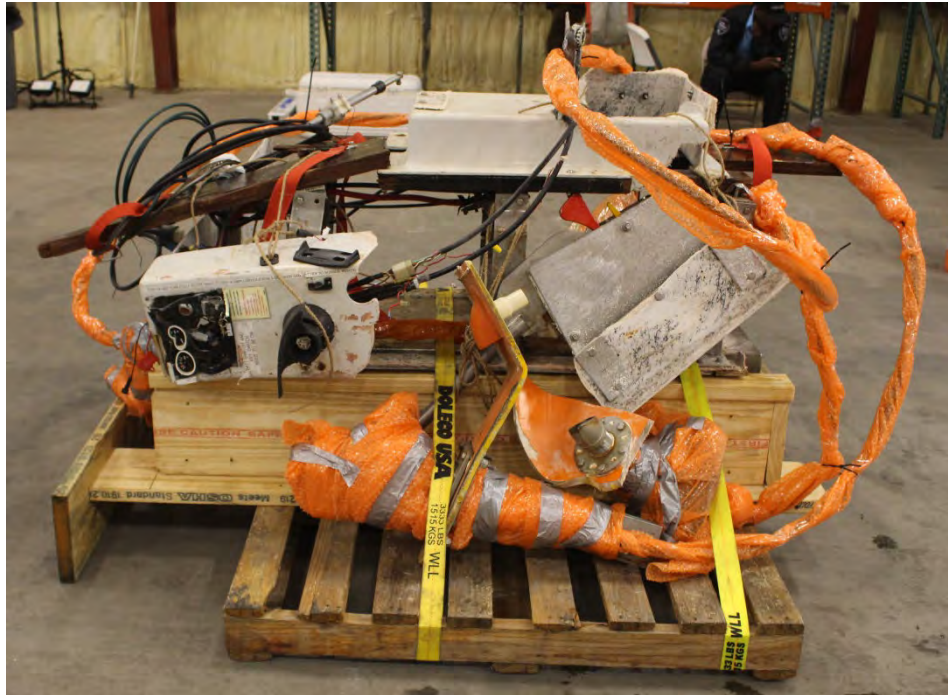
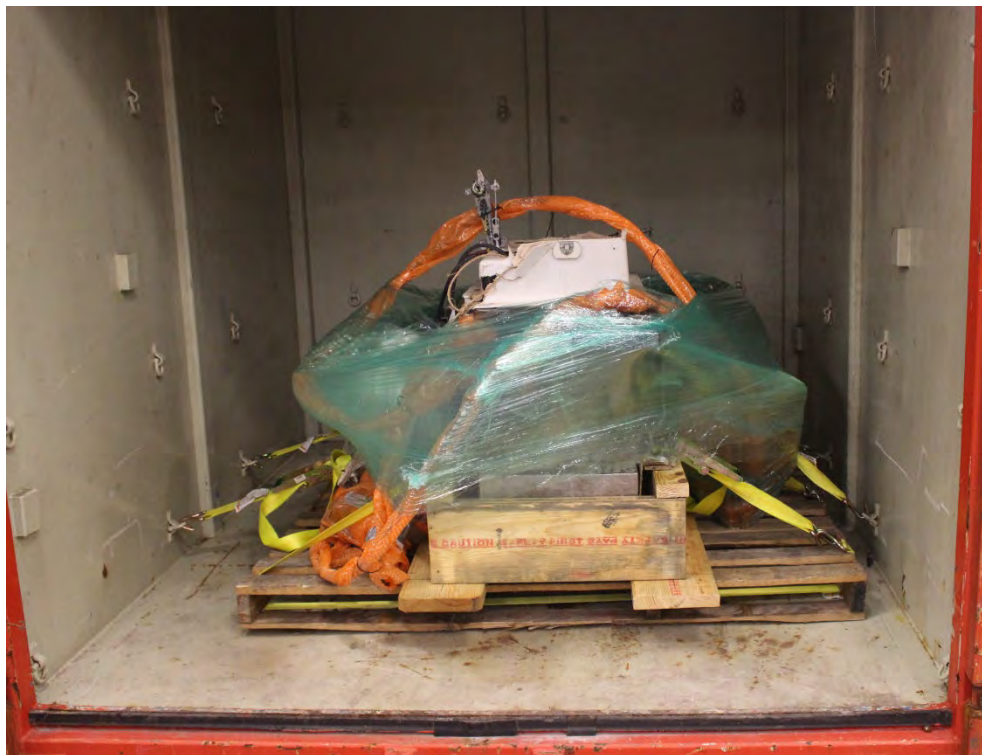
Figure 30. Photographs of the key components of Lifeboat 6 after removal and preparing for transit to DNV GL.

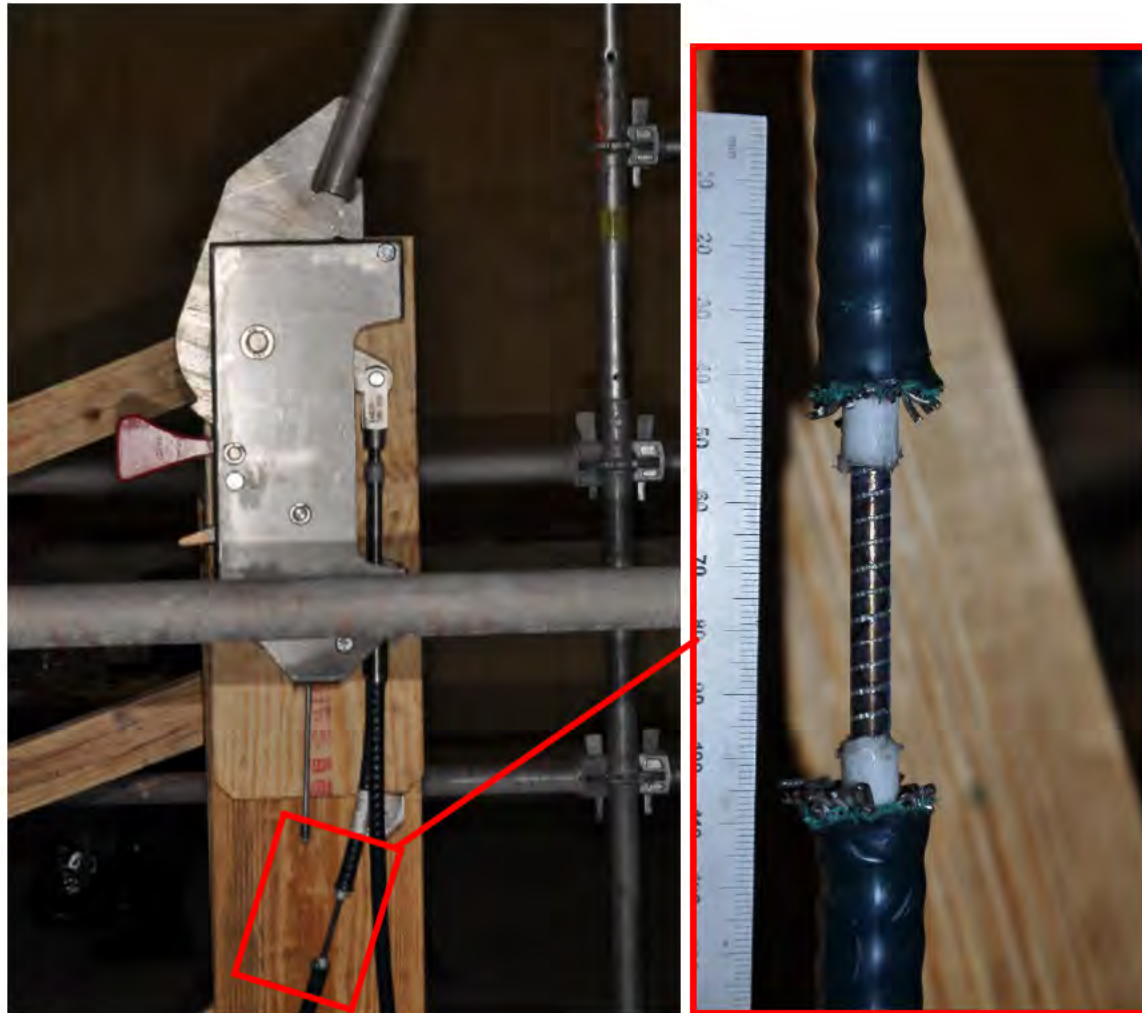
Figure 32. Photographs showing a failure in an Exemplar Cable when the wire layer and liner were severed at the approximate location of failure as on the Subject Aft Cable. Handle for the Exemplar Release Unit was in the closed position. Ruler is in mm.

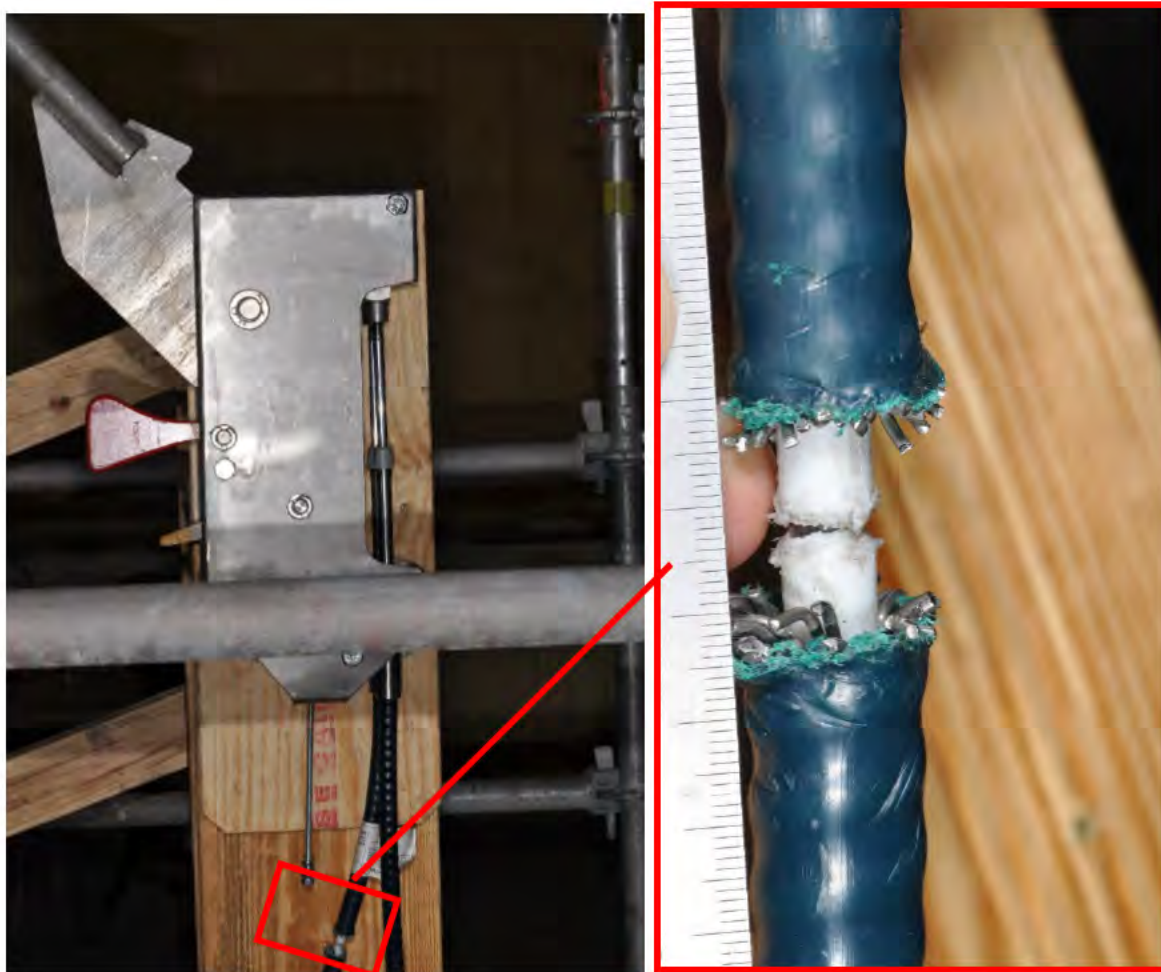
Figure 33. Photographs showing a failure in an Exemplar Cable when the wire layer and liner were severed at the approximate location of failure as on the Subject Aft Cable. Handle for the Exemplar Release Unit was in the open position. Ruler is in mm.
