Final Report

Auger Lifeboat 6 Incident

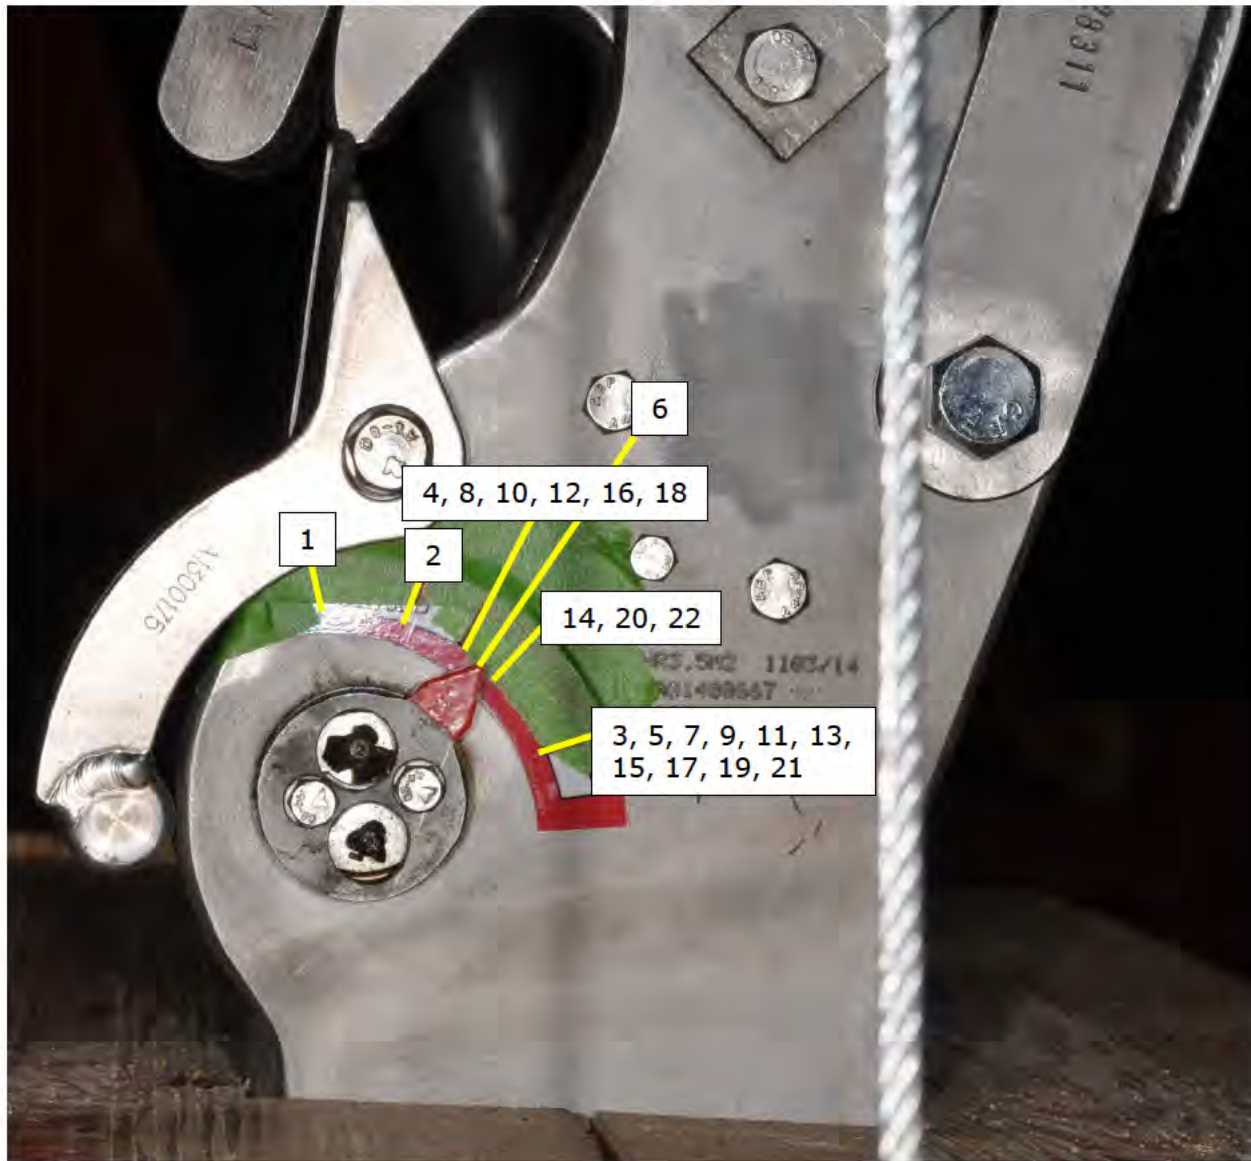
| Step | Position of Exemplar Release Unit | Action | Measurement at Gap (inches) | Estimated Degrees of Rotation to Open Position (Degrees) | Locking Shaft Prevents Hook from Rotating |

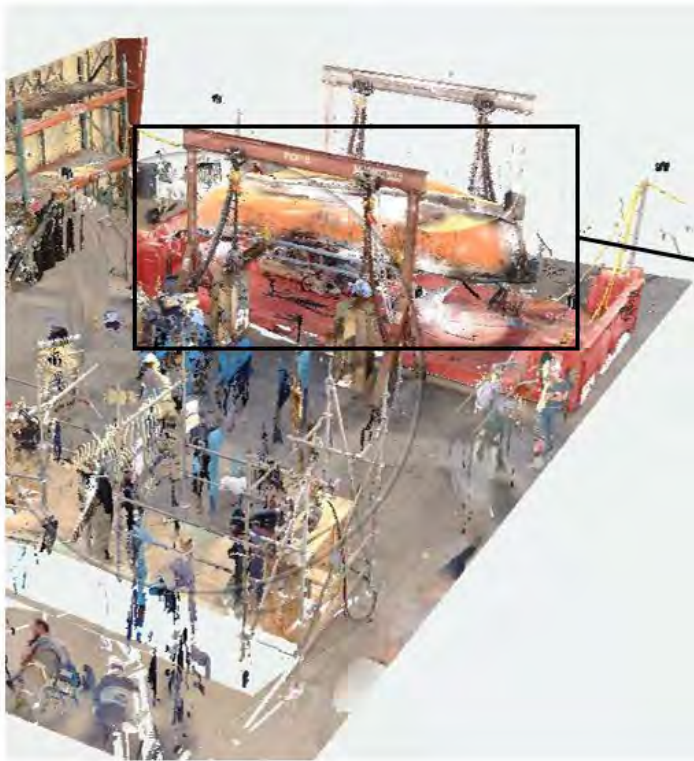
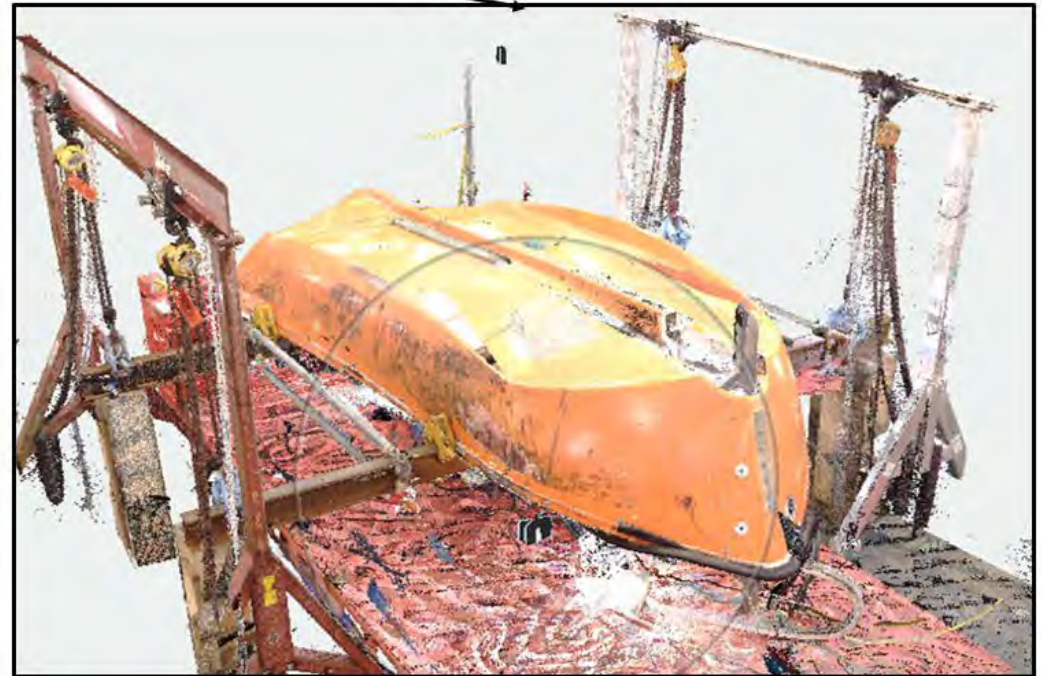
Figure 35. Laser scan of the Lifeboat 6, performed at Harvey Terminal after recovery.

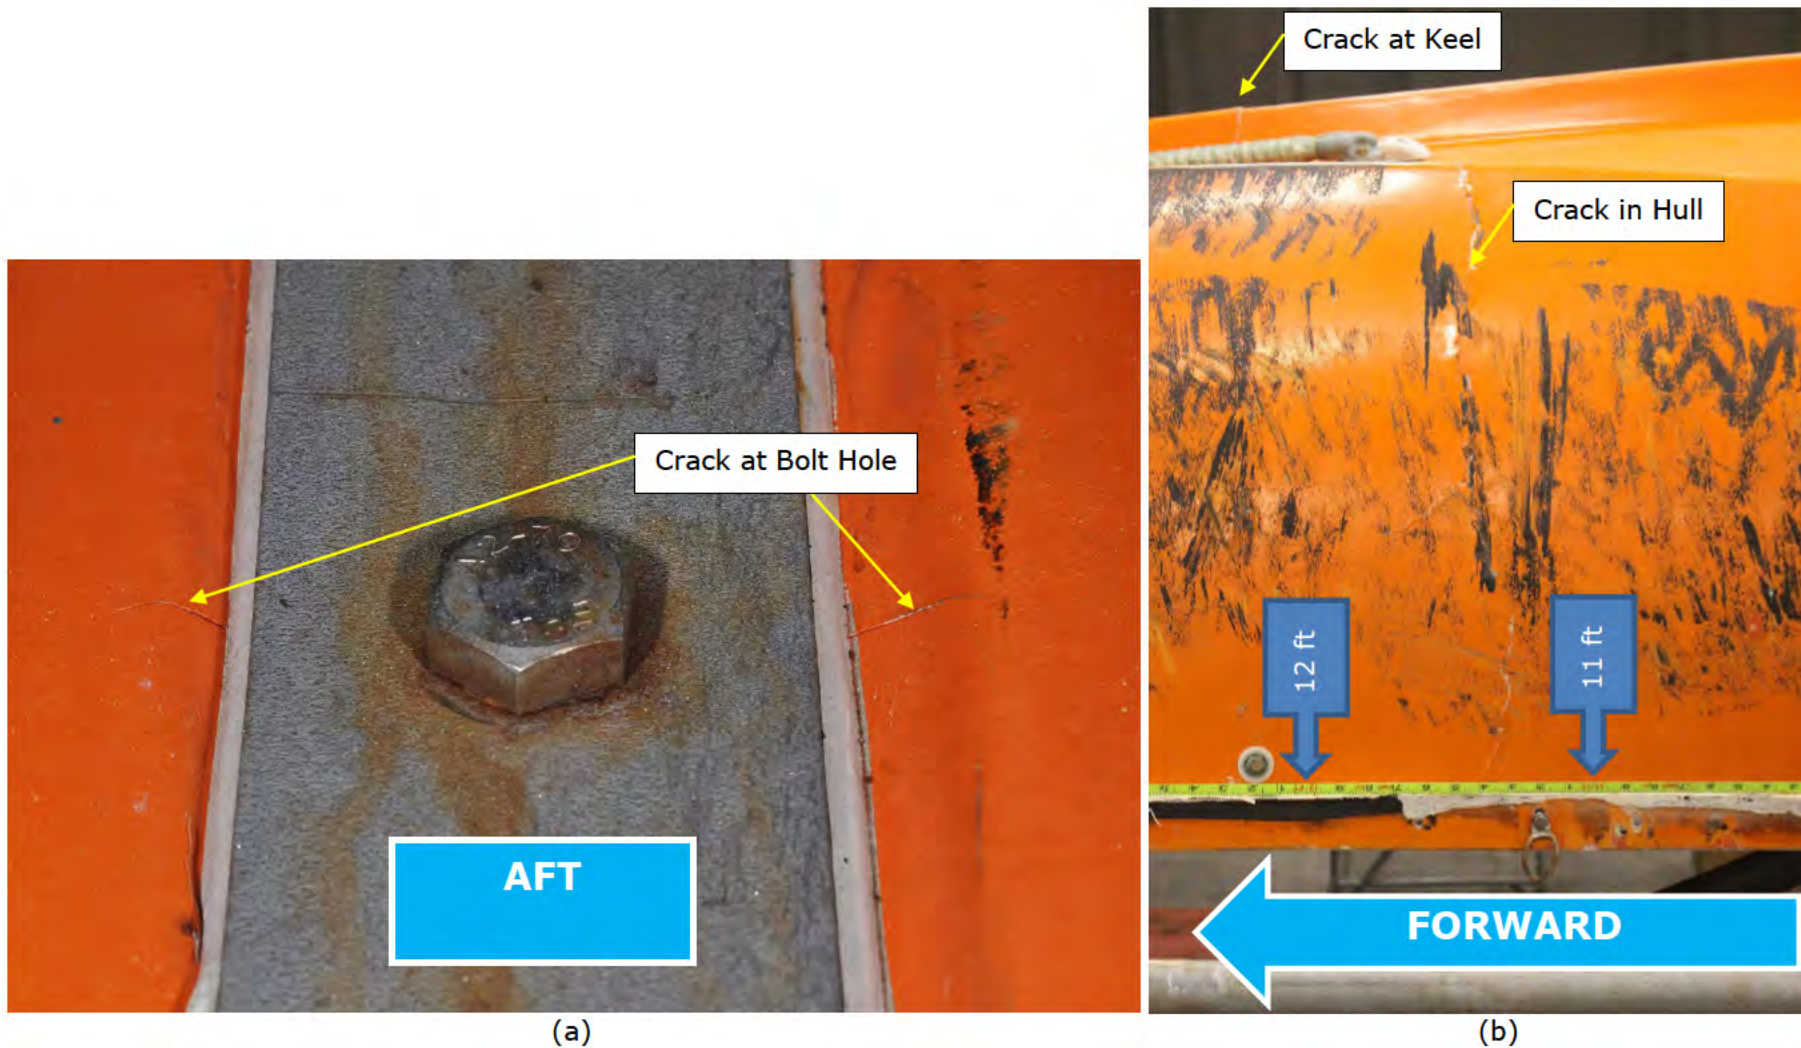
Figure 37. Photographs showing locations of cracks of interest at (a) the aft shoe plate and (b) 11.4 feet from reference location; locations shown in Figure 36. Tape measure is in feet.

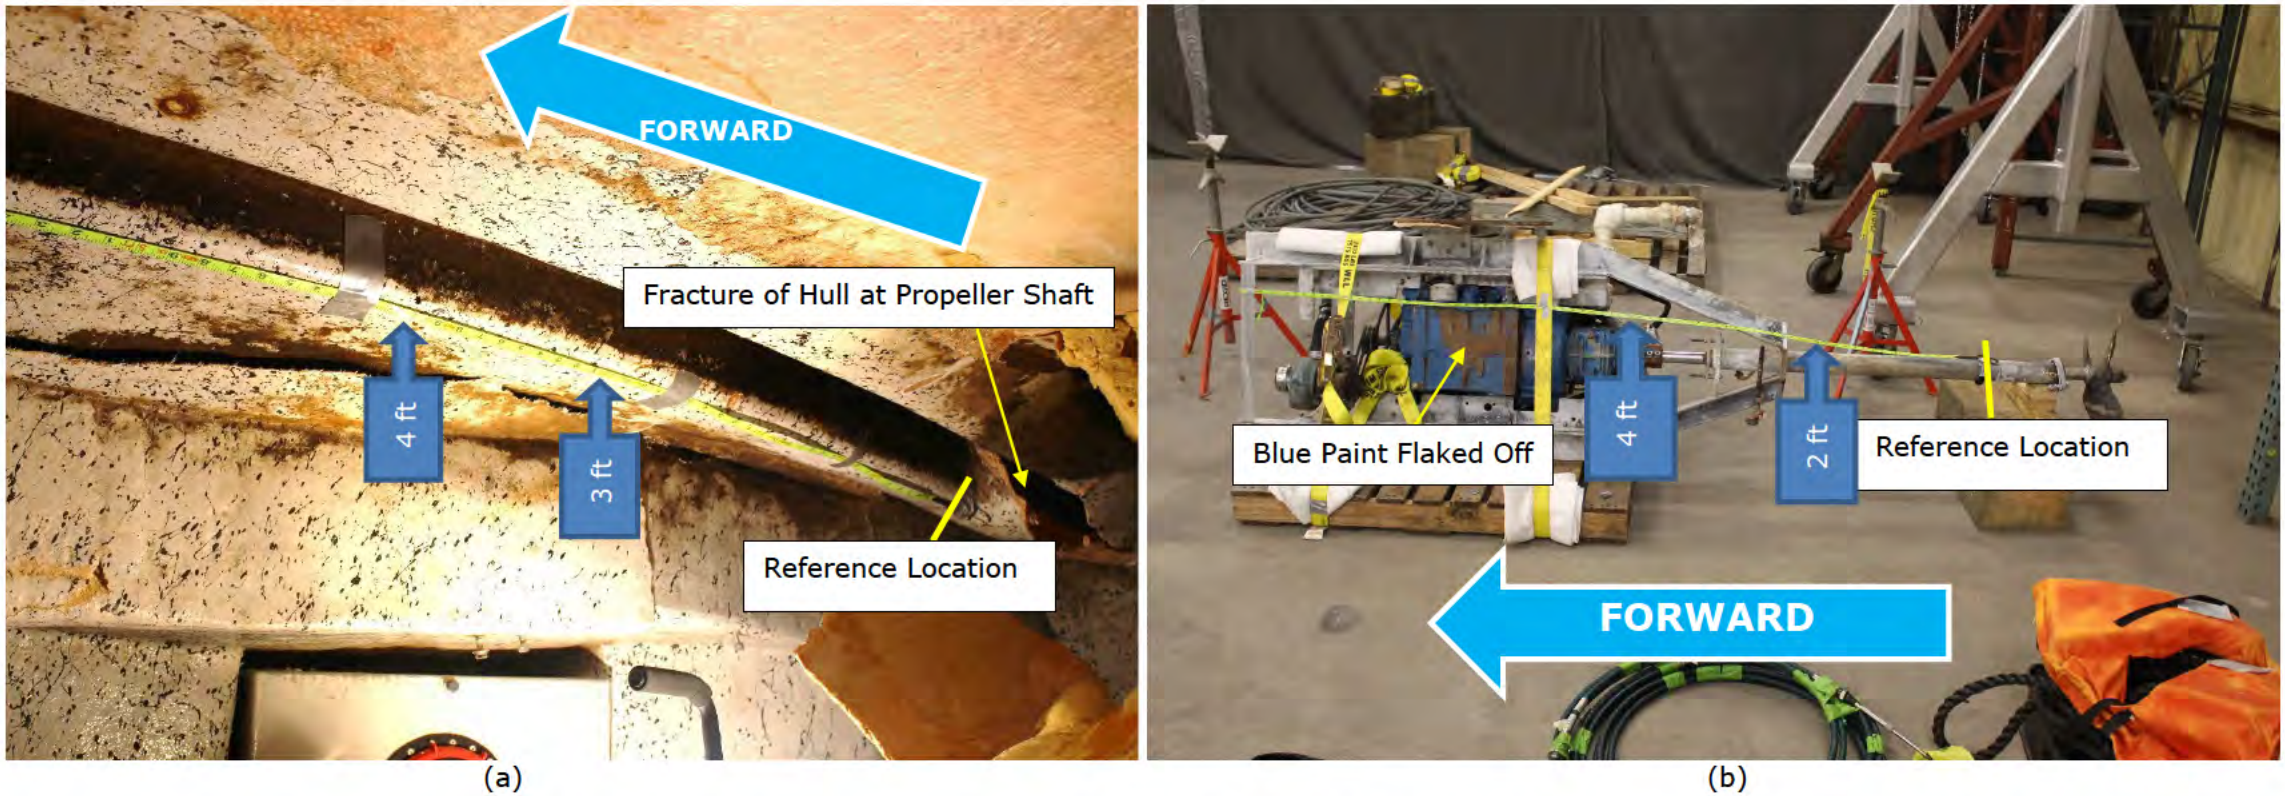
Figure 38. Photographs showing (a) the reference location for measurements on the interior of the hull and (b) the corresponding location on the engine and engine cradle. Tape measure is in feet.

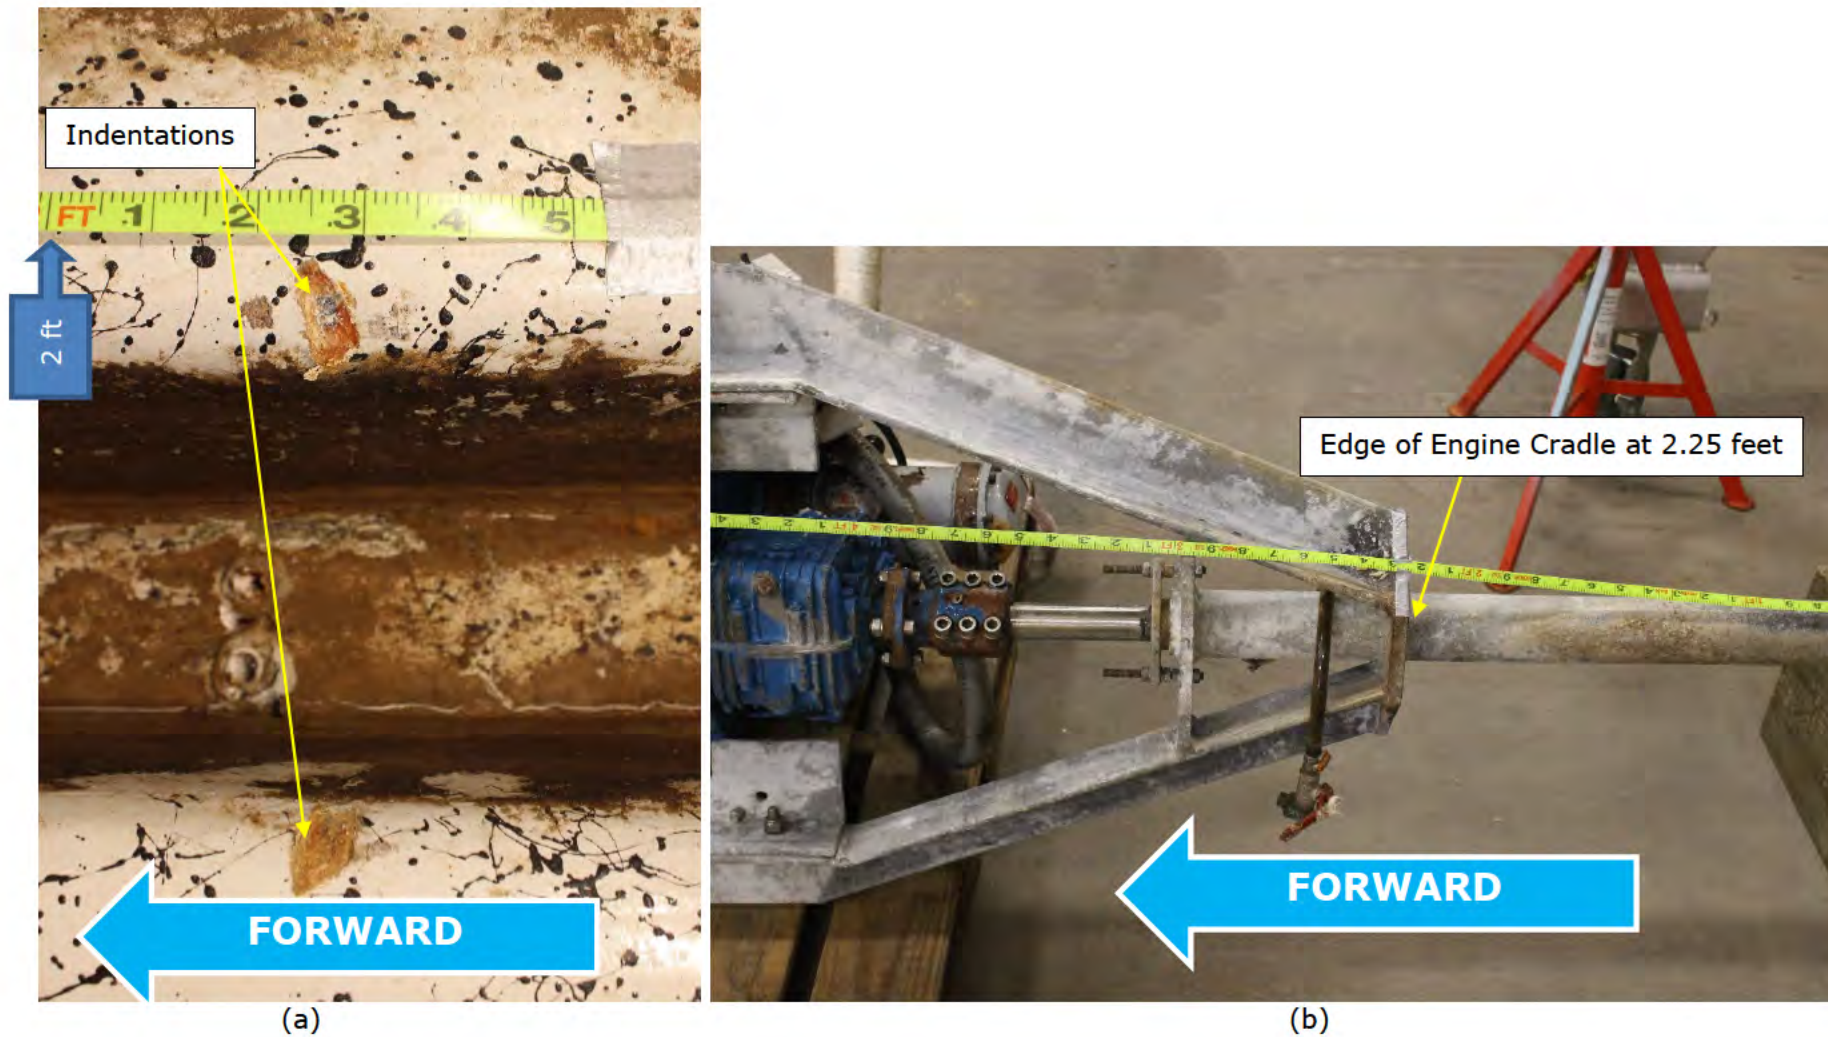
Figure 39. Photographs showing (a) indentations / contact damage at the hull interior 2.25 feet from the reference location and (b) the corresponding location on the engine and engine cradle. Tape measure is in feet.

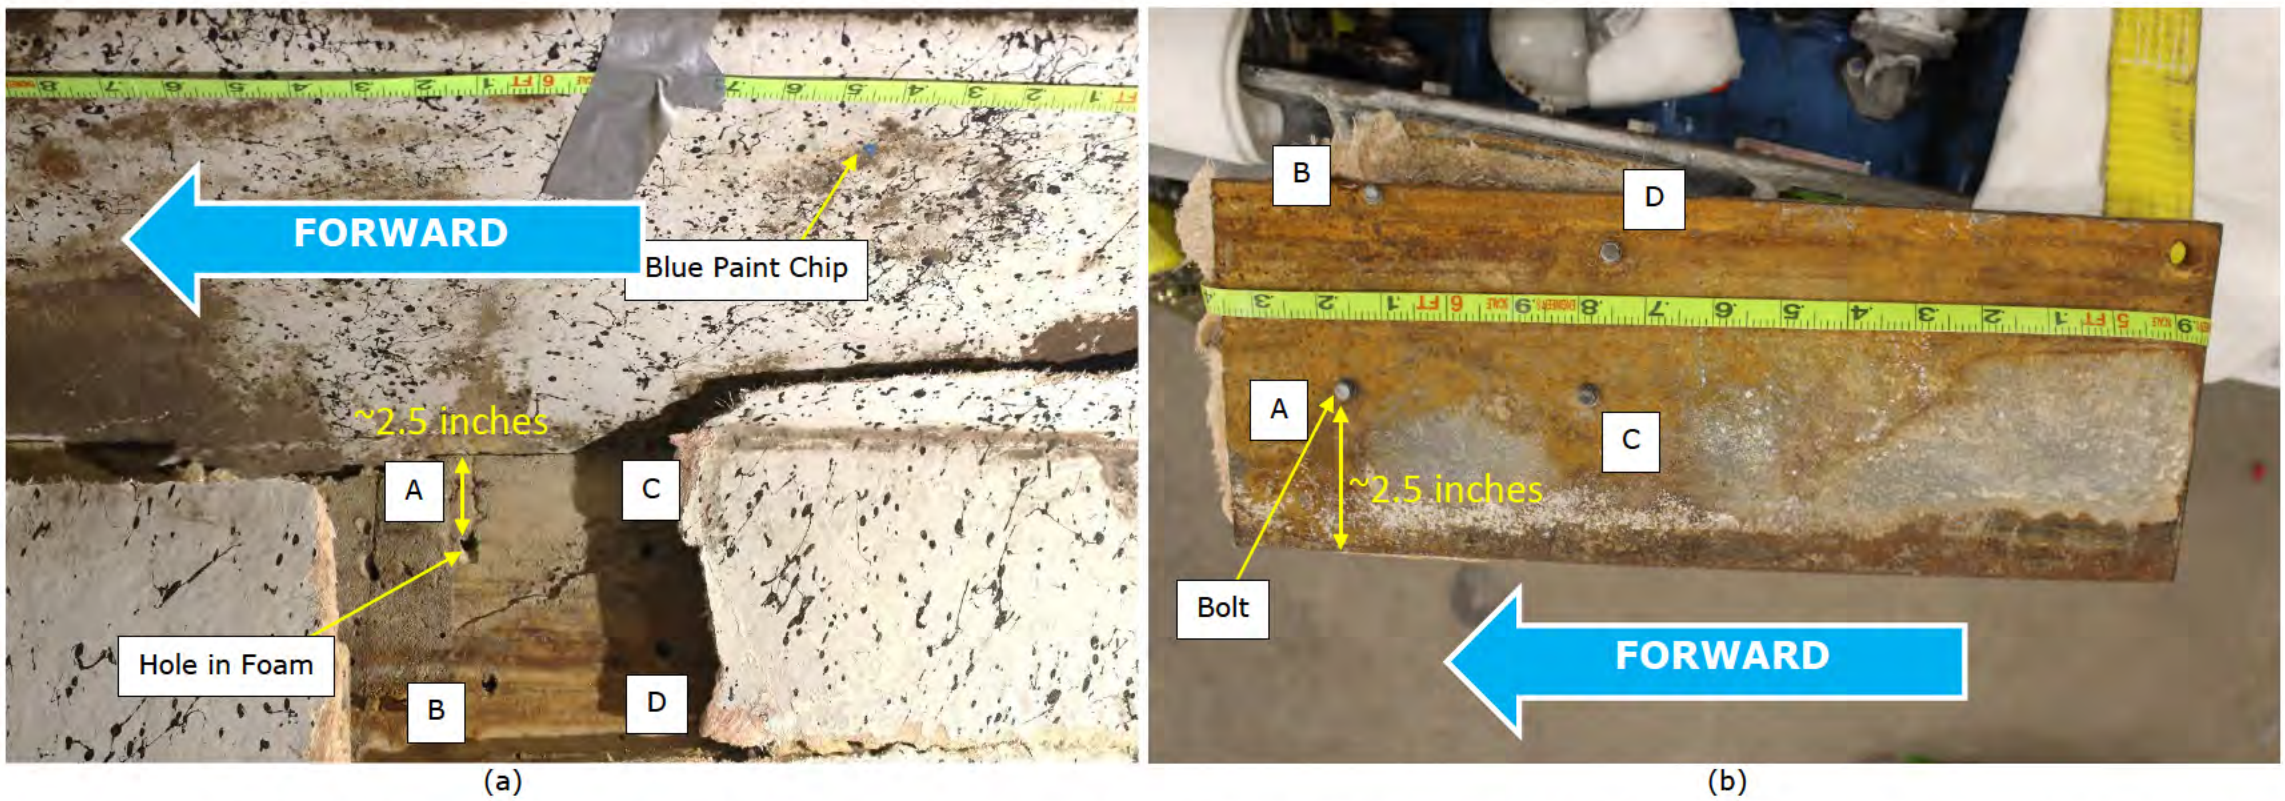
Figure 40. Photographs showing (a) a missing section of the hull interior 5.8 feet to 6.4 feet from the reference location and (b) the corresponding location on the engine and engine cradle. Tape measure is in feet.

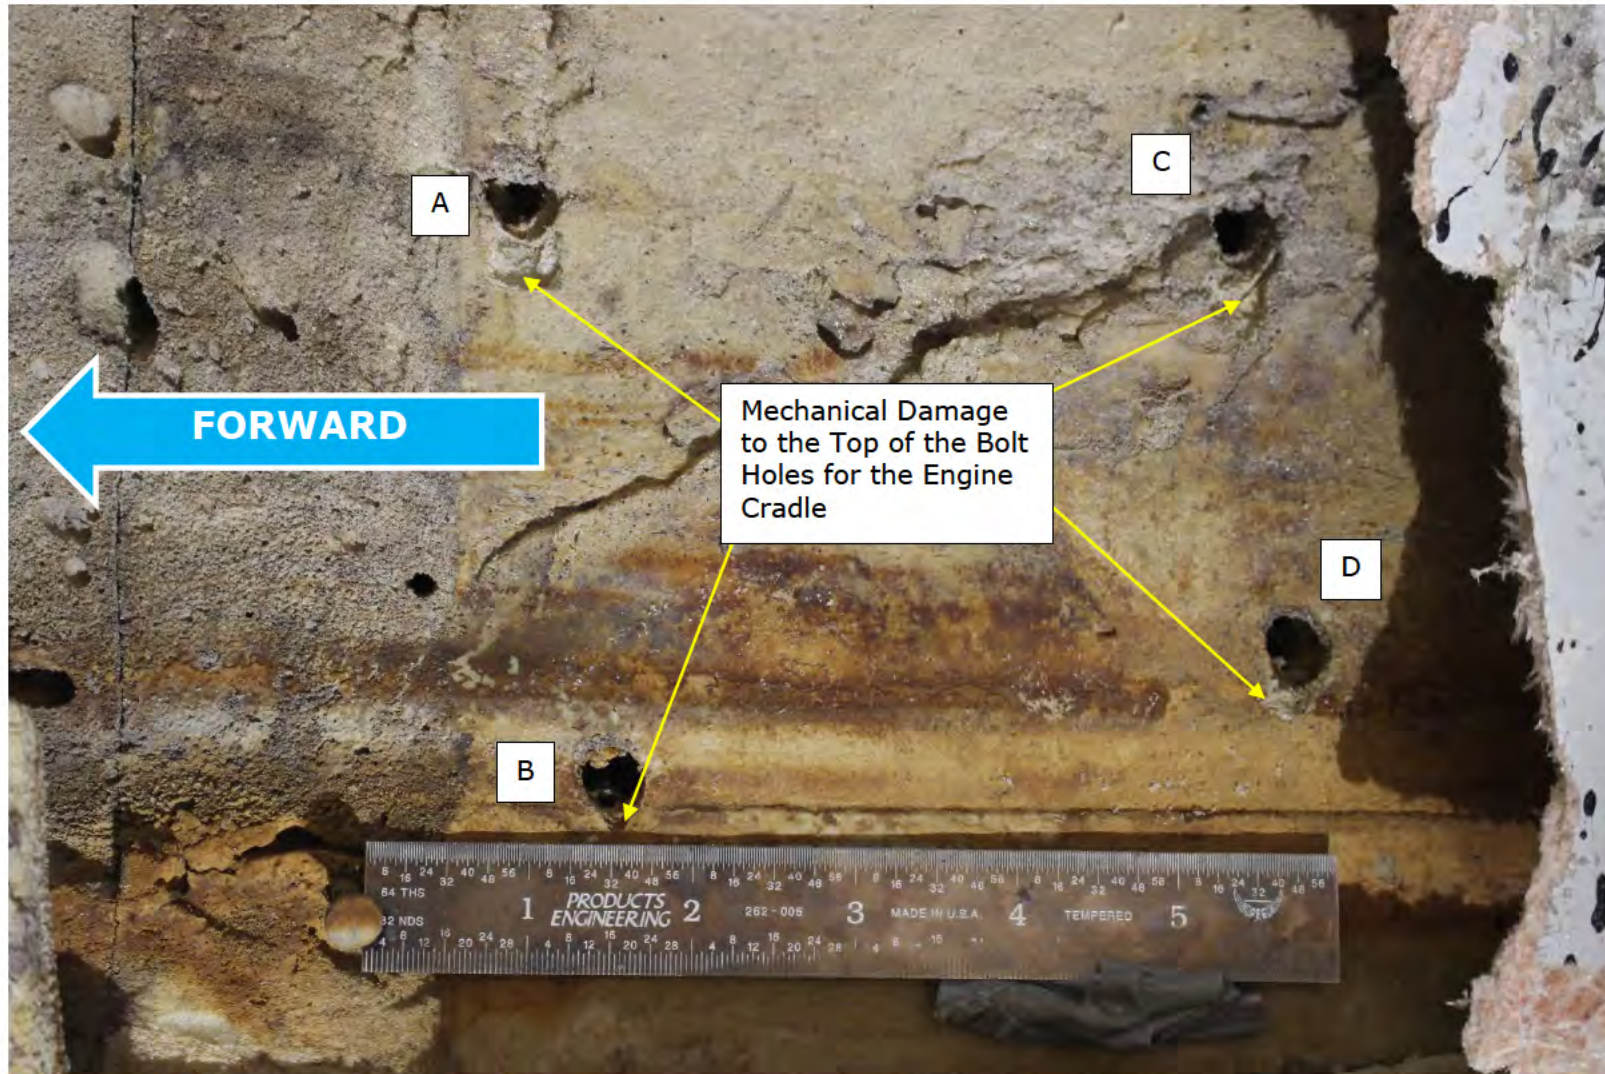
Figure 41. Photograph showing hole impressions left from the bolt studs used to attach support structure for the engine. Directionality of the damage can be seen adjacent to each hole. Ruler is in inches.

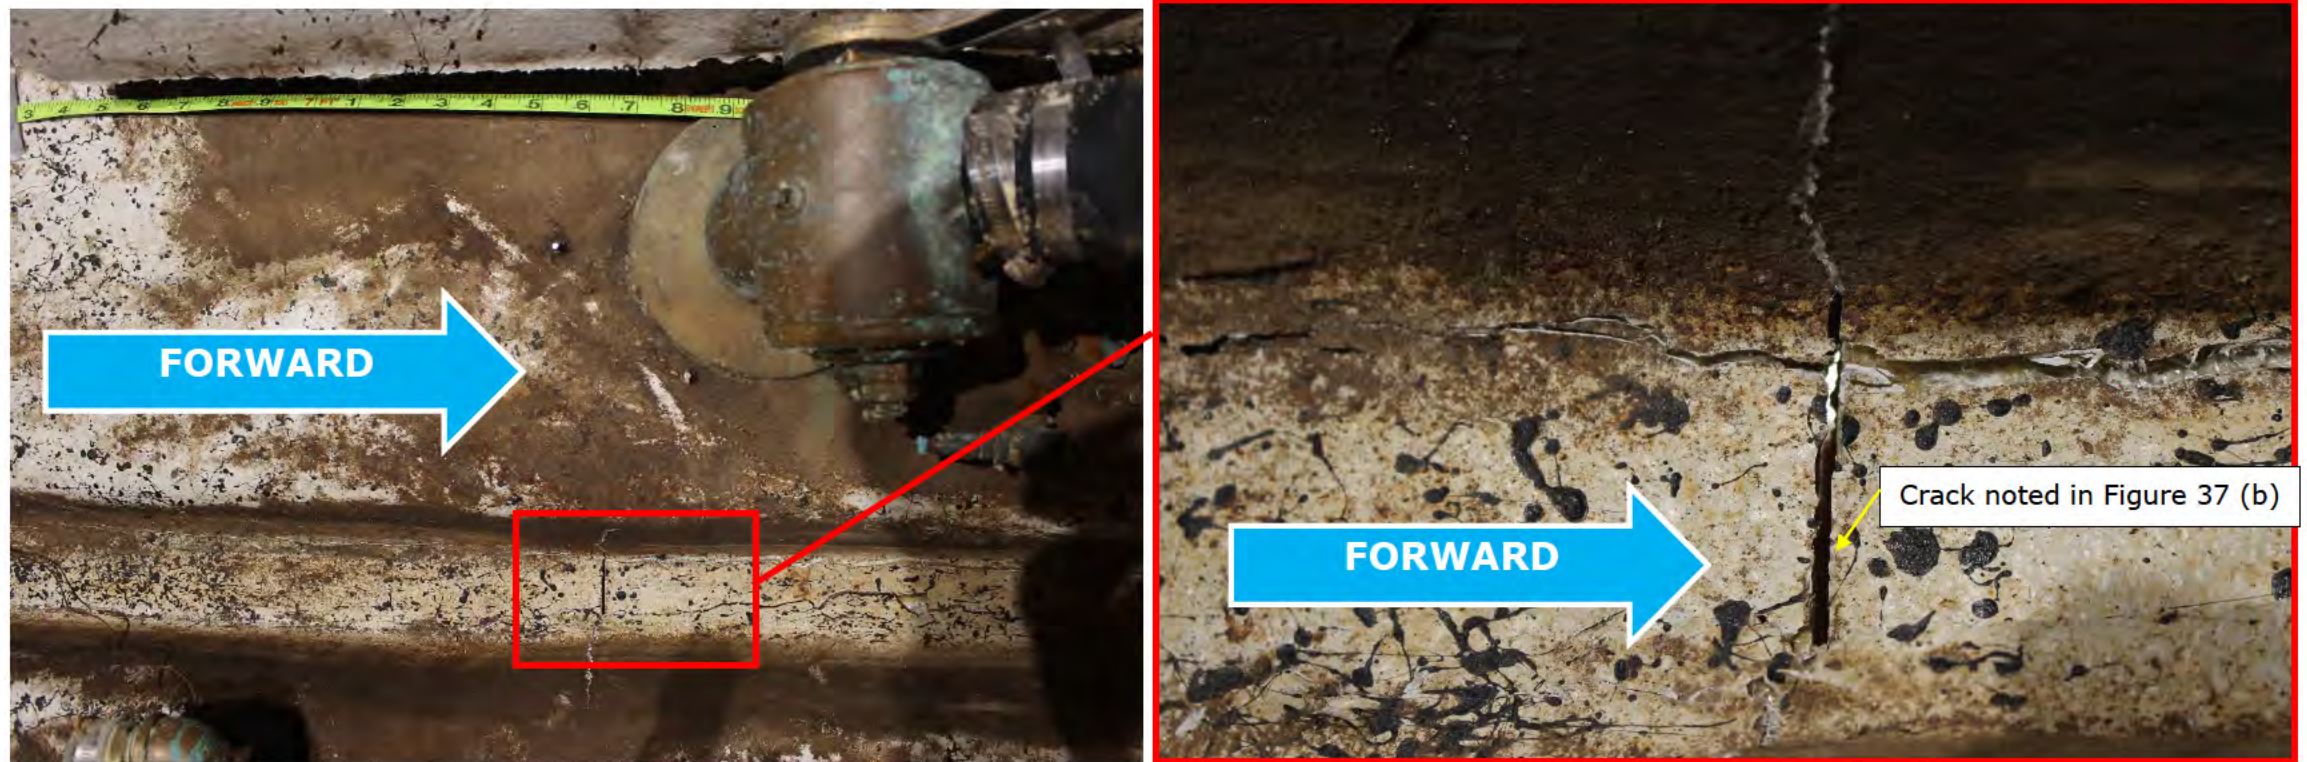
Figure 42. Photographs showing a transverse crack in the keel of the hull interior located 7.6 feet from the reference location. Tape measure is in feet.

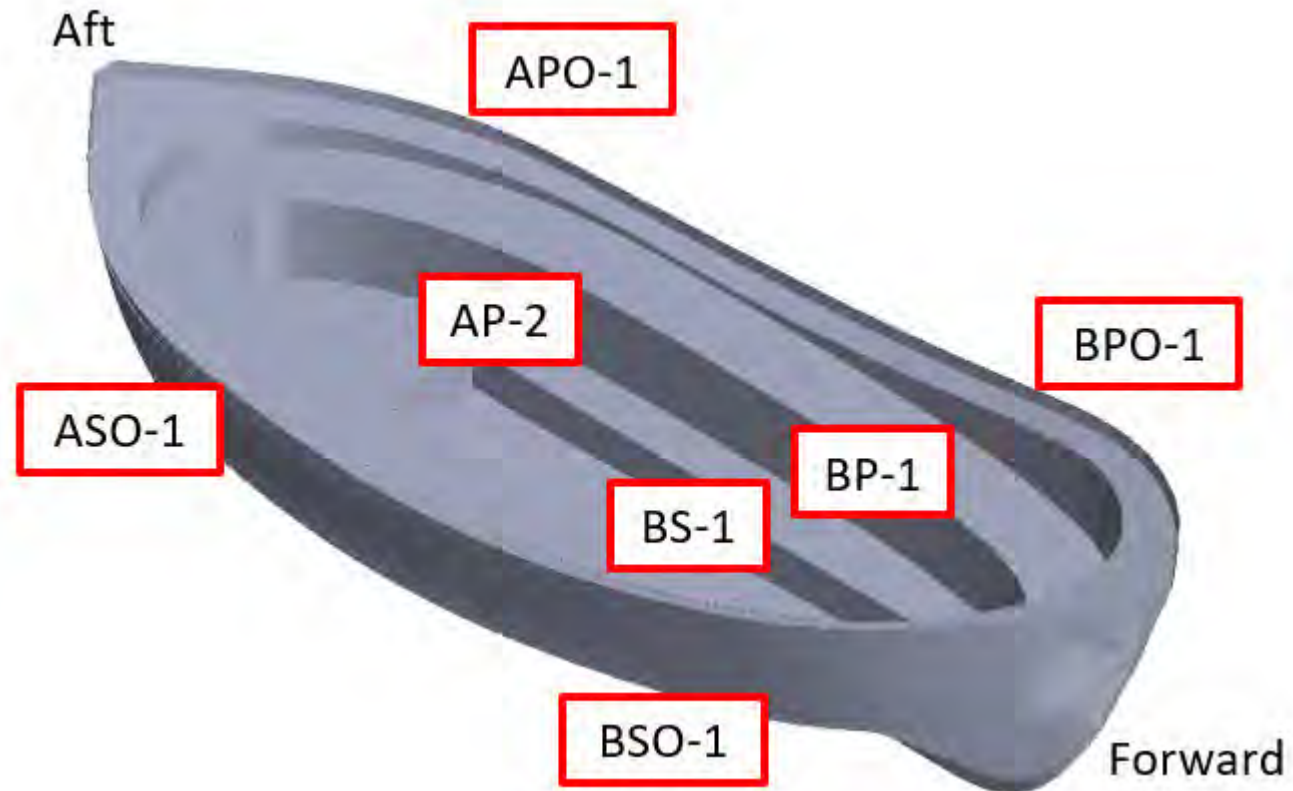
Figure 43. Schematic showing the approximate locations of each 24-inch by 24-inch panel extracted from the outer and inner hull of Lifeboat 6. Samples BSO-1, ASO-1, BPO-1, and APO-1 were extracted from the outer hull. Samples AP-2, BP-1, and BS-1 were extracted from the interior seating area.

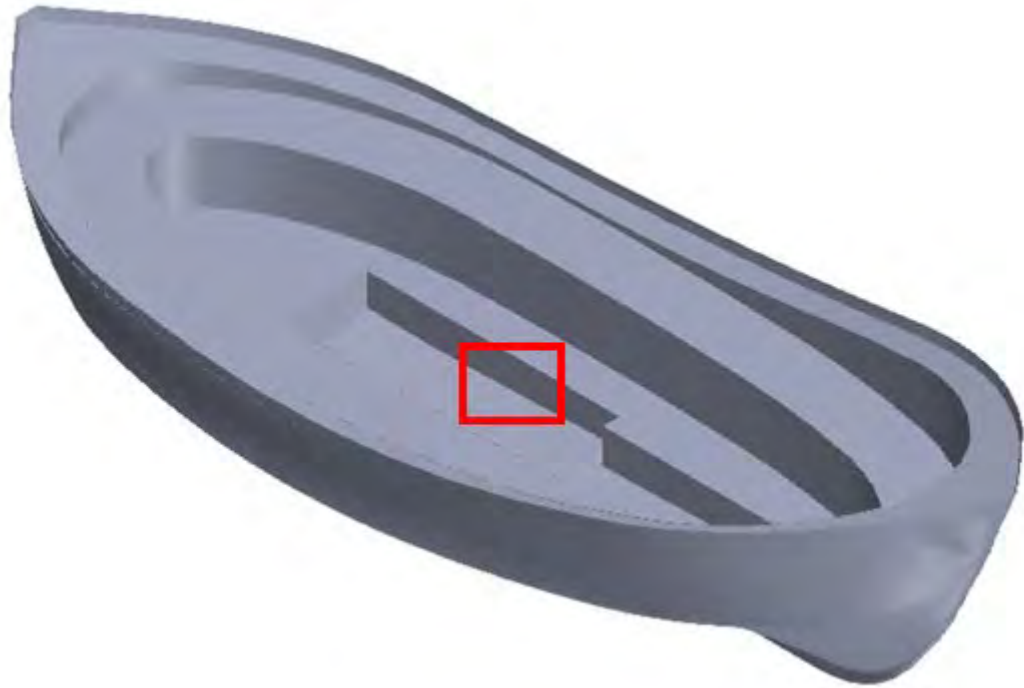
Figure 44. 3D representation of the approximate location of Sample C-1. The crack observed was located at the interior of boat at the fiberglass-engine mount interface.

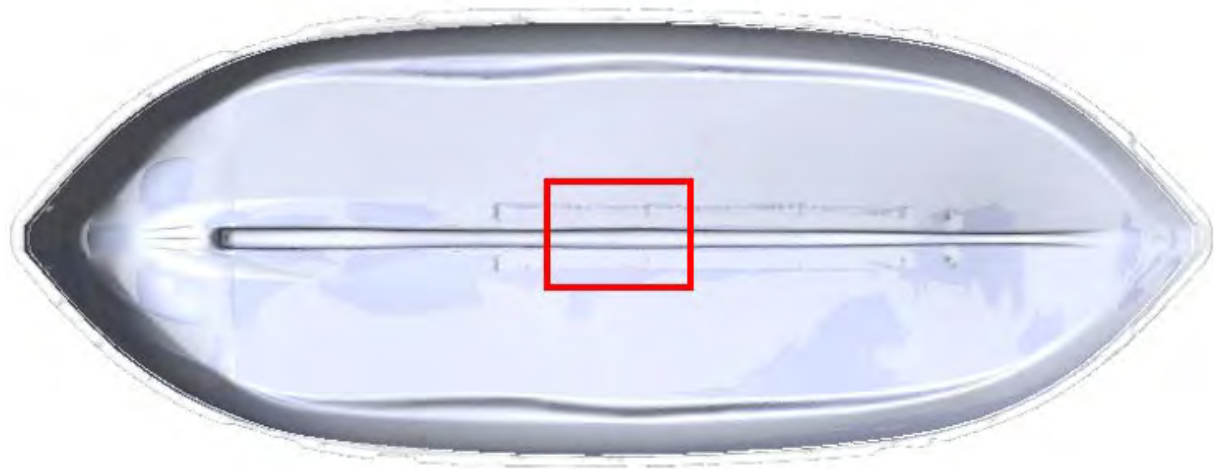
Figure 45. 3D representation of the approximate location of Sample C-2. The crack observed was located at the exterior of the hull on the keel of the boat. The crack propagated through the thickness of the keel.

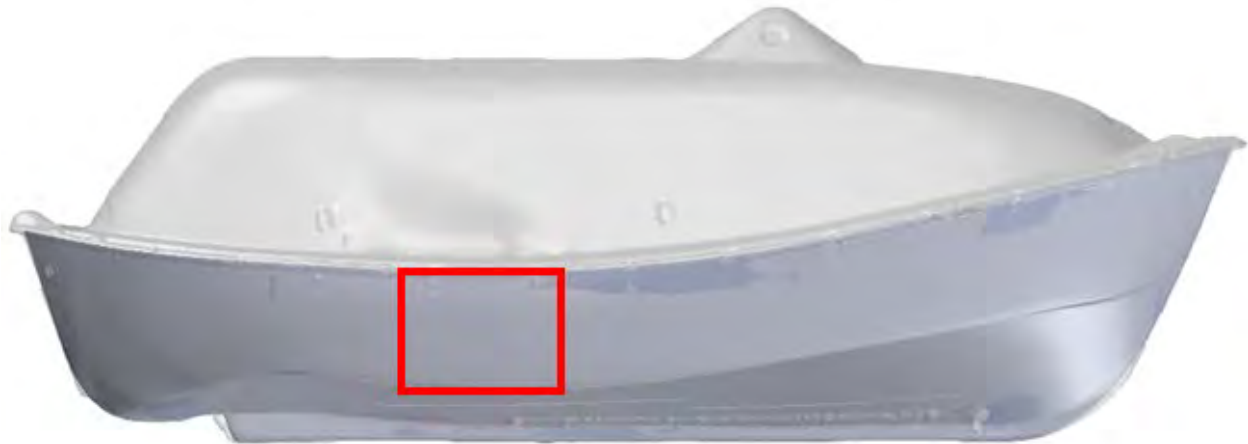
Figure 46. 3D representation of the approximate location of Sample C-3. The crack observed was located at the exterior of the hull on the starboard side. The crack ran from the hull-canopy interface towards the keel.

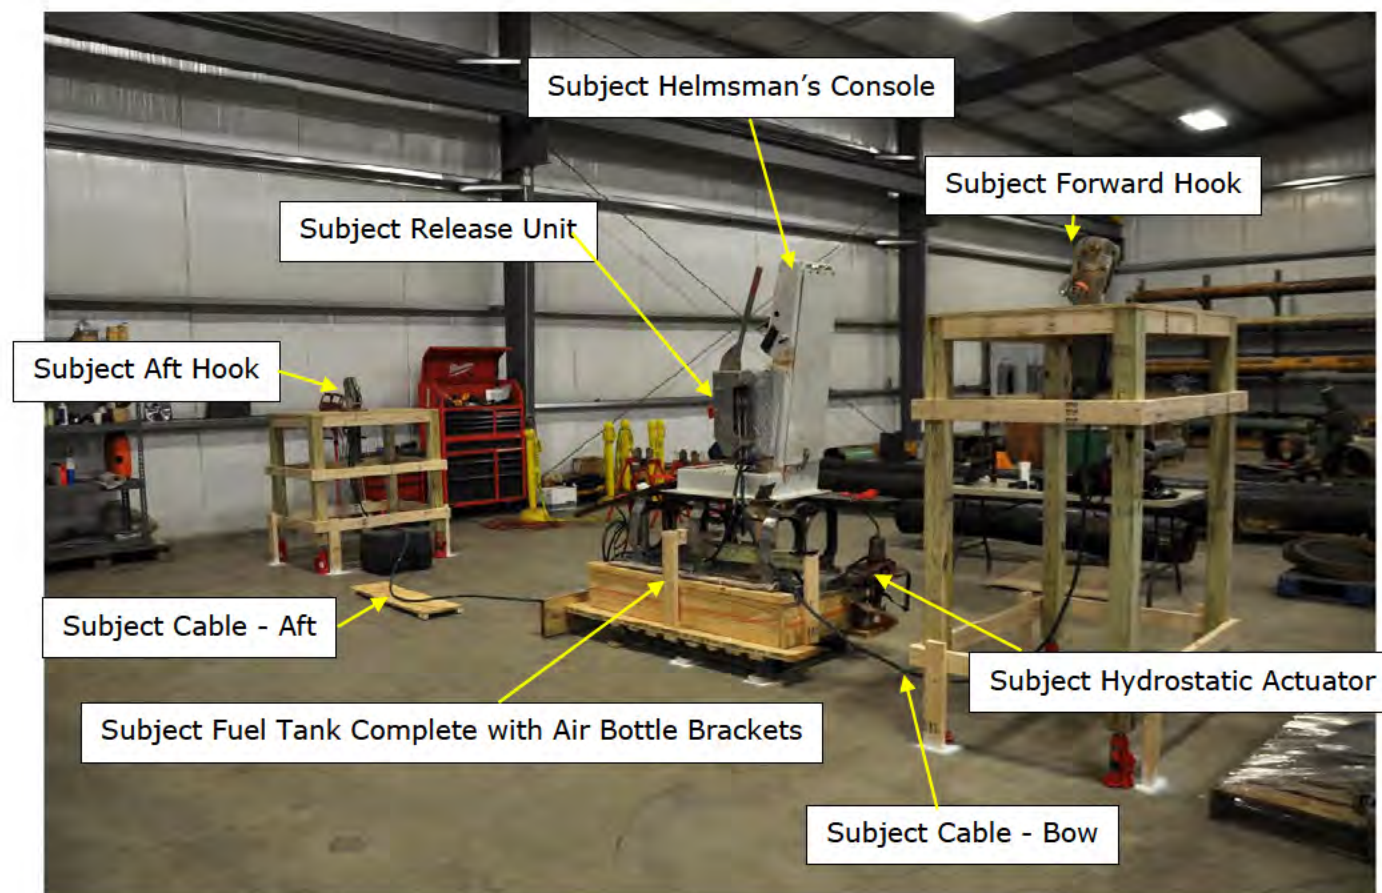
Figure 47. Photograph of the reconstruction of the relevant components from Lifeboat 6 located at DNV GL's warehouse.

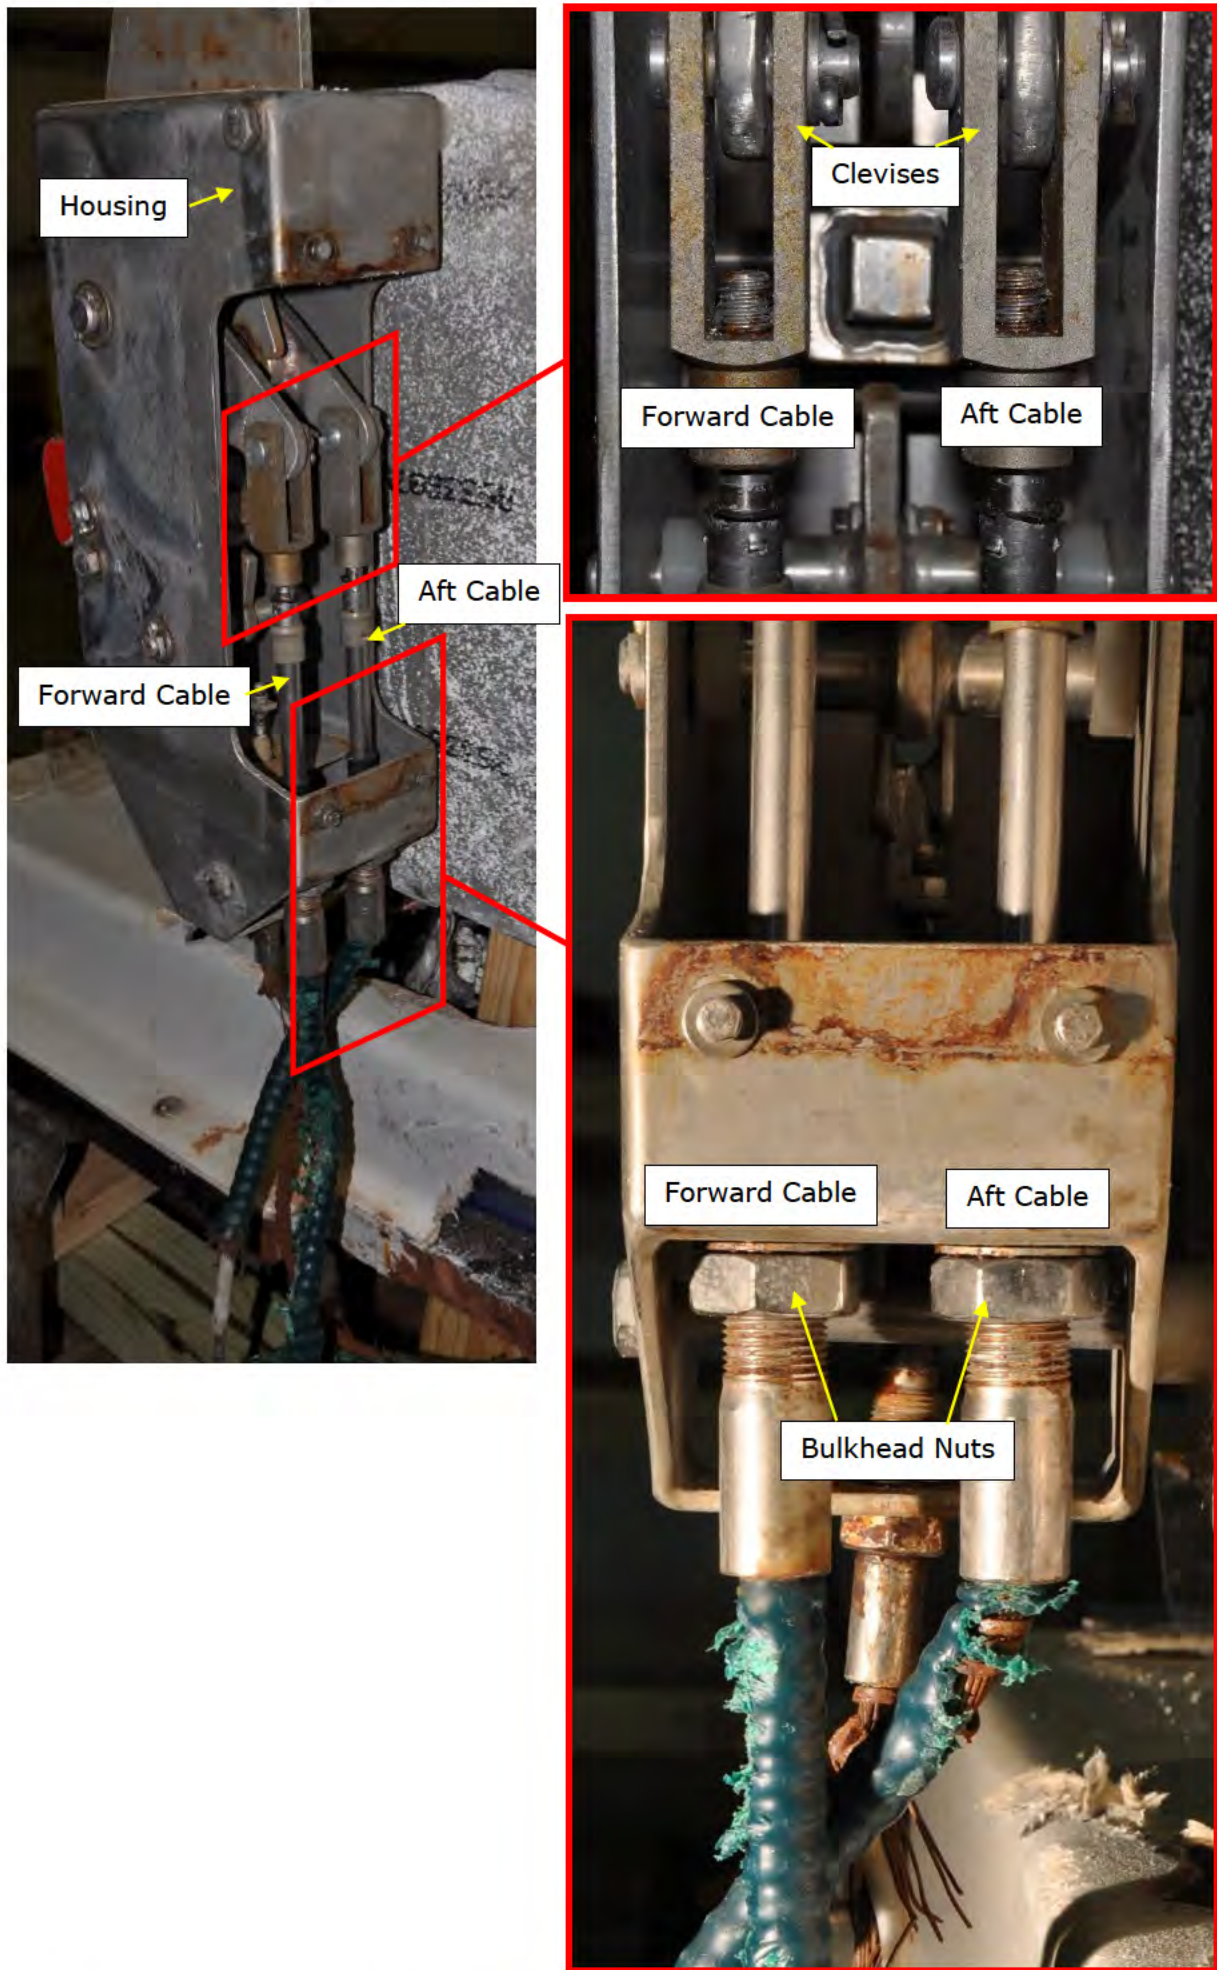
Figure 54. Photographs of the Subject Release Unit at DNV GL showing the as-found condition of the clevises and bulkhead nuts, after removing the protective coverings.

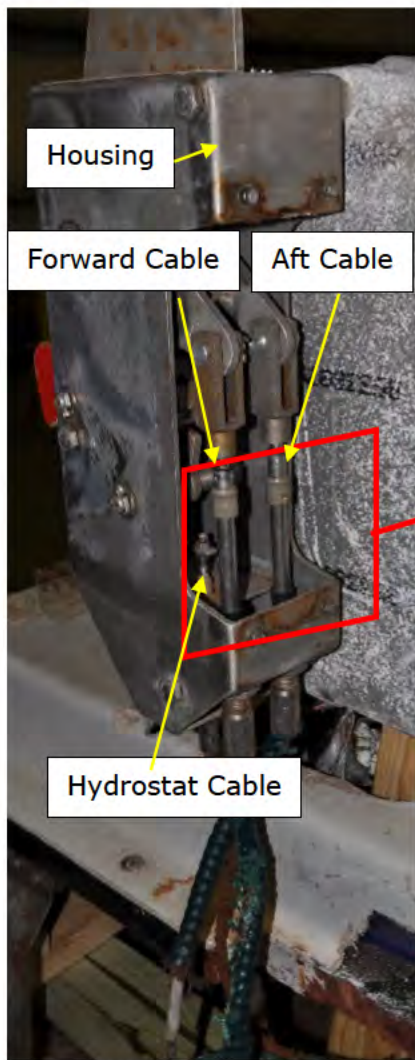
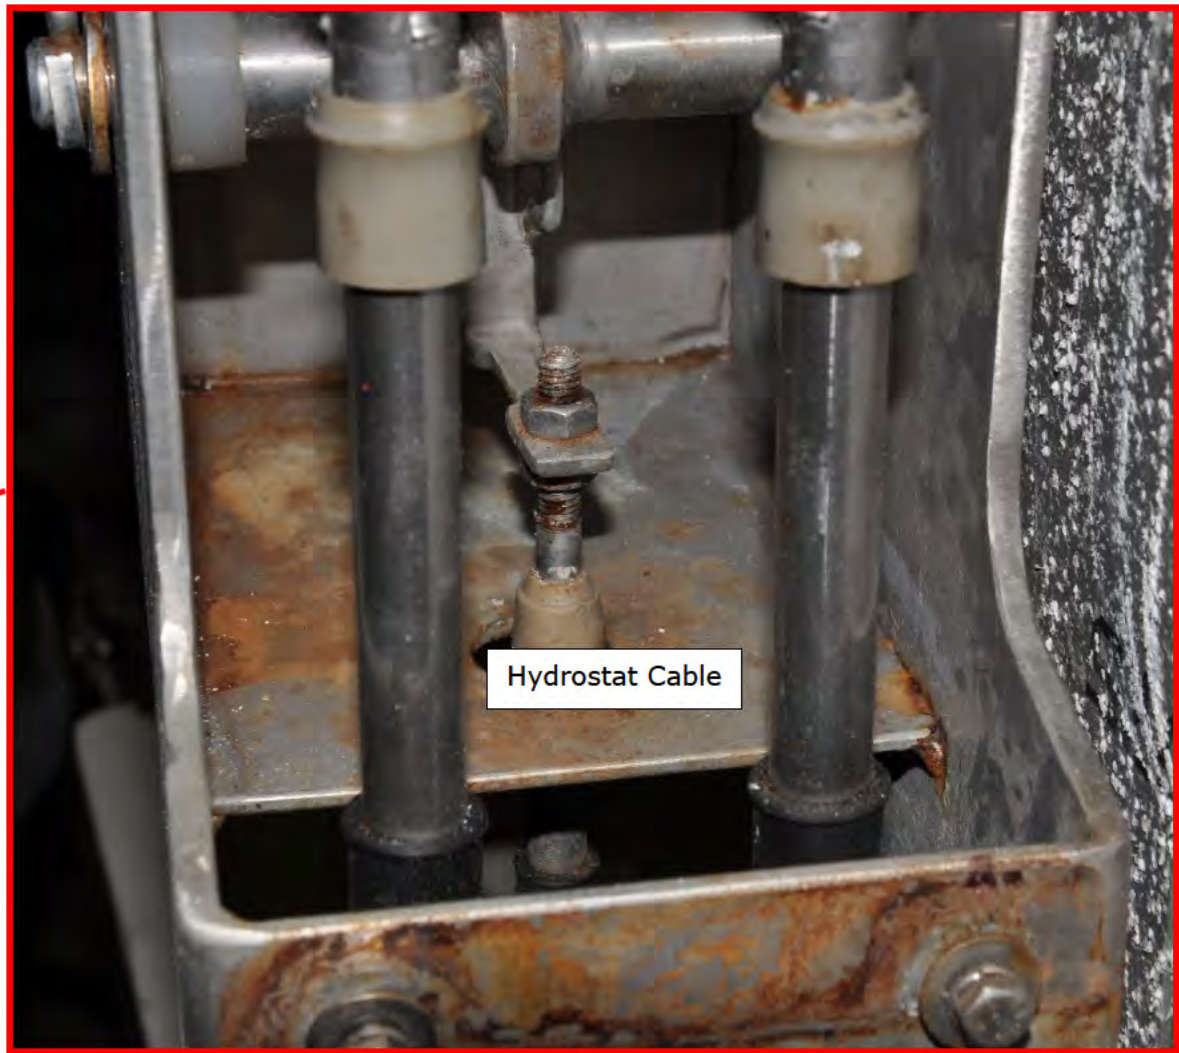
Figure 55. Photographs of the Subject Release Unit at DNV GL showing the as-found condition of the hydrostat cable and end rod jam nuts, after removing the protective coverings.
