Final Report

Auger Lifeboat 6 Incident

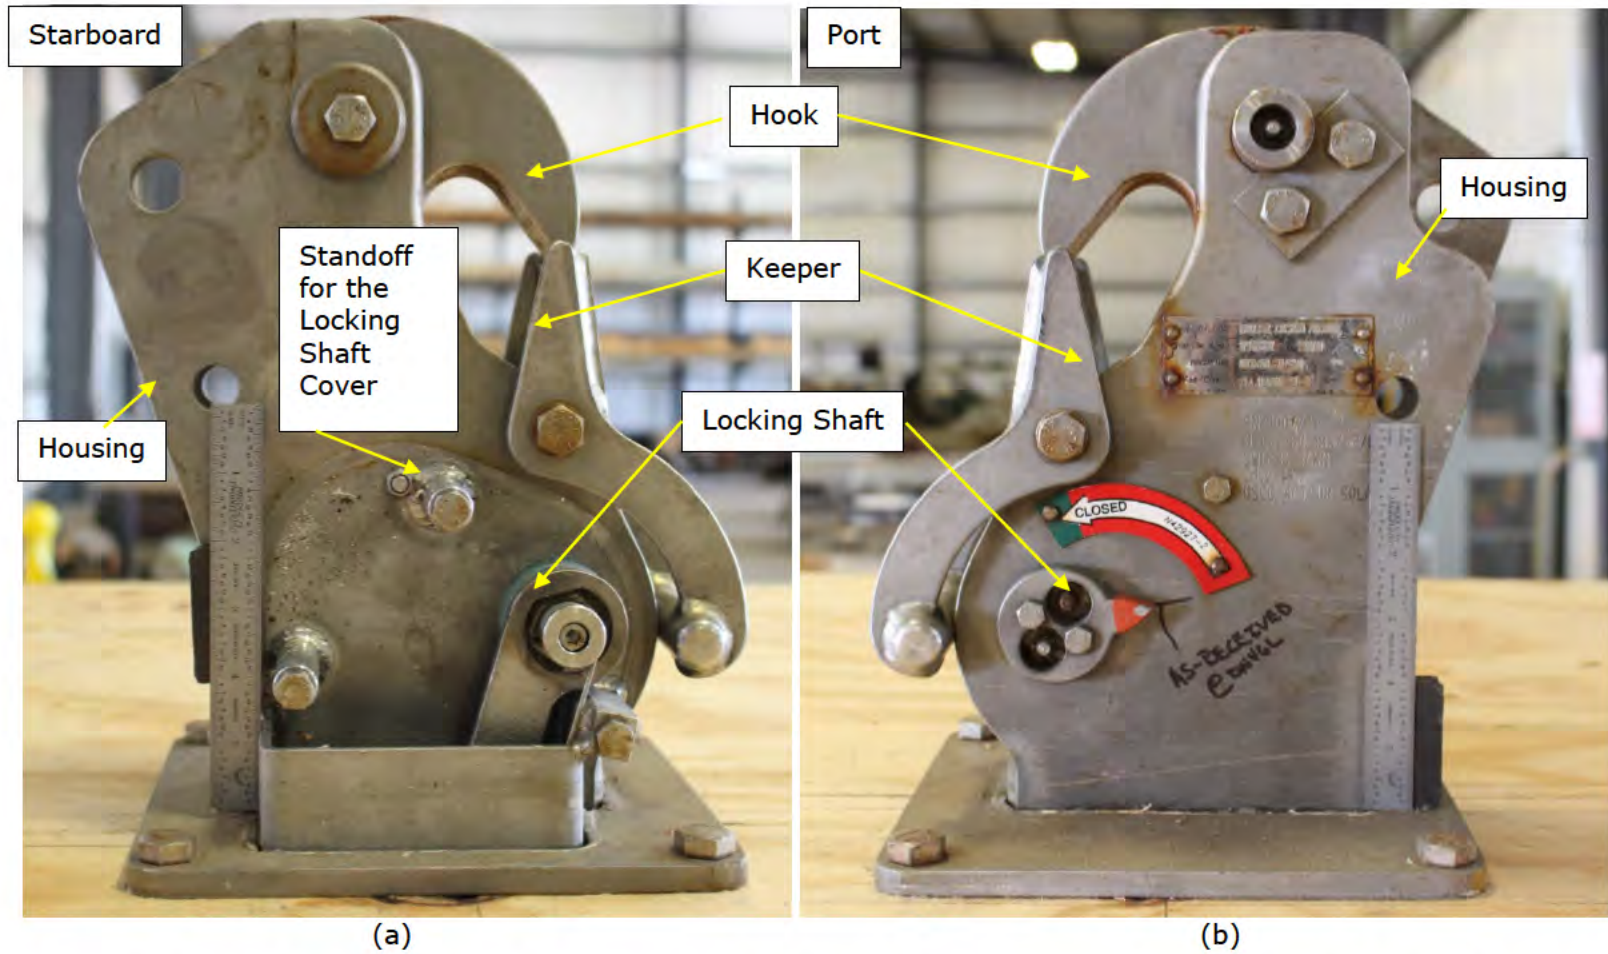
Figure 56. Photographs of the Subject Aft Hook with the locking shaft cover removed, viewed from (a) the starboard side and (b) the port side. Ruler is in inches.

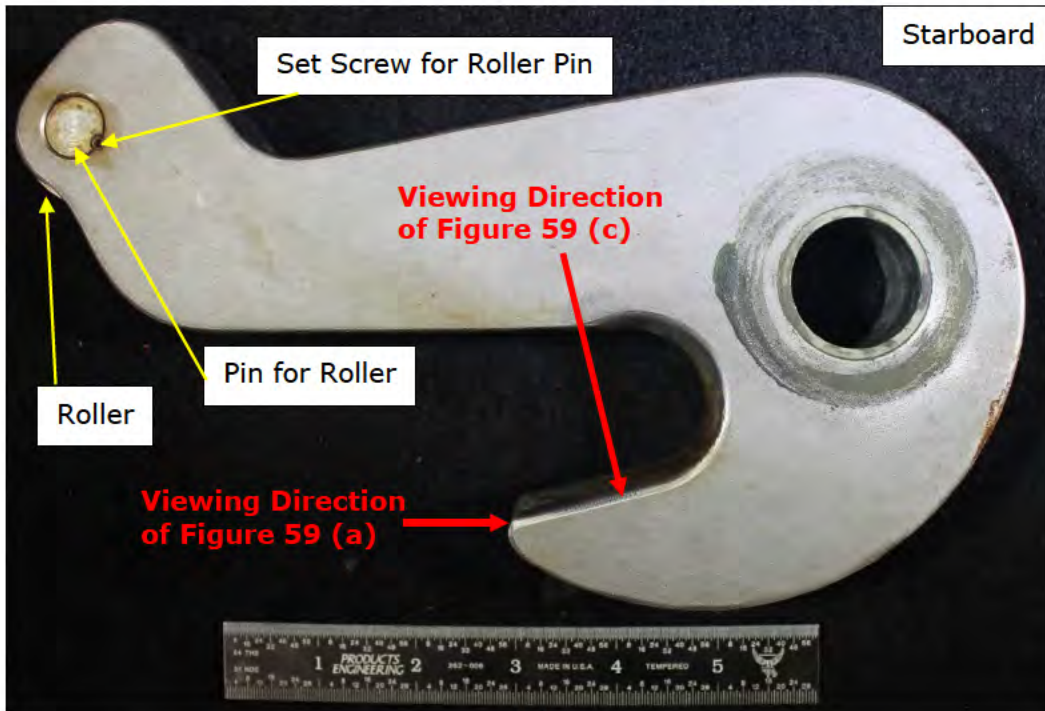
Figure 57. Photographs showing the as-found condition of the threaded connections of the Subject Aft Hook (a) at the clevis and (b) at the bulkhead nuts; the locations of the clevis and bulkhead nuts are shown in Figure 14. Ruler in left image is in inches.

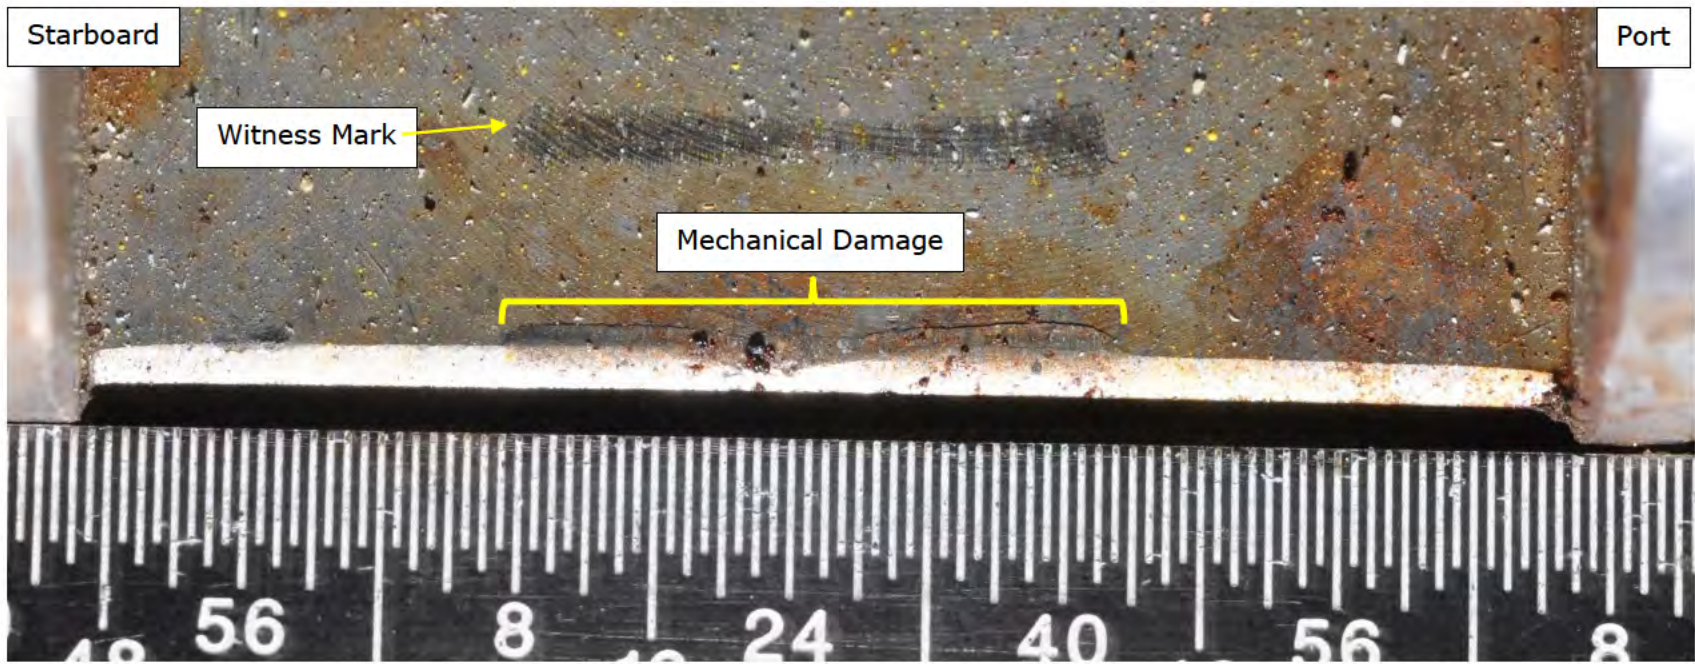
Figure 62. Photograph of the locking shaft from the Subject Aft Hook showing the mechanical damage on the edge between the round and the flat of the locking shaft. Ruler is in inches.

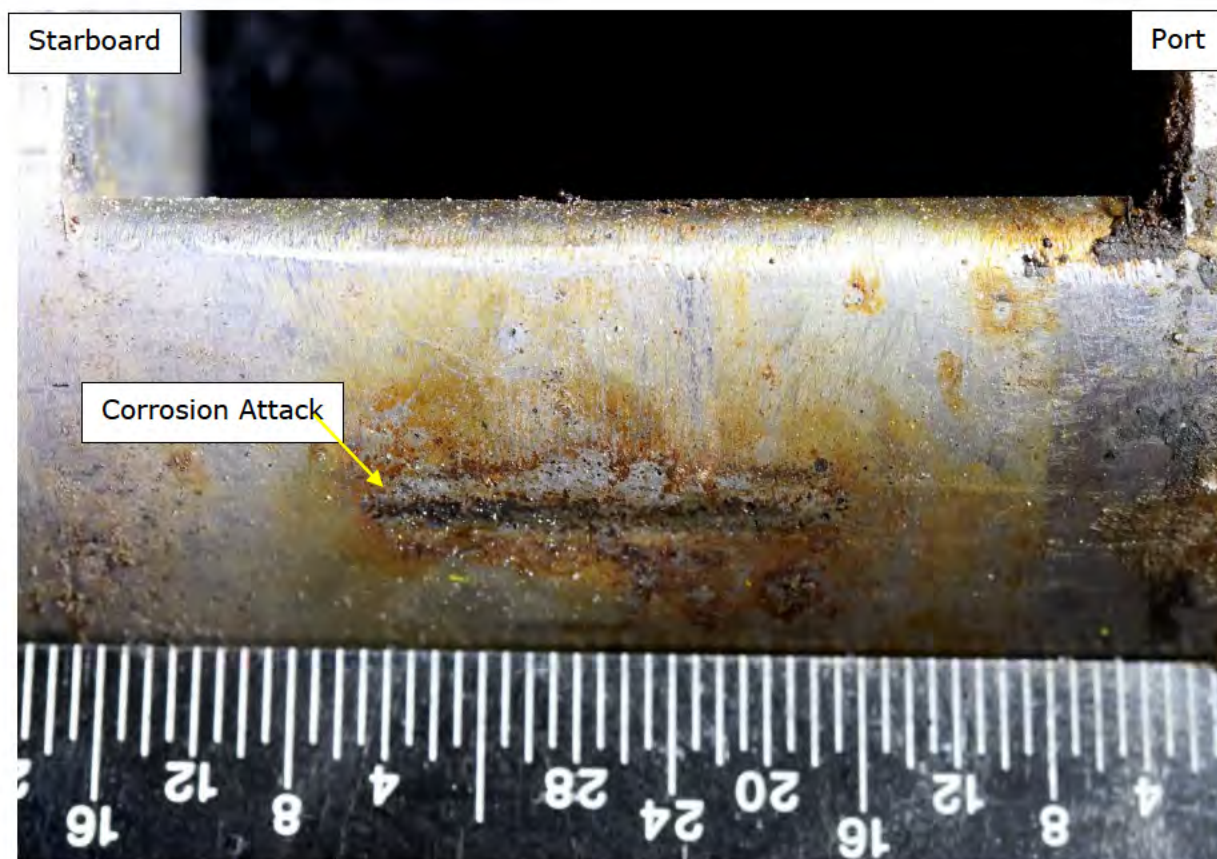
Figure 63. Photograph of the locking shaft from the Subject Aft Hook showing an area with corrosion attack on the round of the locking shaft. Ruler is in inches.

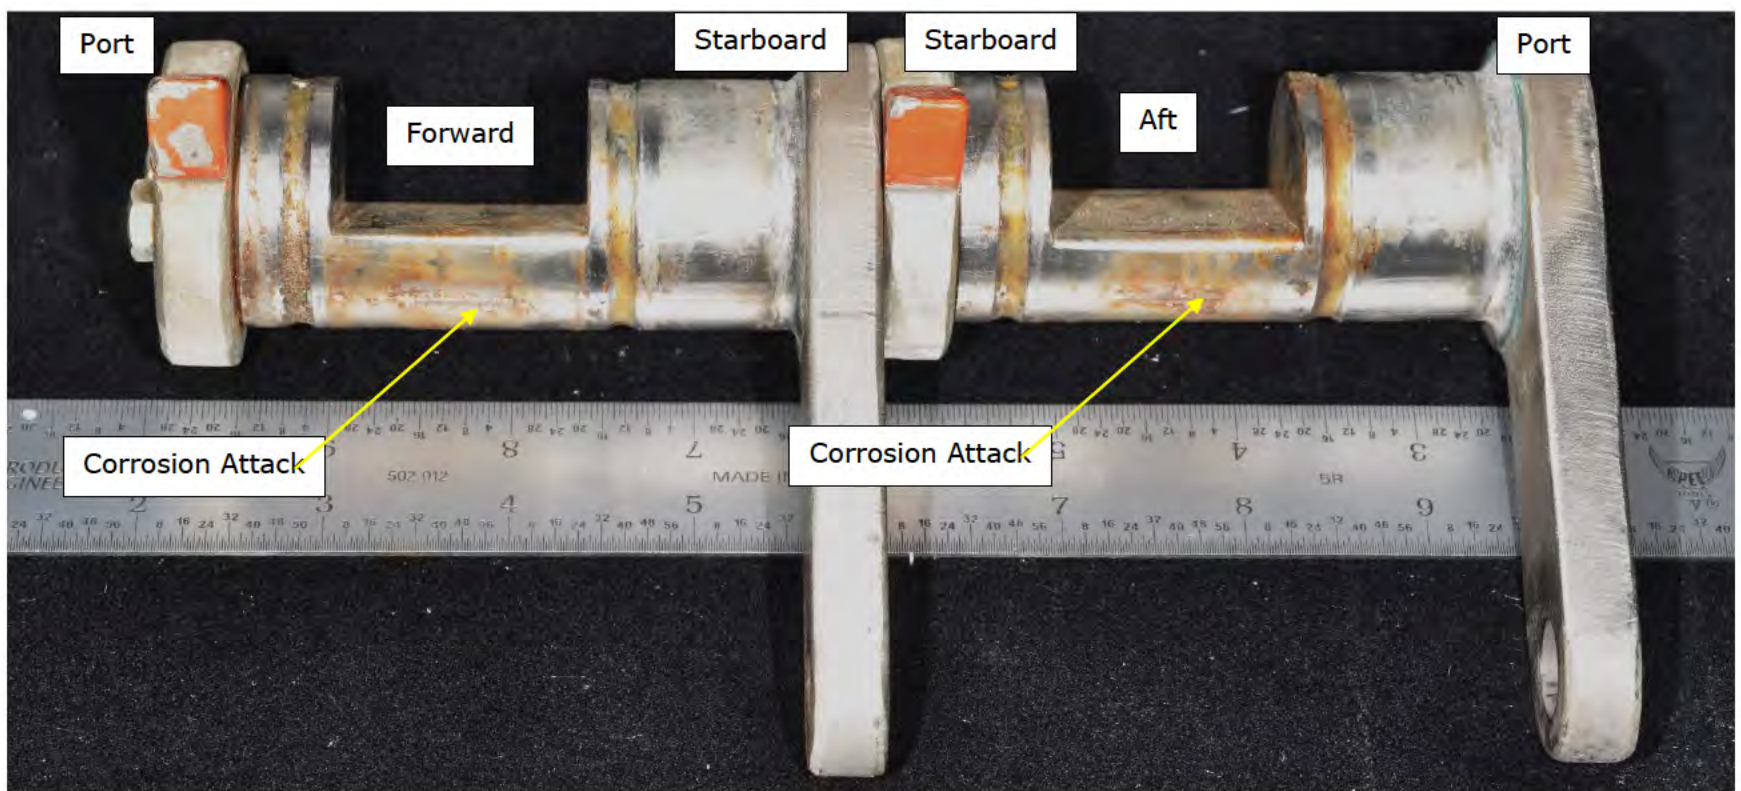
Figure 64. Photograph of the locking shaft from the Subject Forward and Aft Hooks comparing the areas of corrosion attack on the round of the locking shaft and comparing the overall geometry. Ruler is in inches.

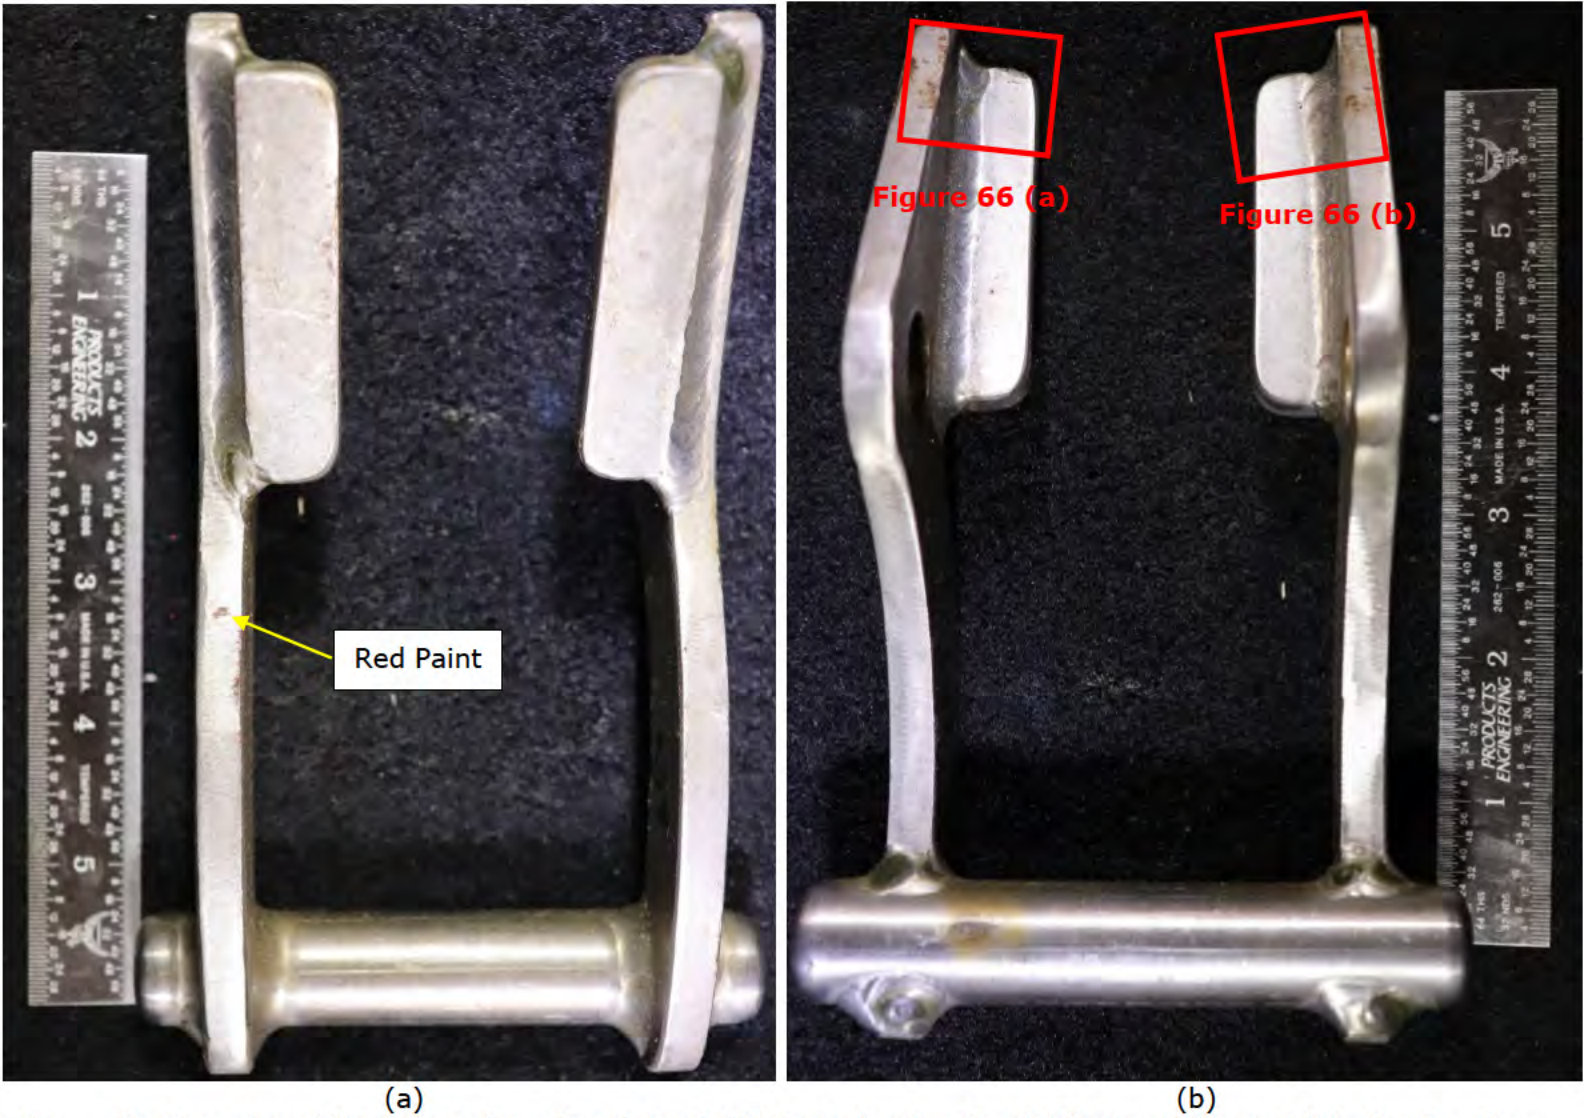
Figure 65. Photographs of the keeper from the Subject Aft Hook showing the (a) forward side and (b) aft side, after disassembly. Forward and aft refer to the orientation of the keeper relative to the lifeboat. Ruler is in inches.

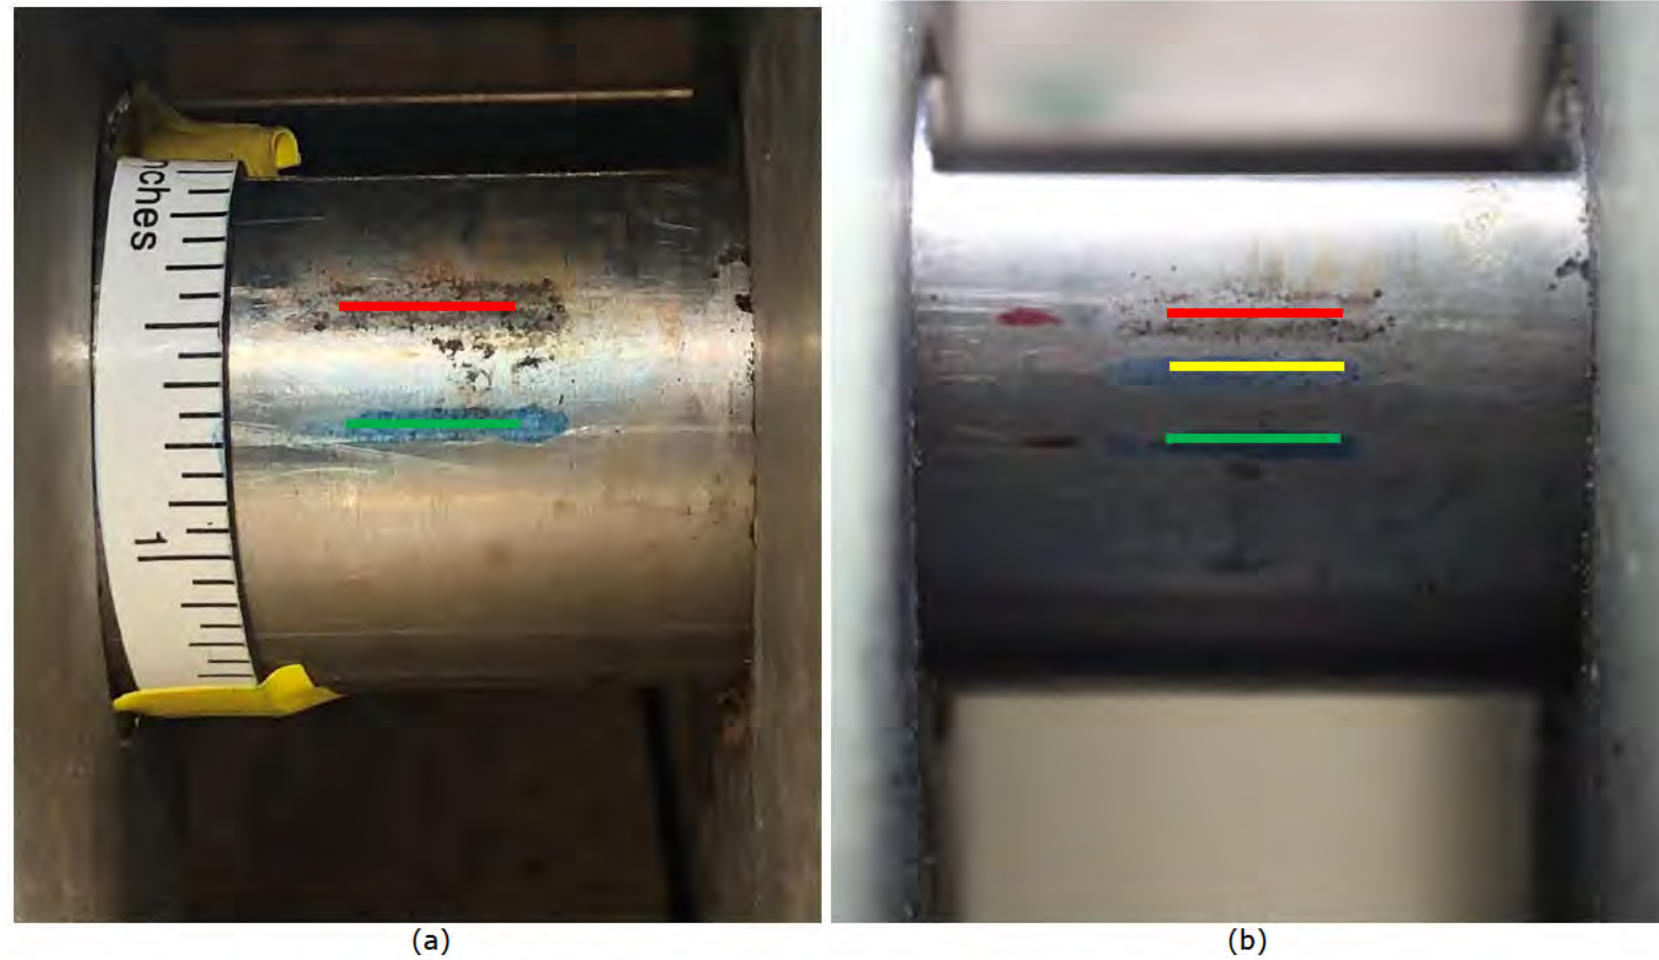
Figure 66. Photographs of the keeper from the Subject Aft Hook showing (a) a possible witness mark and (b) red paint; locations shown in Figure 65. Rulers are in inches.

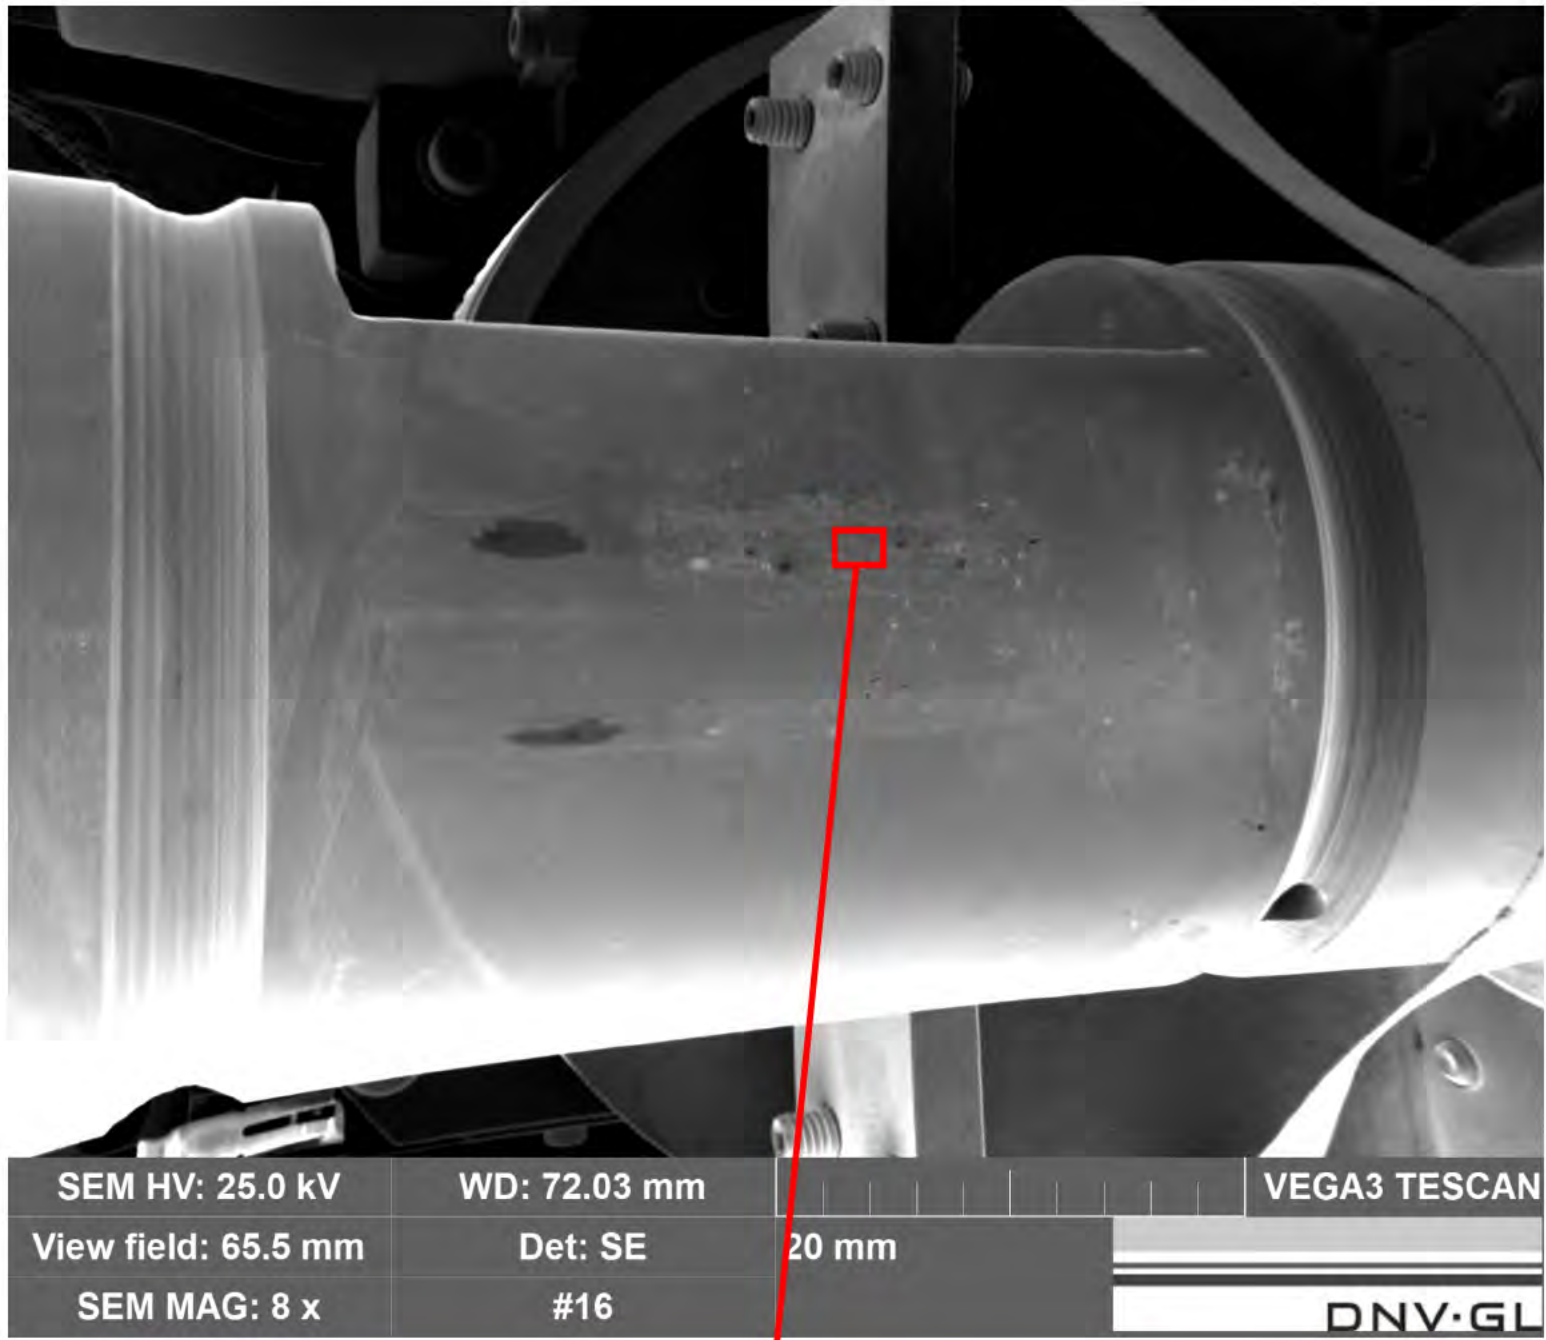
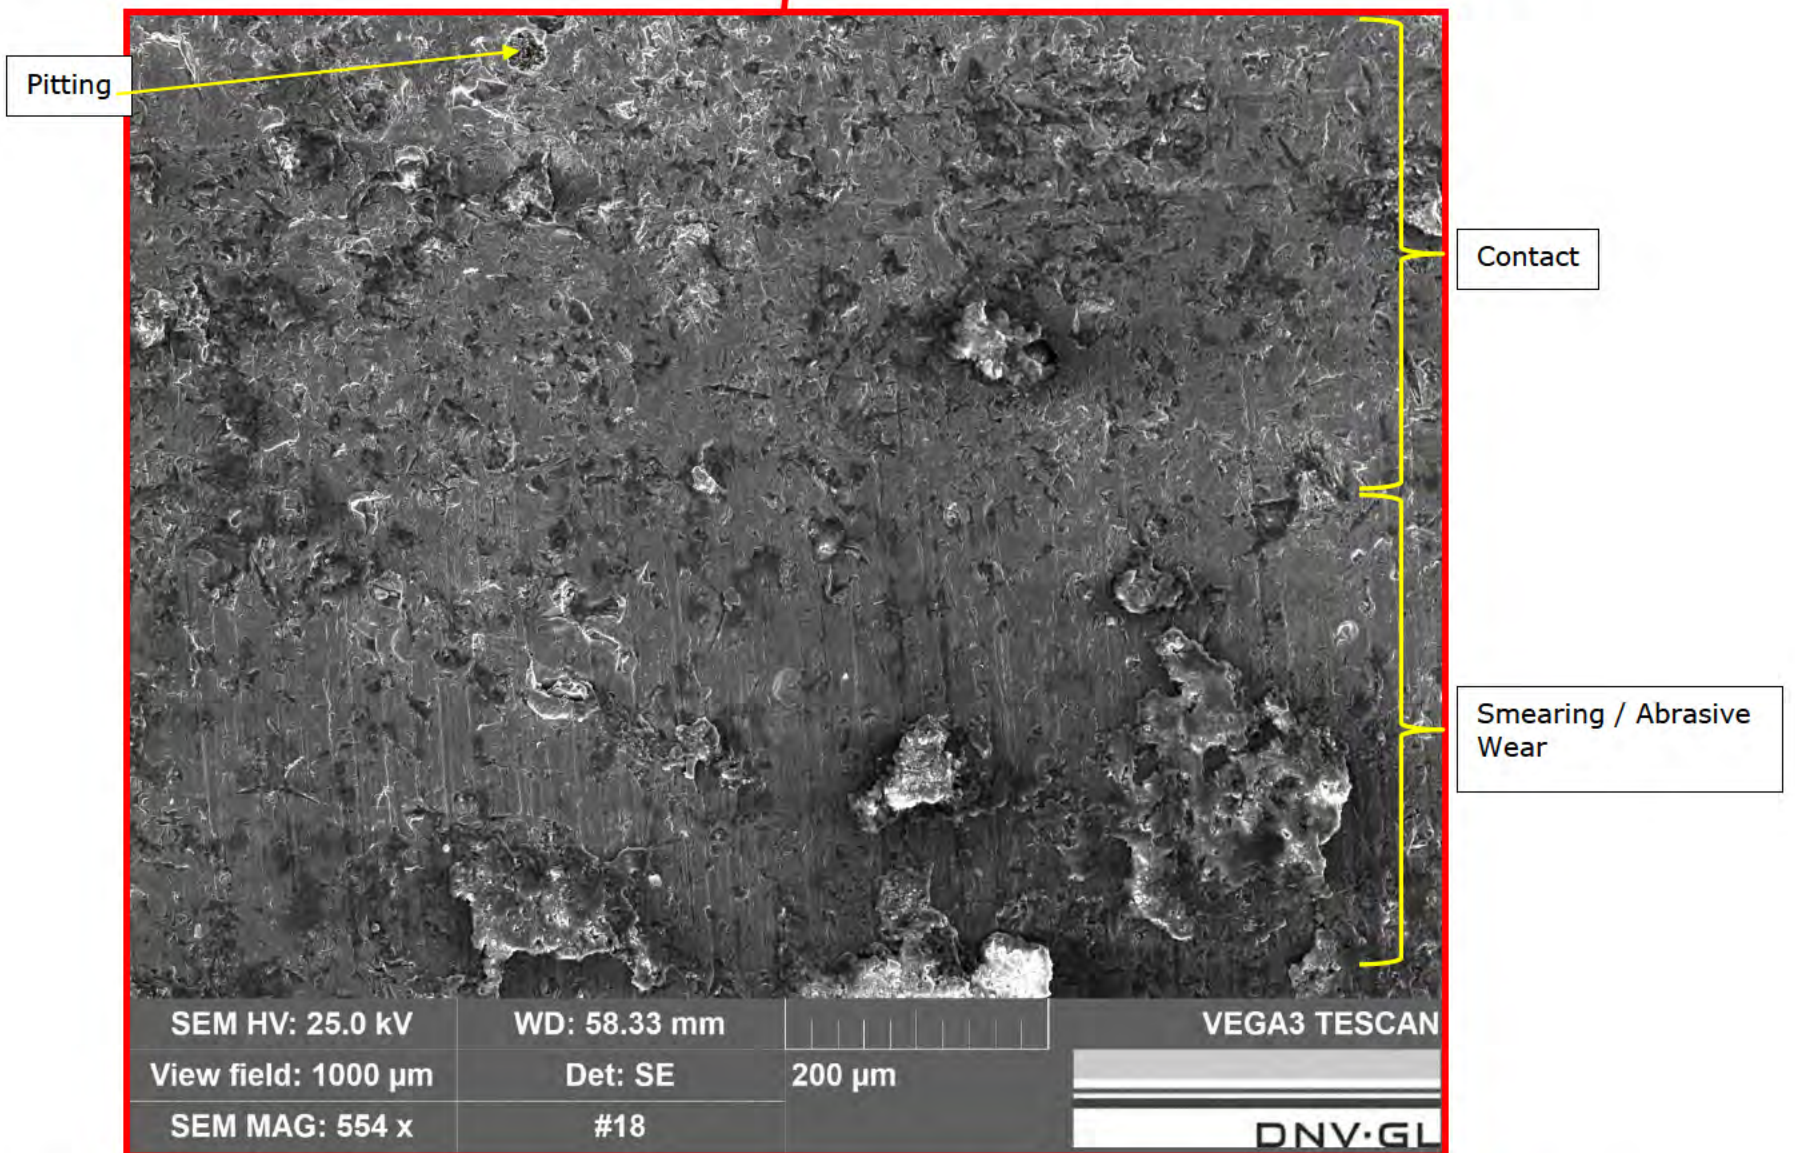
Figure 68. SEM images showing the detail for a suspected area of contact between the roller of the hook and locking shaft from the Subject Aft Hook.

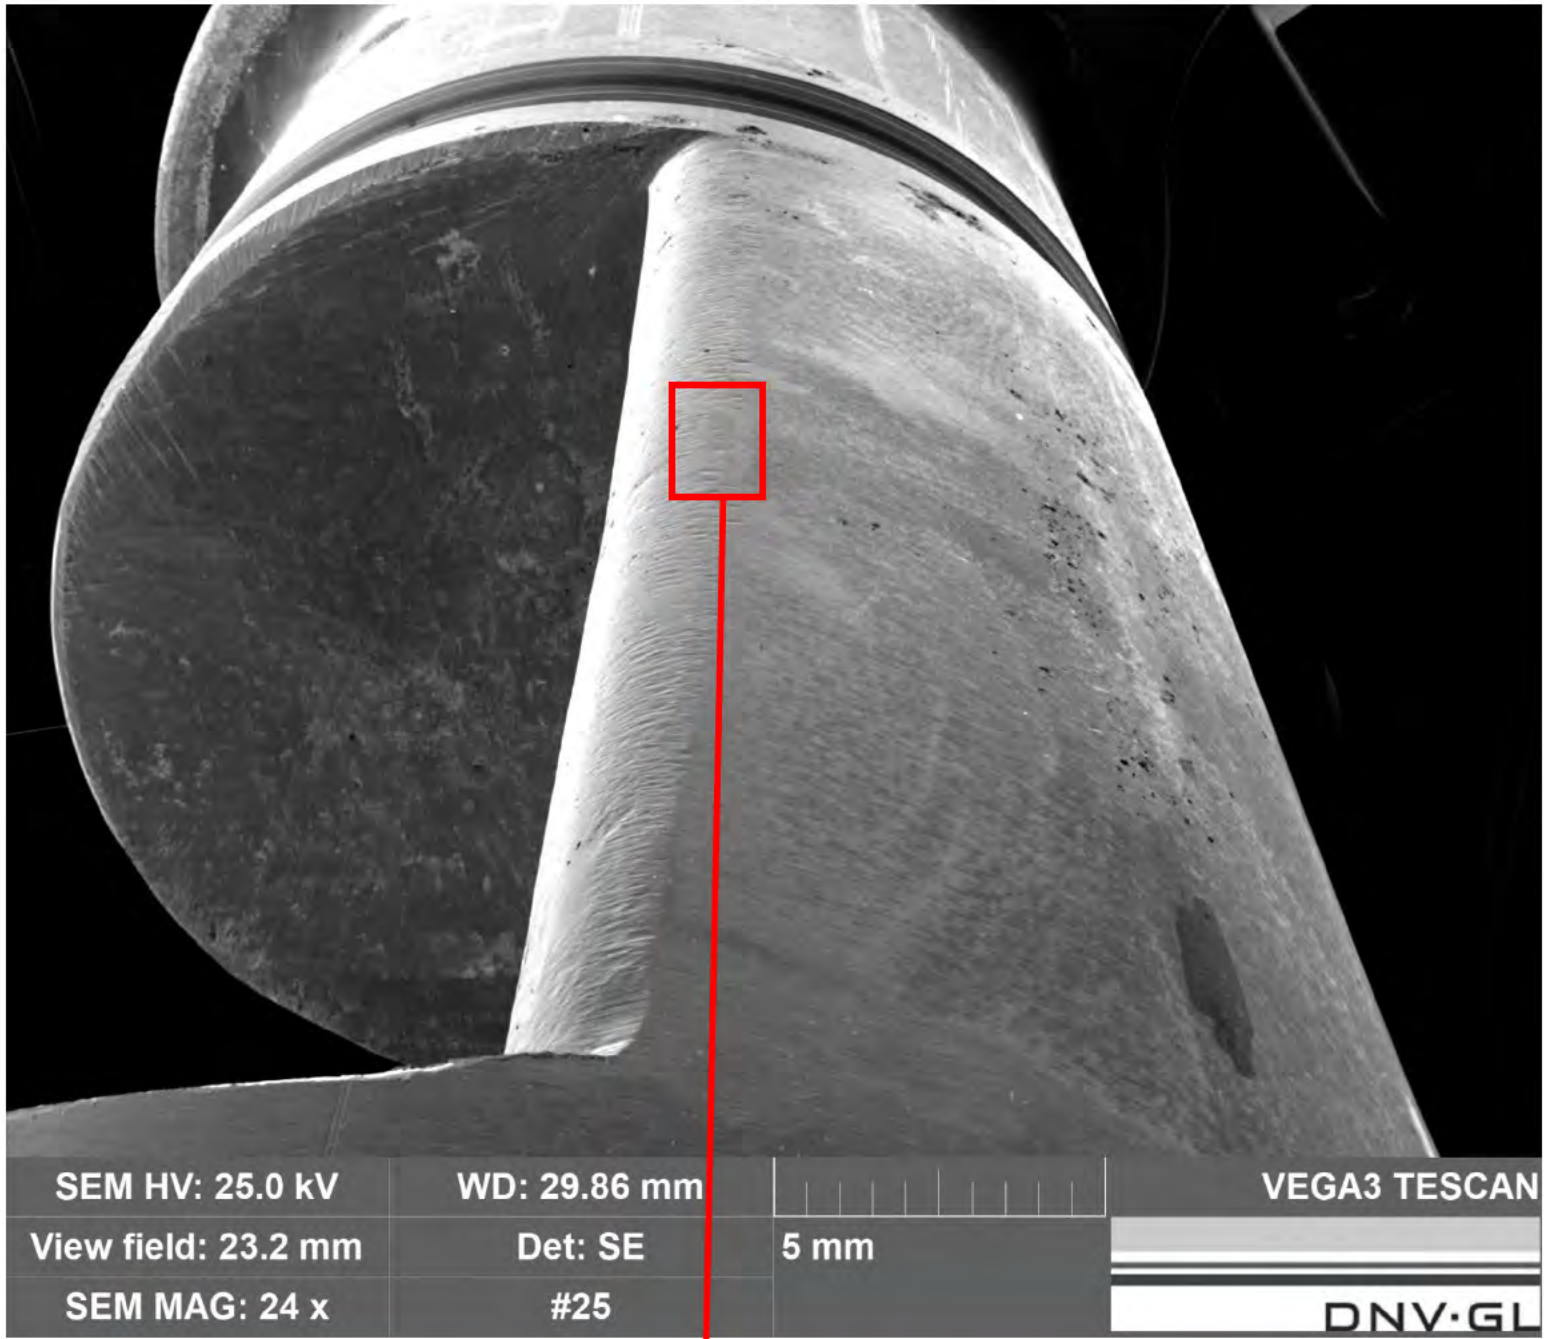
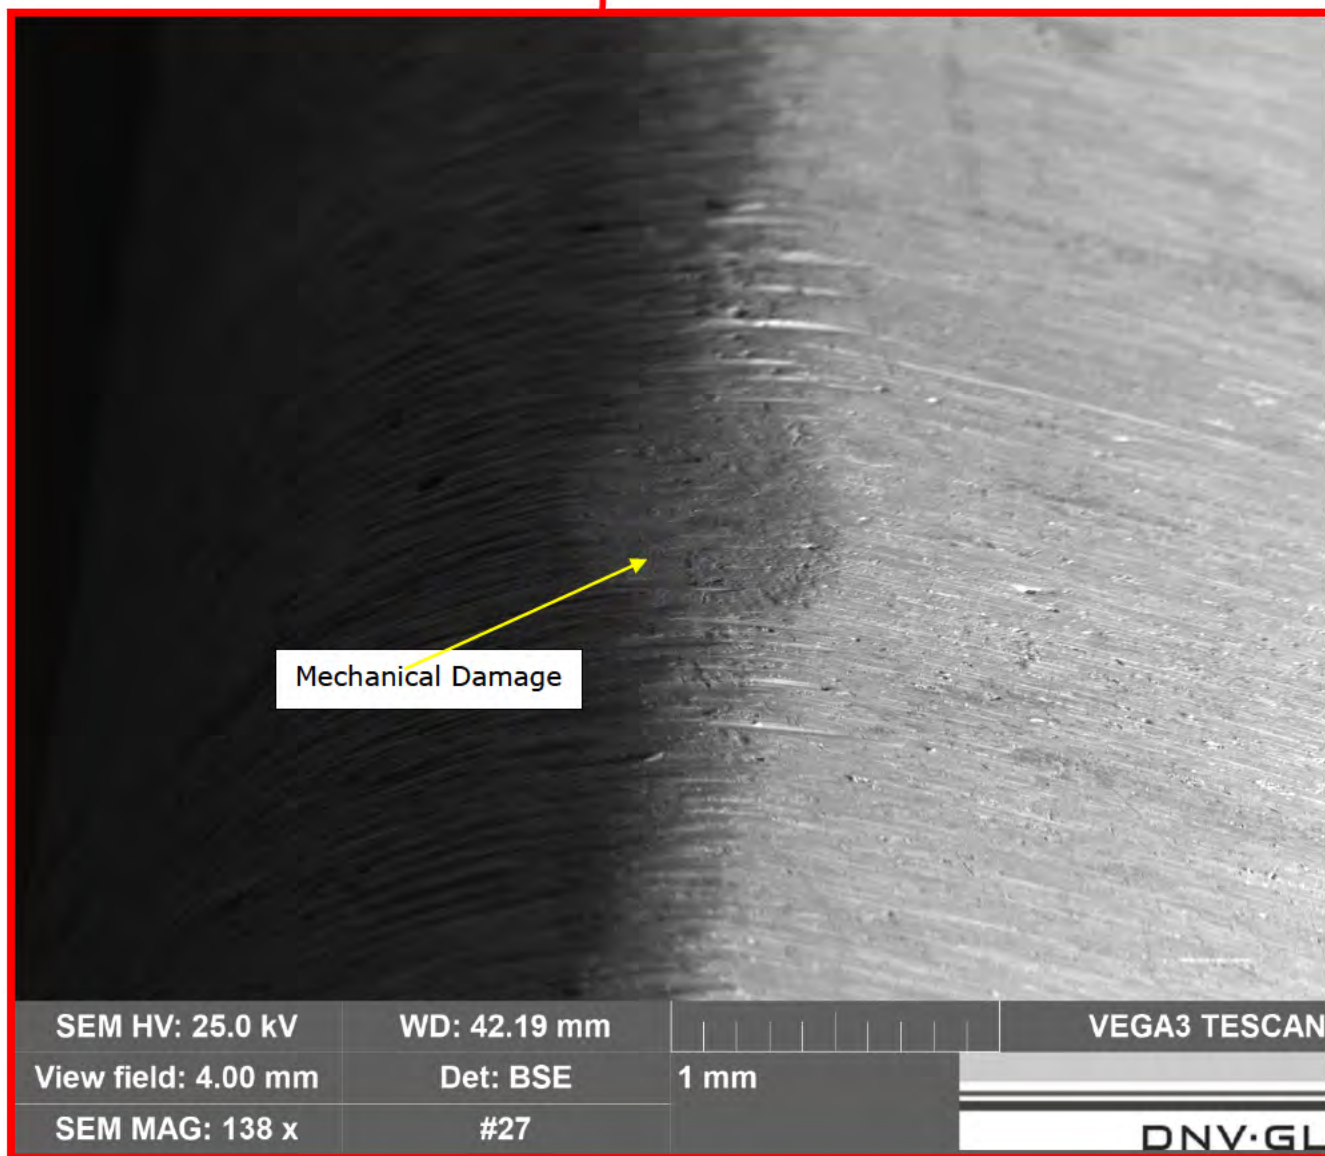
Figure 69. SEM images showing mechanical damage near the transition to the flat of the locking shaft from the Subject Aft Hook.

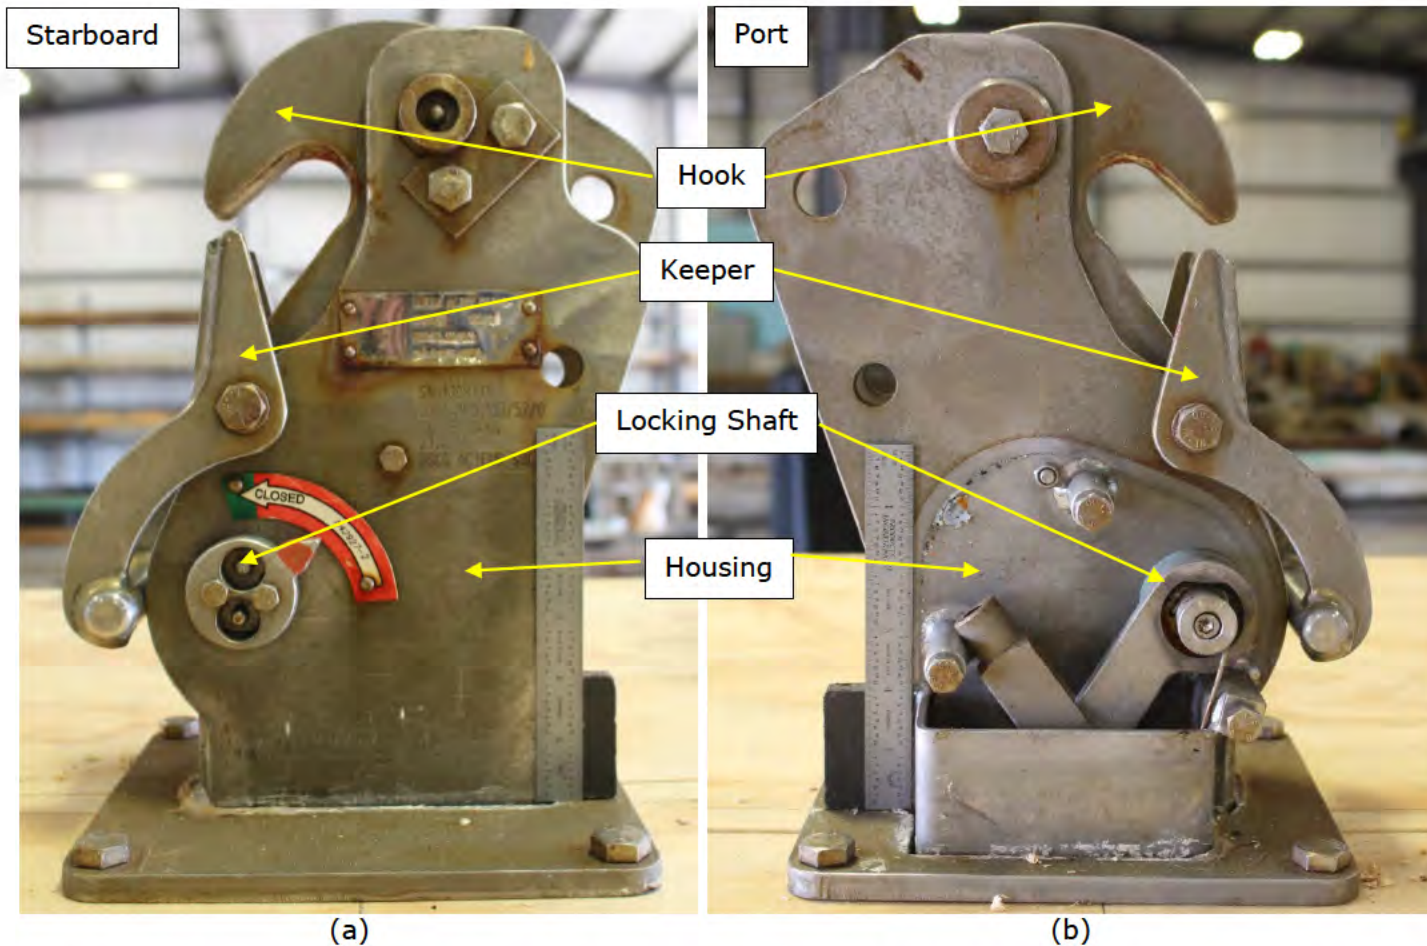
Figure 70. Photographs of the Subject Forward Hook with the locking shaft cover removed, viewed from (a) the starboard side and (b) the port side. Rulers are in inches.

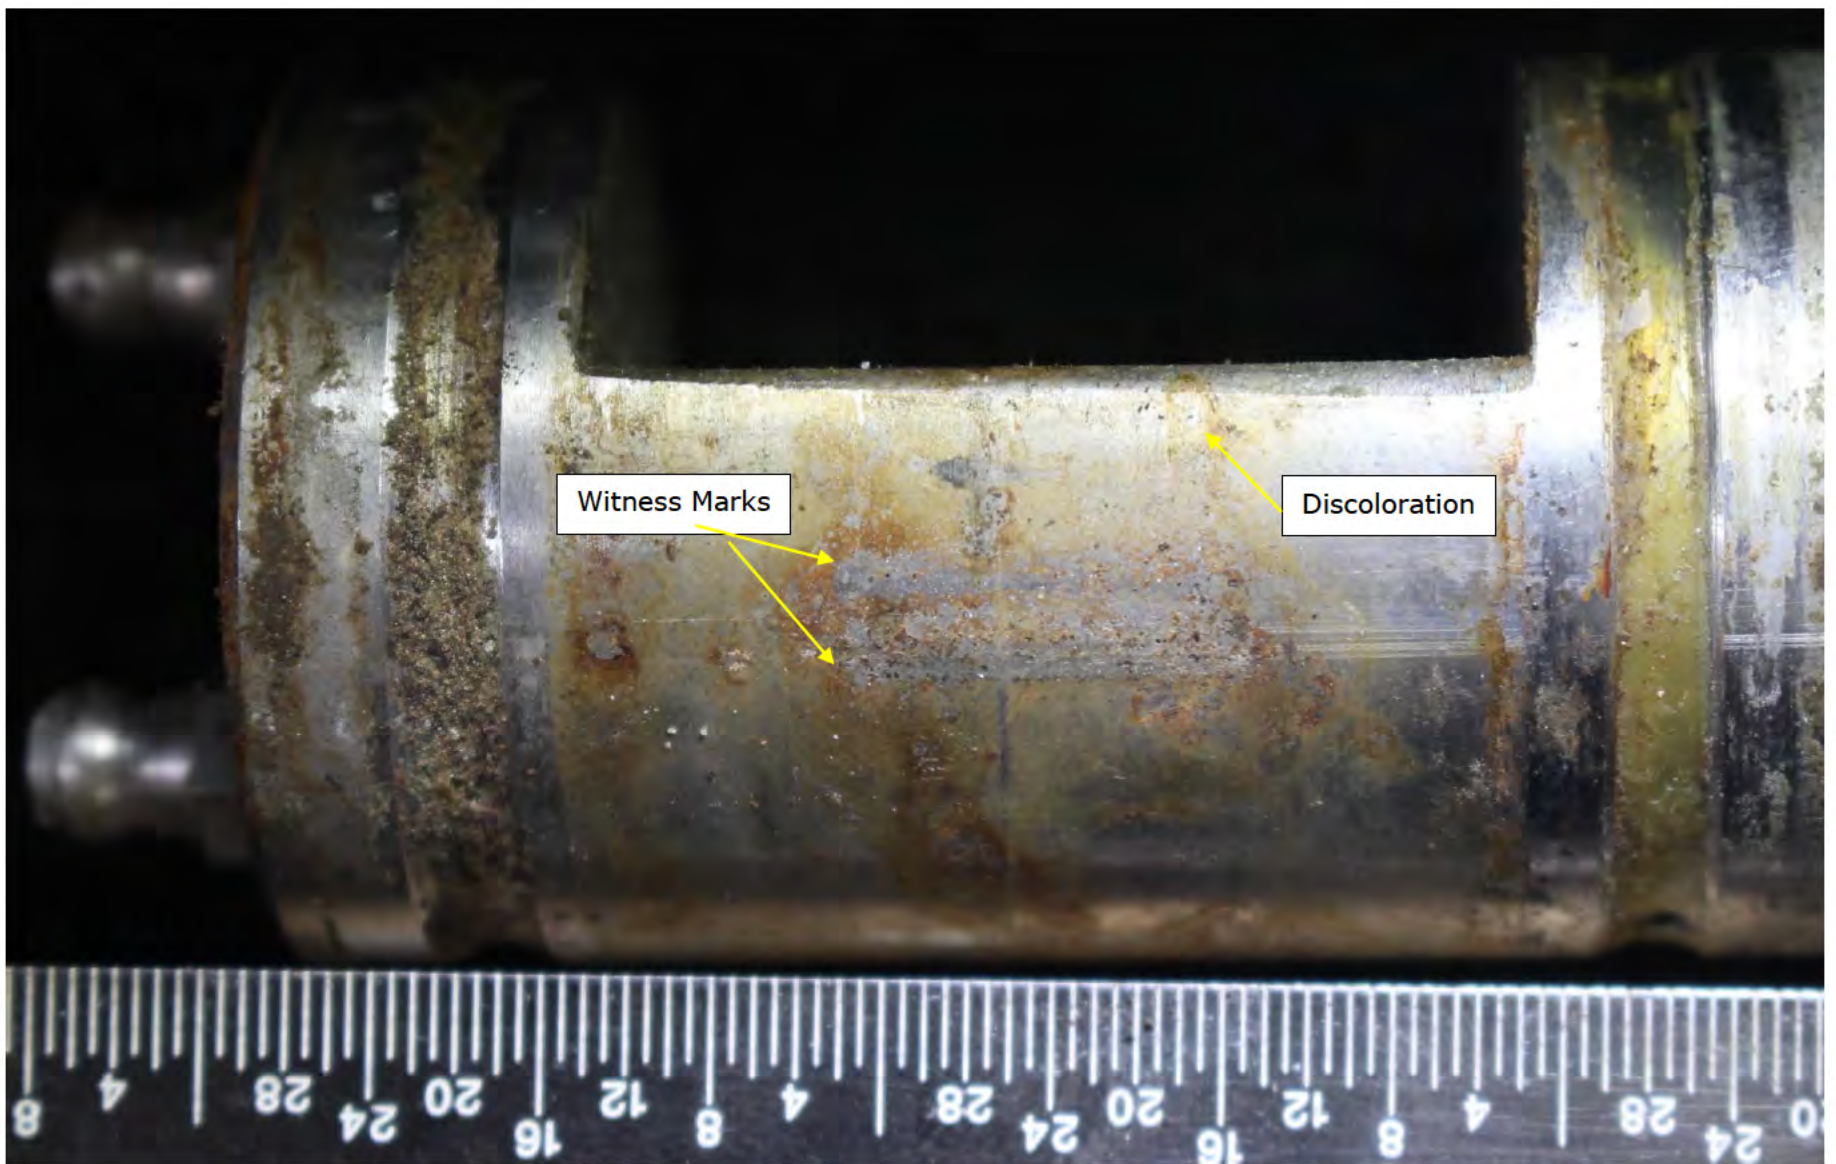
Figure 75. Photograph of the locking shaft from the Subject Forward Hook showing an area with corrosion attack on the round of the locking shaft; area shown in Figure 73. Ruler is in inches.

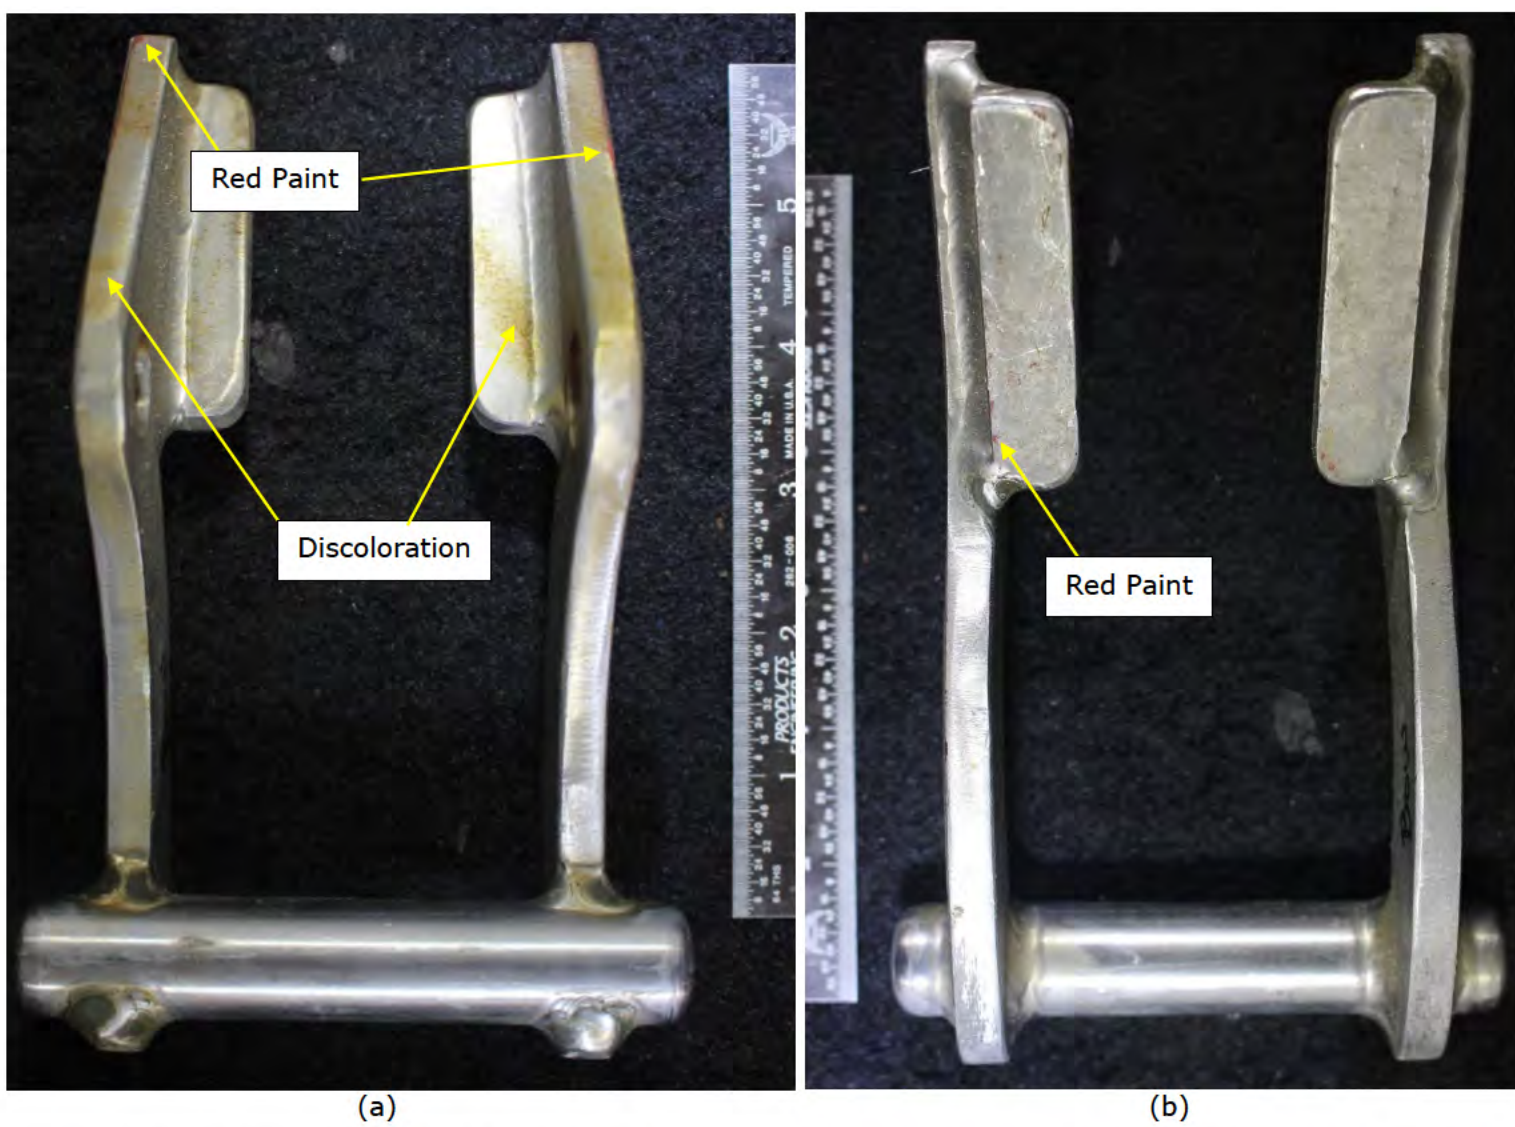
Figure 76. Photographs of the keeper from the Subject Forward Hook showing the (a) forward side and (b) aft side, after disassembly. Forward and aft refer to the orientation of the keeper relative to the lifeboat. Rulers are in inches.
