Final Report

Auger Lifeboat 6 Incident

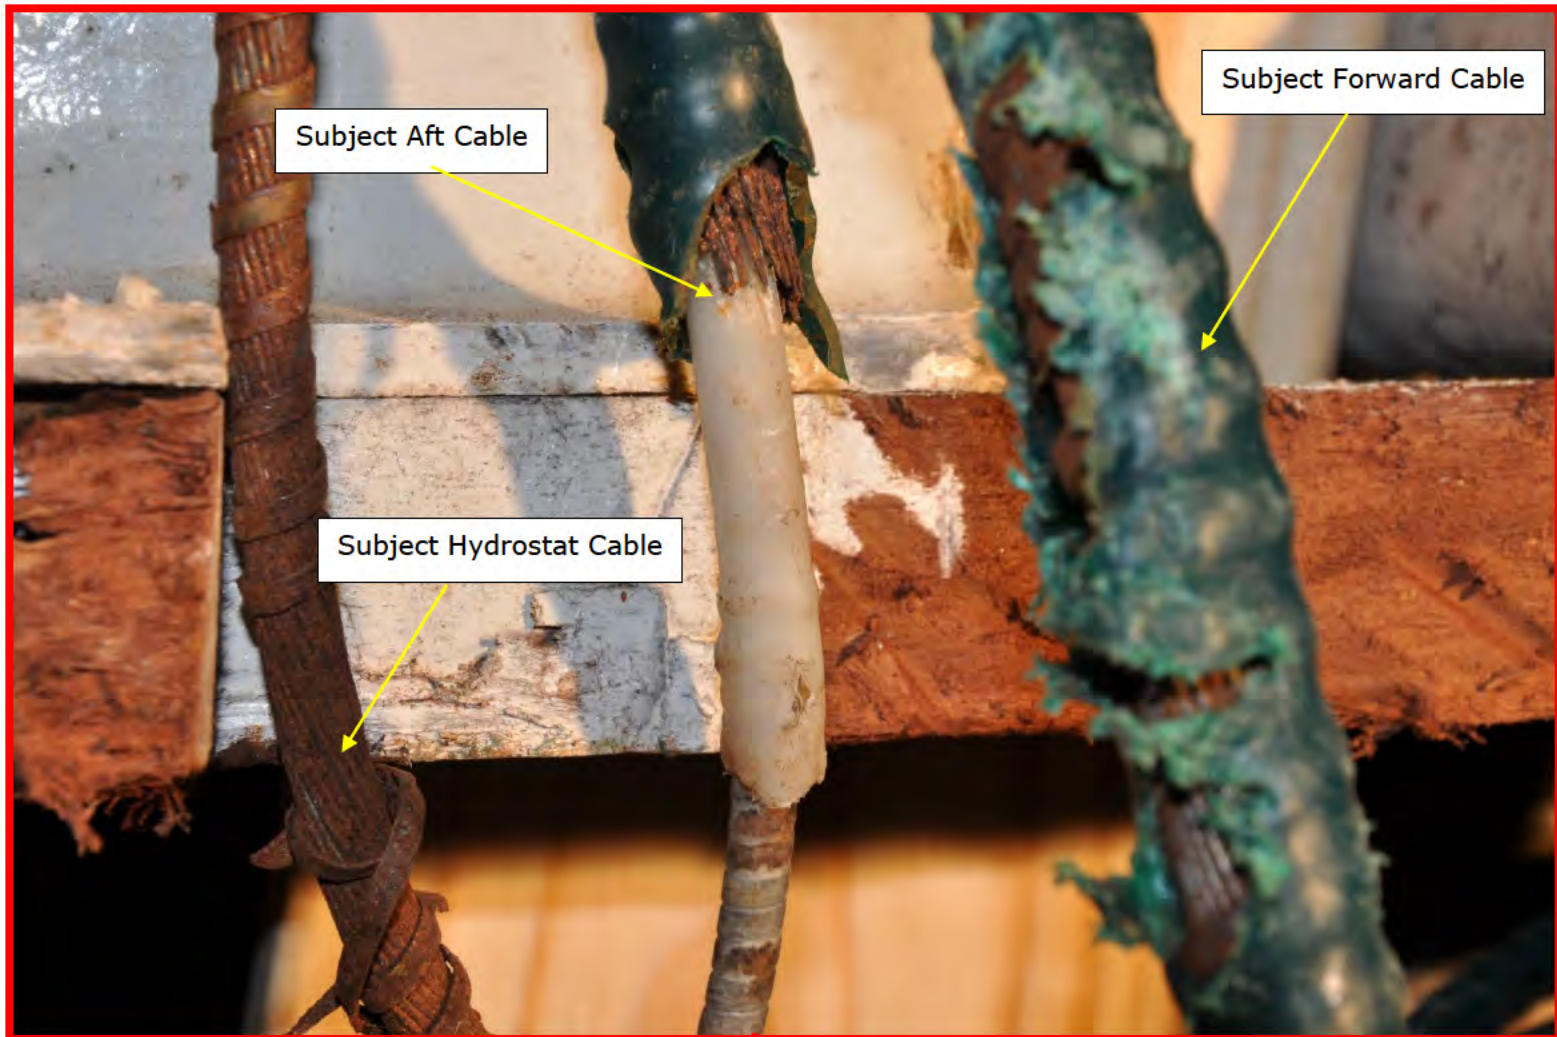
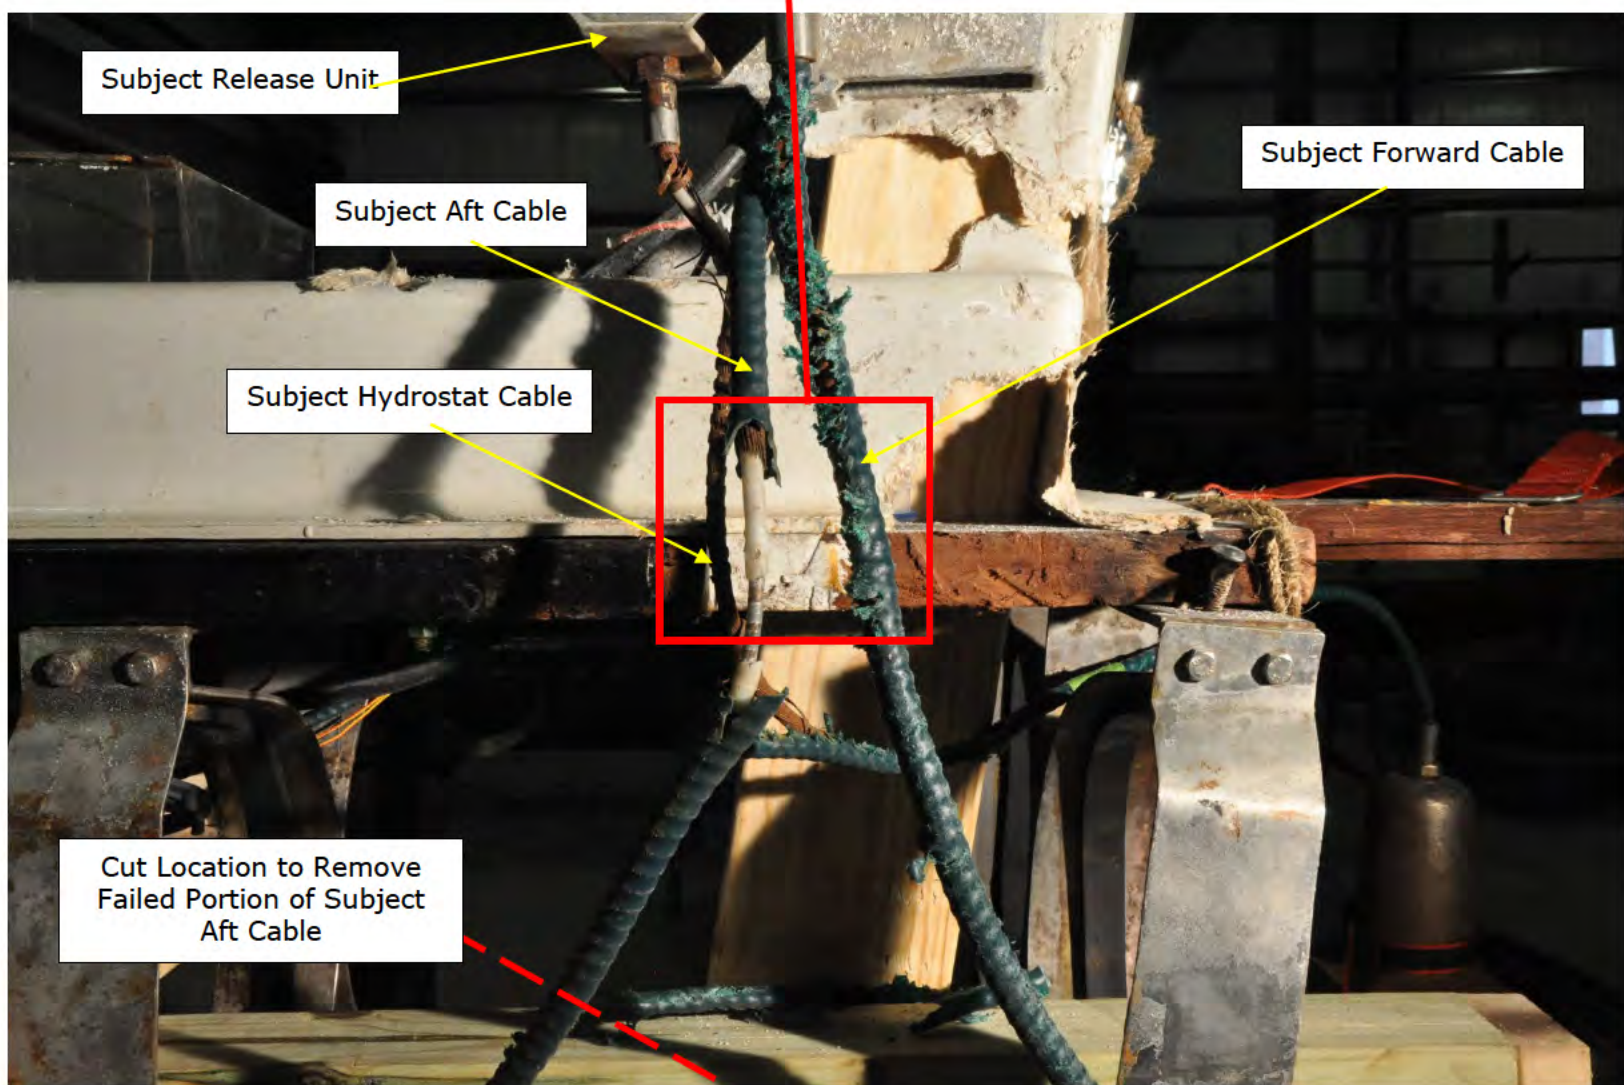
Figure 101. Photograph showing Subject Aft Cable, Subject Forward Cable, and Subject Hydrostat Cable at the Release Unit after reconstruction at DNV GL's facility.

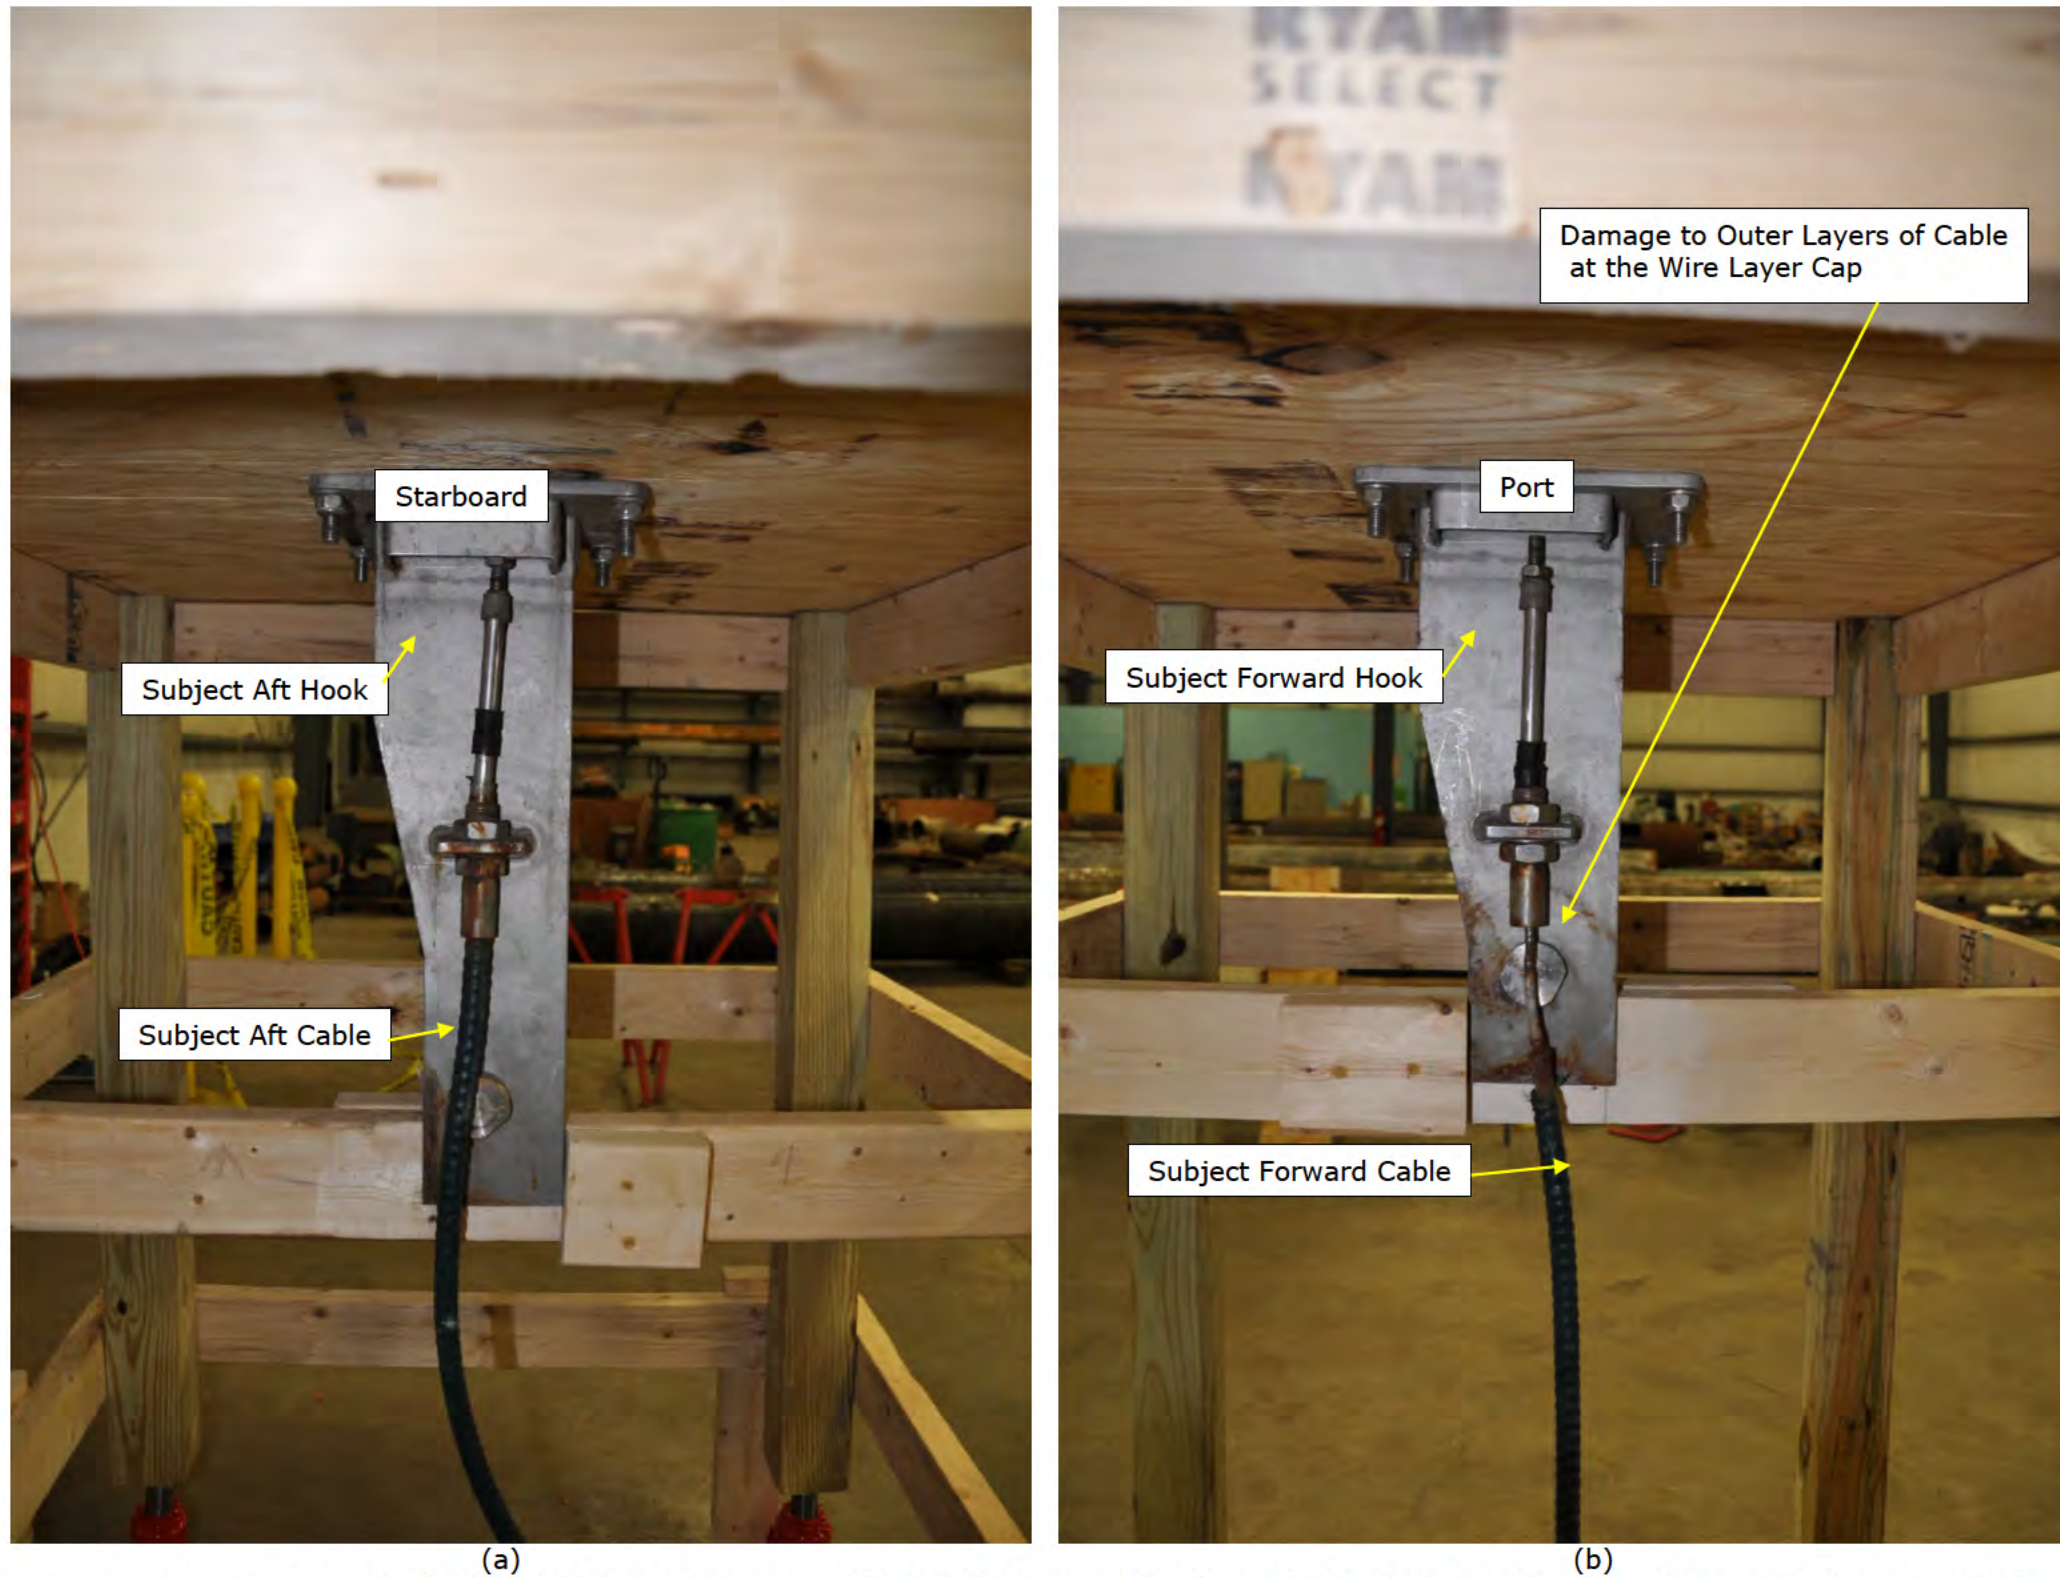
(a) (b)
Figure 102. Photographs showing (a) Subject Aft Cable and (b) Subject Forward Cable at the Subject Aft and Subject Forward Hooks, respectively.

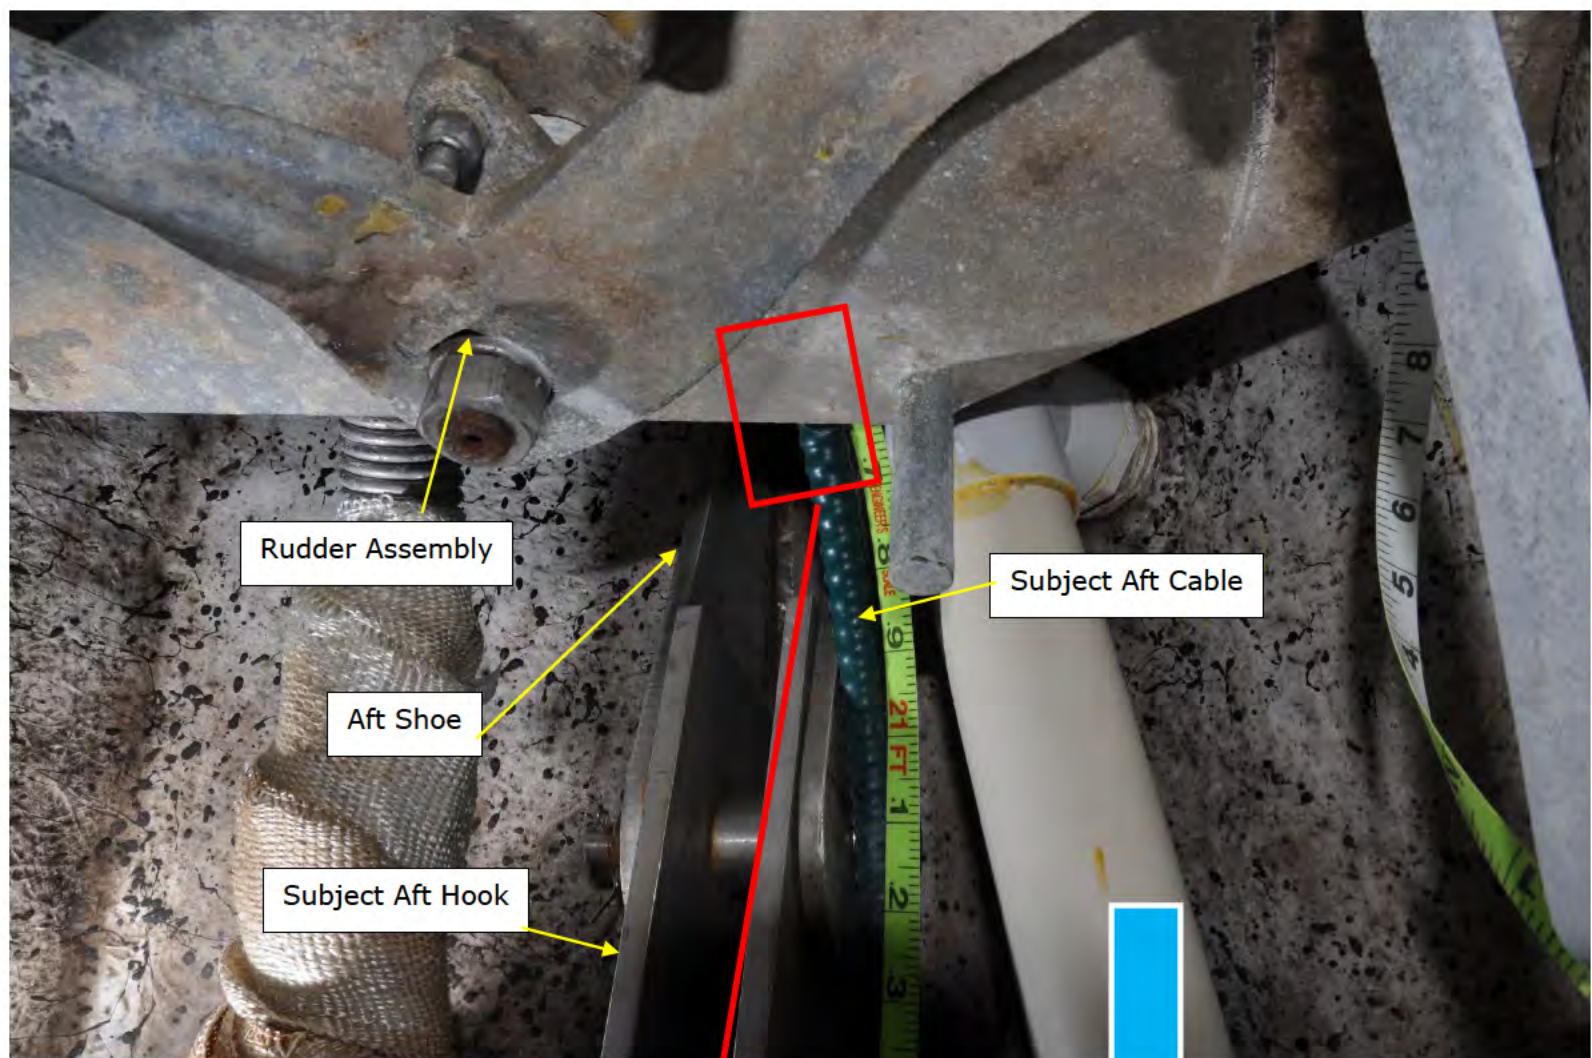
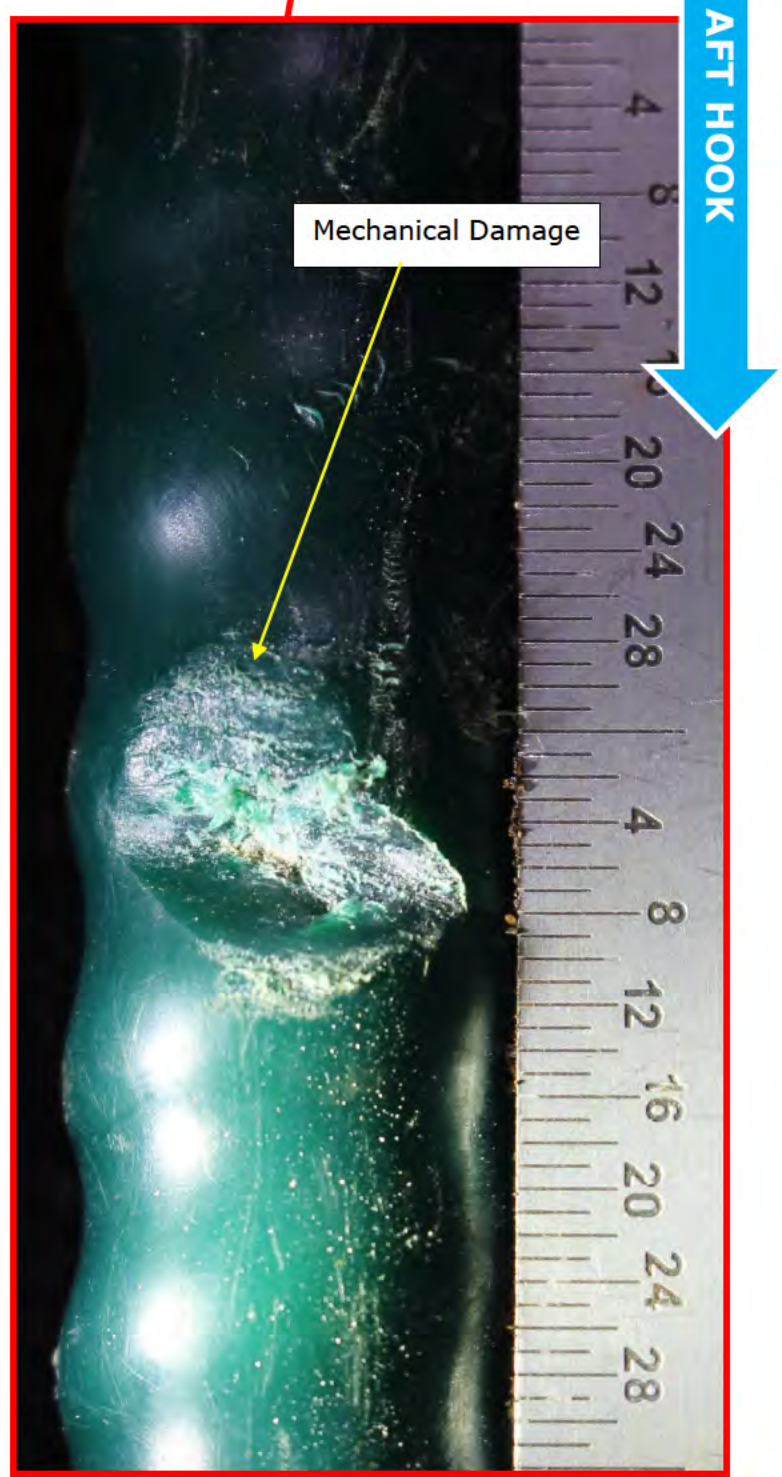
Figure 104. Photographs showing mechanical damage to the cover layer of the Subject Aft Cable 20.63 feet from the conduit cap at the Subject Release Unit. The top photograph was taken by DNV GL during a site visit to Harvey Terminal on July 31, 2019 and the lower photograph was taken at DNV GL's laboratory in Dublin, Ohio. The direction of the Subject Aft Hook is noted with the blue arrow. Tape measure is in feet and ruler is in inches.

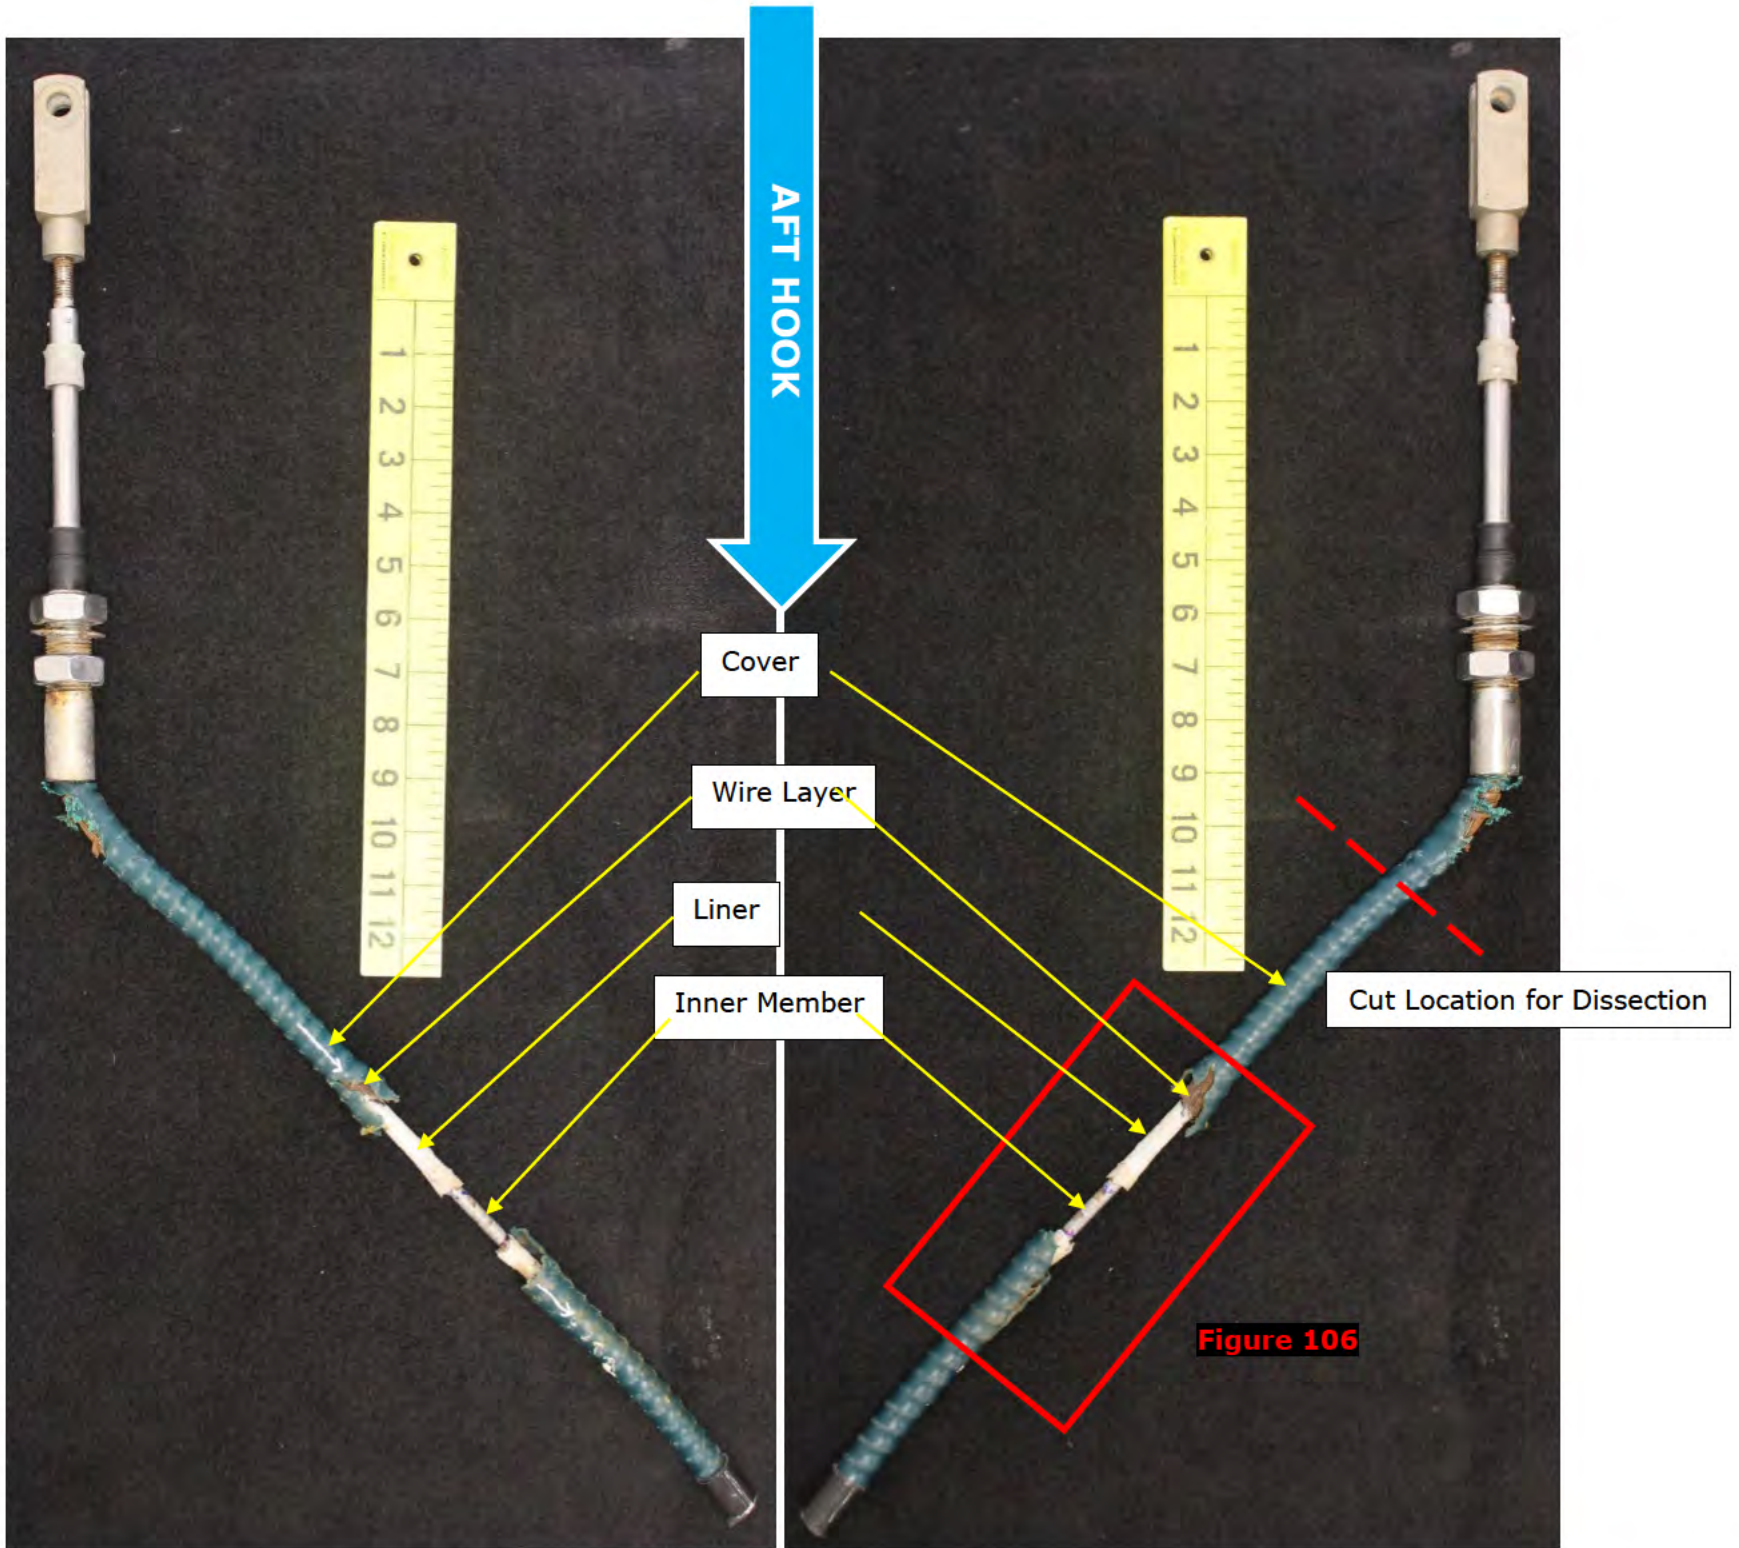
Figure 105. Photographs of the Subject Aft Cable after removing a section with the failure in the outer layers. The direction of the Subject Aft Hook is noted with the blue arrow. Rulers are in inches.

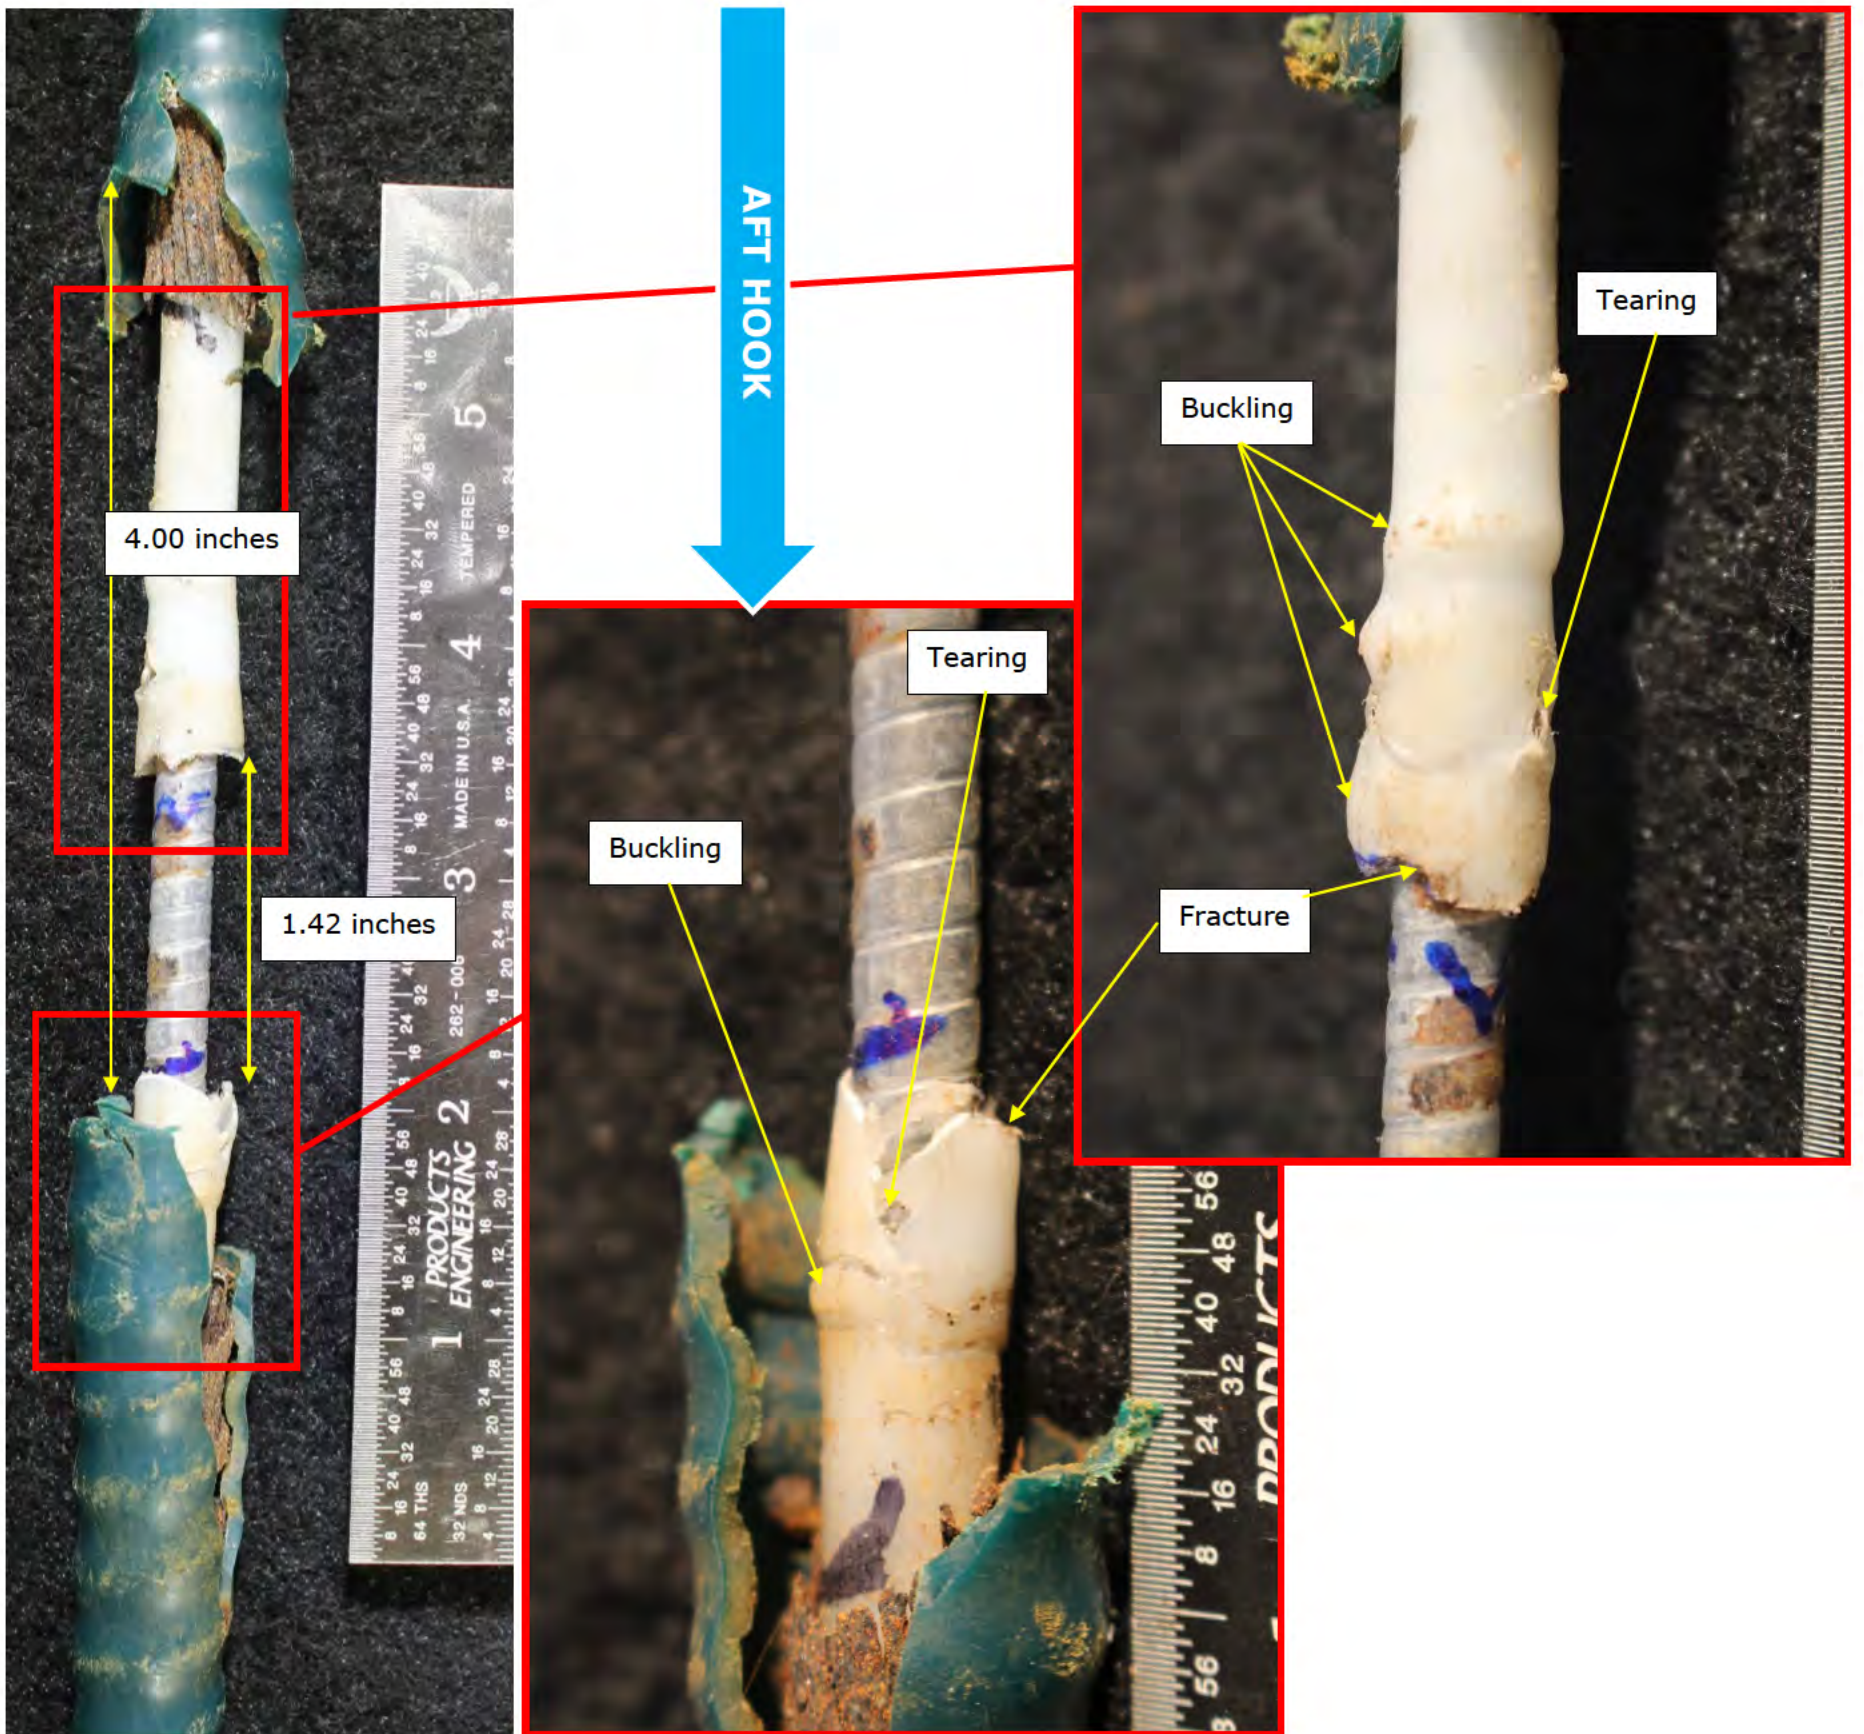
Figure 106. Photographs of the Subject Aft Cable showing the detail of the failure. The direction of the Subject Aft Hook is noted with the blue arrow. Rulers are in inches.

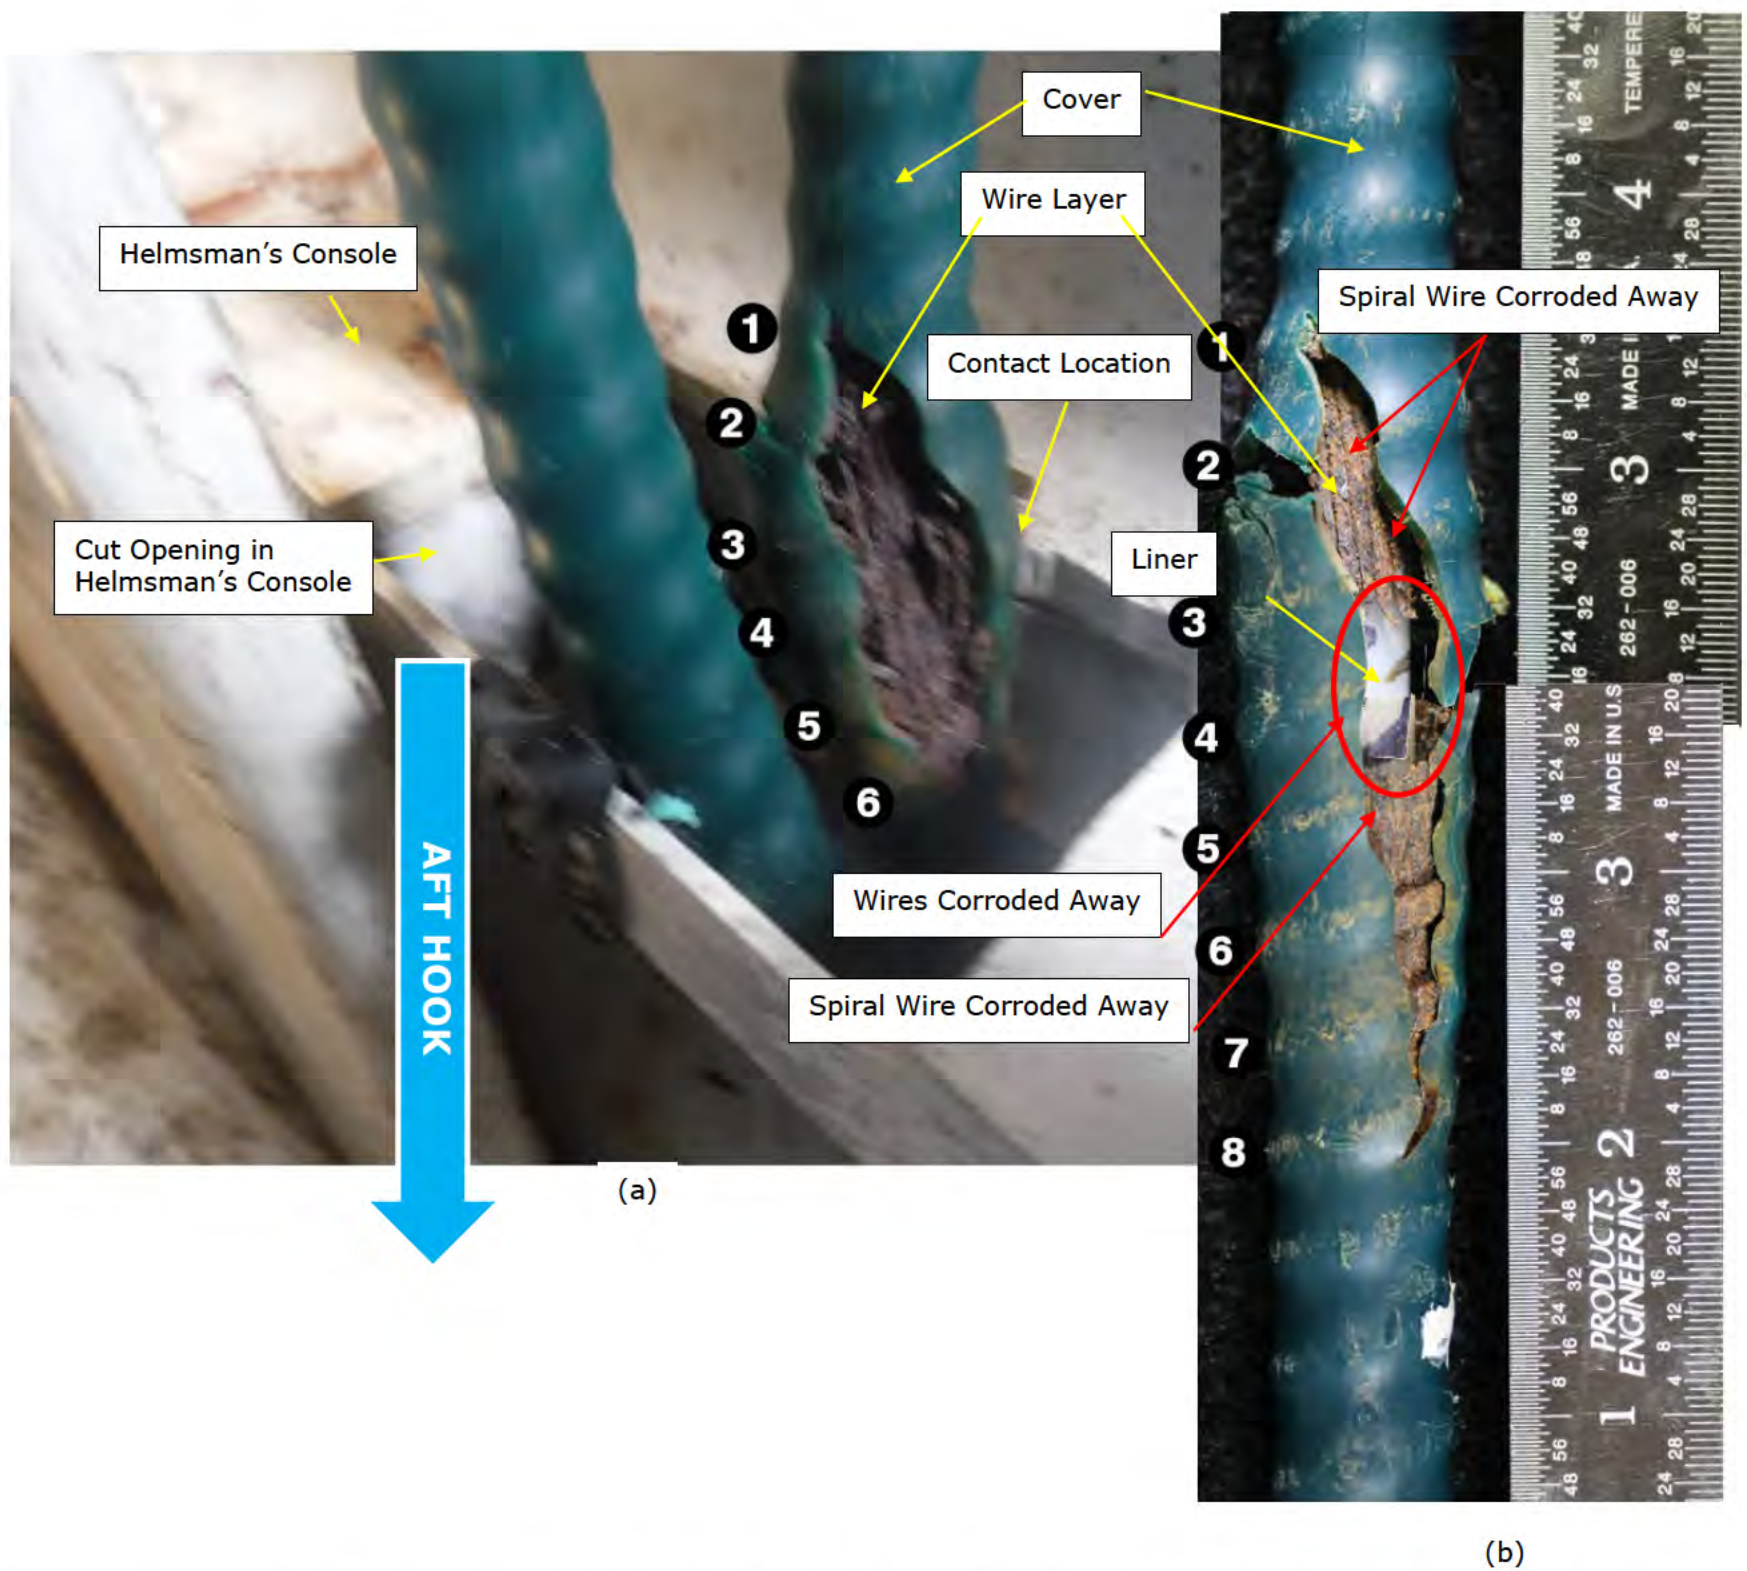
Figure 107. Photograph and montage of photographs of the Subject Aft Cable (a) taken in the field on June 6, 2019 by Palfinger and (b) taken in the laboratory by DNV GL, respectively. For the montage, the fracture surfaces of the cover were matched to generate an image similar to the photograph shown in Figure 107 (a). The numbers in Figure 107 (a) and (b) are corresponding locations along the length the control cable. The direction of the Subject Aft Hook is noted with the blue arrow. Ruler is in inches.

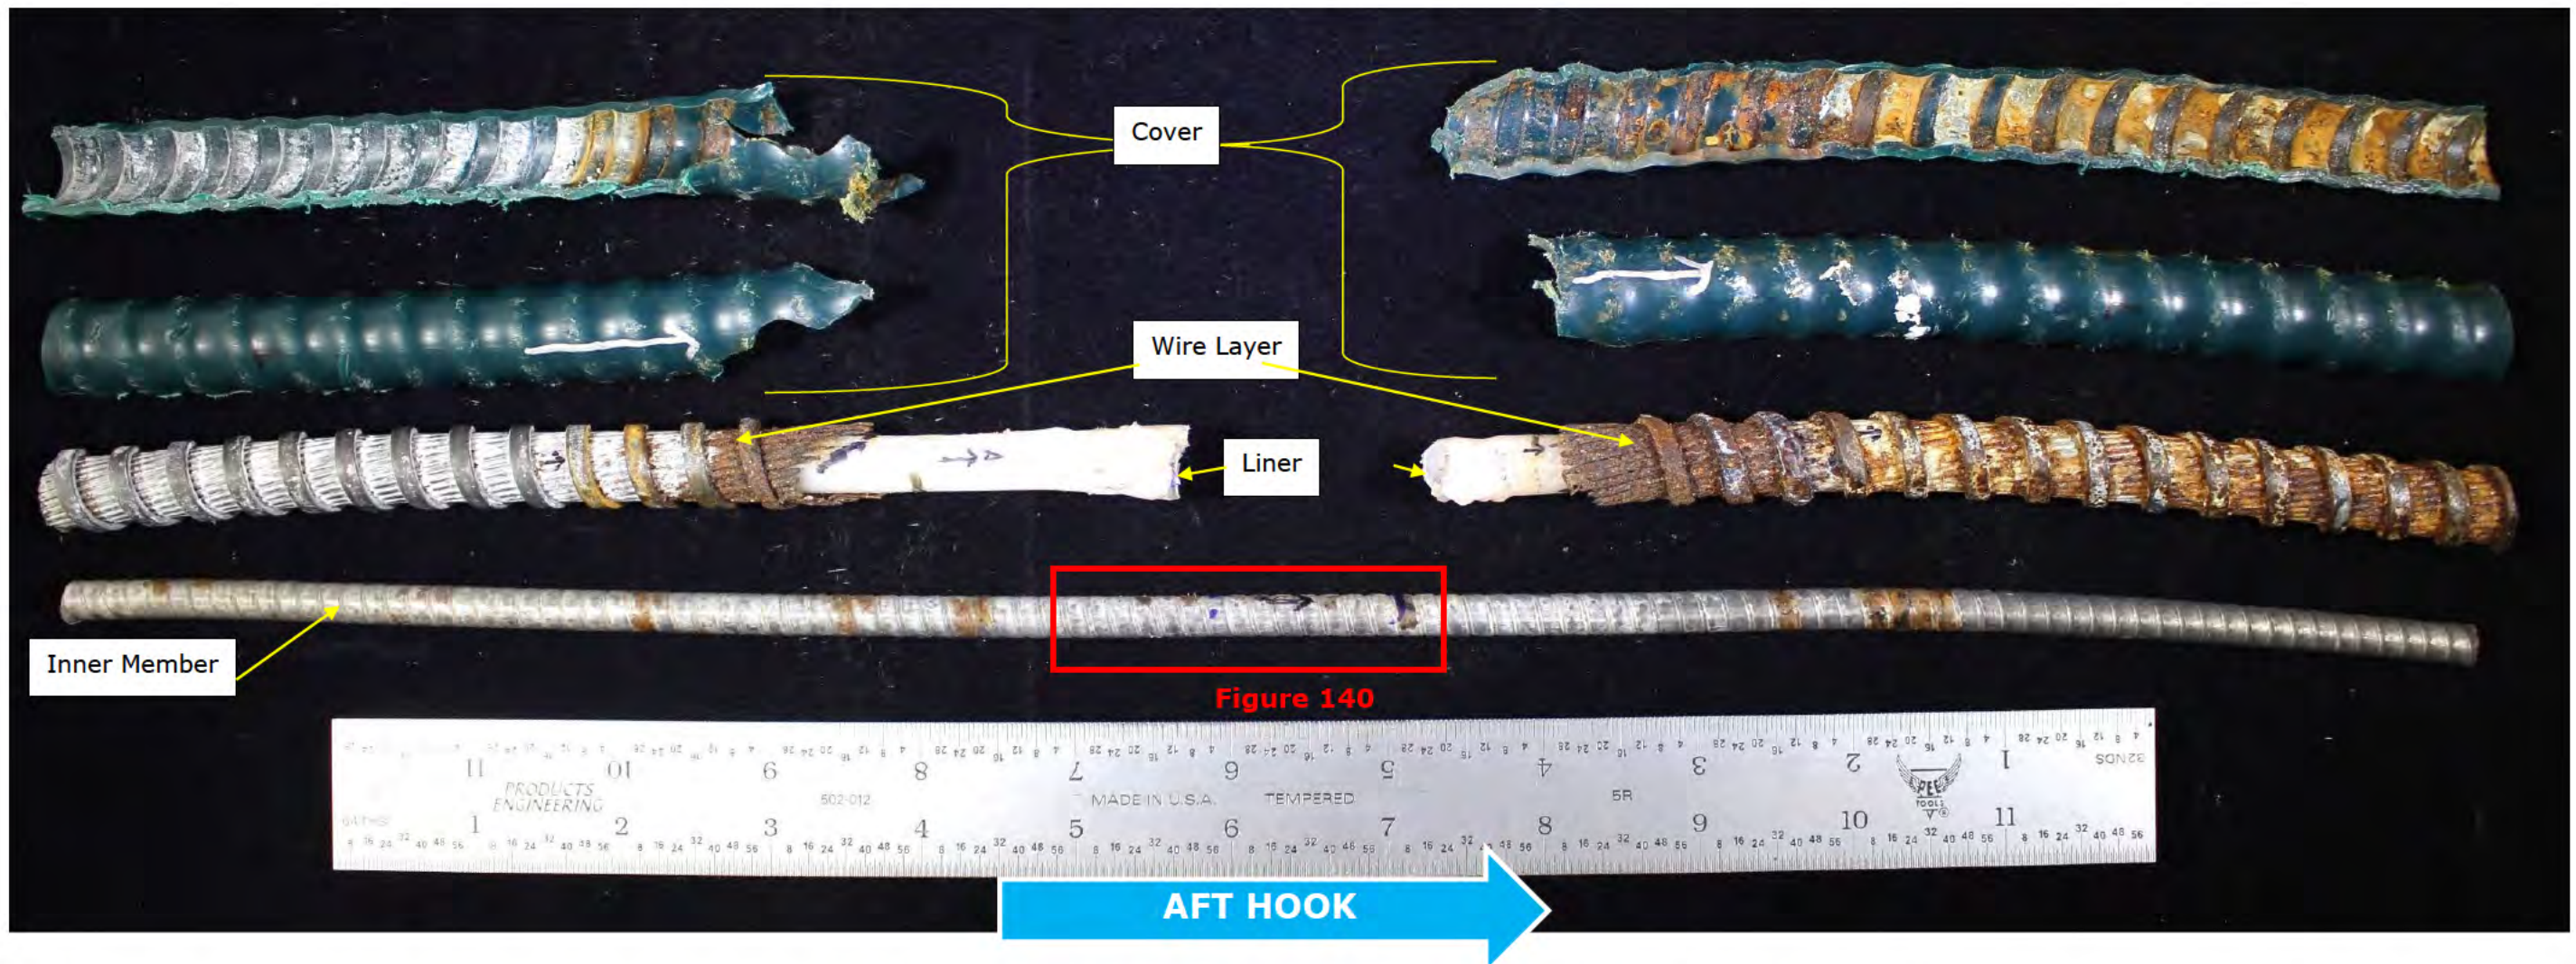
Figure 108. Photograph of the Subject Aft Cable showing the layers of the control cable after dissection near the location of failure. The direction of the Subject Aft Hook is noted with the blue arrow. Ruler is in inches.
