Final Report

Auger Lifeboat 6 Incident

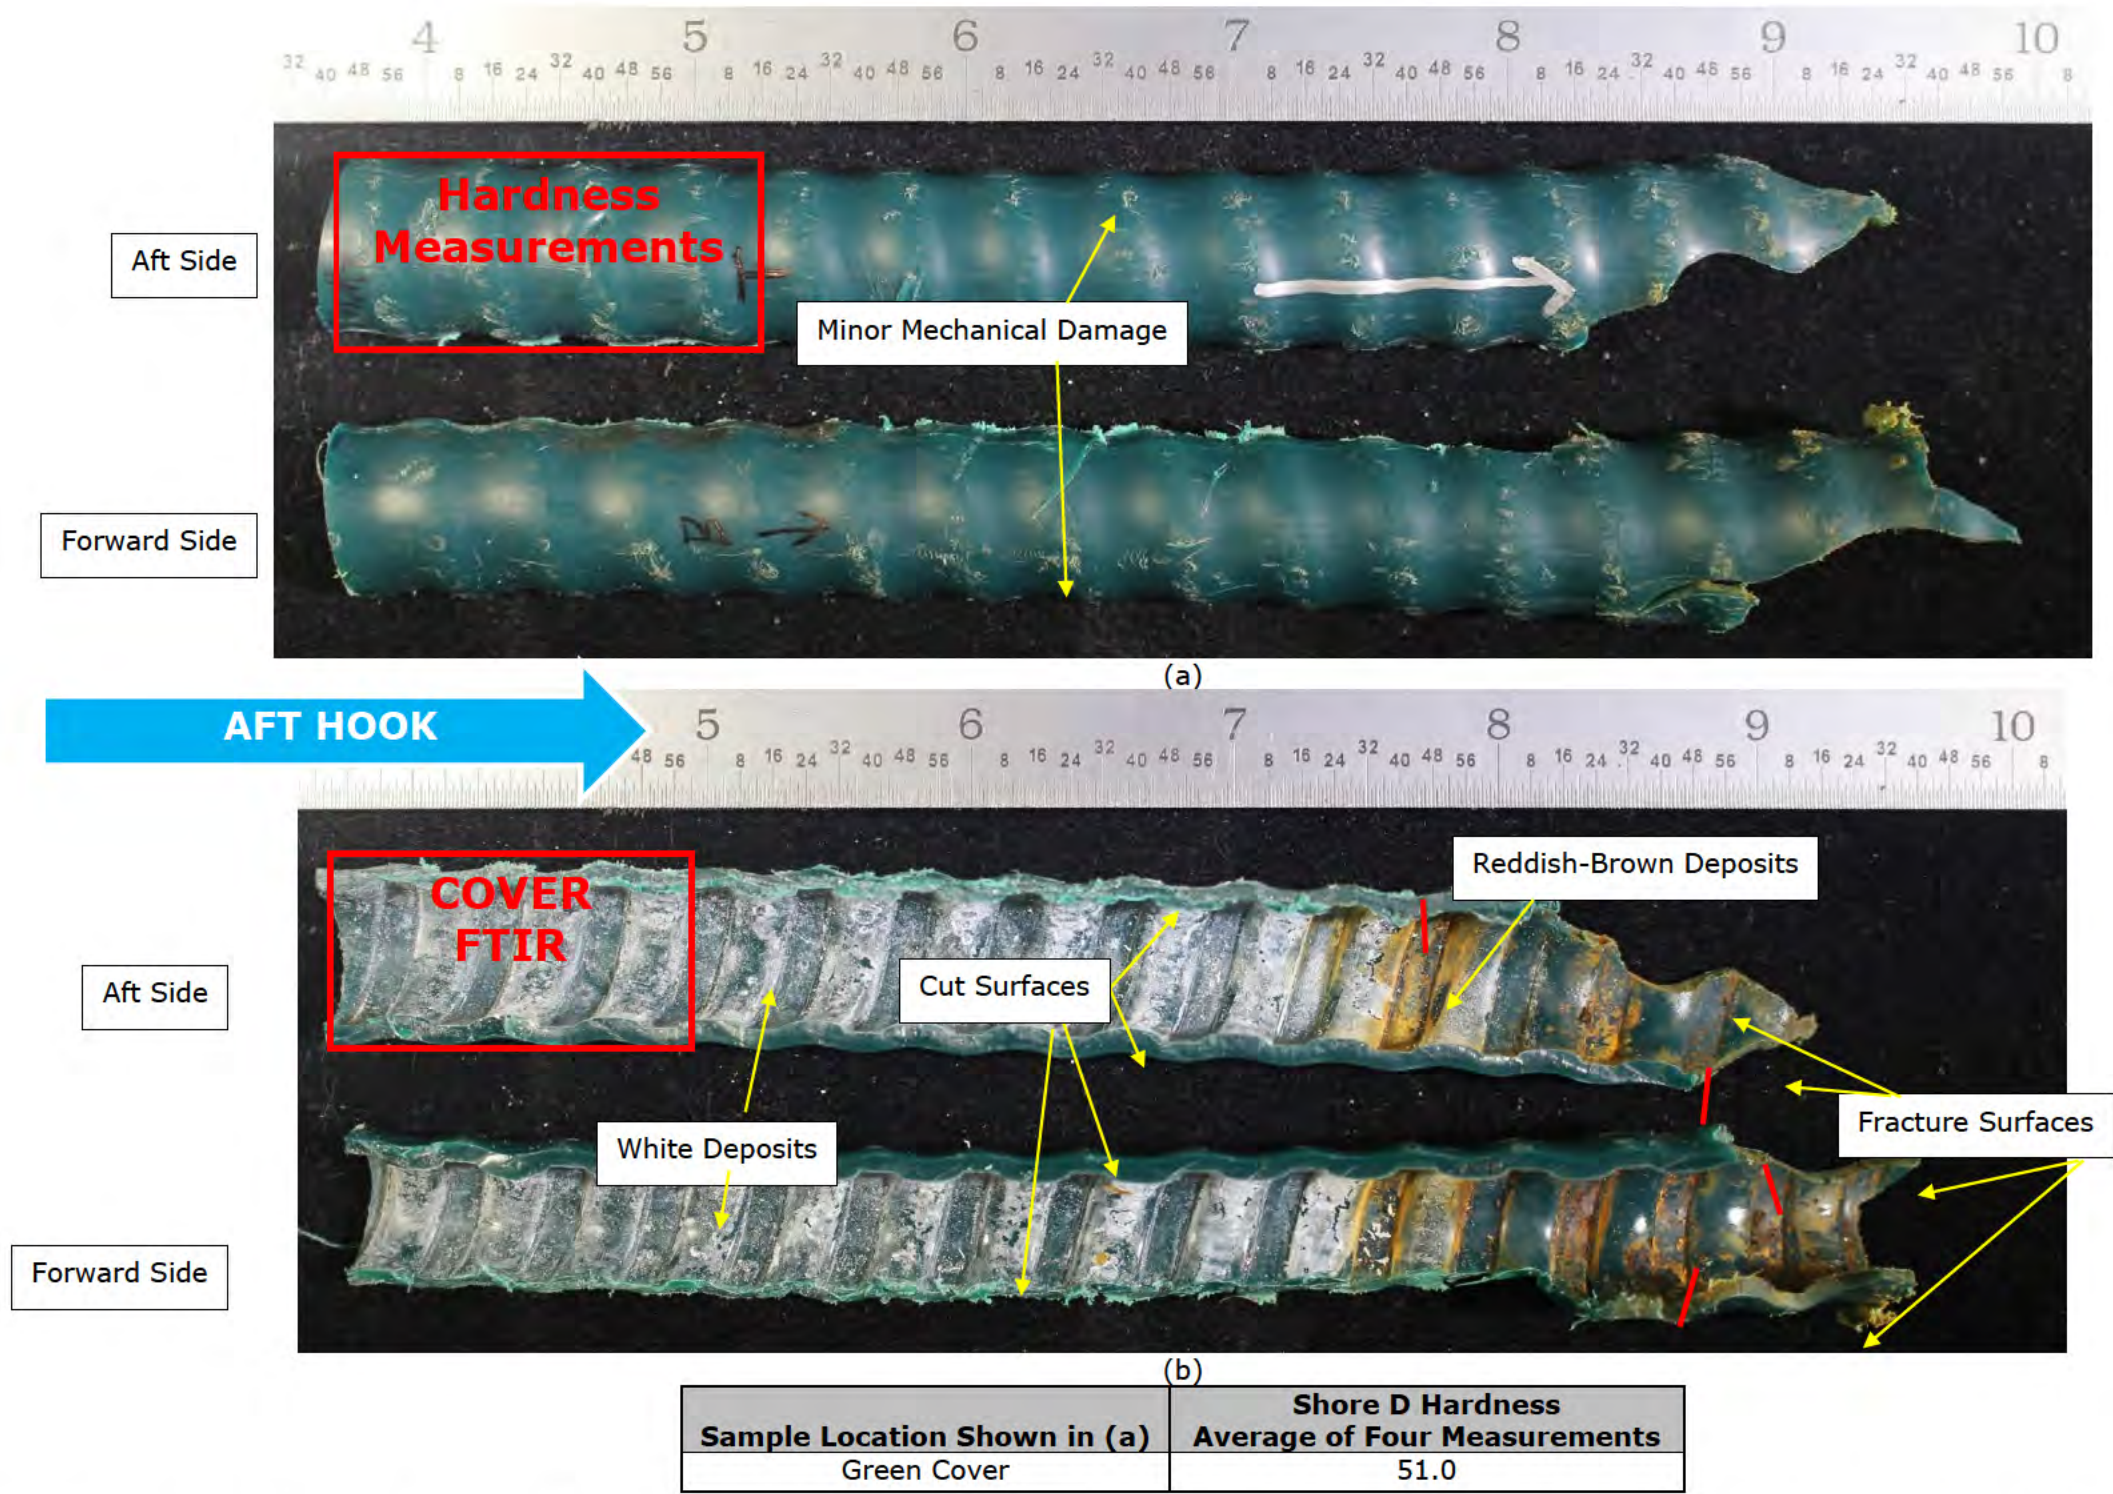
Figure 109. Photographs of the cover from the Subject Release Unit side of the failure in the Subject Aft Cable after dissection showing the (a) external surface and (b) internal surface; samples shown in Figure 108. Forward and aft refer to the orientation of the cover relative to the lifeboat. The direction of the Subject Aft Hook is noted with the blue arrow. Results of hardness measurements shown in table. Ruler is in inches.

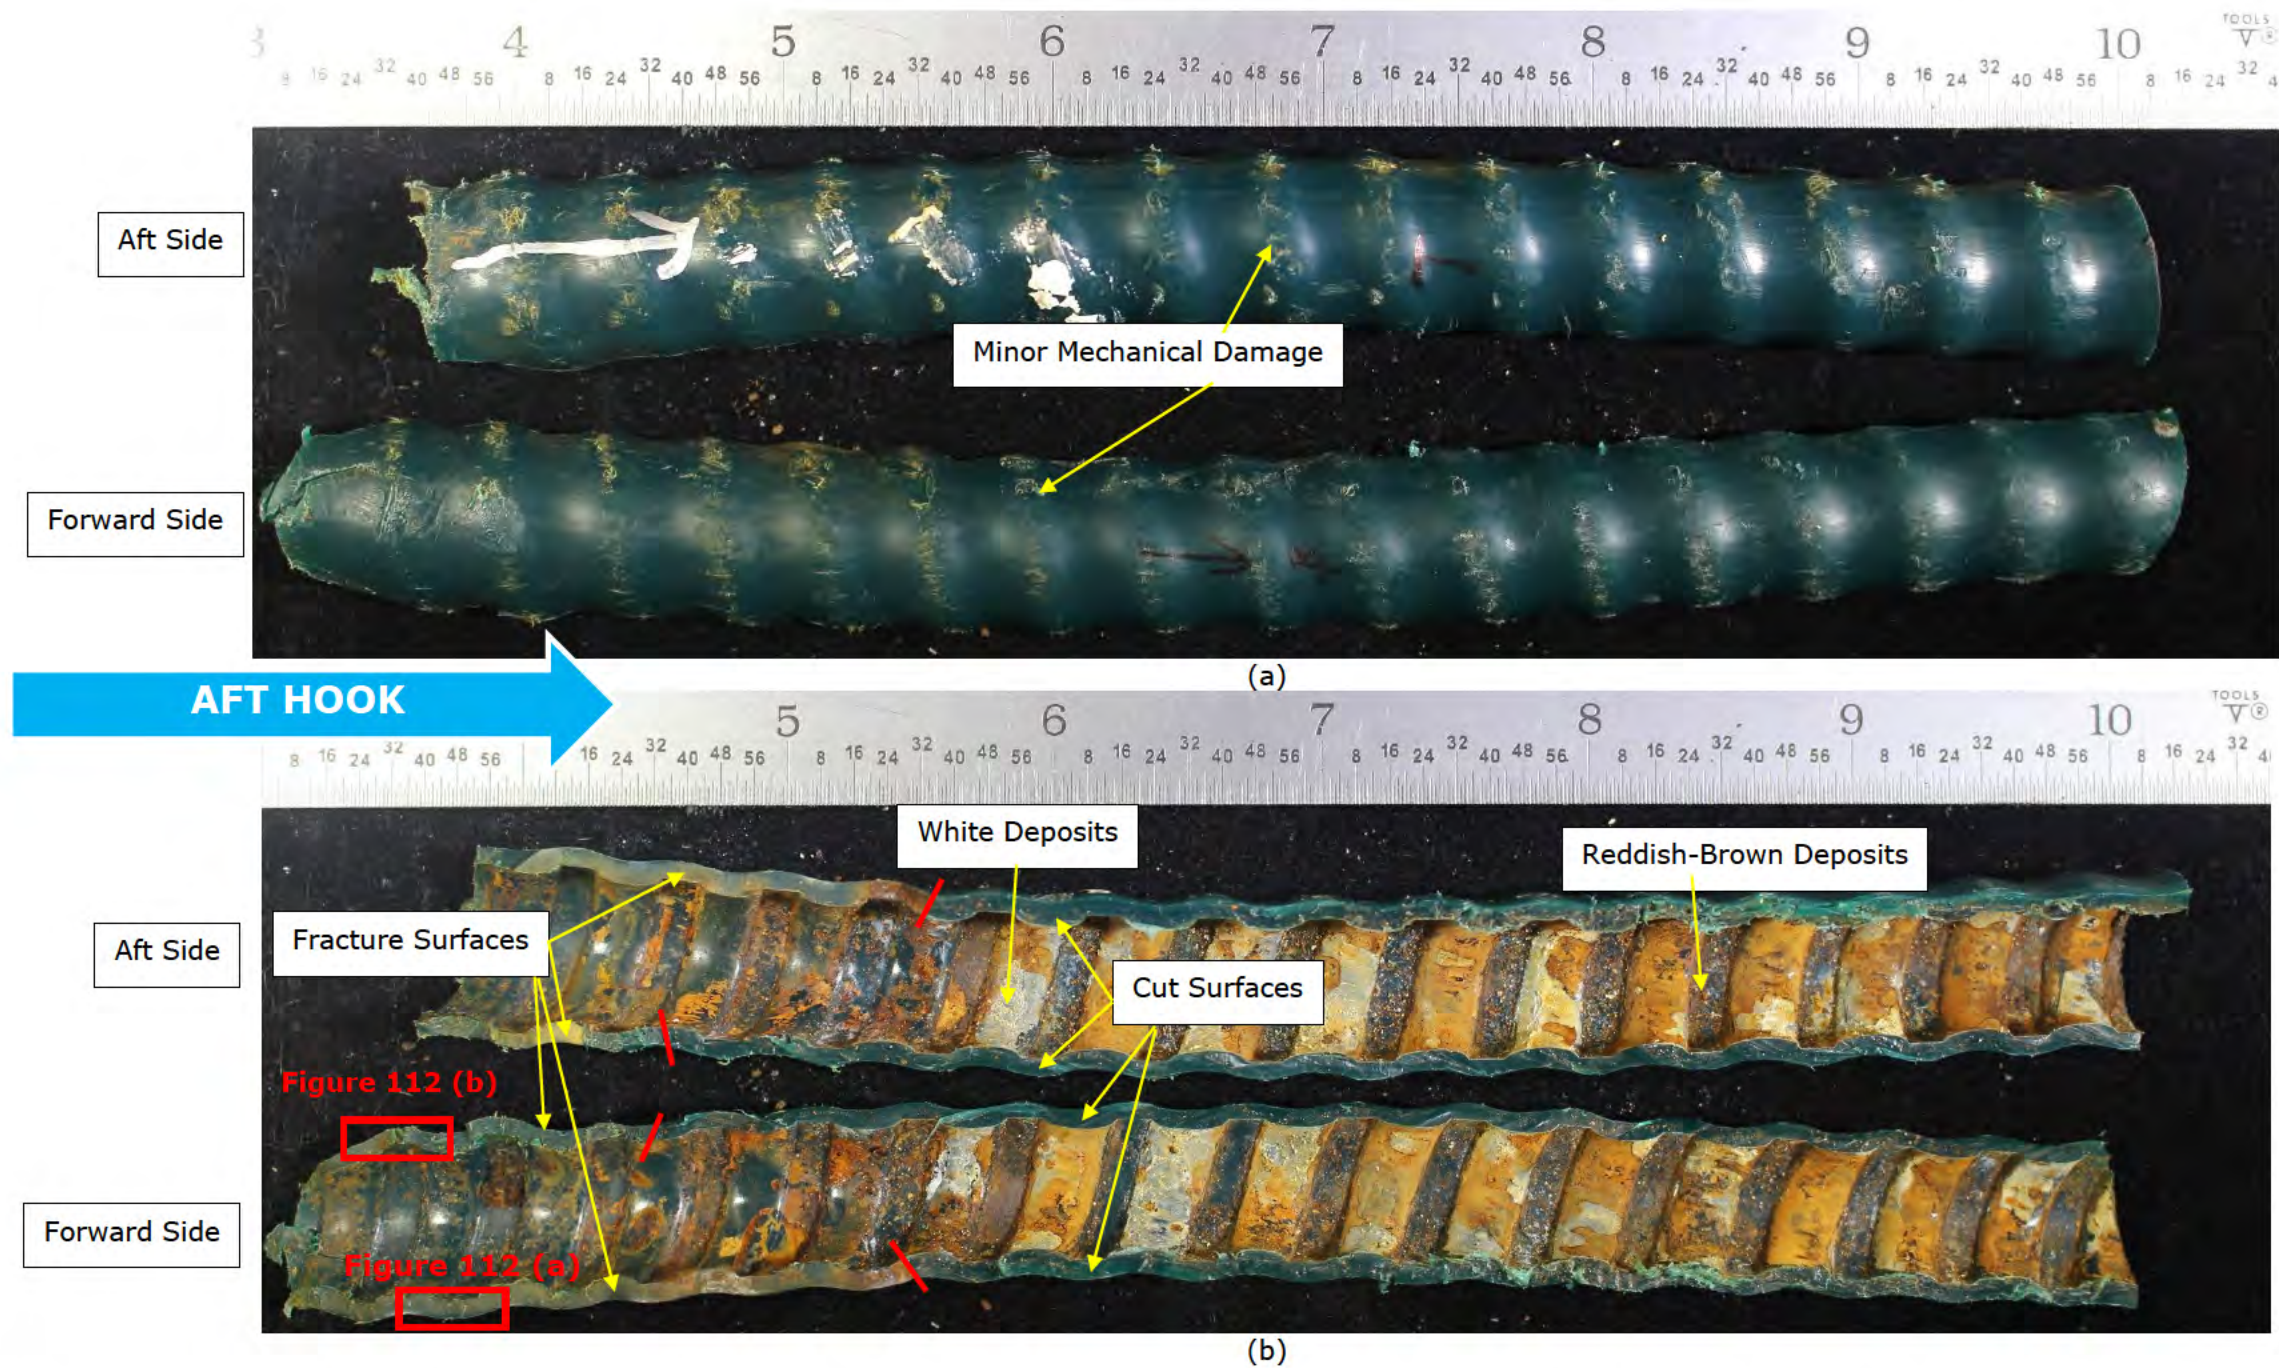
Figure 110. Photographs of the cover from the Subject Aft Hook side of the failure in the Subject Aft Cable after dissection showing the (a) external surface and (b) internal surface; samples shown in Figure 108. Forward and aft refer to the orientation of the cover relative to the lifeboat. The direction of the Subject Aft Hook is noted with the blue arrow. Ruler is in inches.

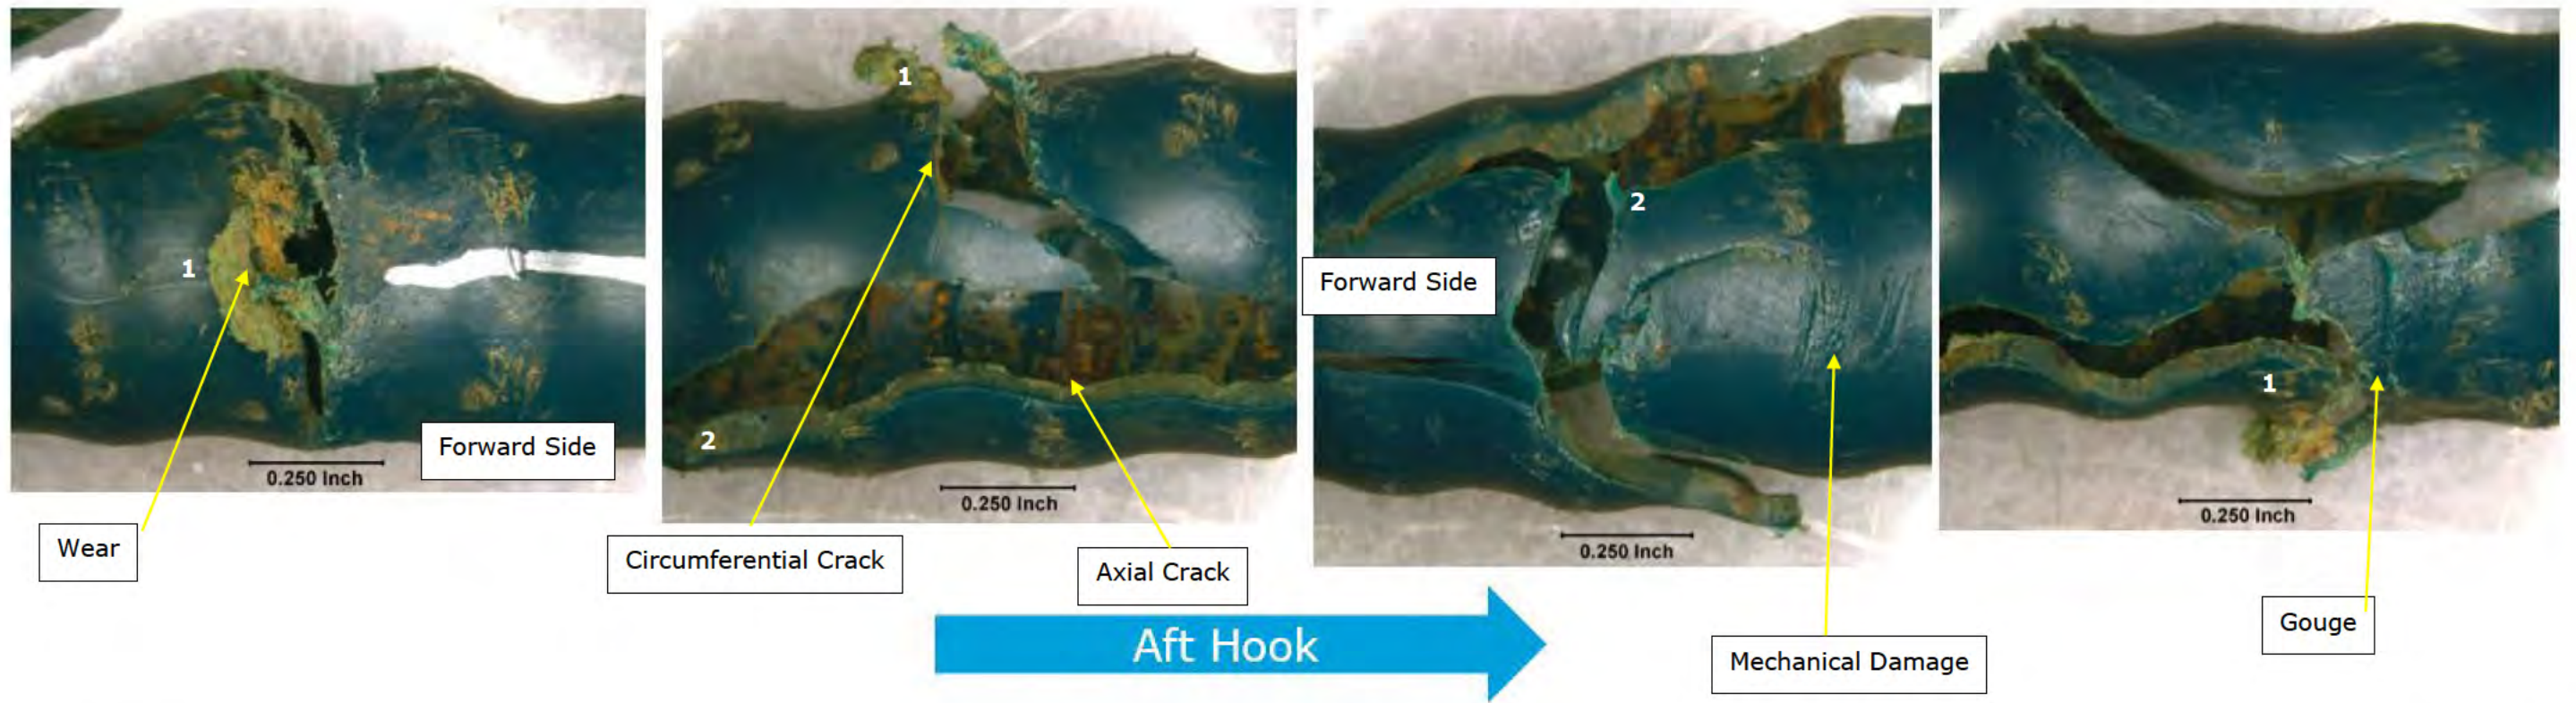
Figure 111. Light photomicrographs of the cover from the Subject Aft Cable after matching the fractures surfaces at the failure. The numbers "1" and "2" are reference locations. Forward and aft refer to the orientation of the cover relative to the lifeboat. The direction of the Subject Aft Hook is noted with the blue arrow.

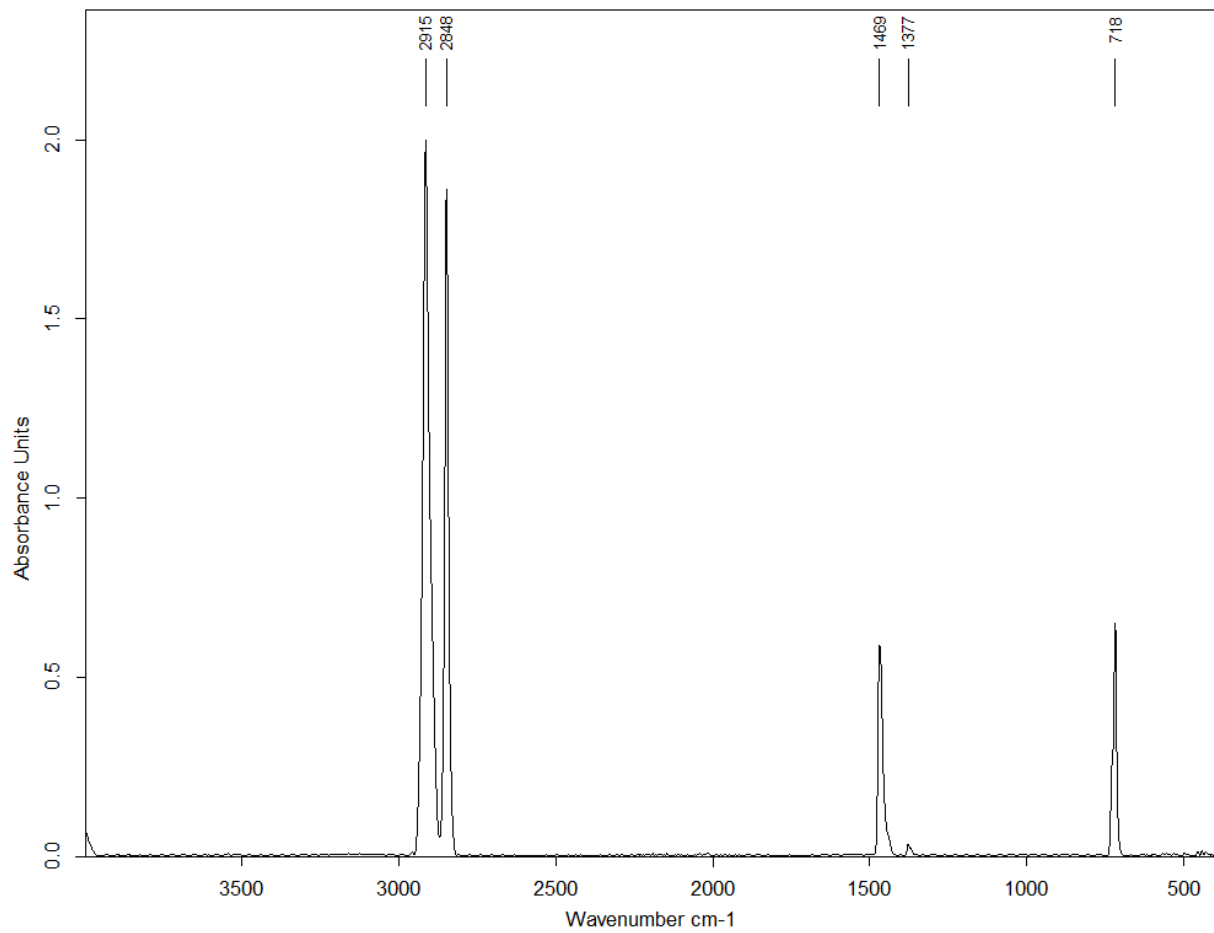
Figure 113. Fourier-transform Infrared Spectroscopy spectrum of the FTIR sample removed from the cover of the Subject Aft Cable; sample location shown in Figure 109.

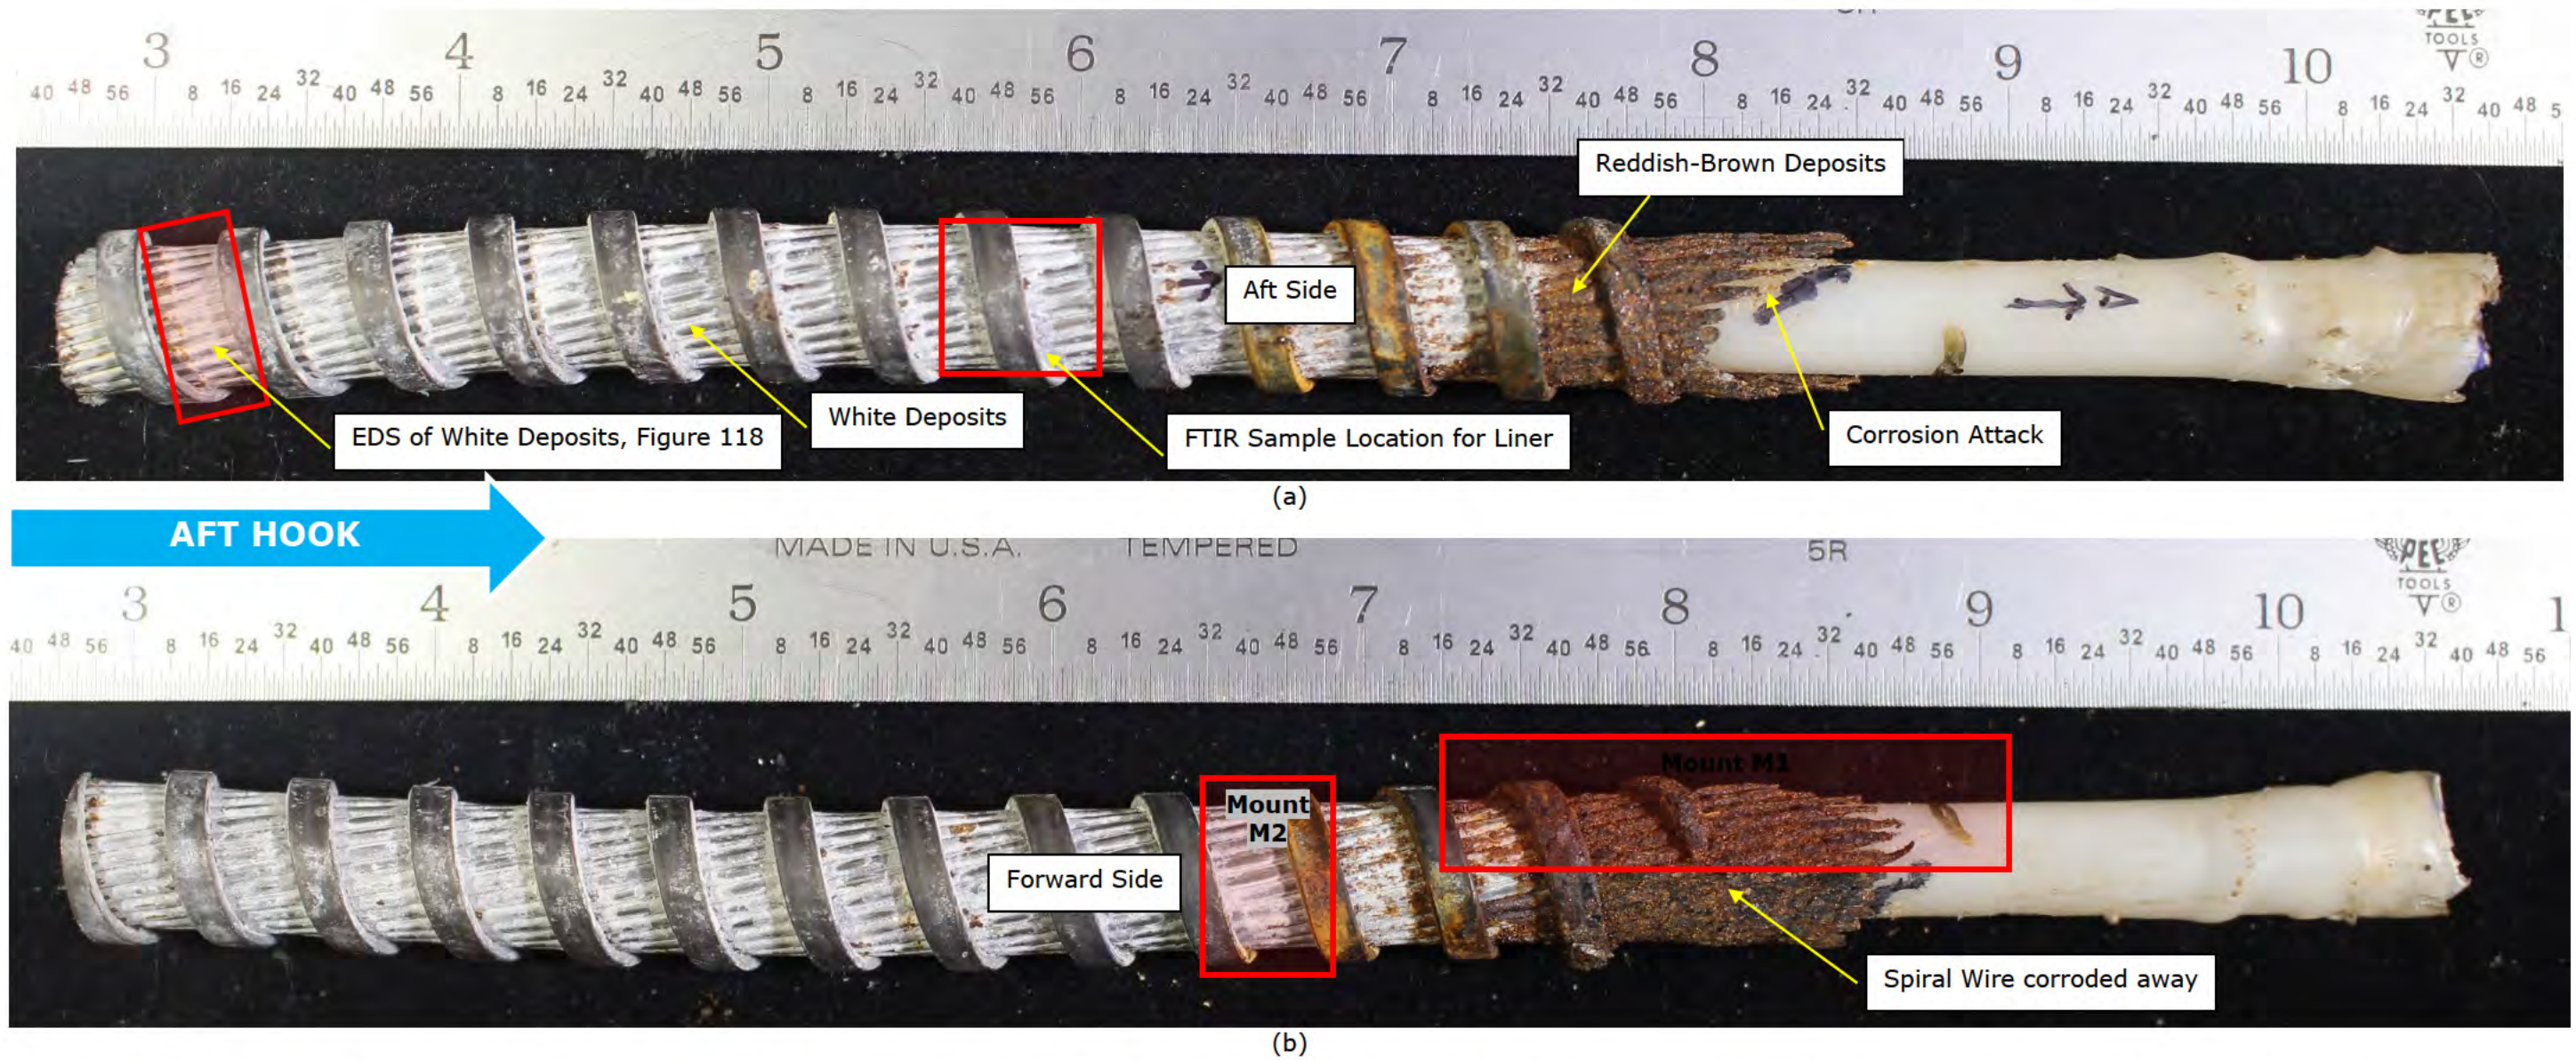
Figure 114. Photographs of the wire layer from the Subject Release Unit side of the failure in the Subject Aft Cable after dissection showing the (a) aft side and (b) forward side; samples shown in Figure 108. Forward and aft refer to the orientation of the keeper relative to the lifeboat. The direction of the Subject Aft Hook is noted with the blue arrow. Rulers are in inches.

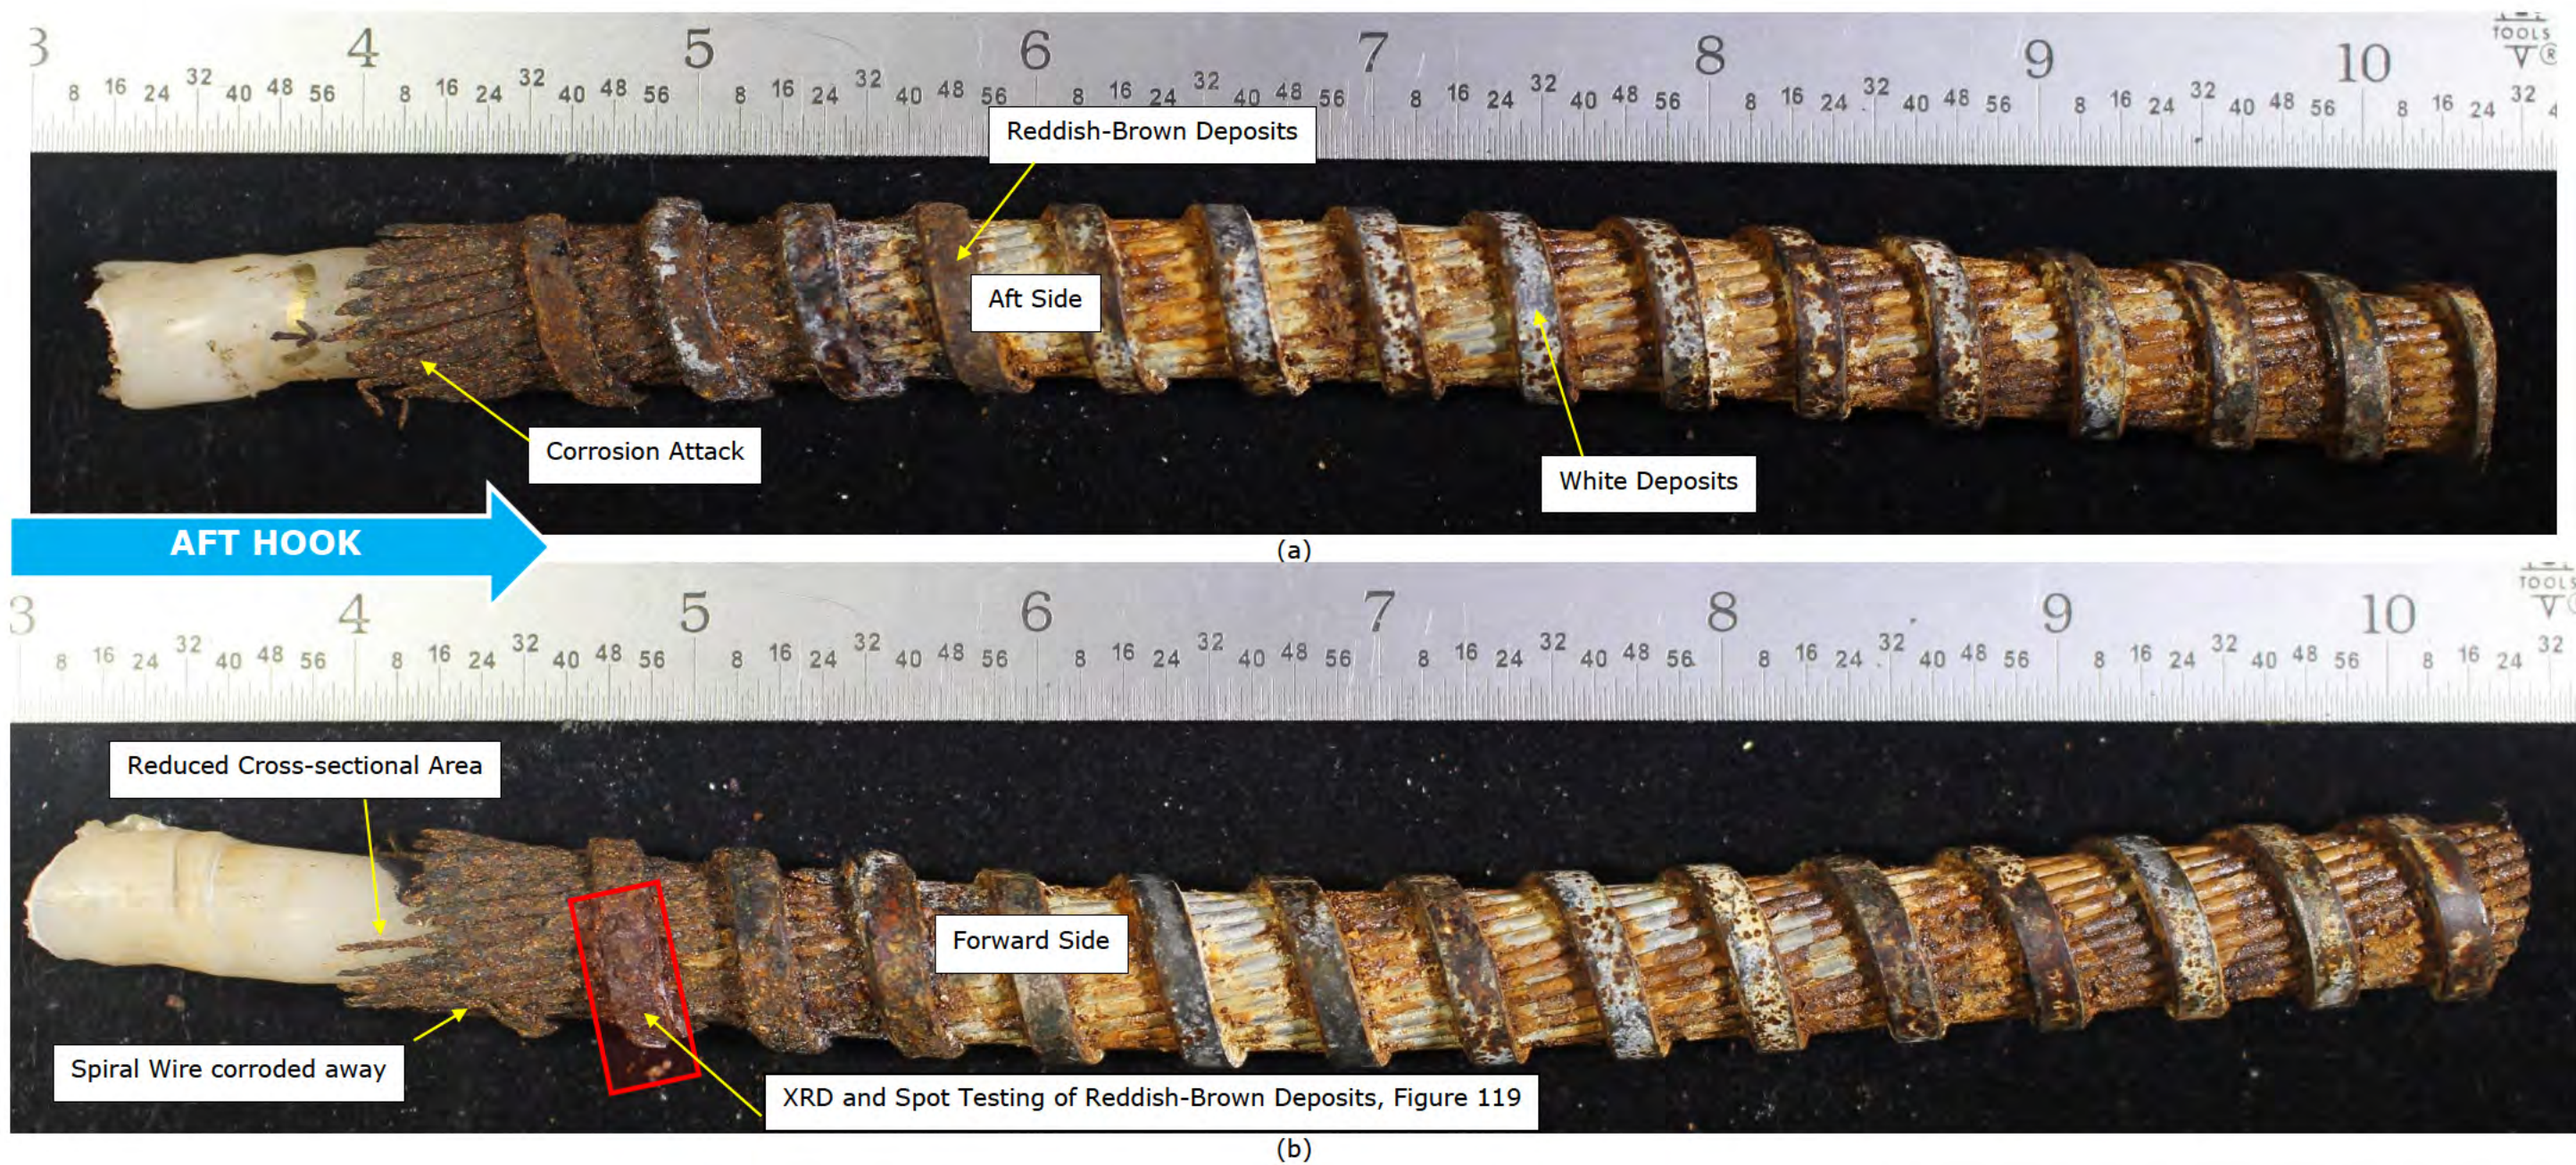
| Deposits | Sulfides | Carbonates |

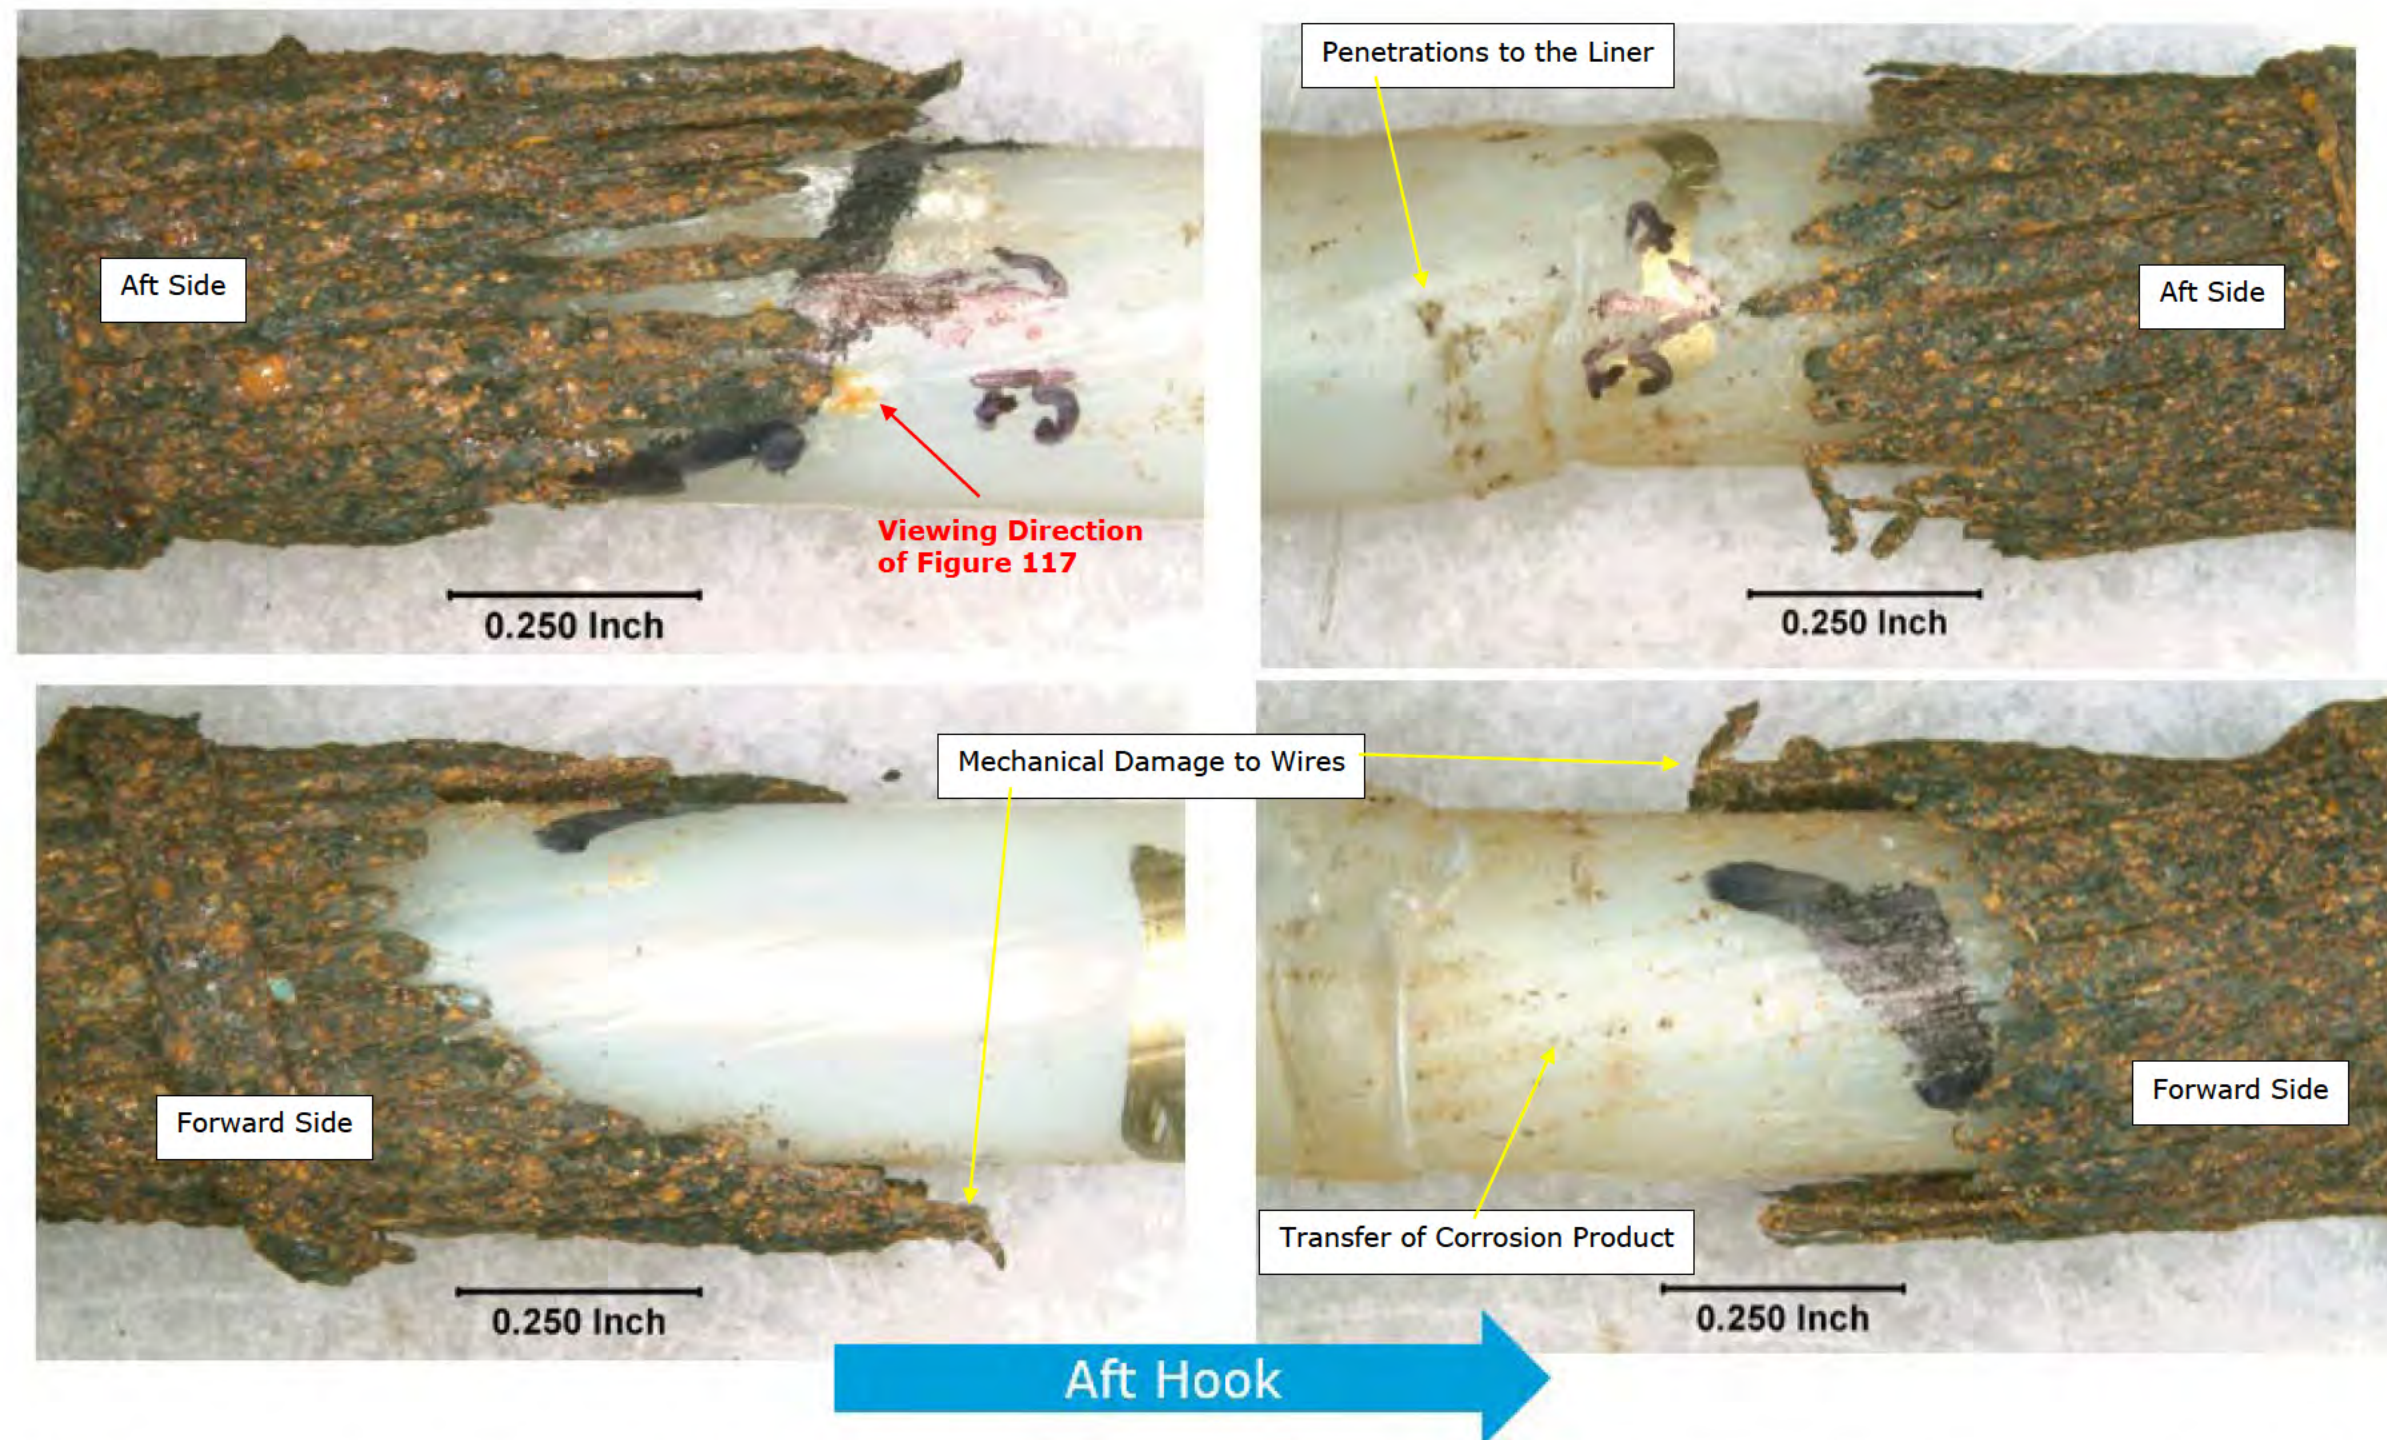
Figure 116. Light photomicrographs of the wire layer from the Subject Aft Cable showing the corrosion damage at the failure. The direction of the Subject Aft Hook is noted with the blue arrow.

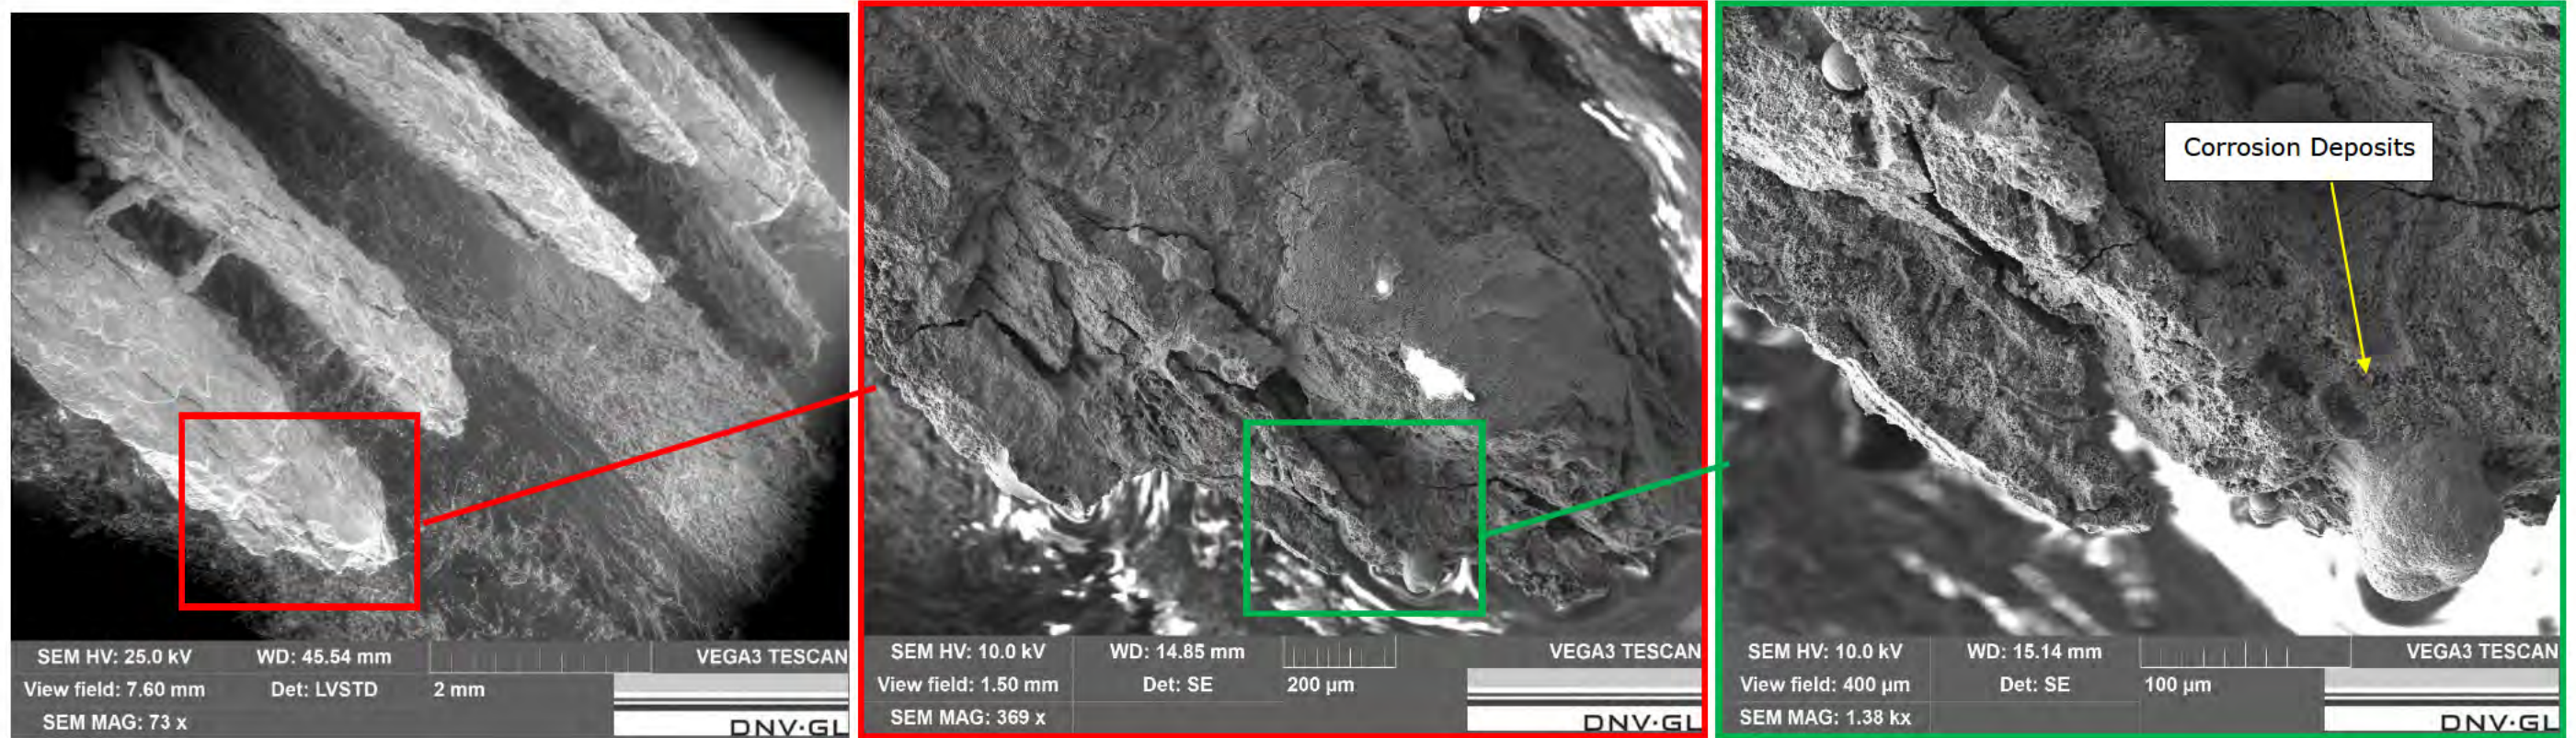
Figure 117. SEM images taken of the strand wires from the wire layer of the Subject Aft Cable showing corrosion damage; viewing direction is shown in Figure 116.

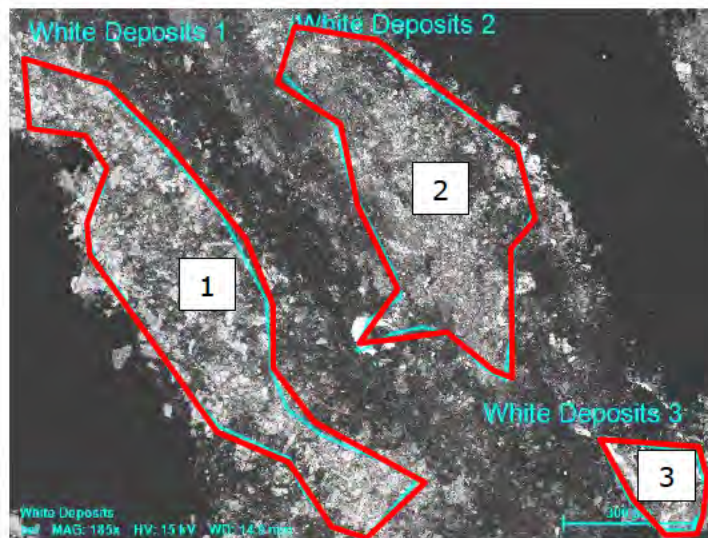
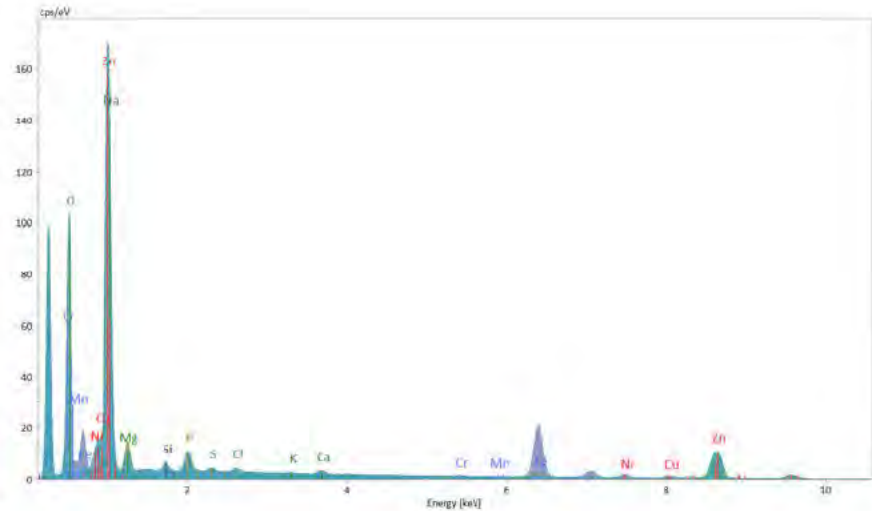
| Location | Oxygen (O) | Sodium (Na) | Magnesium (Mg) | Silicon (Si) | Phosphorus (P) | Sulfur (S) | Chlorine (Cl) | Potassium (K) | Calcium (Ca) | Chromium (Cr) | Manganese (Mn) | Iron (Fe) | Nickel (Ni) | Copper (Cu) | Zinc (Zn) |
