Final Report

Auger Lifeboat 6 Incident

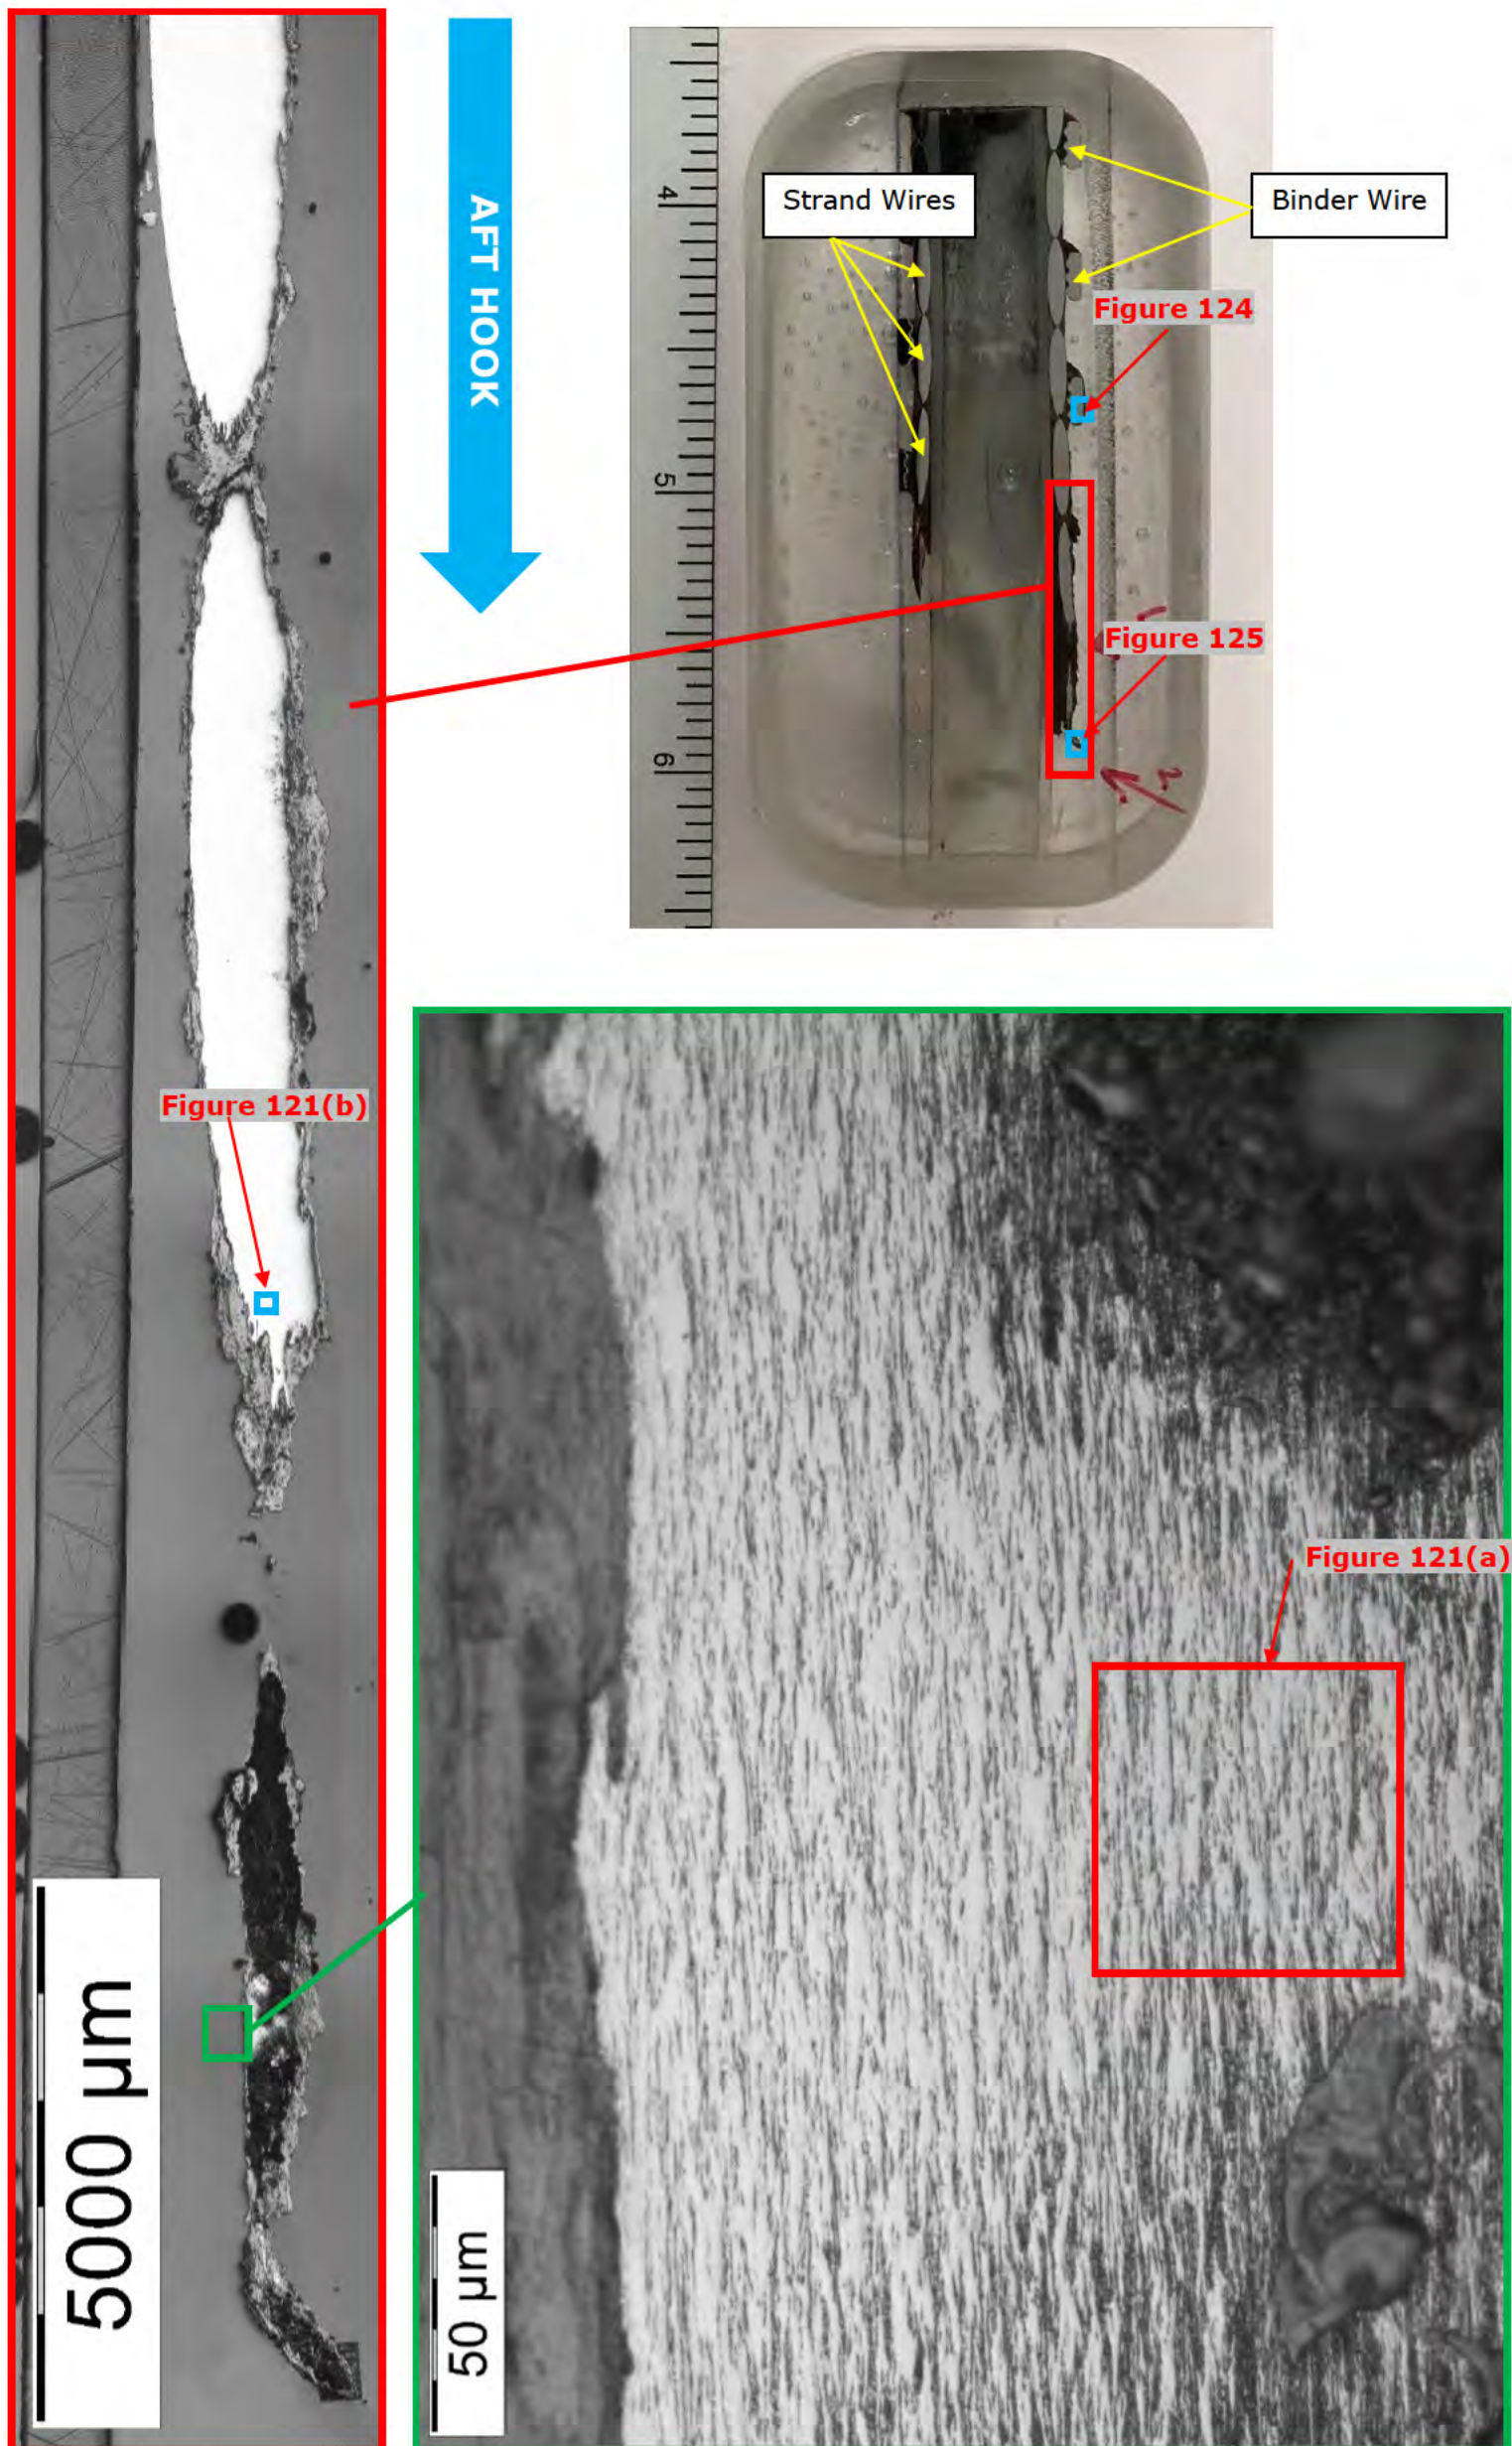
Figure 120. Photograph and photomicrographs of a longitudinal metallographic mount, Mount M1, showing the corrosion attack of the strand wires from the wire layer of the Subject Aft Cable; mount removed from location shown in Figure 114. The direction of the Subject Aft Hook is noted with the blue arrow. The ruler in the upper right photograph is in inches.

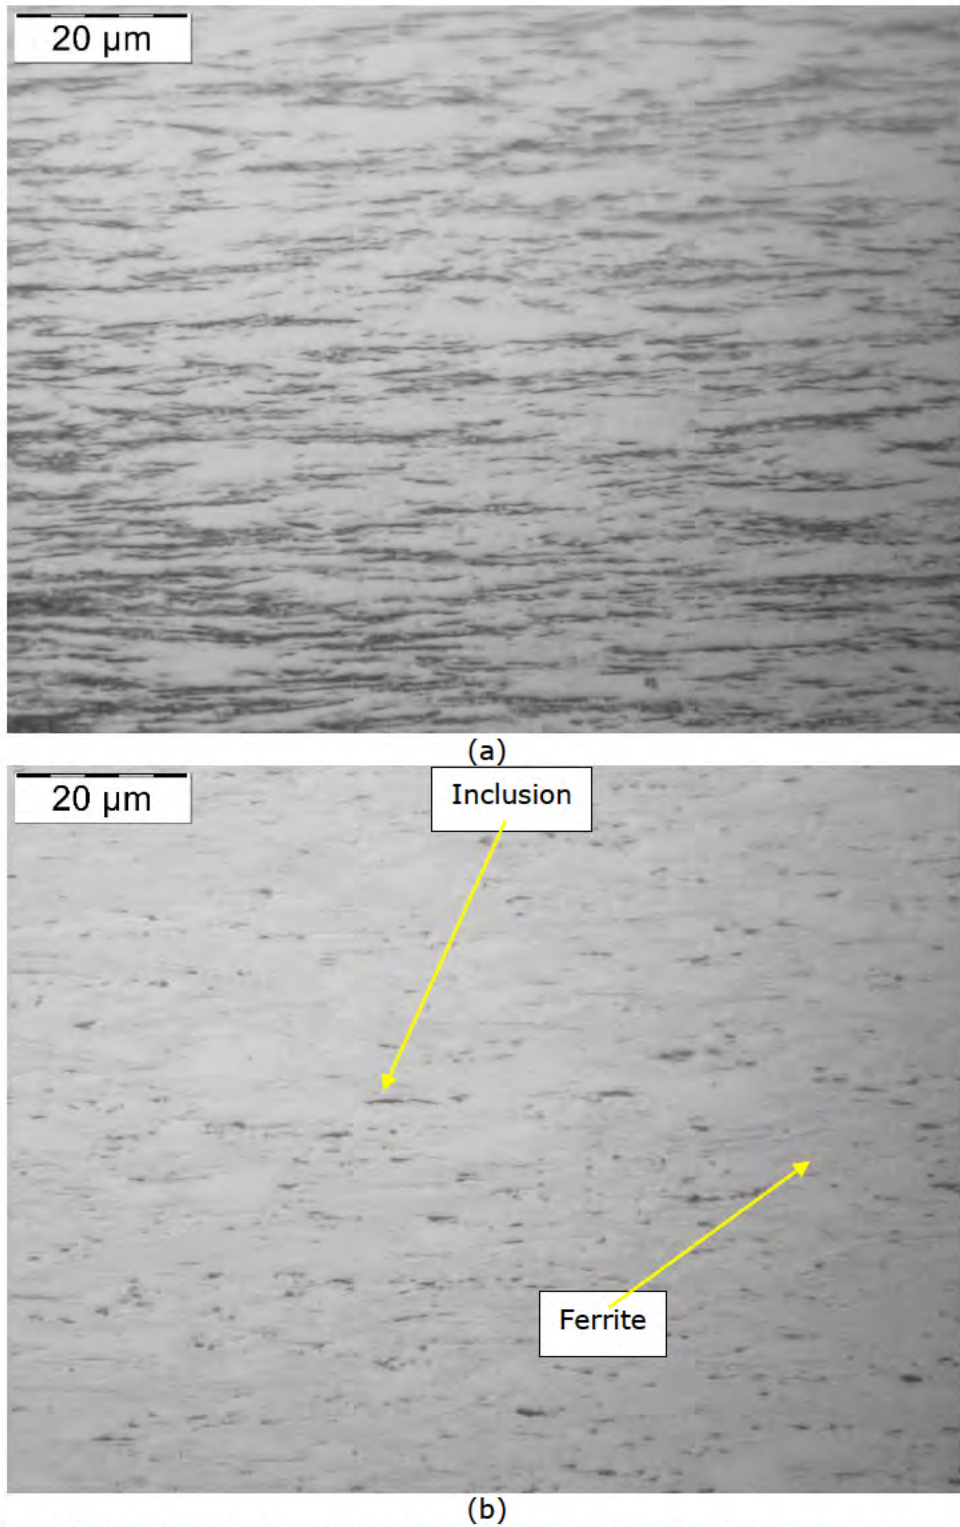
Figure 121. Photomicrographs of Mount M1 showing (a) the detail of the corrosion attack and (b) the microstructure of the strand wires from the wire layer of the Subject Aft Cable; locations shown in Figure 120.

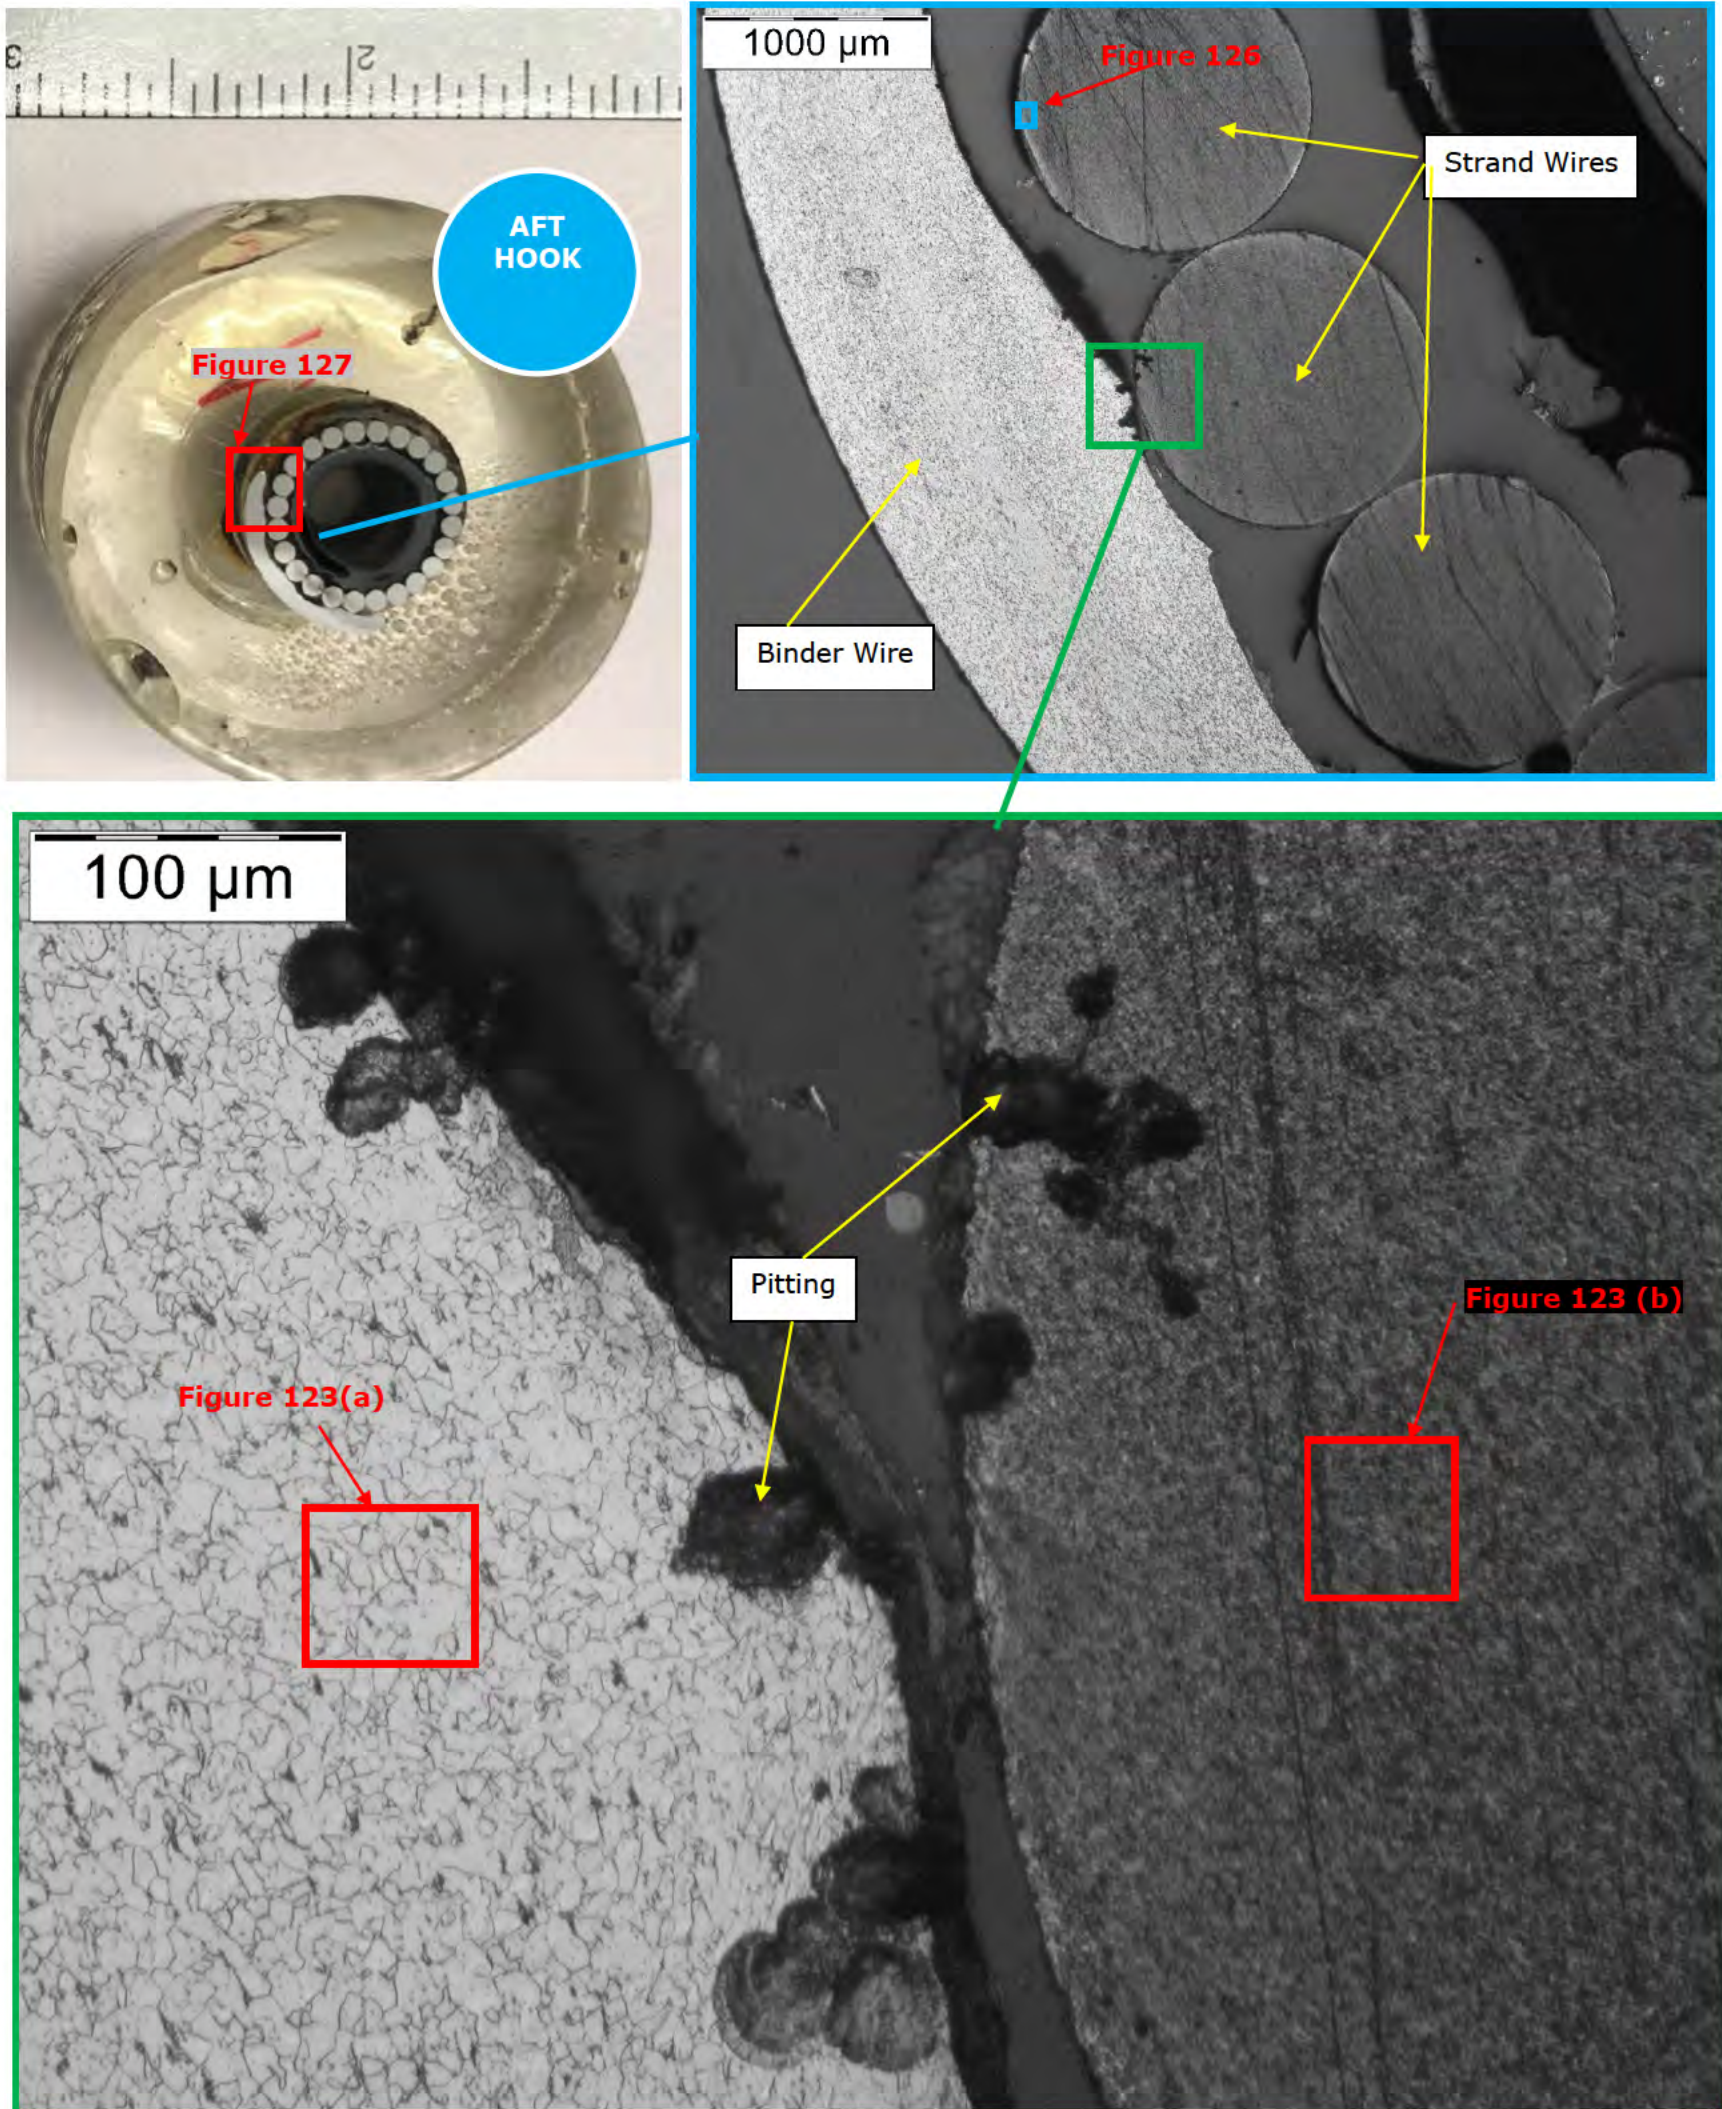
Figure 122. Photograph and photomicrographs of a transverse metallographic mount, Mount M2, showing the corrosion attack of the binder and strand wires from the wire layer of the Subject Aft Cable; mount removed from location shown in Figure 114. The blue circle indicates that the direction toward the Subject Aft Hook is out of the paper. The ruler in the upper left photograph is in inches.

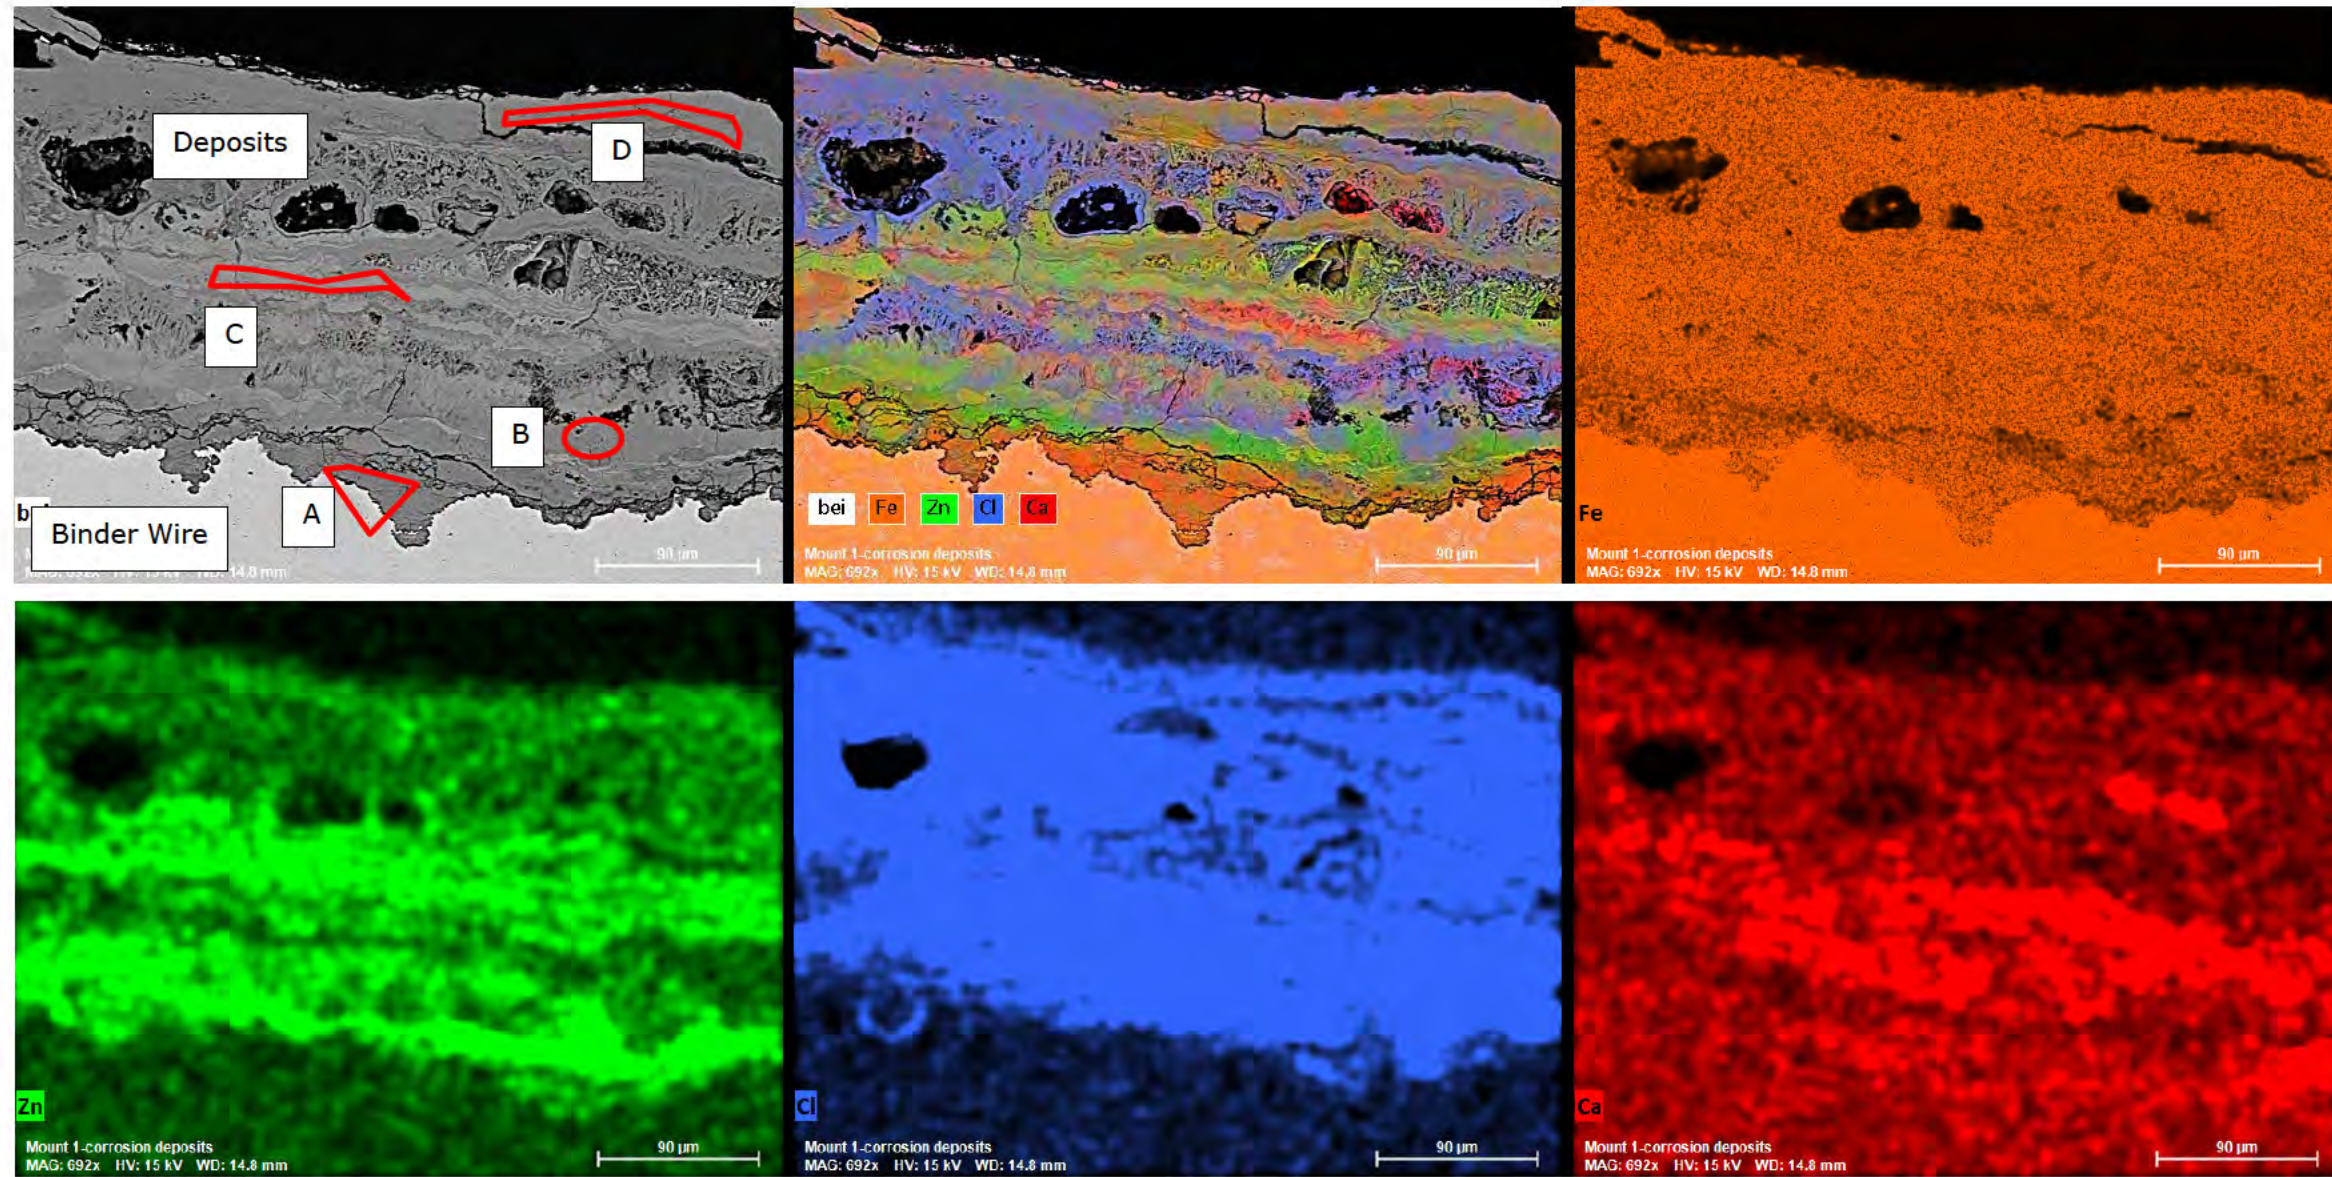
| Location | Oxygen (O) | Sodium (Na) | Magnesium (Mg) | Aluminum (Al) | Silicon (Si) | Sulfur (S) | Chlorine (Cl) | Calcium (Ca) | Chromium (Cr) | Manganese (Mn) | Iron (Fe) | Copper (Cu) | Zinc (Zn) |

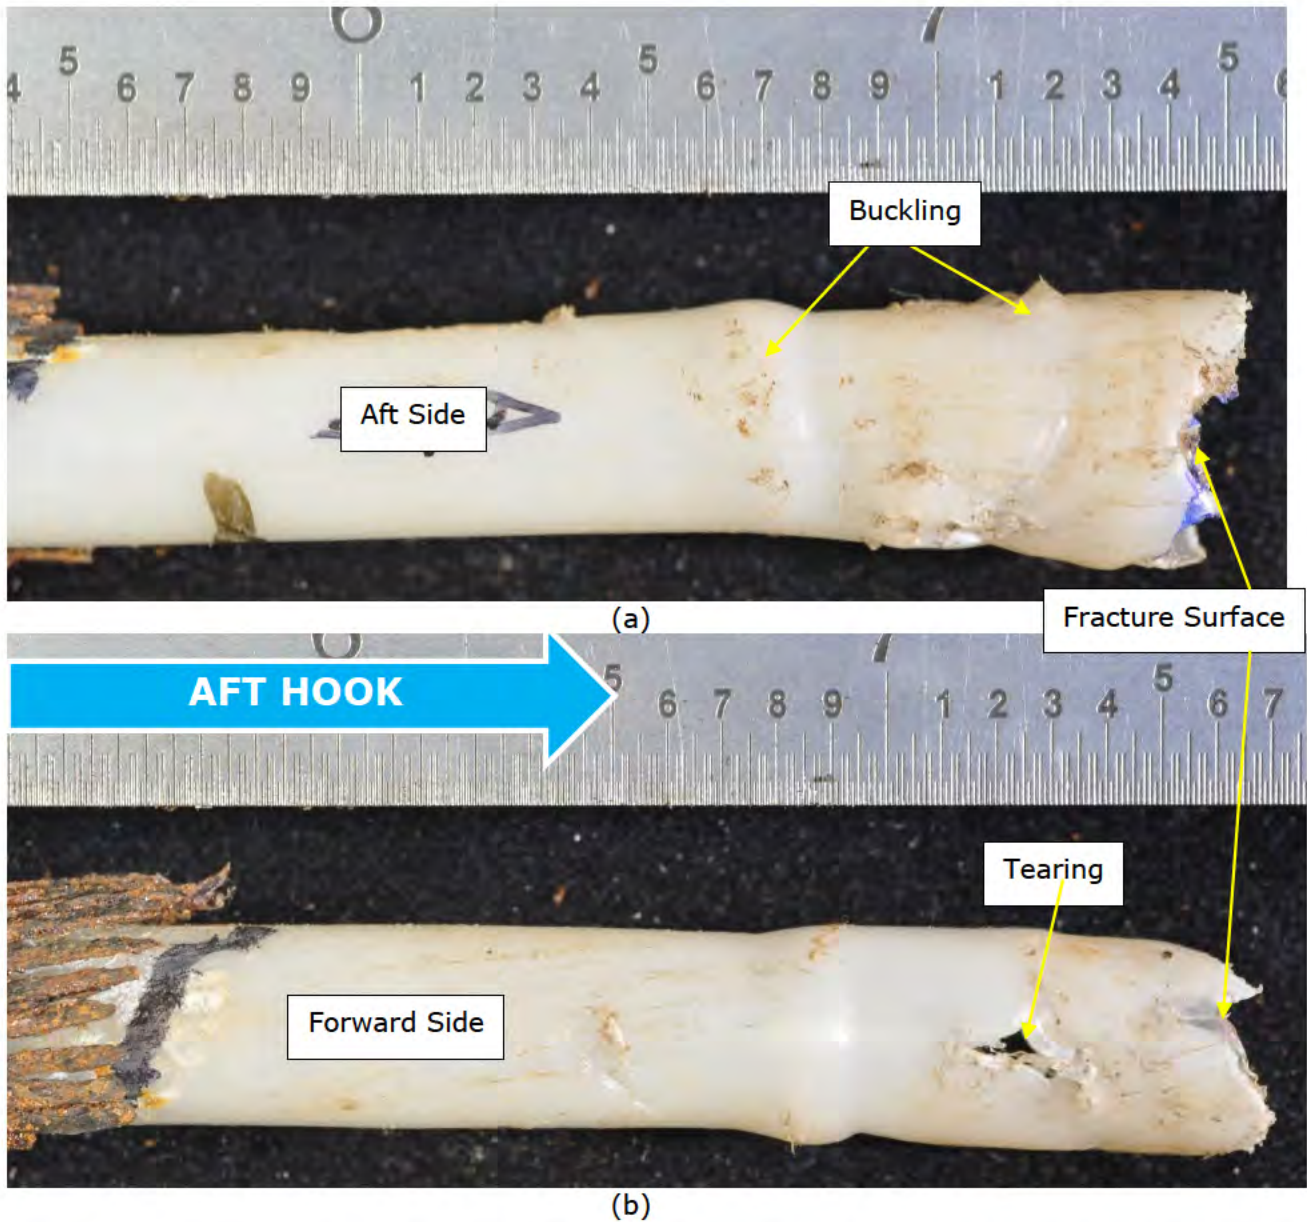
Figure 128. Photographs of the one failed liner from the Subject Release Unit side after dissection showing the (a) aft side and (b) forward side; samples shown in Figure 108. The mating half of the failed liner is shown in Figure 129. Forward and aft refer to the orientation of the keeper relative to the lifeboat. The direction of the Subject Aft Hook is noted with the blue arrow. Rulers are in inches.

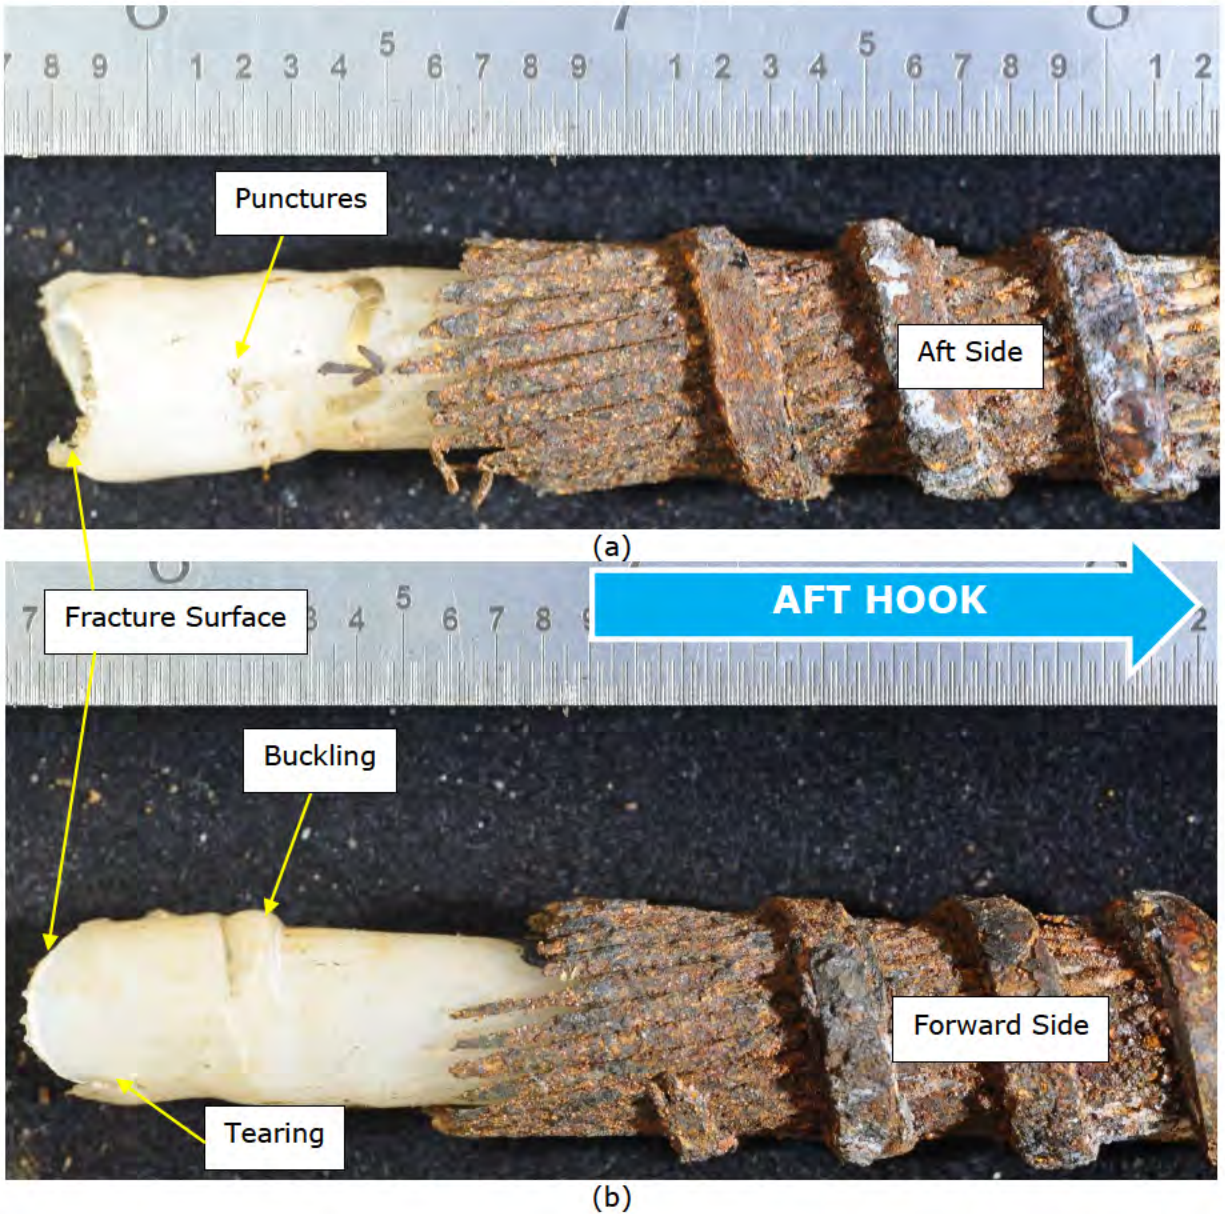
Figure 129. Photographs of the failed liner from the Subject Aft Hook side after dissection showing the (a) aft side and (b) forward side; samples shown in Figure 108. The mating half of the failed liner is shown in Figure 128. Forward and aft refer to the orientation of the keeper relative to the lifeboat. The direction of the Subject Aft Hook is noted with the blue arrow. Rulers are in inches.

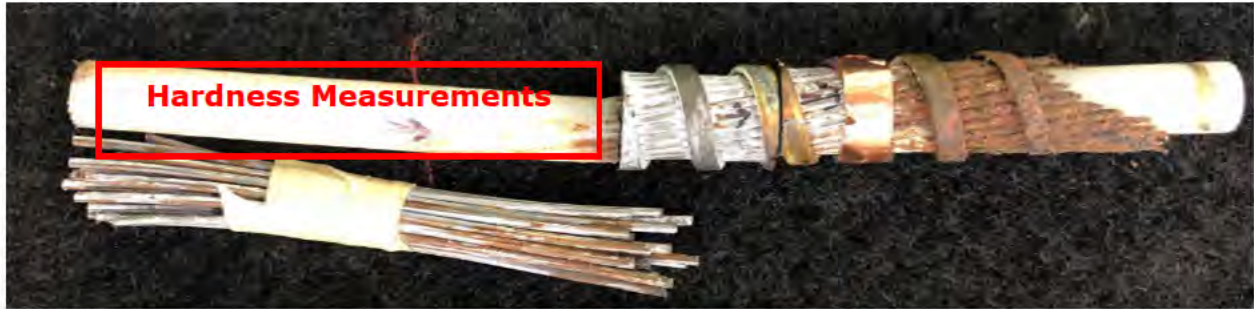
| Sample location shown in (a) | Shore D Hardness Average of Four Measurements |

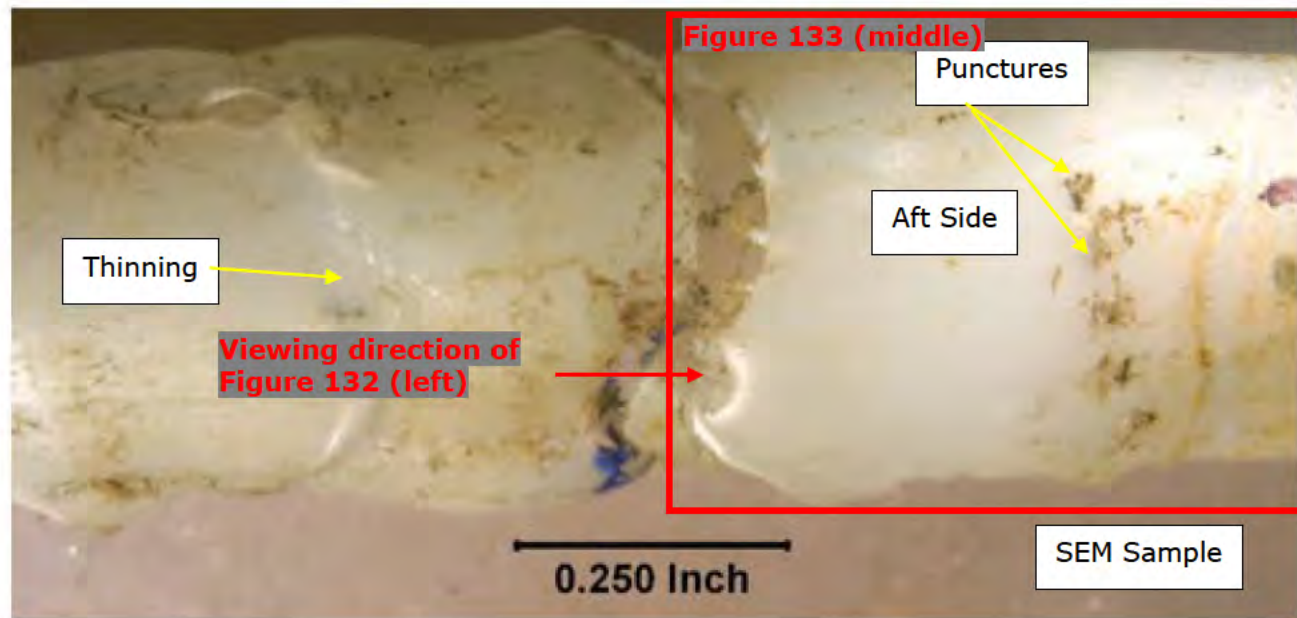
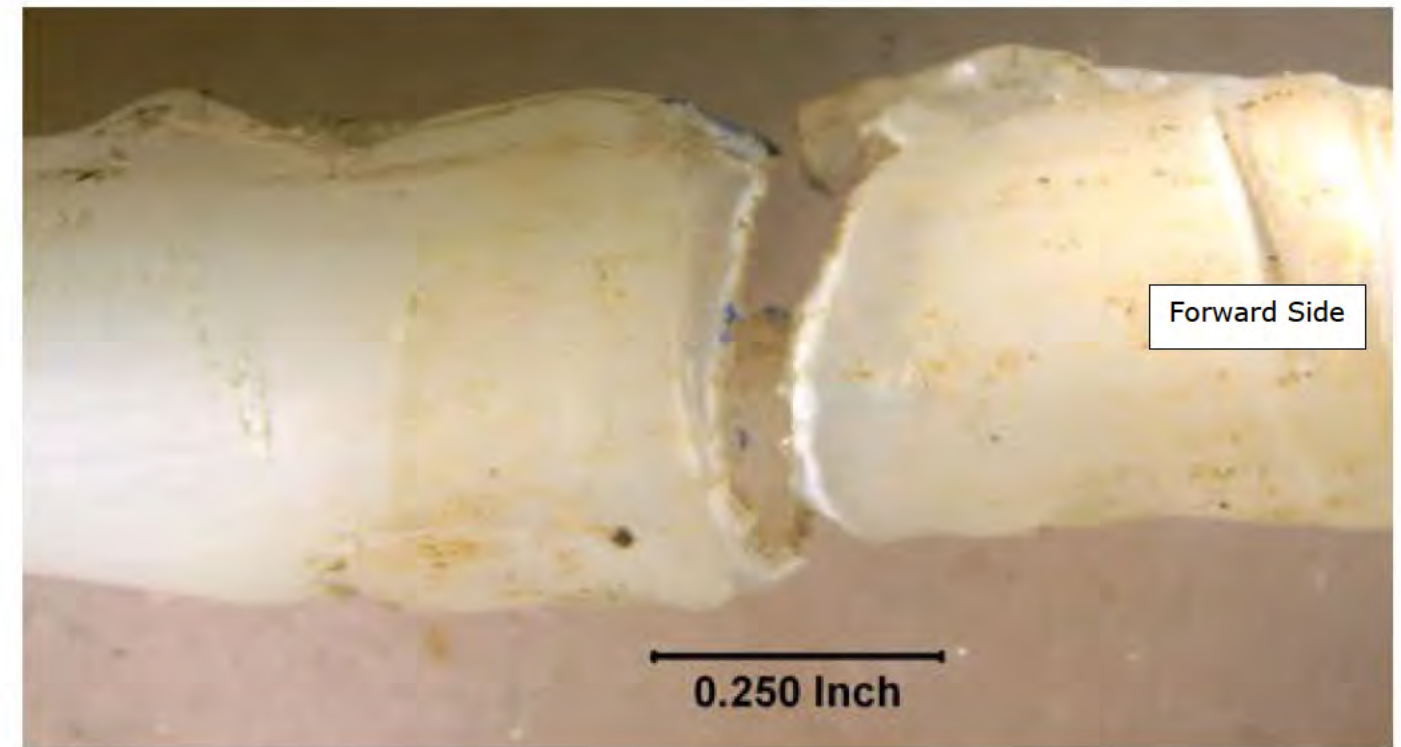
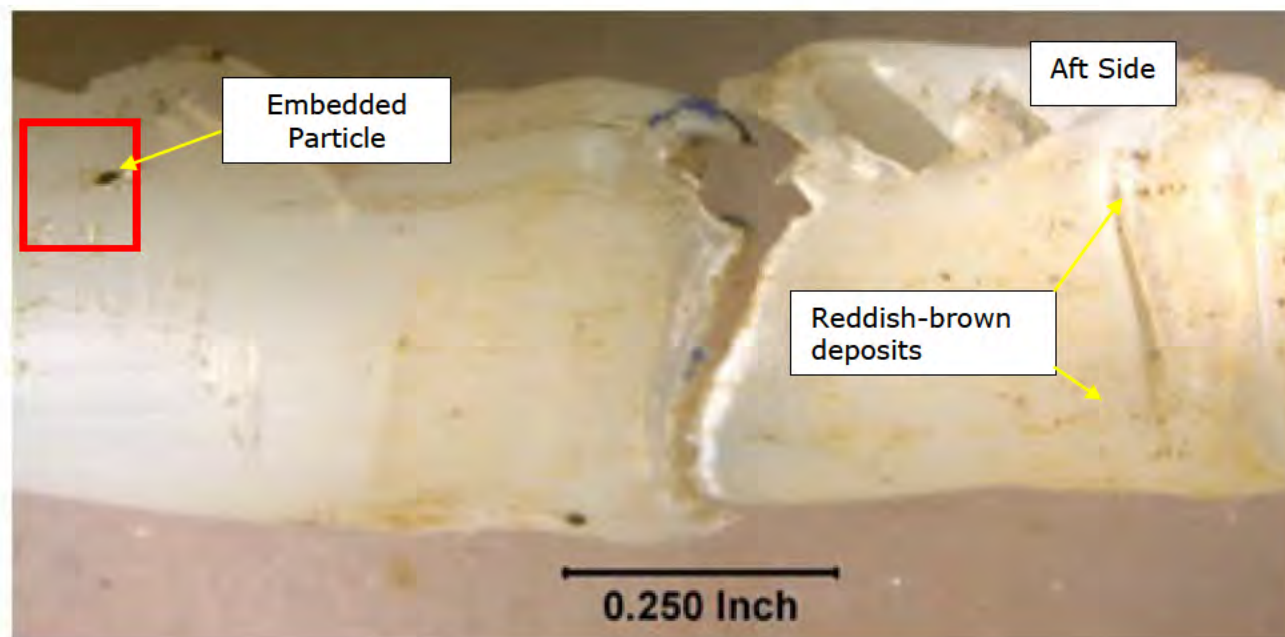
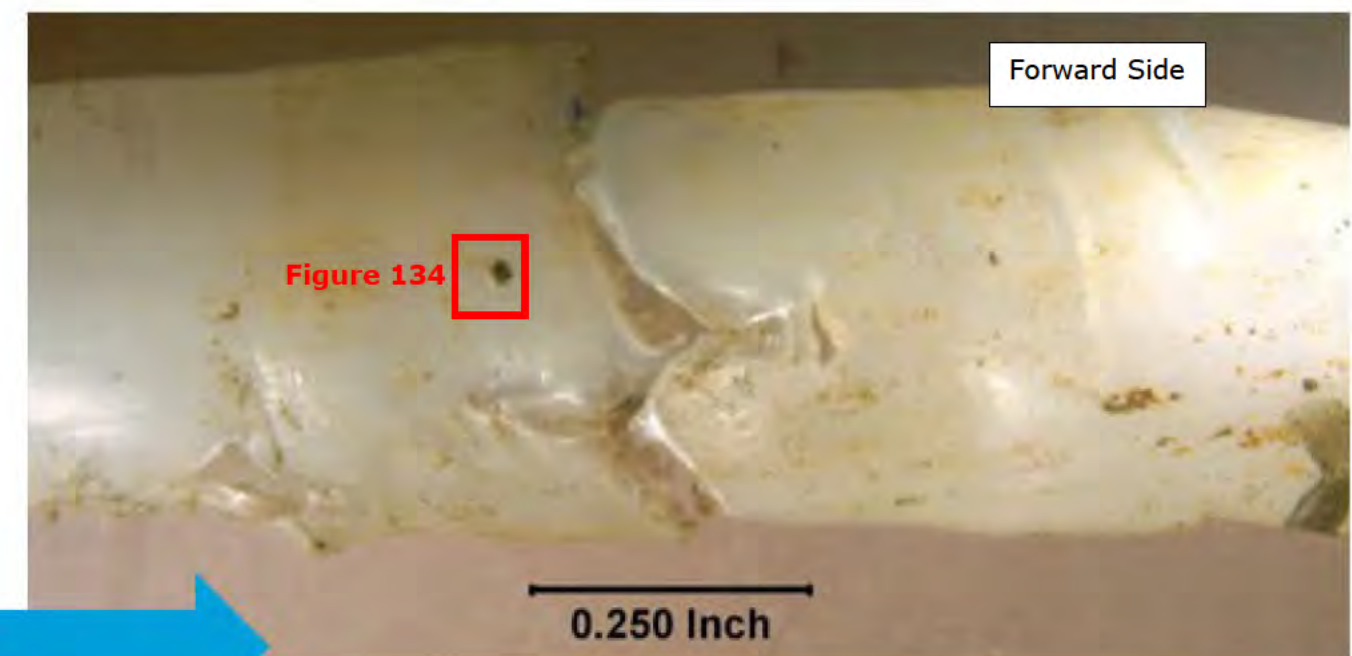
Figure 131. Light photomicrographs of the liner from the Subject Aft Cable showing the failure. The direction of the Subject Aft Hook is noted with the blue arrow.

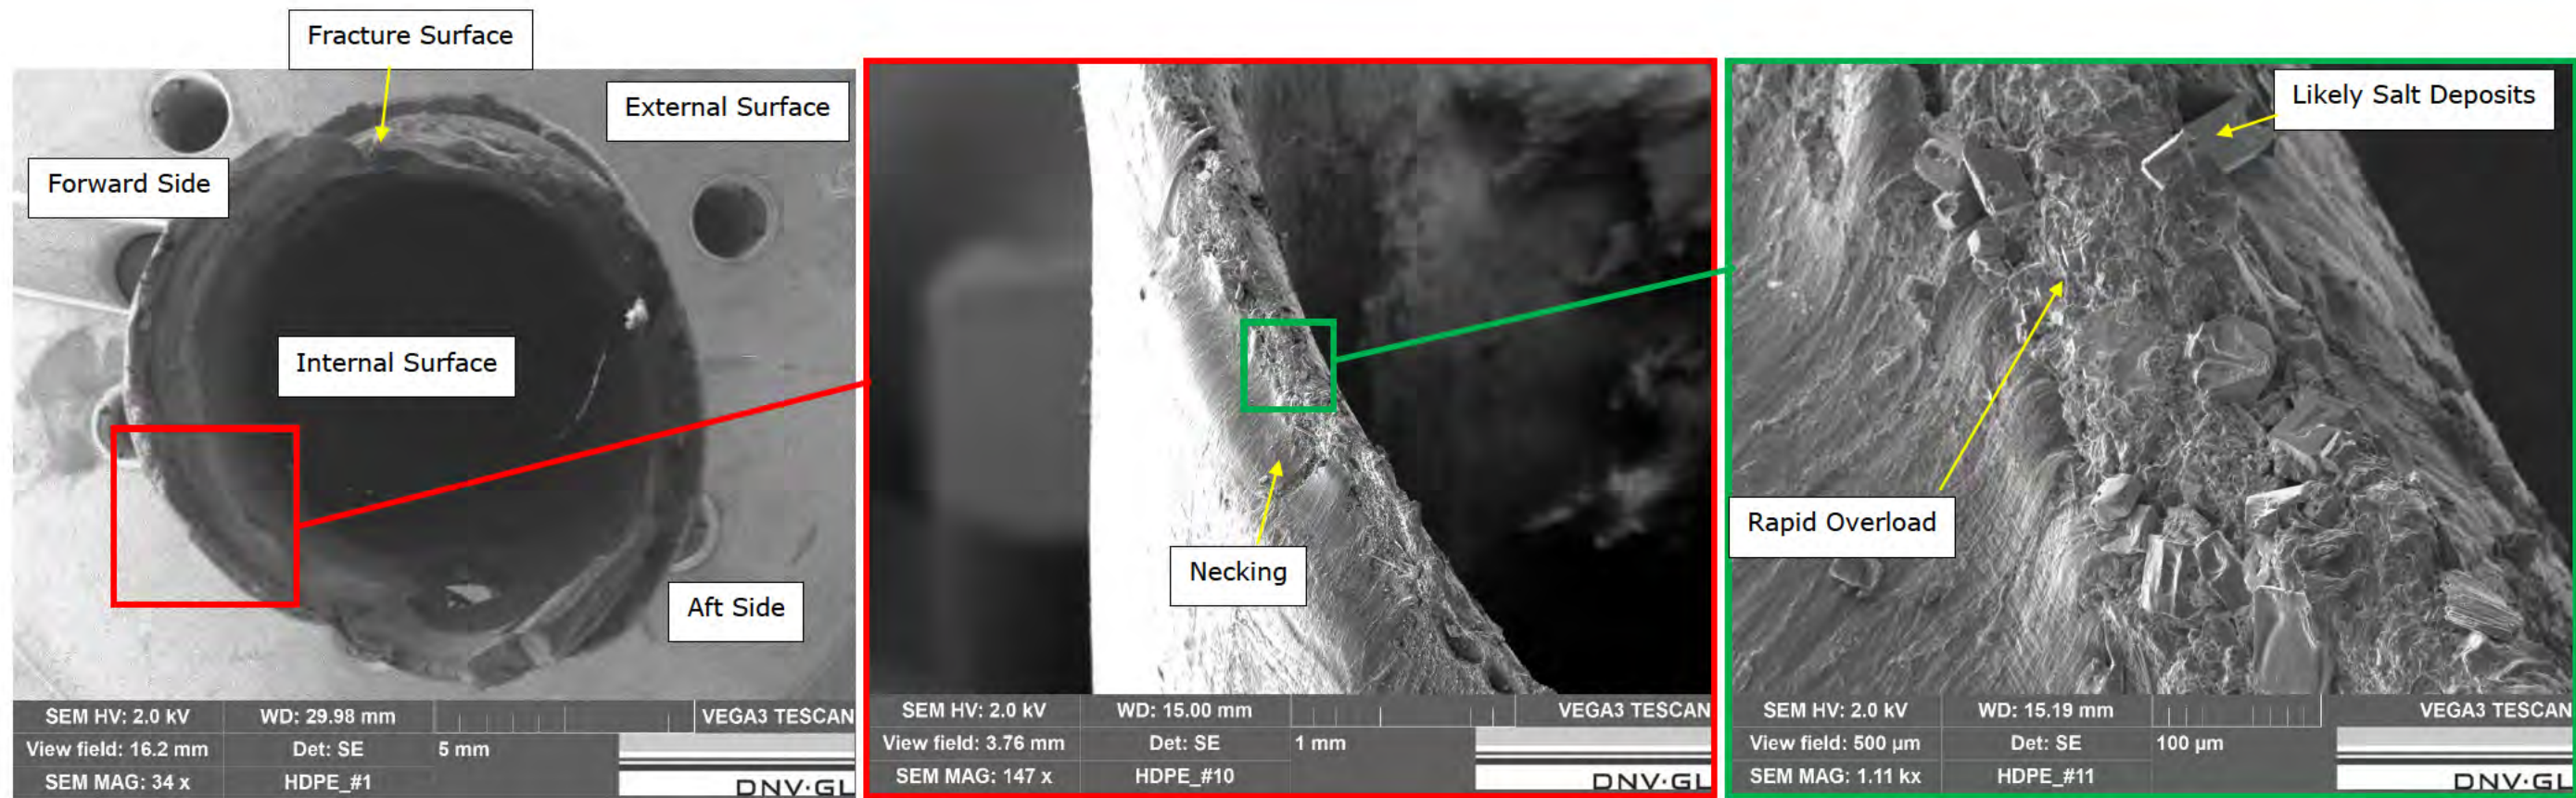
Figure 132. SEM images of the liner from the Subject Aft Hook side of the Subject Aft Cable showing the fracture surface; sample location is shown in Figure 131.

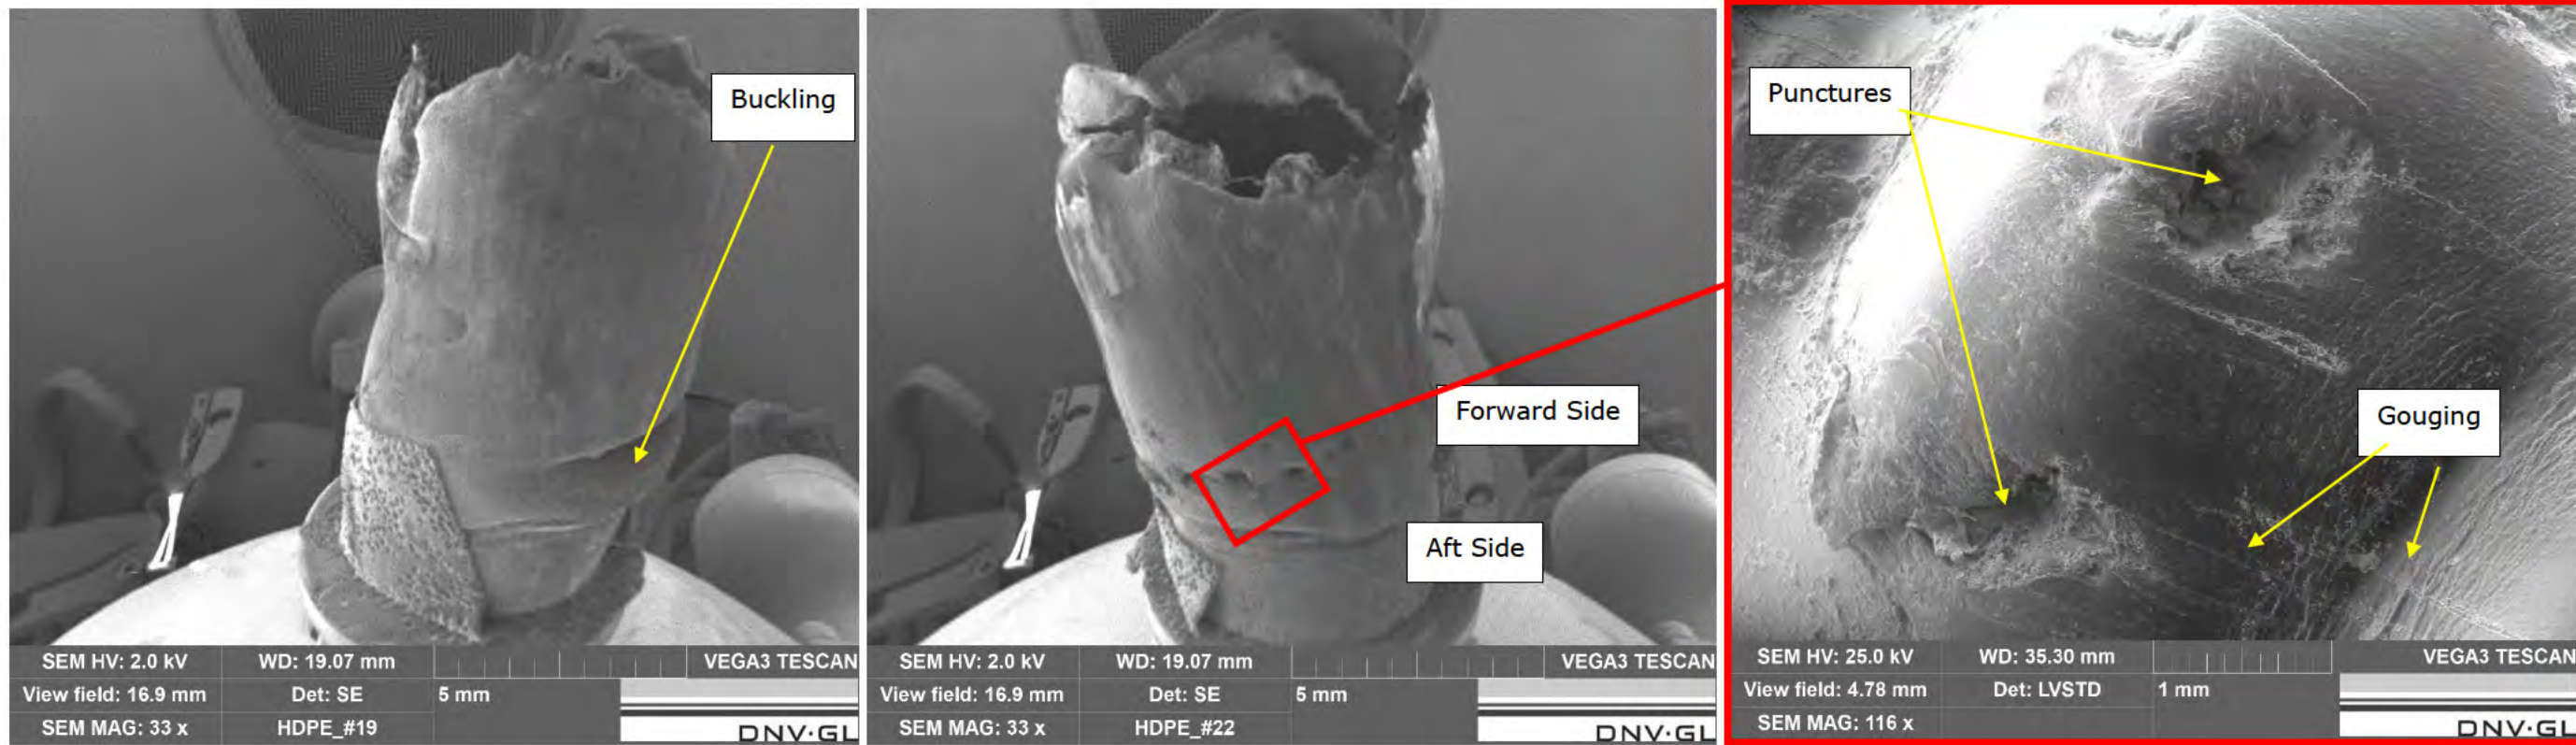
Figure 133. SEM images of the liner from the Subject Aft Hook side of the Subject Aft Cable showing the external surface; sample location is shown in Figure 131.
