Final Report

Auger Lifeboat 6 Incident

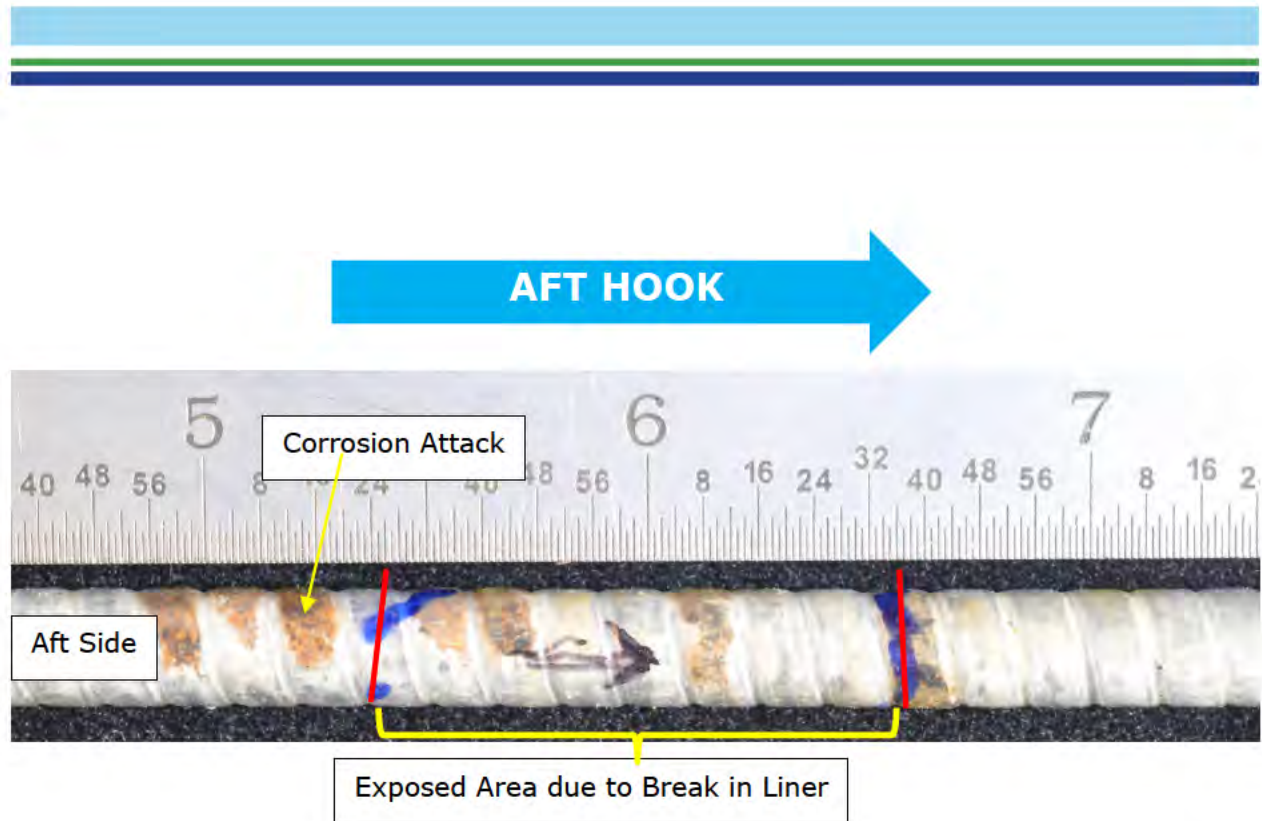
Figure 140. Photograph of the inner member from the Subject Aft Cable after dissection showing the aft side; samples shown in Figure 108. Aft refers to the orientation of the keeper relative to the lifeboat. The direction of the Subject Aft Hook is noted with the blue arrow. Ruler is in inches.

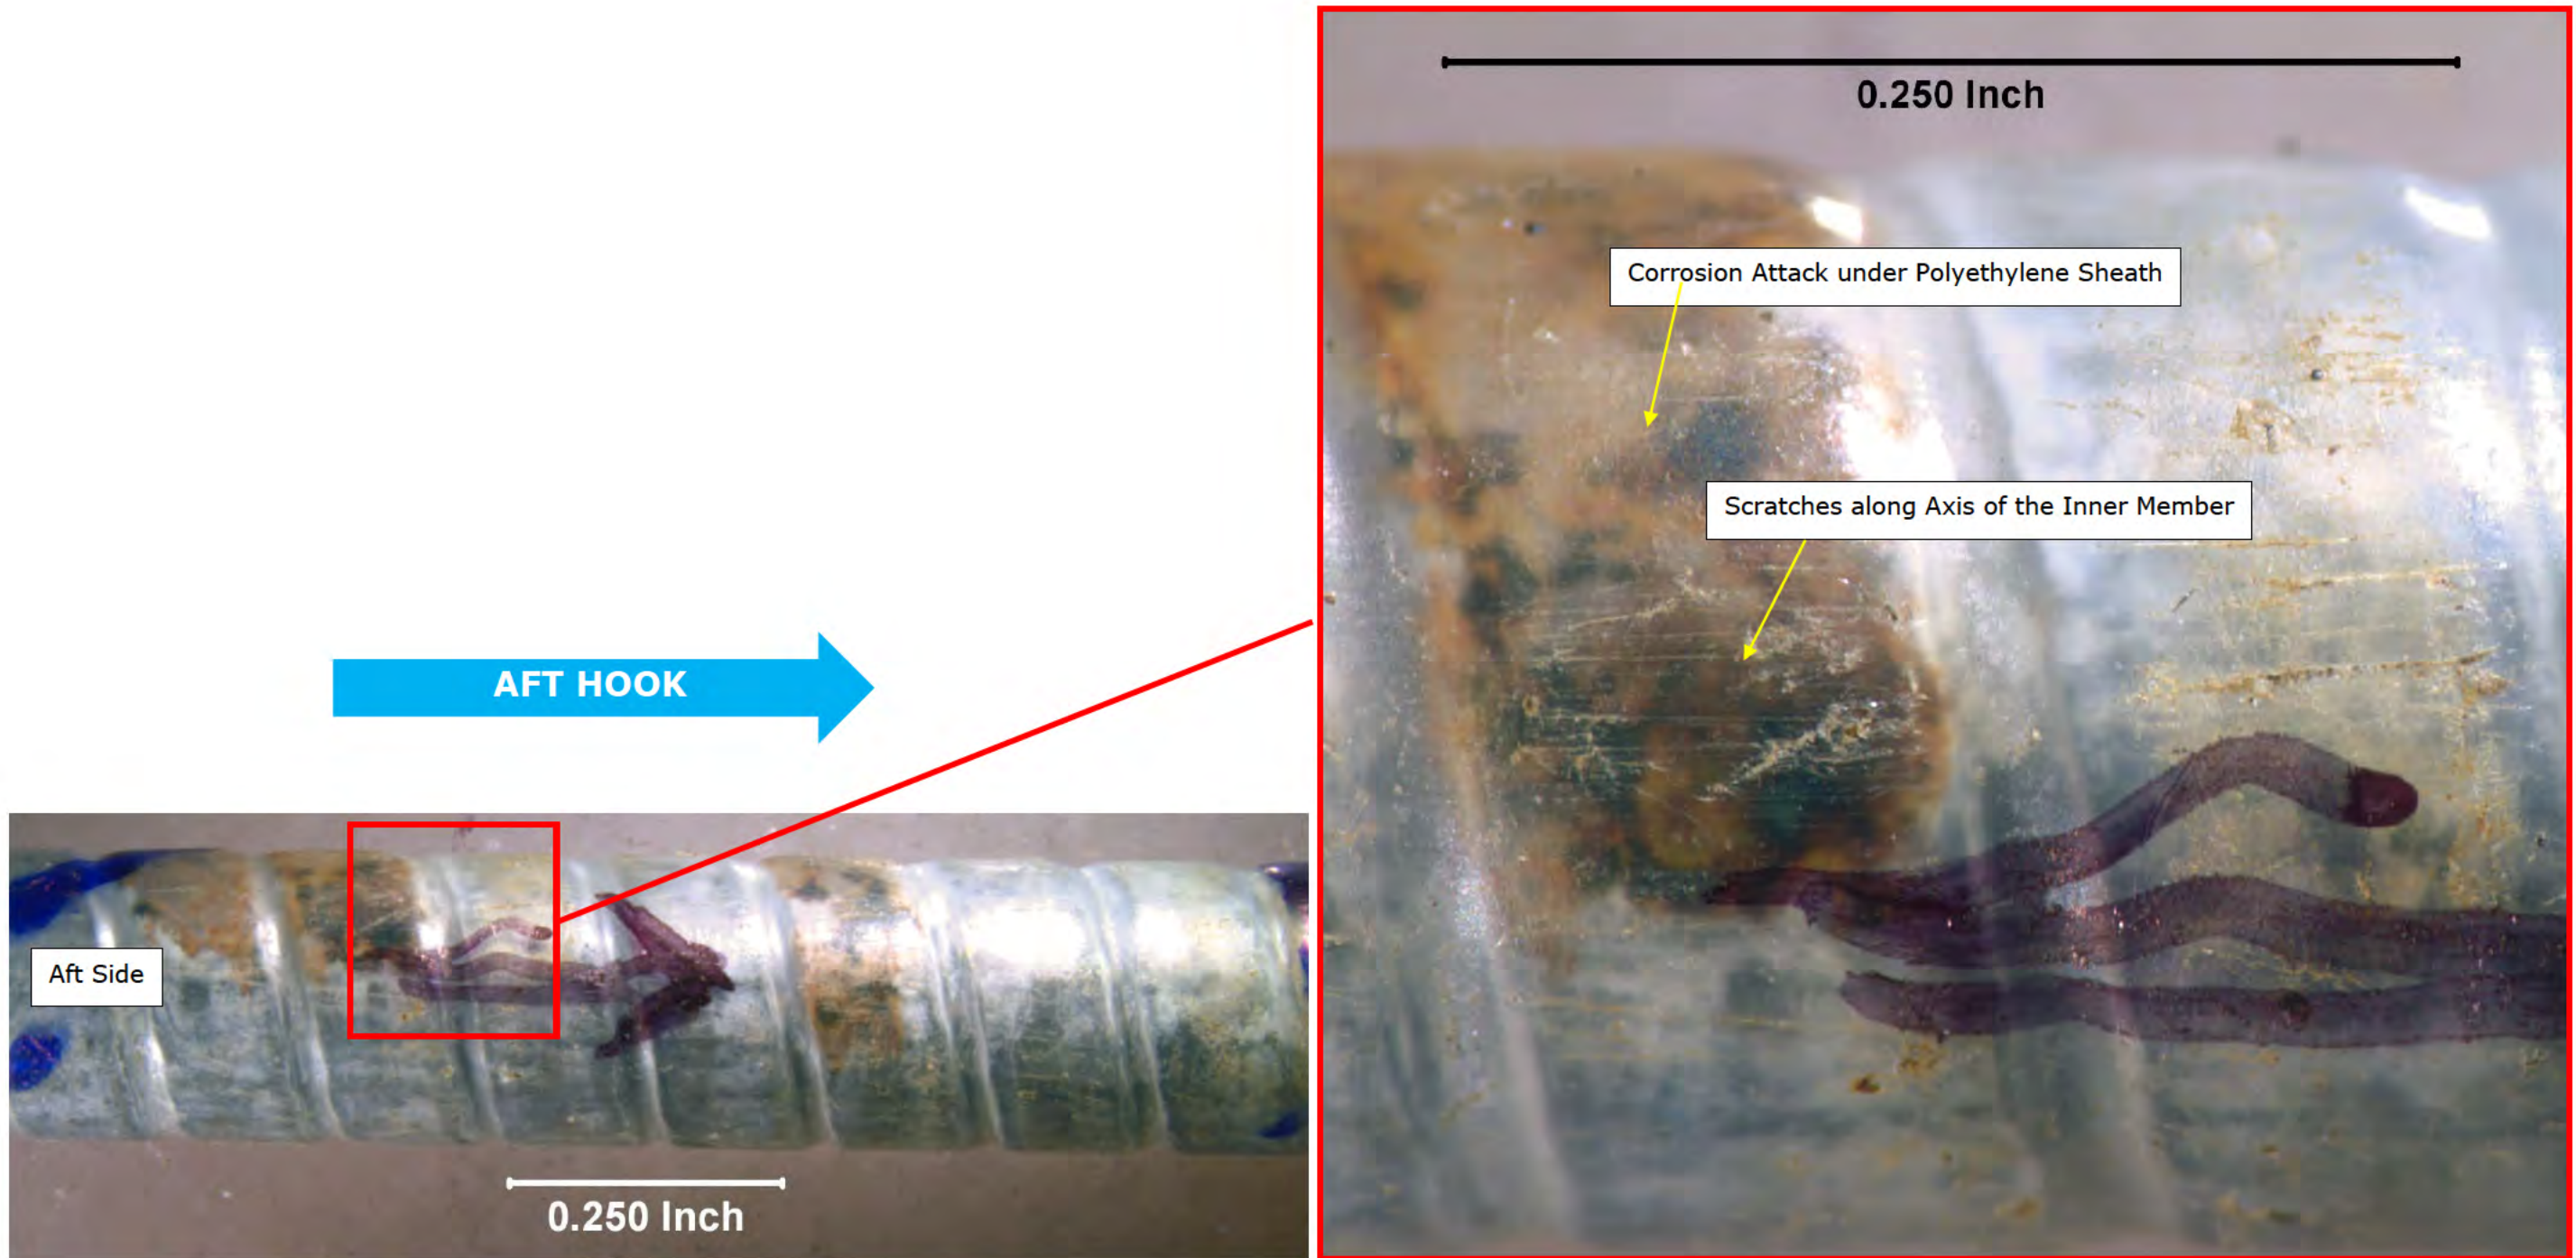
Figure 141. Light micrographs of the inner member of the Subject Aft Cable showing the detail of the minor corrosion attack to the binder wire and damage to the sheath layer of the inner member. The direction of the Subject Aft Hook is noted with the blue arrow.

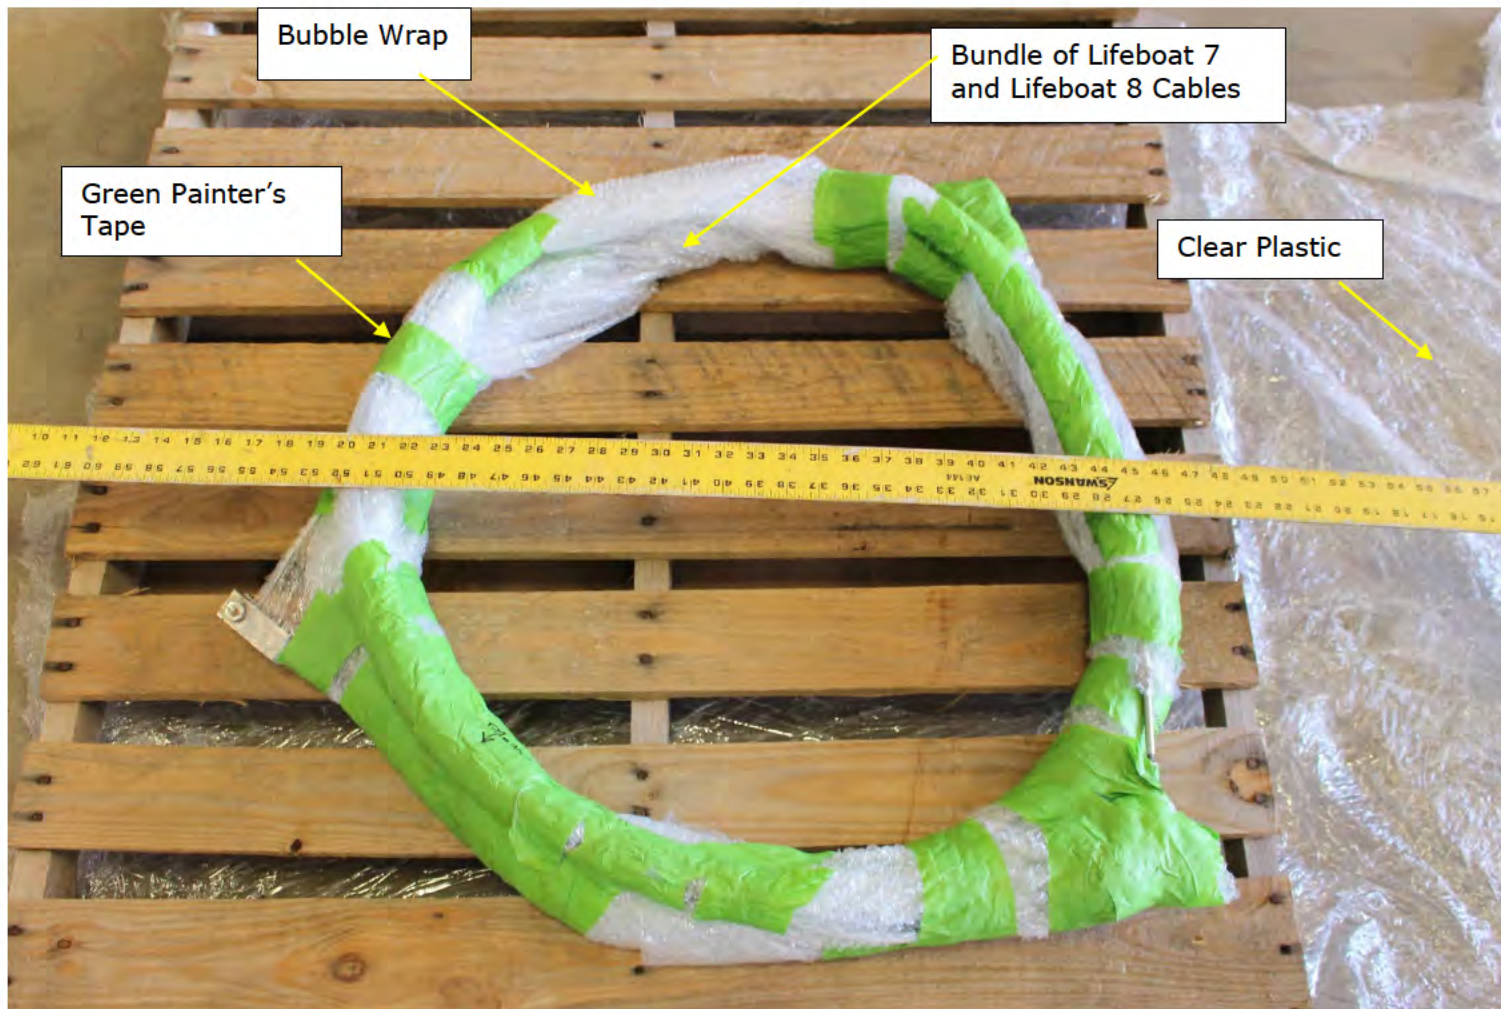
Figure 143. Photograph of the hydrostat cable from Lifeboat 7 and the forward control cable from Lifeboat 8, at DNV GL, after partially removing the wrappings from shipment. Ruler is in inches.

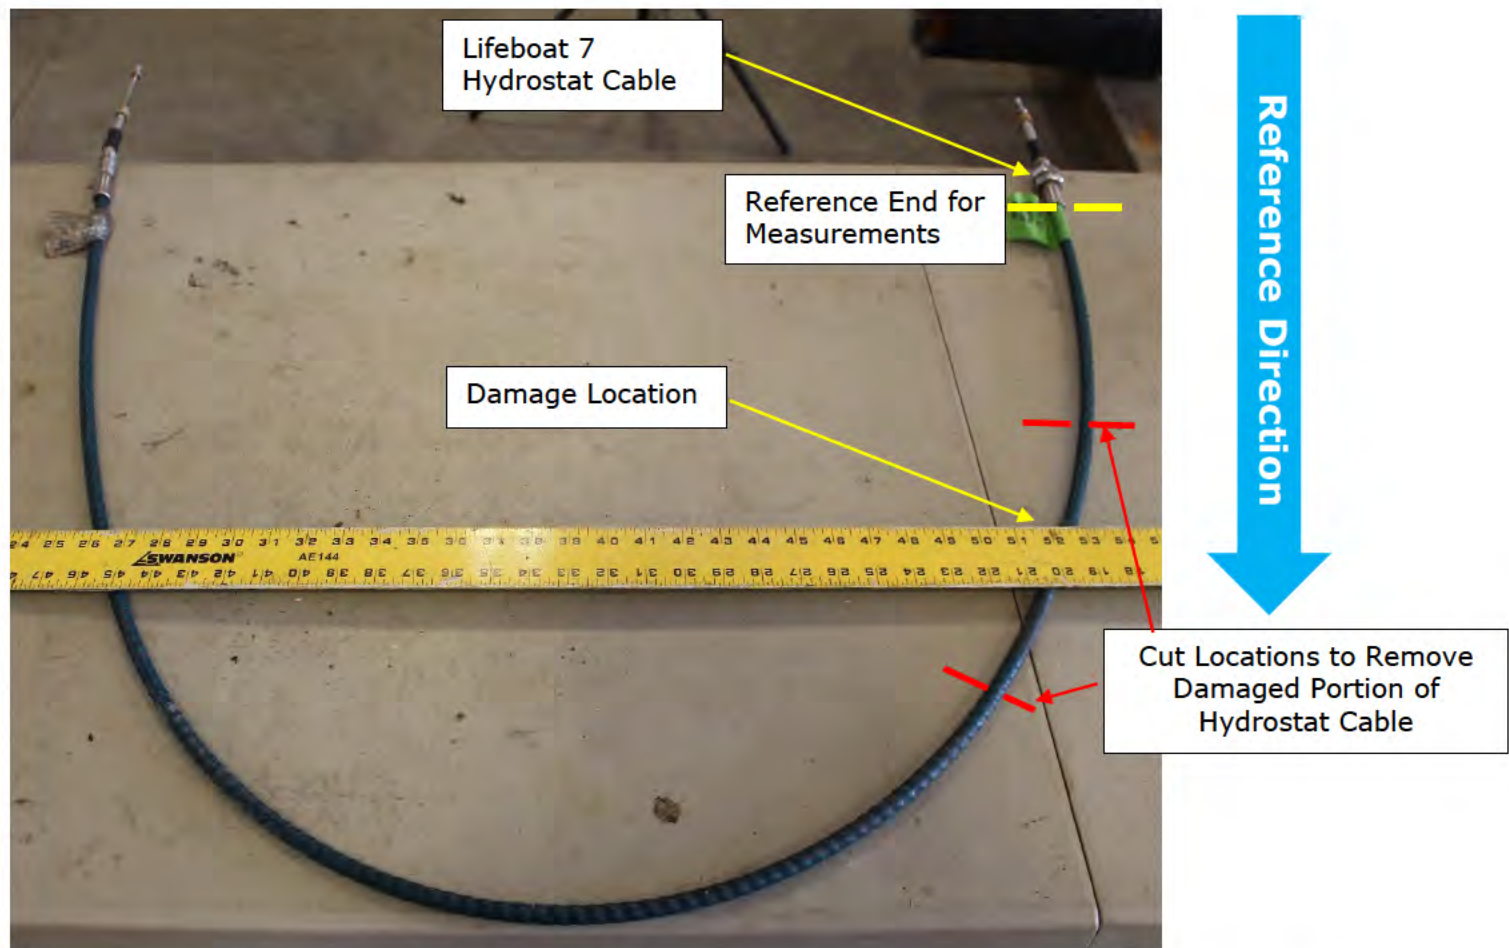
Figure 144. Photograph of the hydrostat cable from Lifeboat 7 after removing the wrappings. Ruler is in inches.

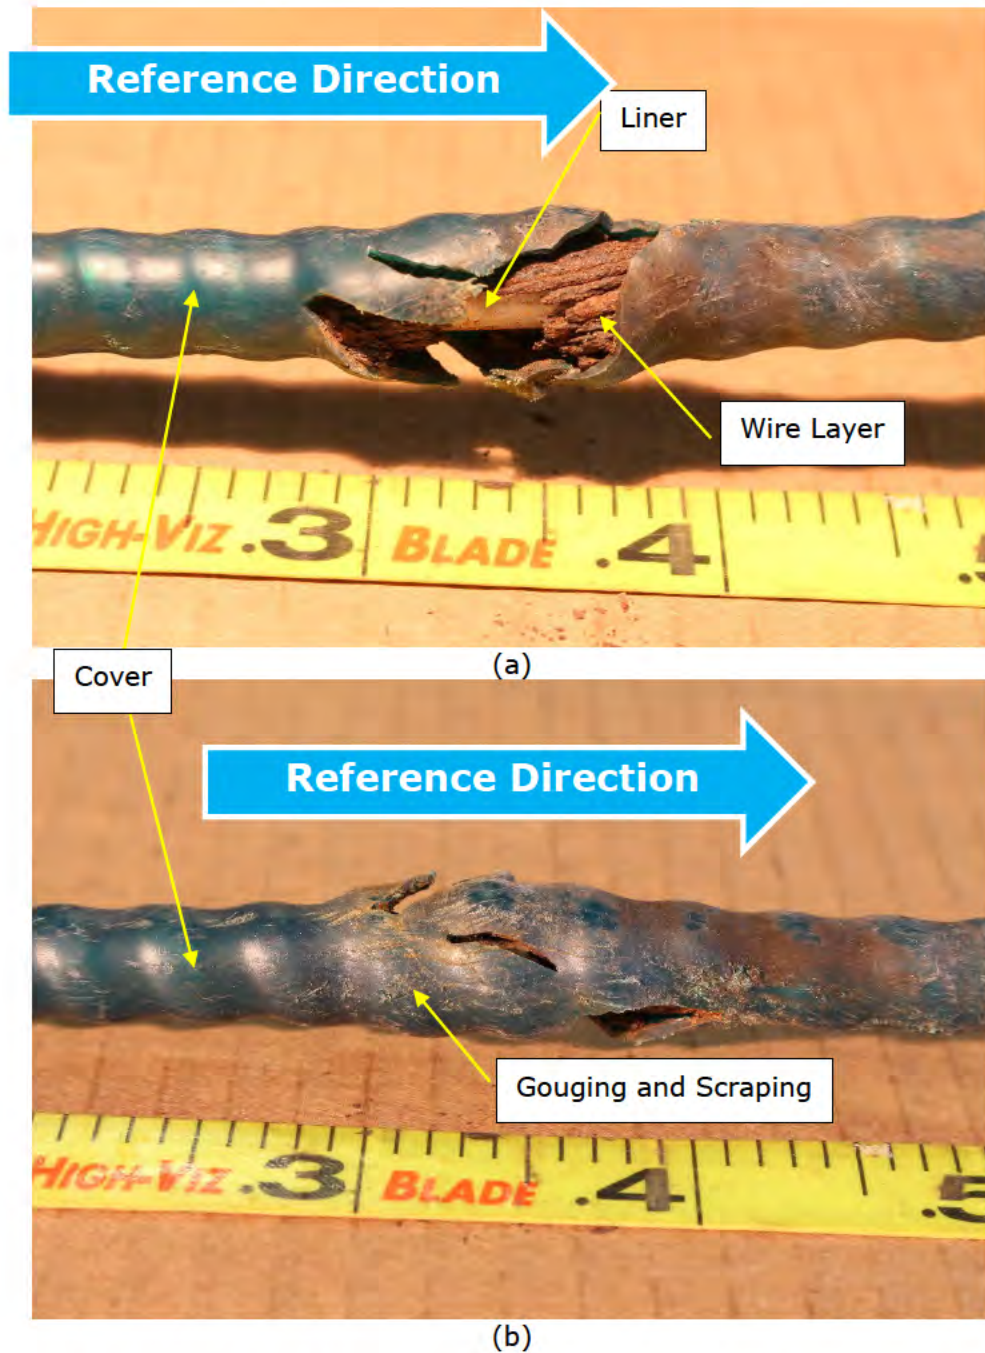
Figure 145. Photographs of the hydrostat cable from Lifeboat 7 showing damage at (a) the assumed top orientation and (b) the assumed bottom orientation. Measuring tape is in feet.

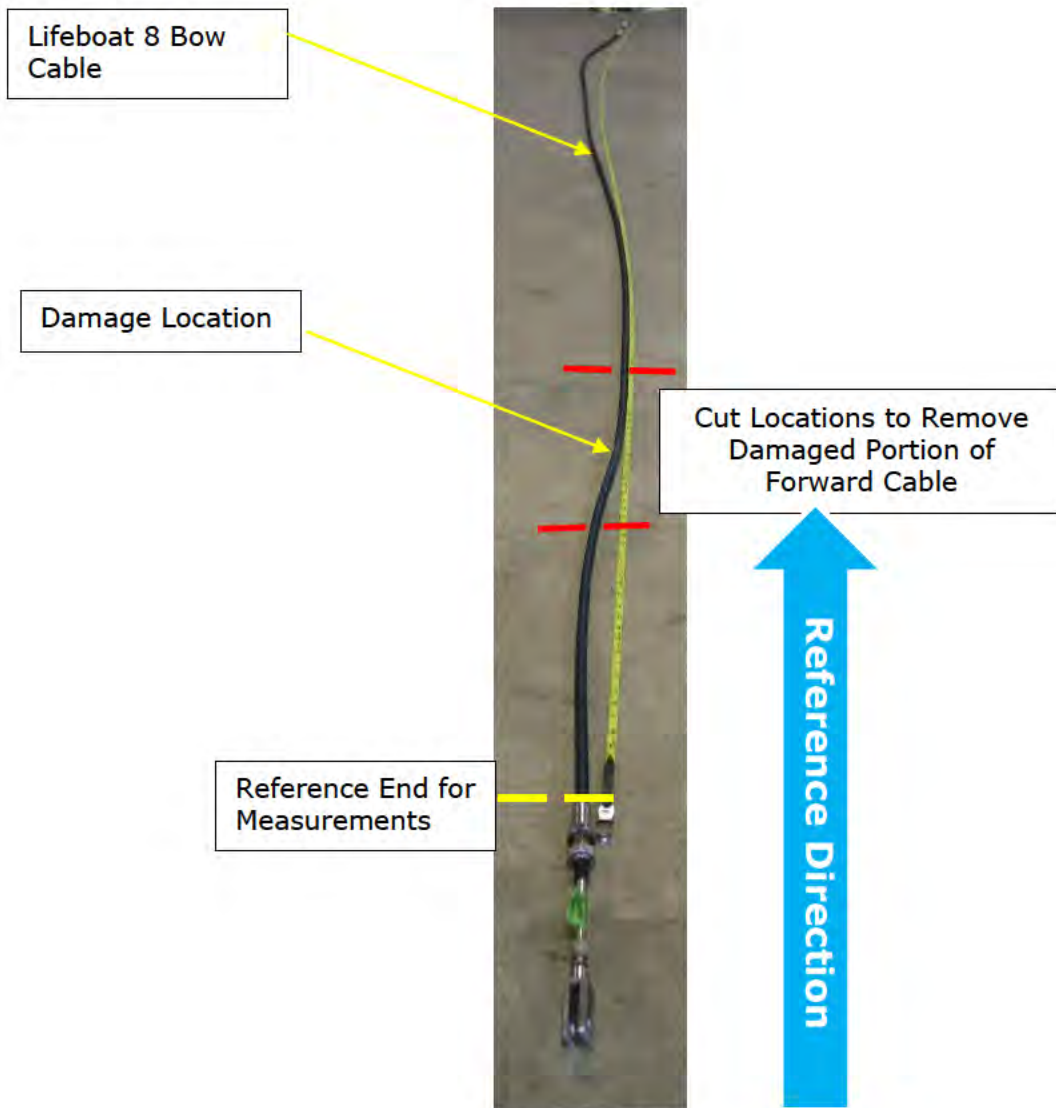
Figure 146. Photograph of the forward control cable from Lifeboat 8 after removing the wrappings. Measuring tape is in feet.

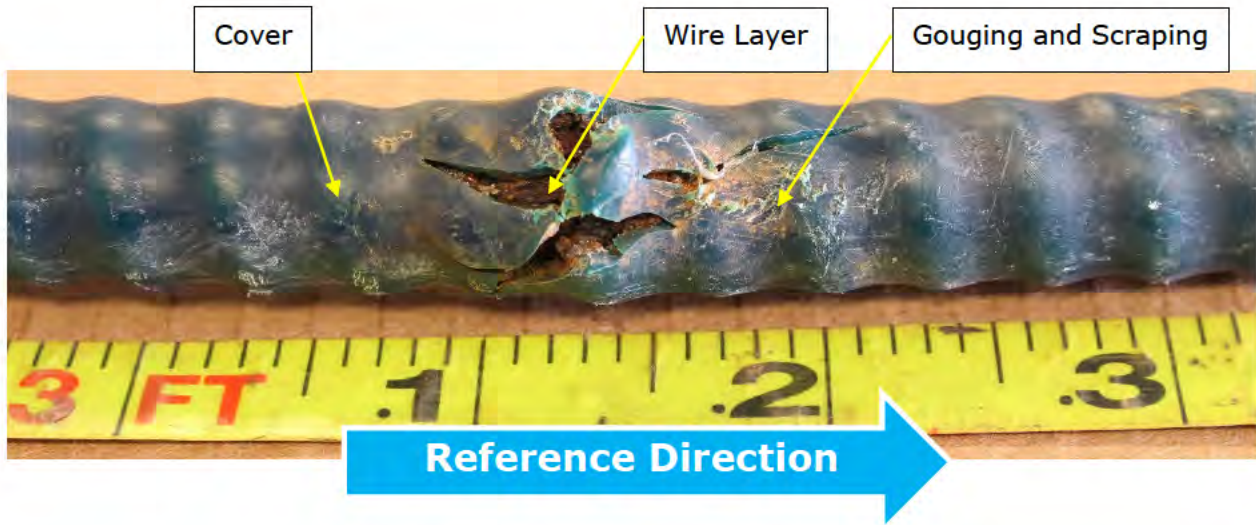
Figure 147. Photograph of the forward control cable from Lifeboat 8 showing damage at the assumed top orientation. Measuring tape is in feet.

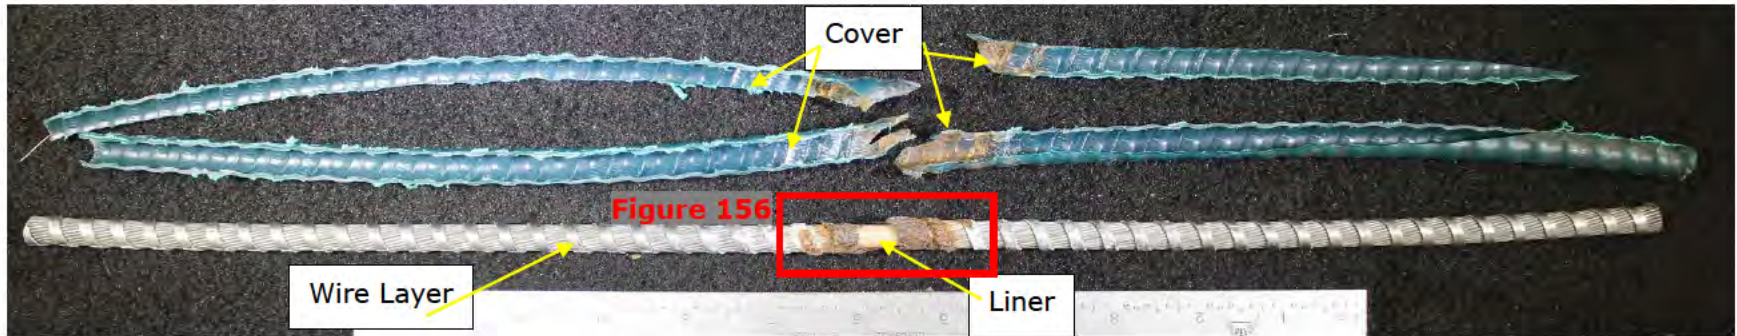
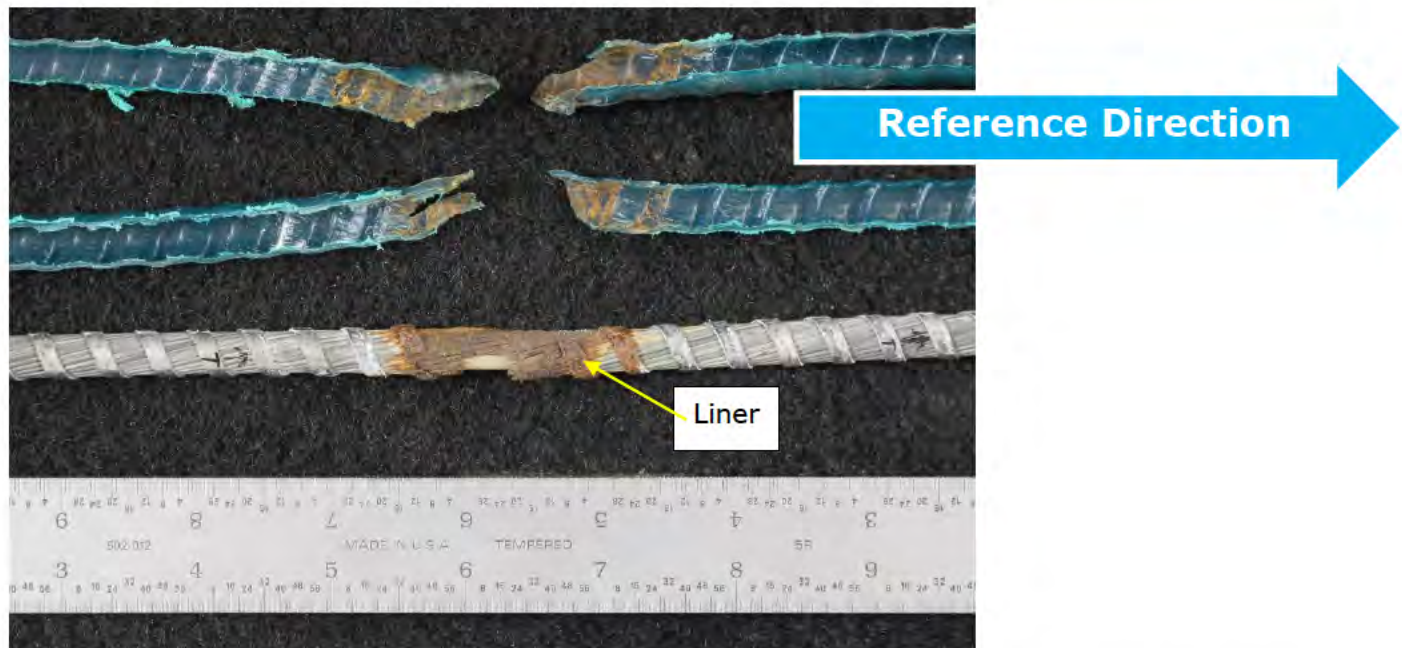
Figure 148. Photograph of the Lifeboat 7 hydrostat cable after dissection near the damaged location. Ruler is in inches.

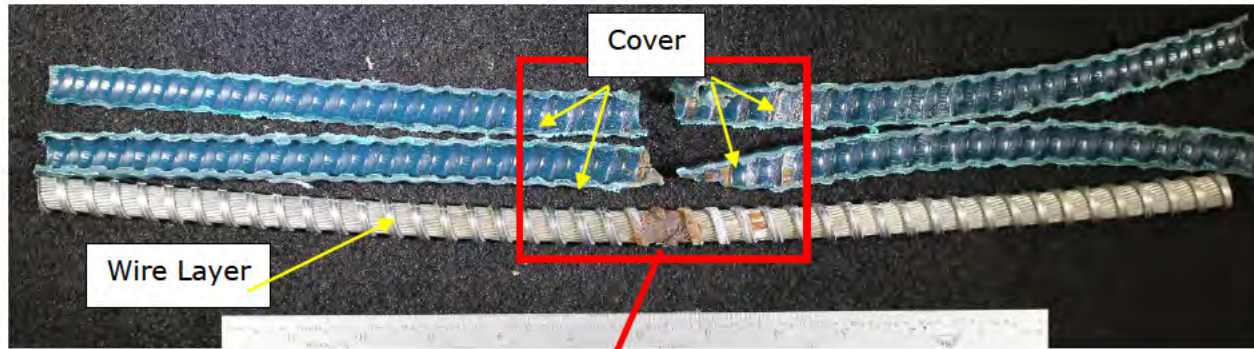
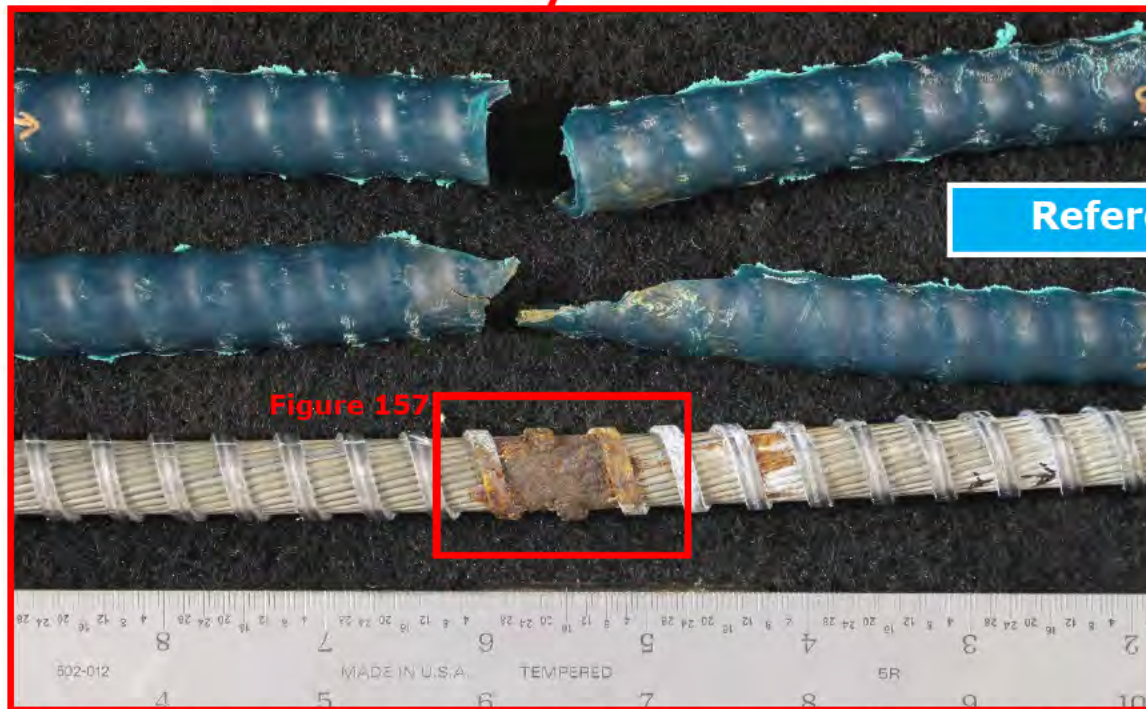
Figure 149. Photograph of the Lifeboat 8 forward control cable after dissection near the damaged location. Rulers are in inches.

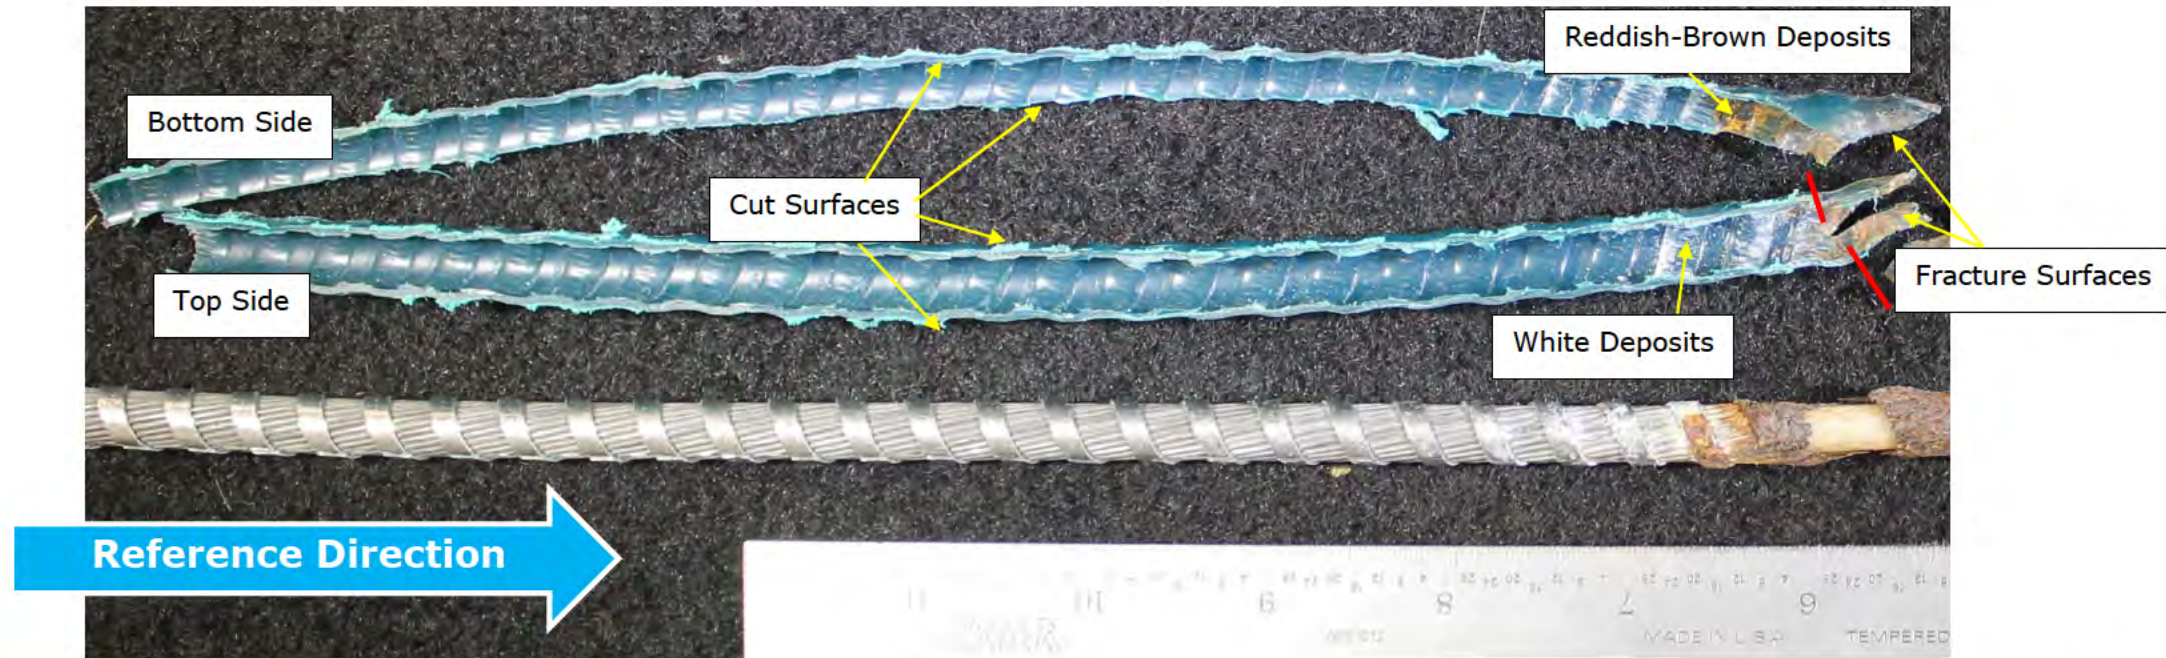
Figure 150. Photographs of the half the cover from the Lifeboat 7 hydrostat cable after dissection showing the internal surface near the damaged location; samples shown in Figure 148. The reference direction is noted with the blue arrow. Rulers are in inches.

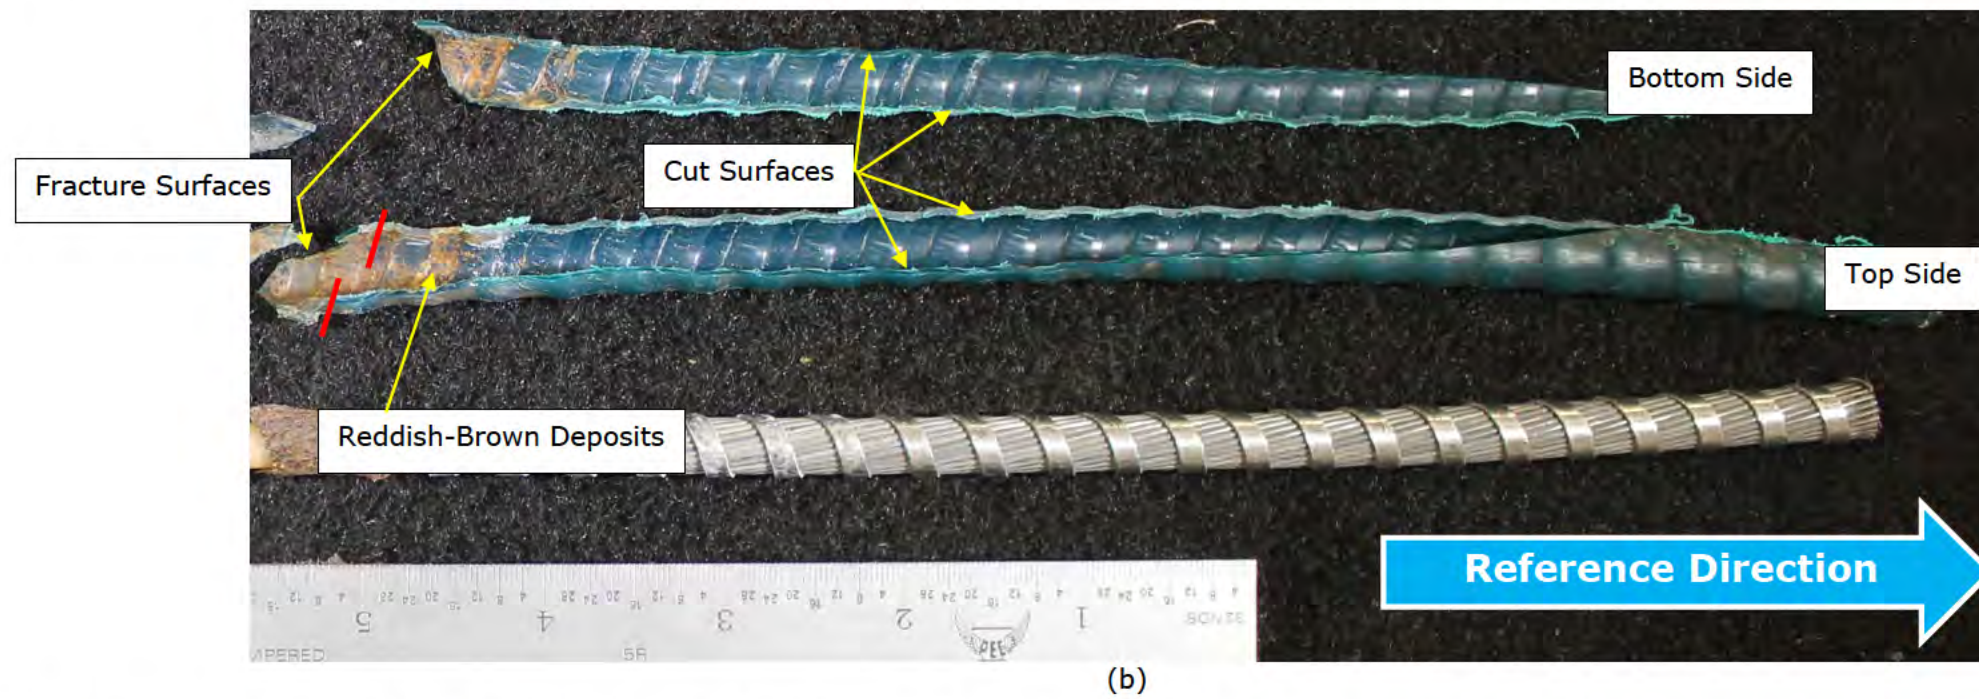
Figure 151. Photographs of the cover from the Lifeboat 7 hydrostat cable after dissection showing the internal surface near the damaged location; samples shown in Figure 148. The reference direction is noted with the blue arrow. Rulers are in inches.

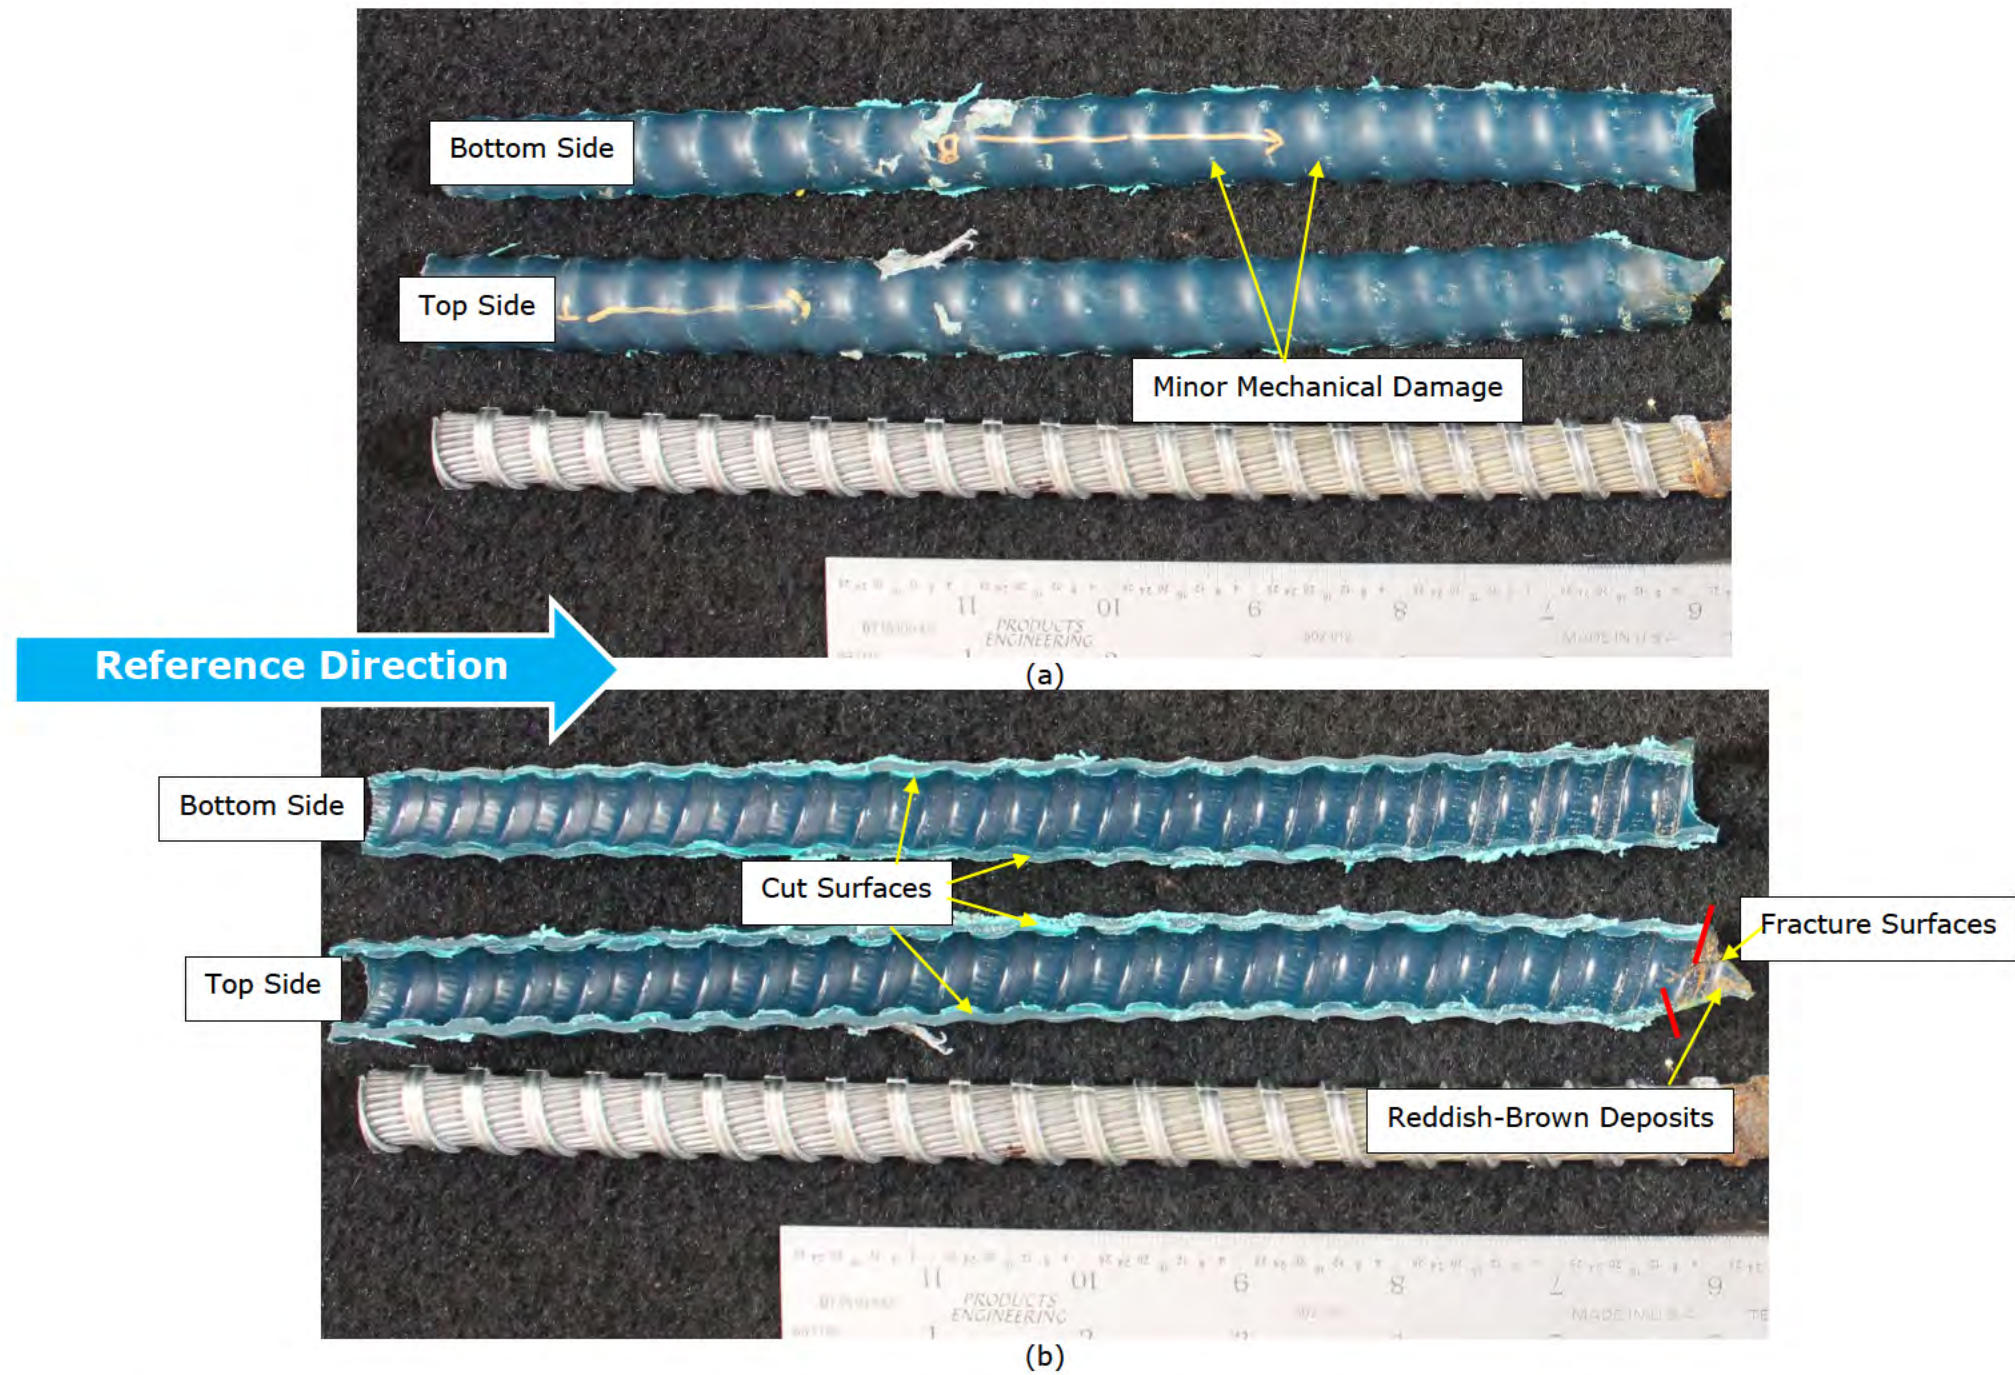
Figure 152. Photographs of the cover from the Lifeboat 8 forward control cable after dissection showing the (a) external surface and (b) internal surface near the damaged location; samples shown in Figure 149 (top). The reference direction is noted with the blue arrow. Rulers are in inches.

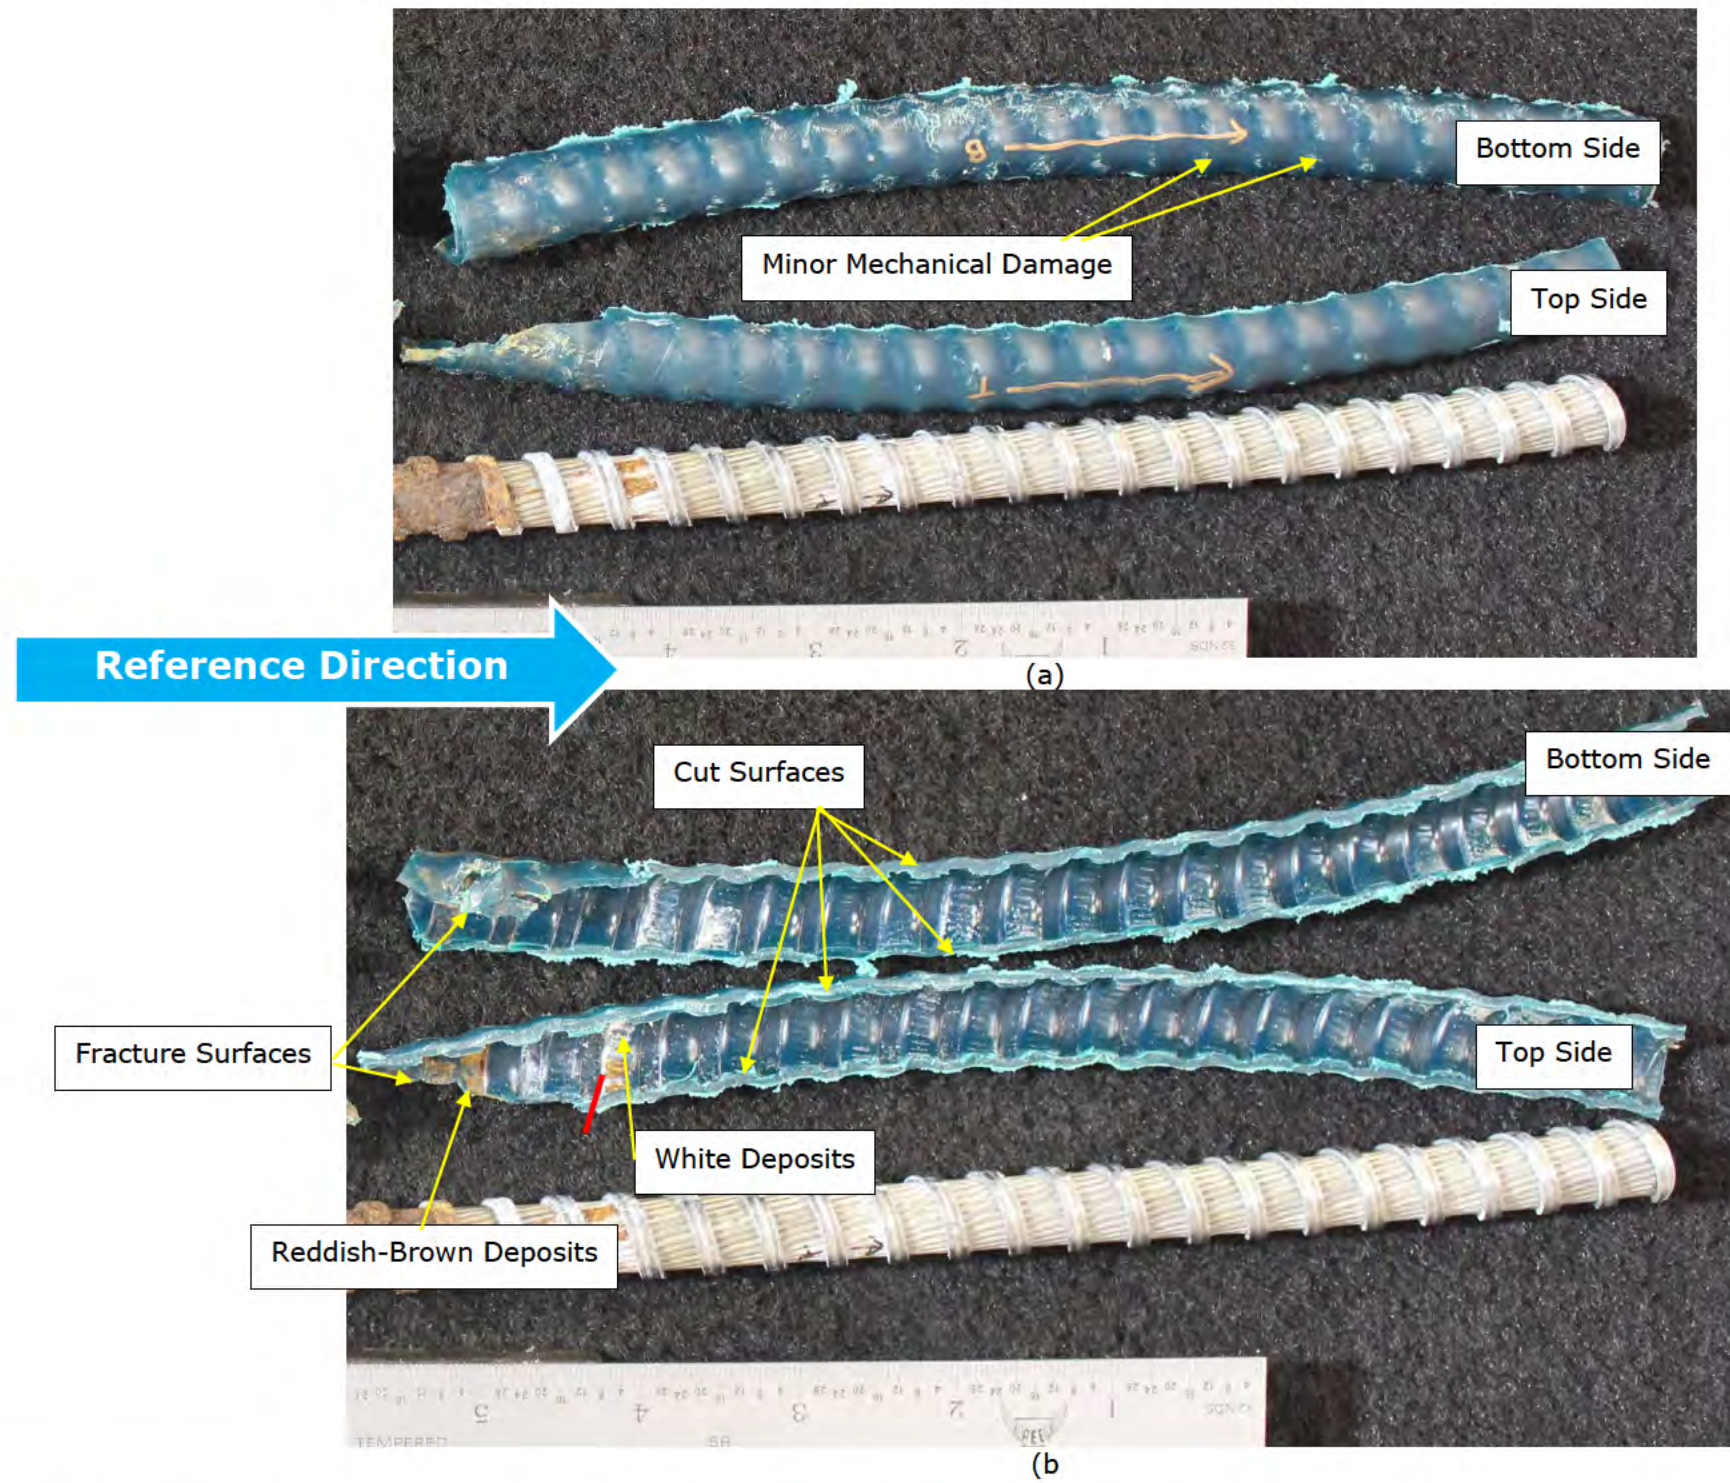
Figure 153. Photographs of the cover from the Lifeboat 8 forward control cable after dissection showing the (a) external surface and (b) internal surface near the damaged location; samples shown in Figure 149 (top). The reference direction is noted with the blue arrow. Rulers are in inches.

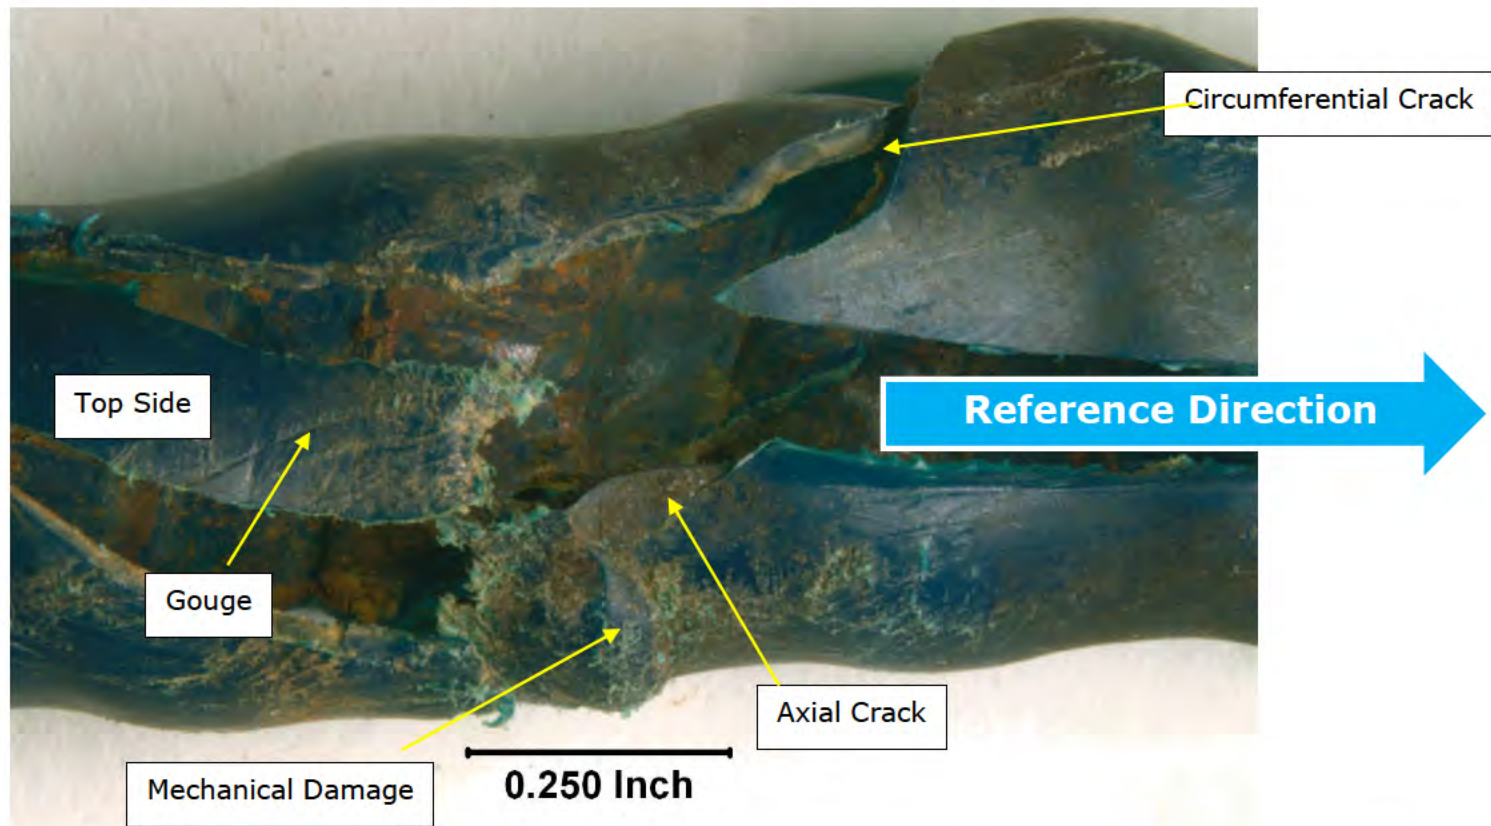
Figure 154. Light photomicrographs of the cover from the Lifeboat 7 hydrostat cable after matching the fractures surfaces. The reference direction is noted with the blue arrow.
