Final Report

Auger Lifeboat 6 Incident

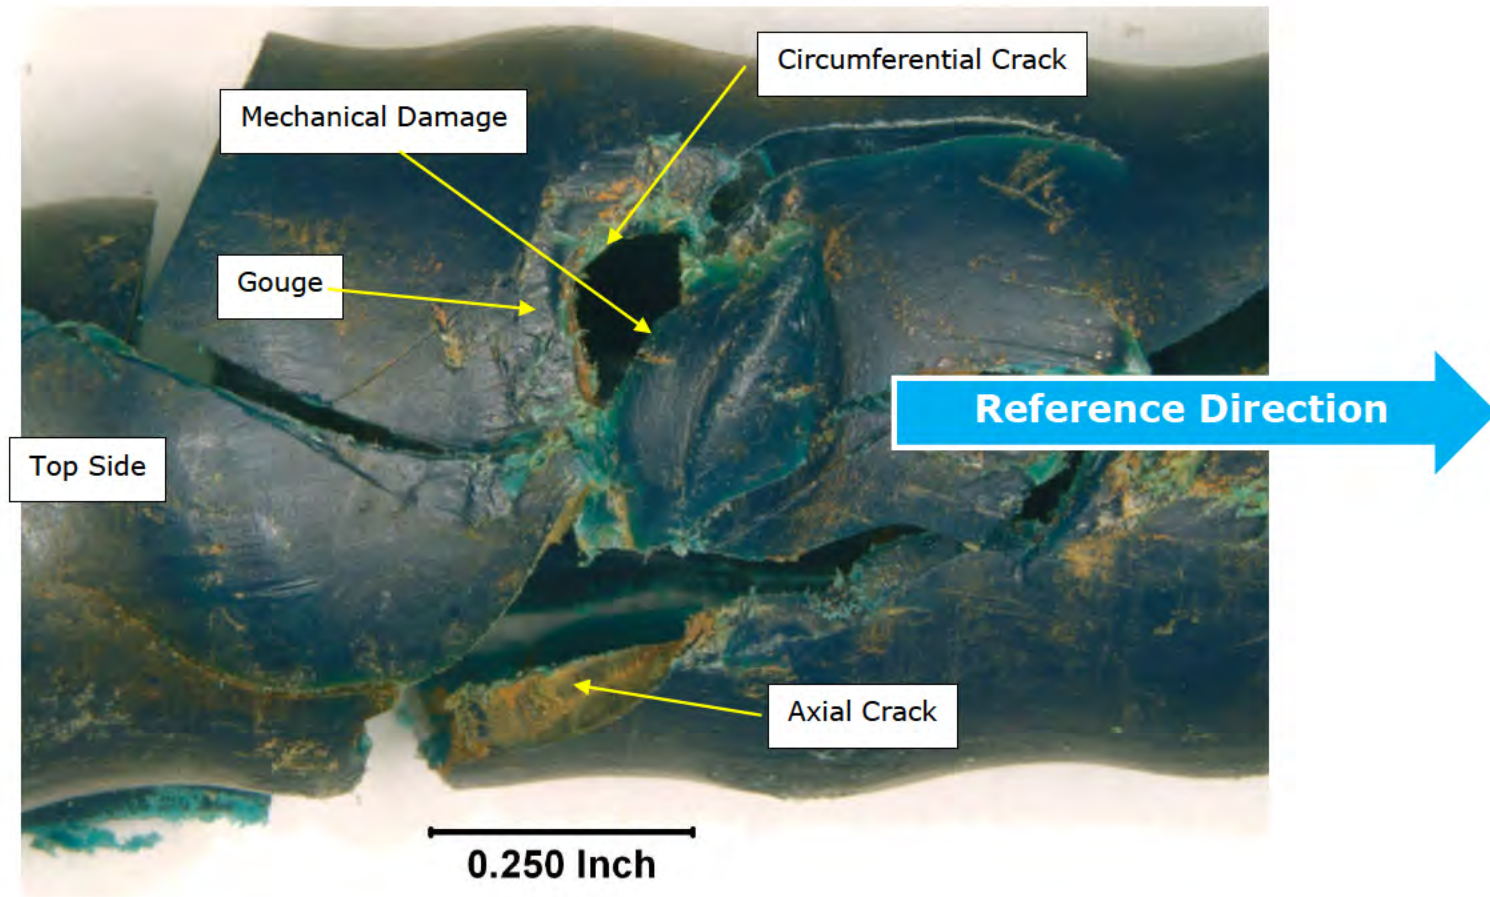
Figure 155. Light photomicrographs of the cover from the Lifeboat 8 forward control cable after matching the fractures surfaces. The reference direction is noted with the blue arrow.

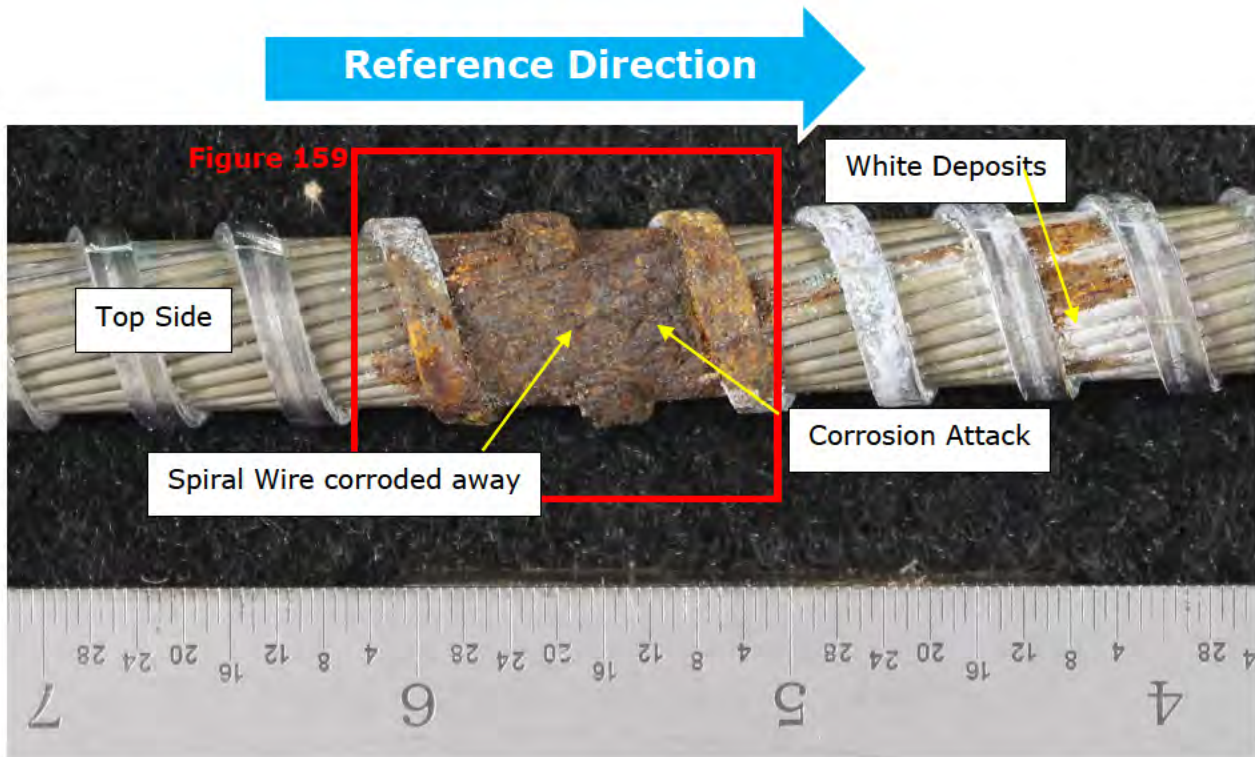
Figure 157. Photograph of the wire layer from the Lifeboat 8 forward control cable at the damaged location showing the corrosion attack to the wire layer; sample location shown in Figure 149. The reference direction is noted with the blue arrow. Ruler is in inches.

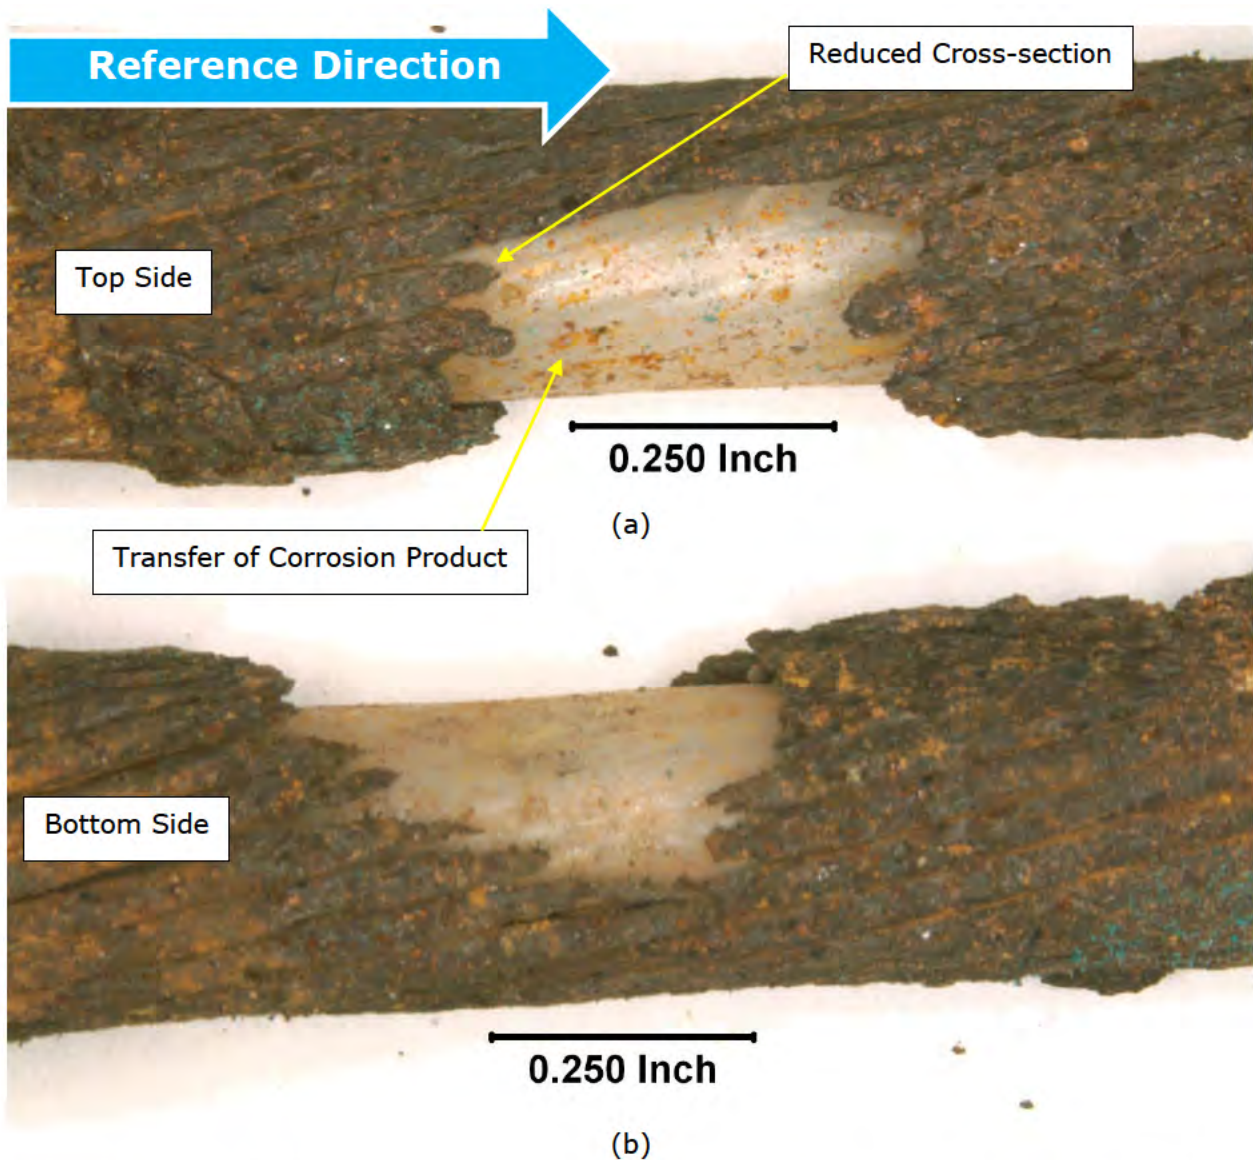
Figure 158. Light photomicrographs showing the (a) top and (b) bottom of the wire layer from the Lifeboat 7 hydrostat cable showing the corrosion damage; location shown in Figure 156. The reference direction is noted with the blue arrow.

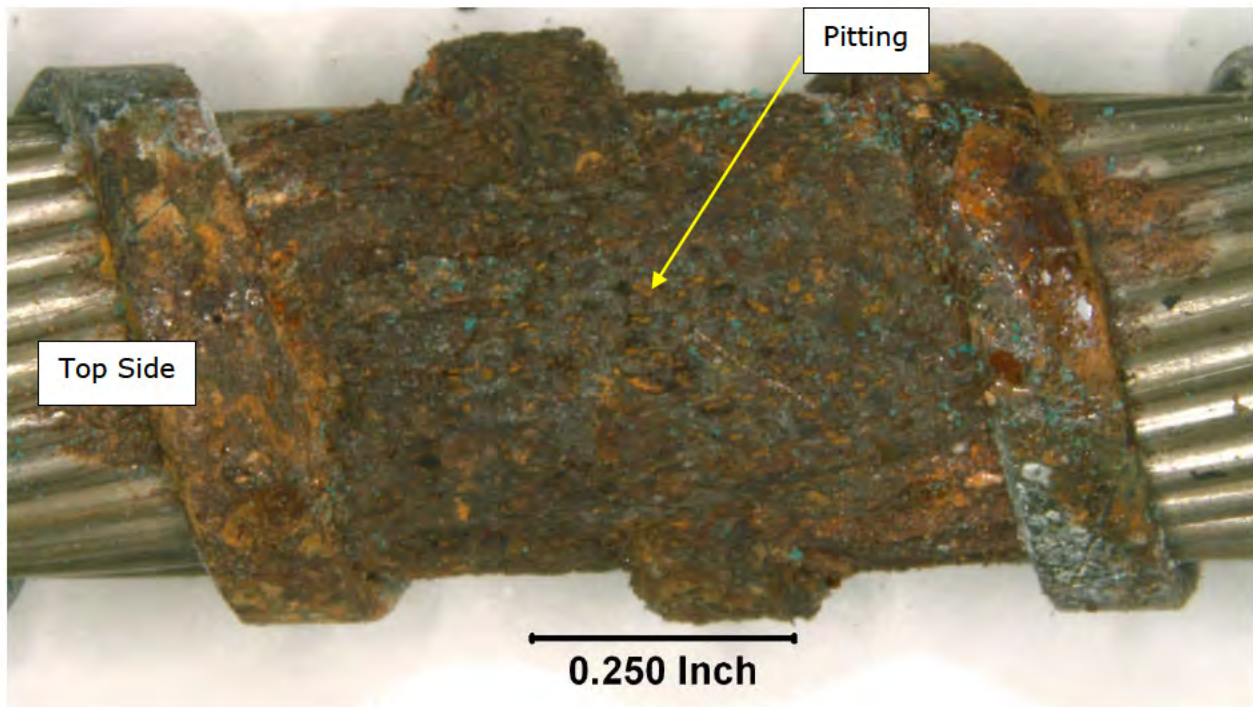
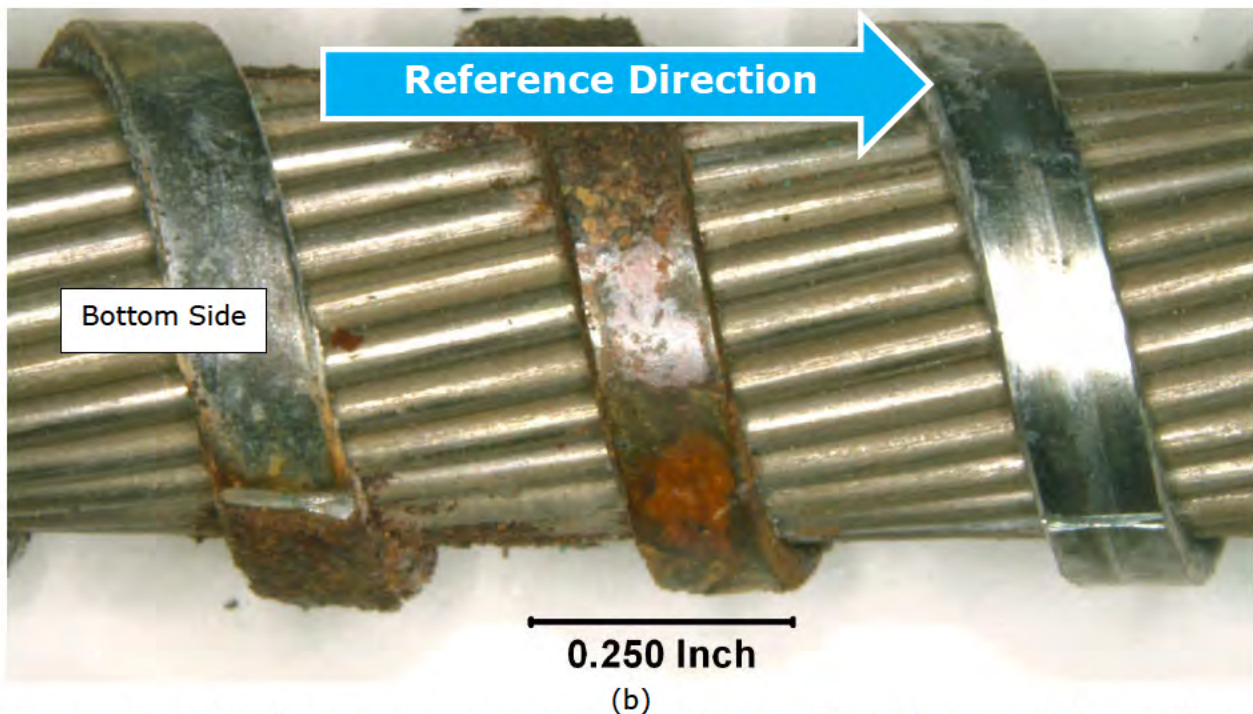
Figure 159. Light photomicrographs showing the (a) top and (b) bottom of the wire layer from the Lifeboat 8 forward control cable showing the corrosion damage; location shown in Figure 157. The reference direction is noted with the blue arrow.

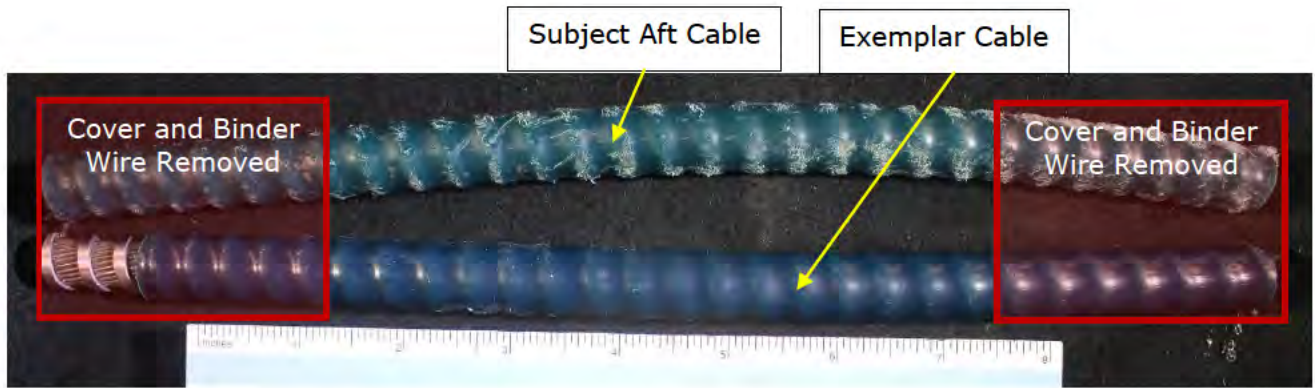
Figure 160. Photograph showing the 12-inch lengths of Subject Aft Cable and Exemplar Cable used for mechanical testing. The cover and binder wire were removed from the locations shown. Ruler is in inches.

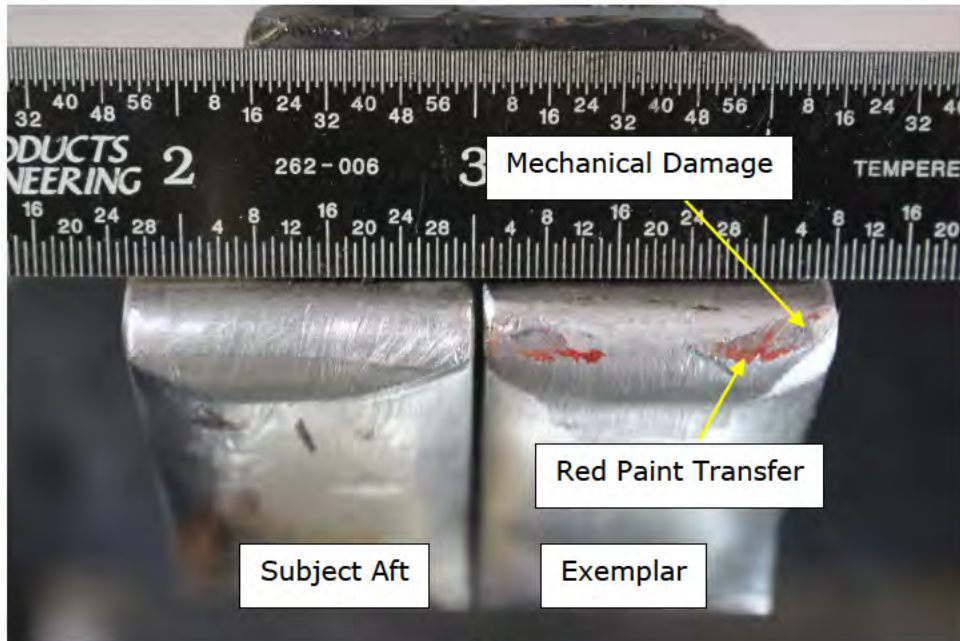
Figure 164. Photographs showing (a) the point of the Exemplar Hook compared to the Subject Aft Hook and (b) the mechanical damage to the ring after testing Scenario 1. Rulers are in inches.

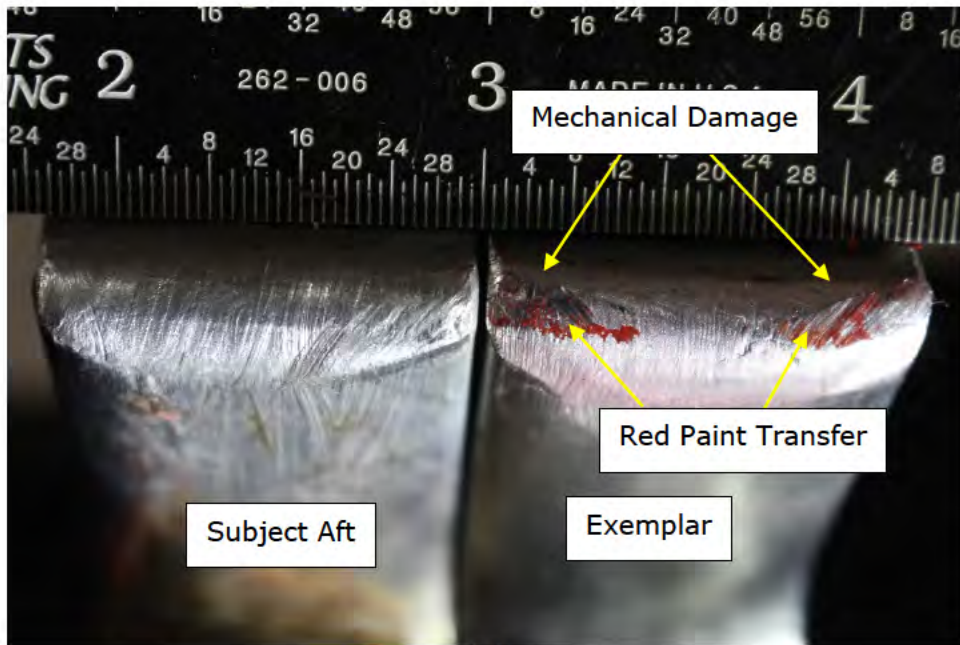
Figure 165. Photographs showing (a) the point of the Exemplar Hook compared to the Subject Aft Hook and (b) the mechanical damage to the ring after testing Scenario 2. Rulers are in inches.

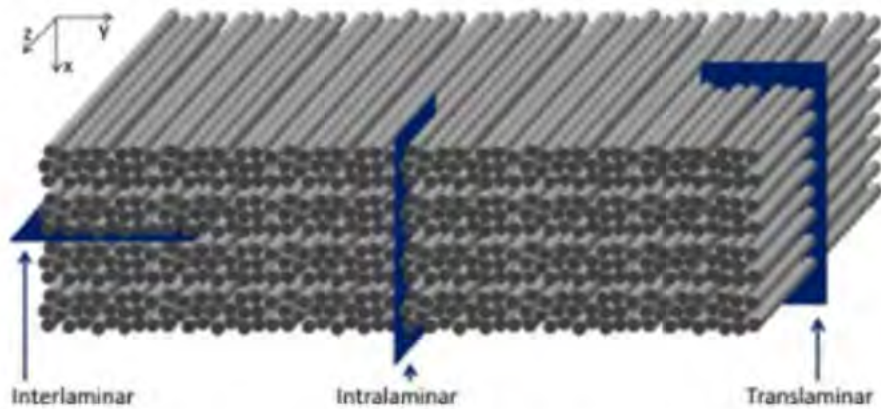
Figure 167. Schematic showing the three failure modes, interlaminar, intralaminar, and translaminar for fiberglass materials.¹⁴

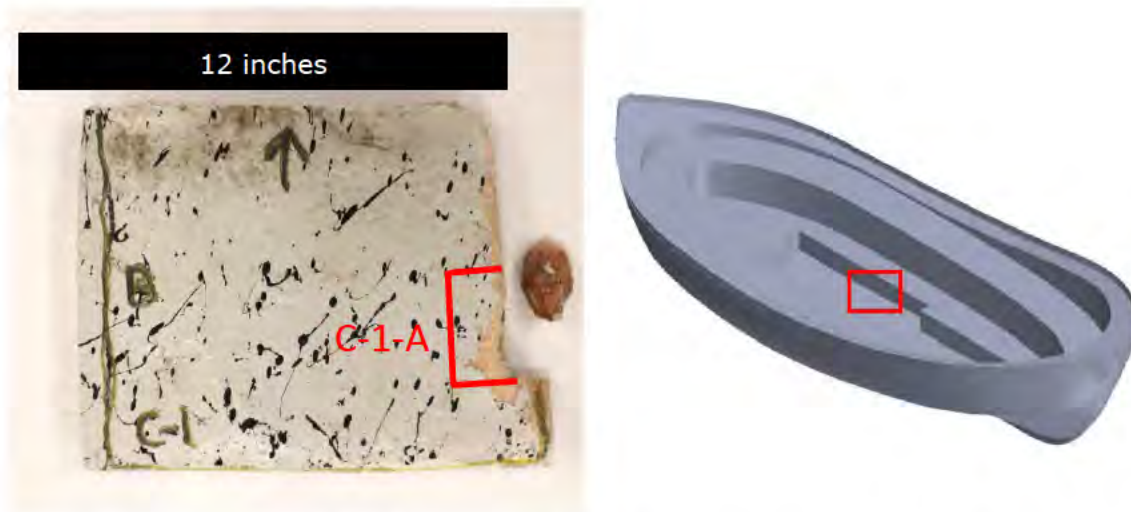
Figure 168. Photograph of Sample C-1 and schematic showing the location where the sample was removed from the inner hull. Sample C-1 was located near the engine mount. The location of the sample examined in the SEM, Sample C-1-A, is shown. Ruler is in inches.

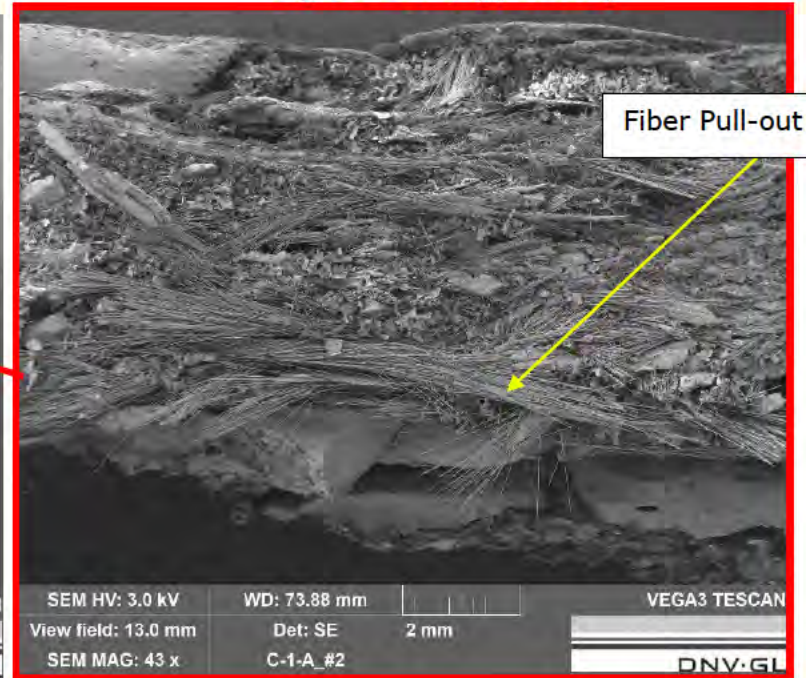
Figure 169. SEM images of Sample C-1-A and schematic showing the fracture surface at a low magnification. Fiber pull-out from the resin matrix is visible near the internal surface. Sample location is shown in Figure 168.

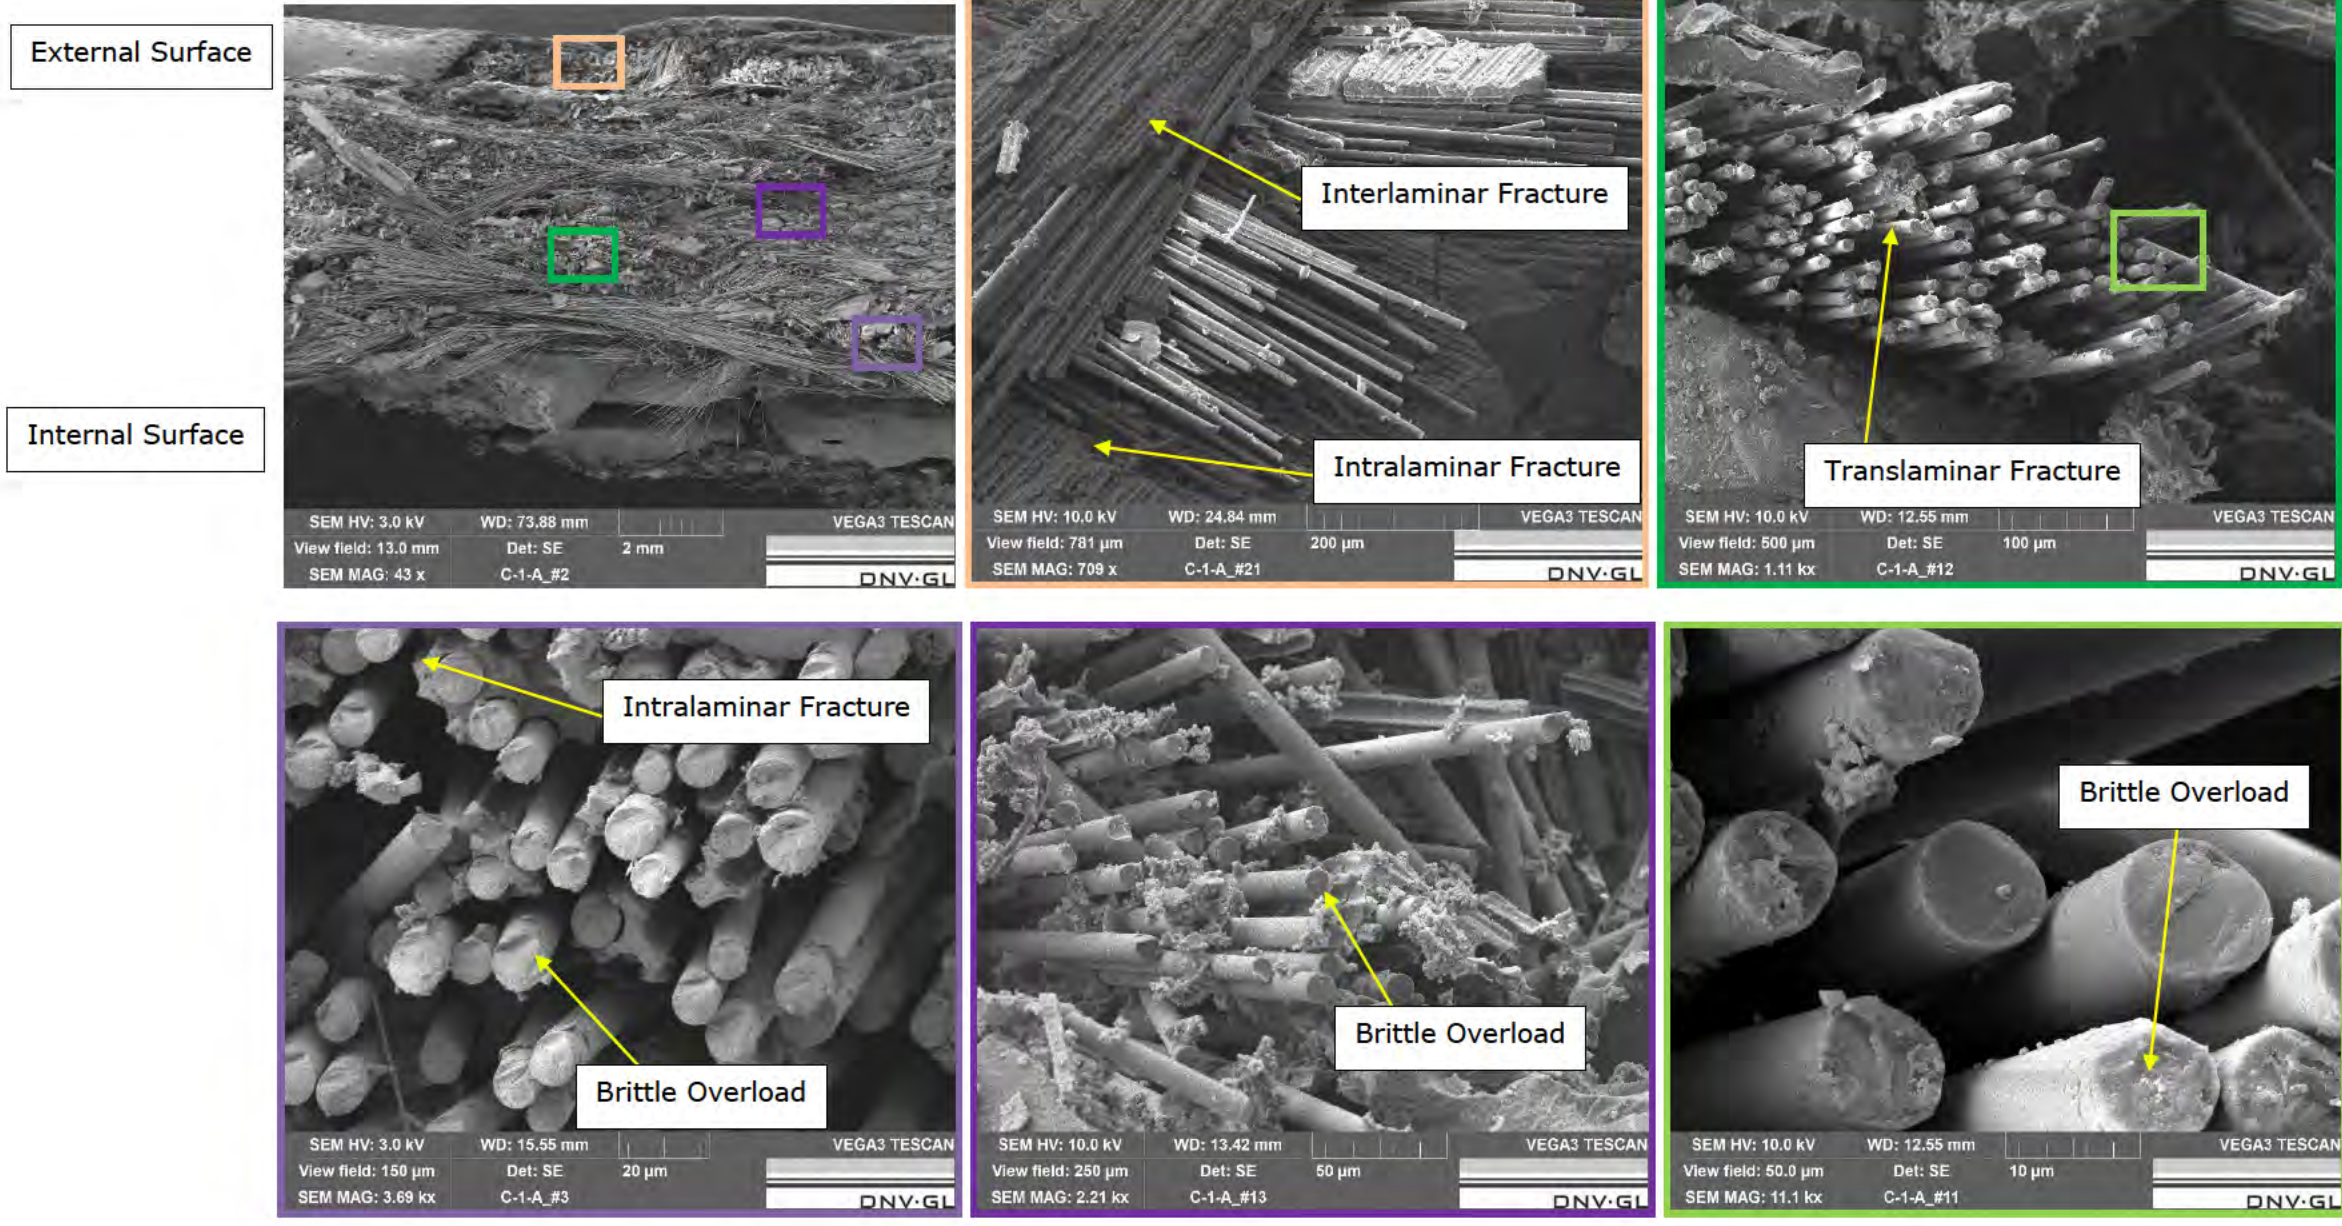
Figure 170. SEM images of Sample C-1-A showing notable fractures of glass fibers. Location of upper left image shown in Figure 169 (right).

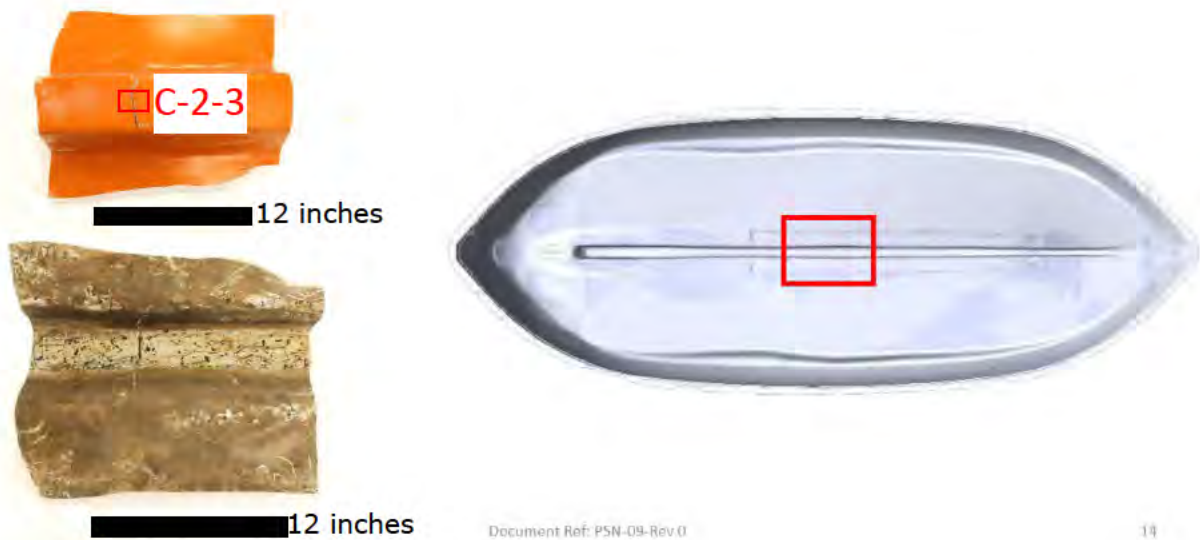
Document Ref: PSN-09-Rev.0

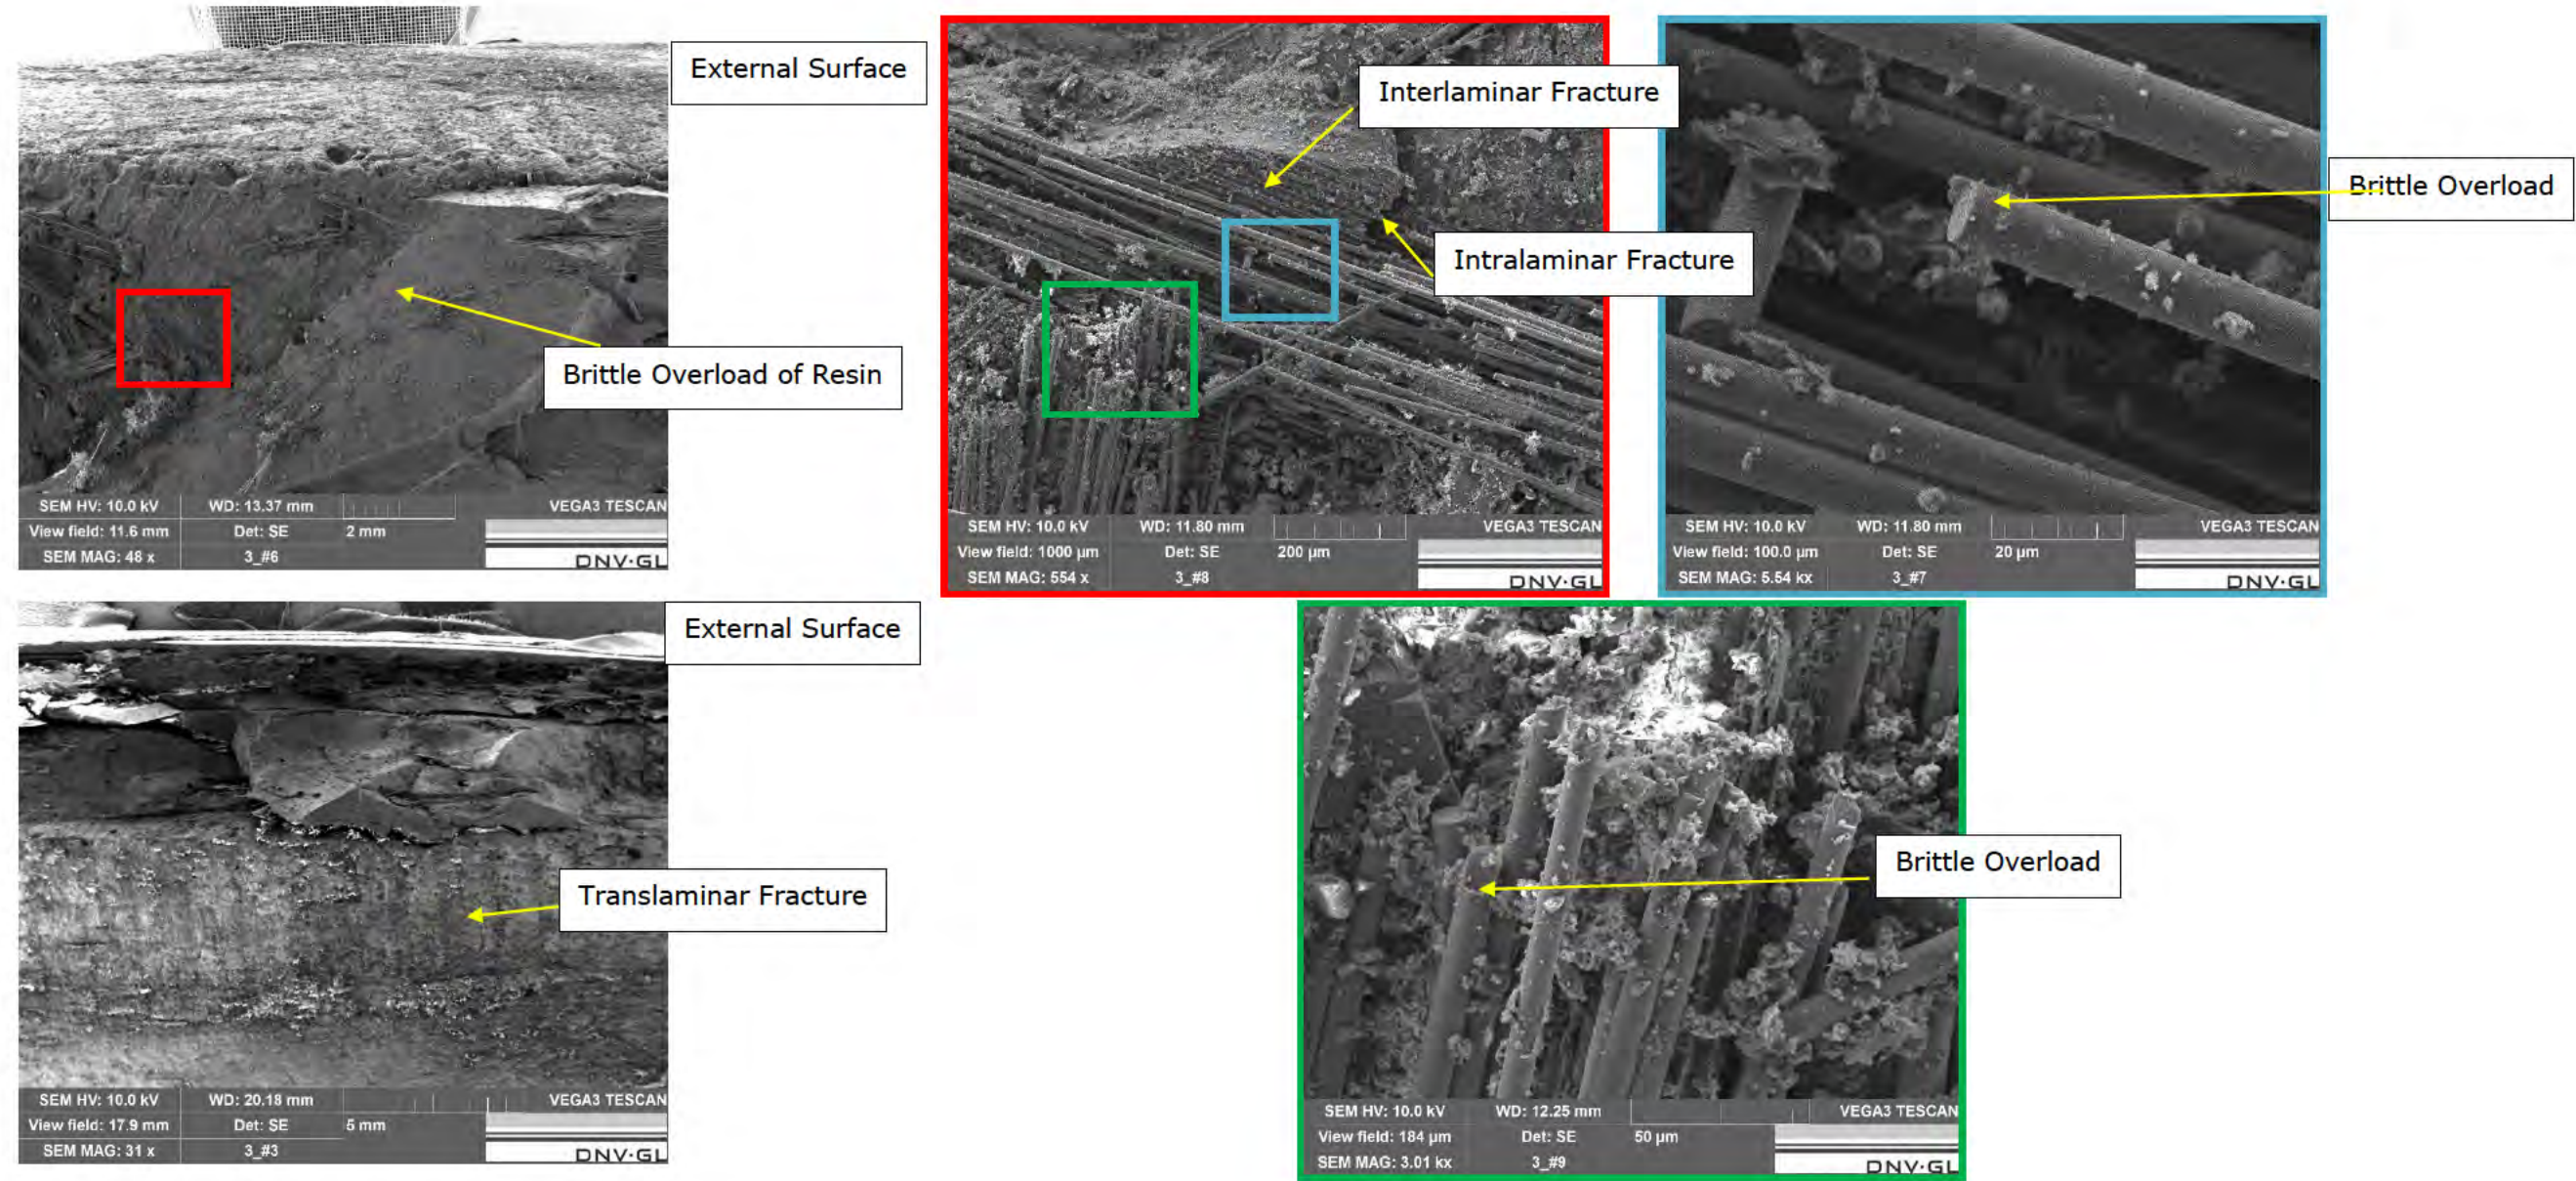
Figure 172. SEM images of Sample C-2-3 showing notable fractures of glass fibers.

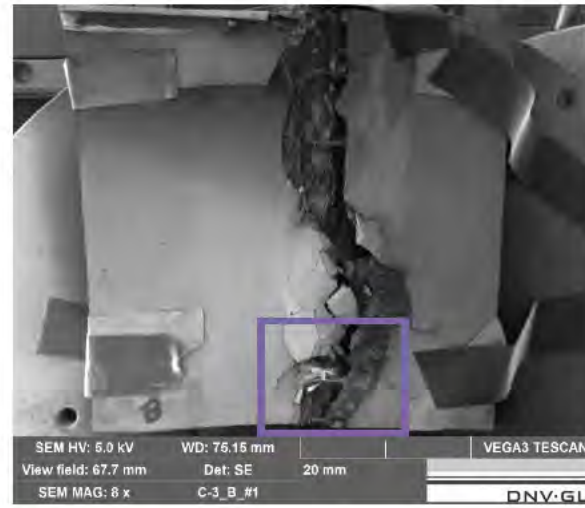
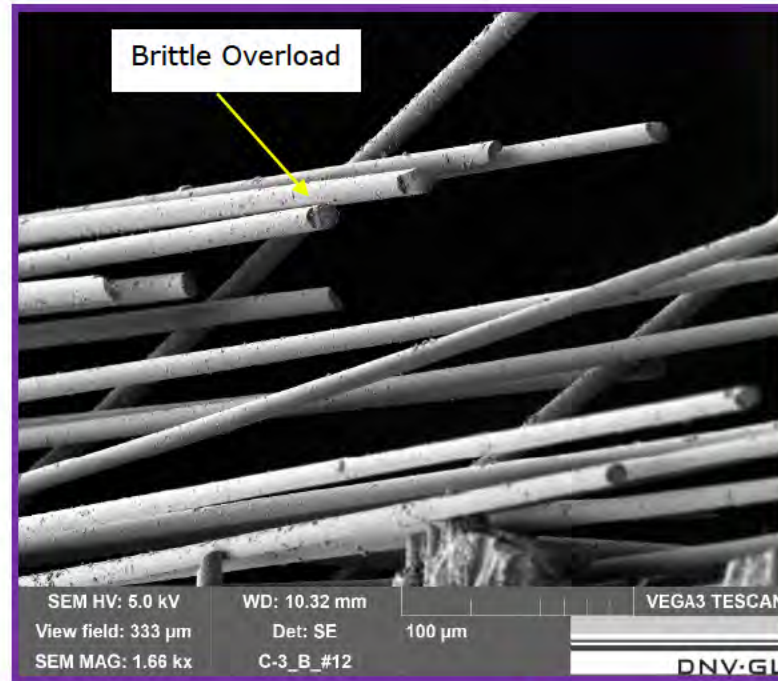
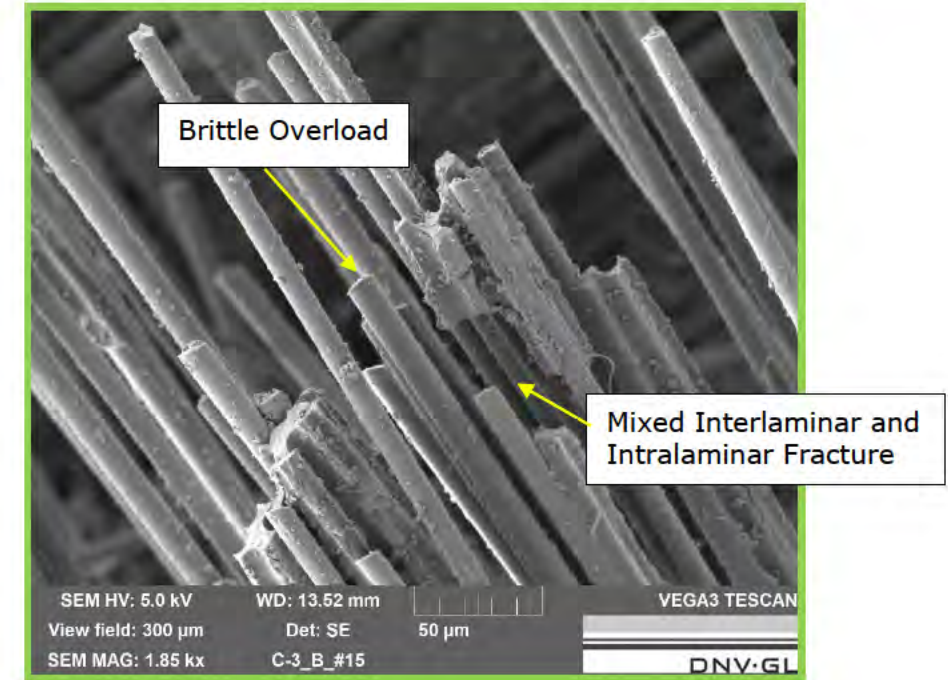
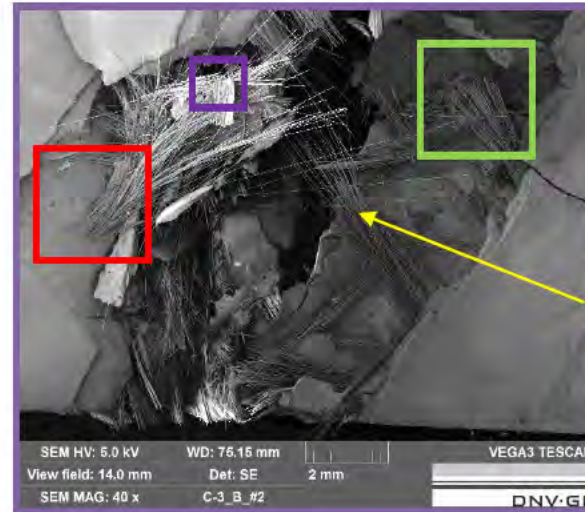
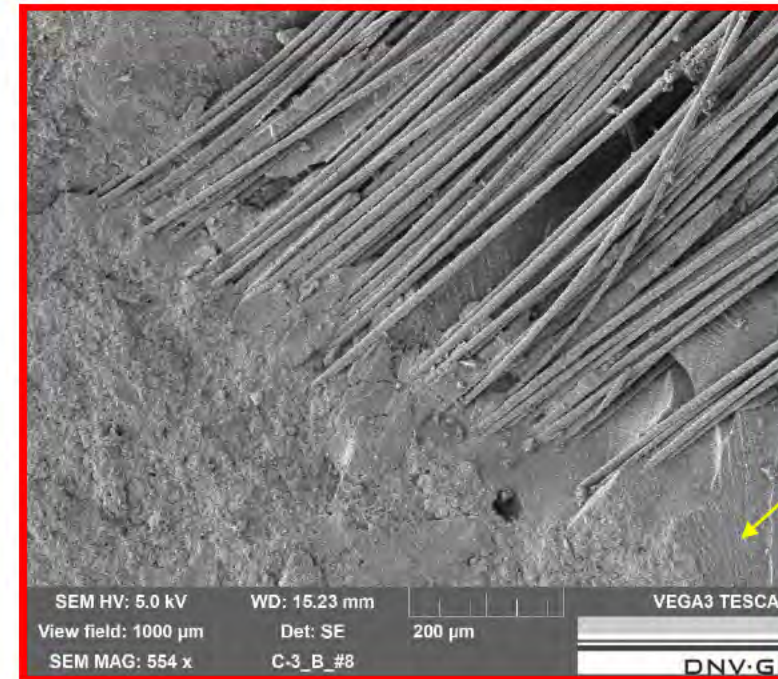
Figure 174. SEM images of Sample C-3-B showing notable fractures of glass fibers.

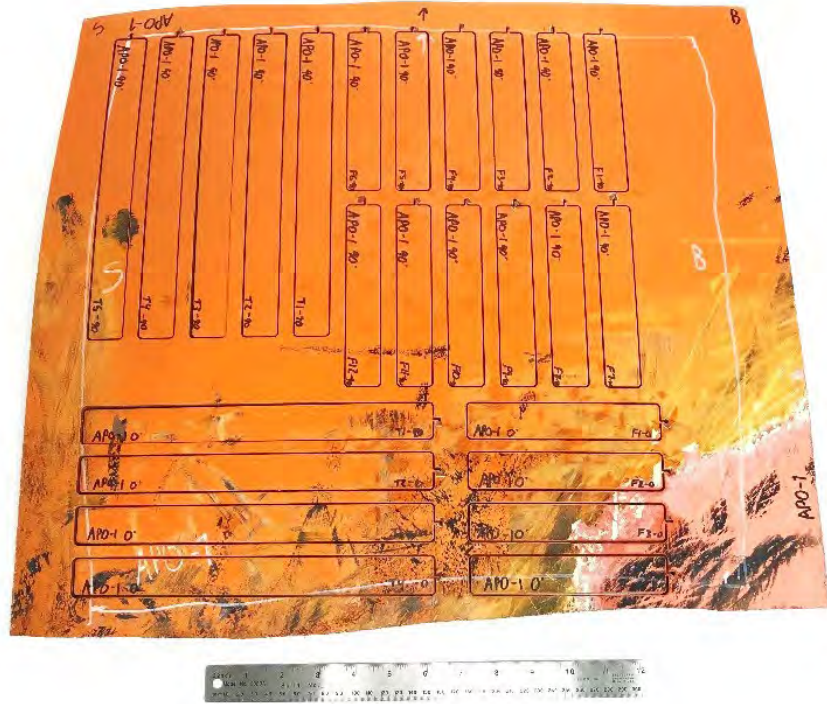
Figure 175. Photograph of an extracted panel (APO-1, location shown in Figure 43) showing the locations where testing coupons were removed using waterjet cutting. Ruler is in inches.

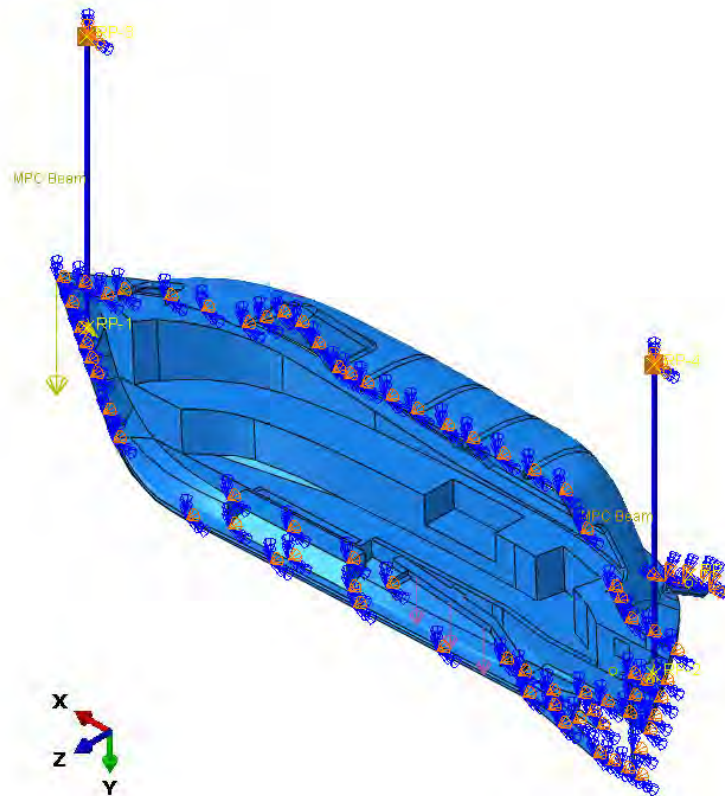
Figure 181. Schematic showing boundary conditions applied in model: XY symmetry, gravity, engine weight, and vertical displacements.

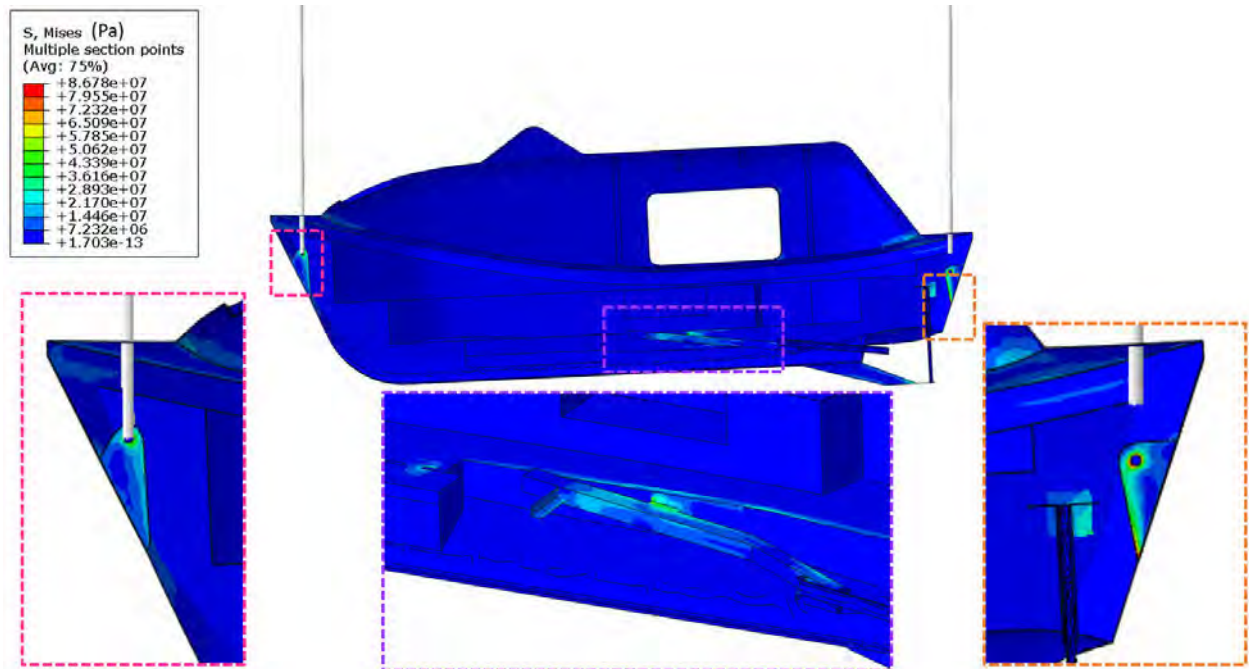
Figure 182. Von Mises Stress Contour of lifeboat in Step 1 with gravity and engine weight only applied to the lifeboat.
