# **NATIONAL TRANSPORTATION SAFETY BOARD**

## **MARINE ACCIDENT REPORT**

**CAPSIZING AND SINKING OF THE  
U.S. MOBILE OFFSHORE DRILLING  
UNIT OCEAN RANGER OFF THE  
EAST COAST OF CANADA  
166 NAUTICAL MILES EAST OF  
ST. JOHN'S, NEWFOUNDLAND  
FEBRUARY 15, 1982**

NTSB-MAR-83-2

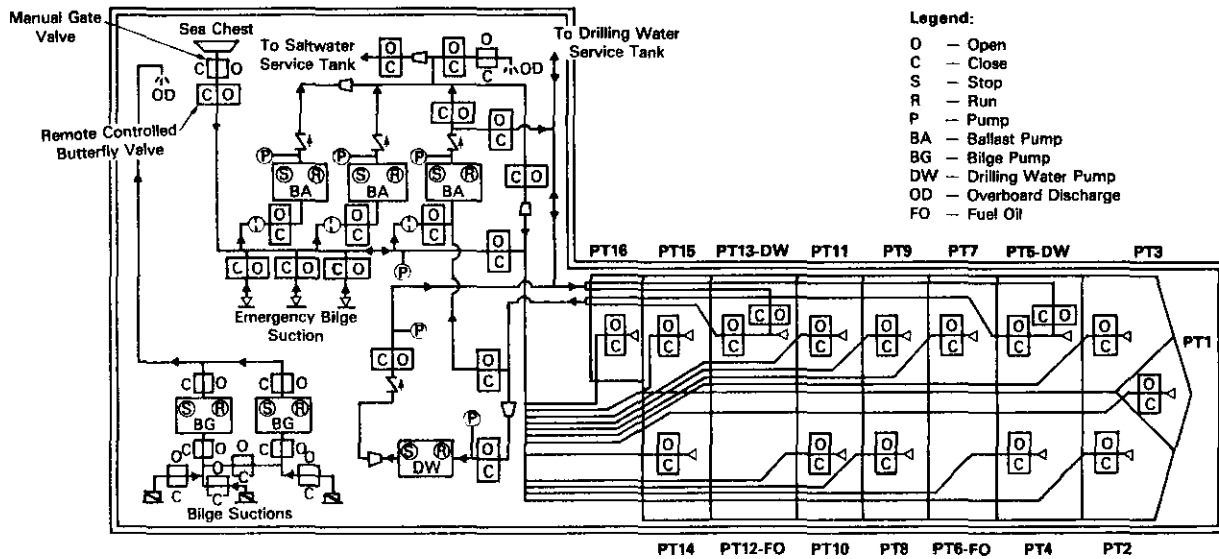
Figure 5.—Ballast control console and details of port mimic board.

The ballast control panel in the control room was designed especially for the OCEAN RANGER. A mimic board with the tank configuration and pipeline flow diagram of both the port and starboard hulls showed the operator the relationship of the tanks, piping, and corresponding valve control switches. (See figure 5.) Although the valves to the ballast and drill water tanks actually were located in the pumproom, control switches were mounted in the tank diagram of the mimic board panel. Each side of the panel was equipped with 32 pairs of valve control switches that operated the valves for 16 ballast and drill water tanks, 3 ballast pump suction valves, 1 drill water pump suction valve, 1 ballast pump discharge valve to the saltwater service tank, 1 ballast pump discharge valve to overboard, 1 ballast pump discharge valve to the tank manifold, 3 emergency bilge suction valves, 1 suction and discharge valve to the drill water pump, 1 suction valve to 1 ballast water pump for the drill water system, 1 discharge valve from 1 ballast water pump to the drill water system, 1 stop valve between the tank manifold and the 3 ballast pump suction valves, and 1 remote controlled sea chest valve. When depressed, each "open" switch activated a holding relay which, in turn, closed the circuit for the corresponding solenoid valve in the cabinet and opened the circuit for the indicating lamp in the red "close" switch. The solenoid valve admitted compressed air to the tubing connected to the valve operating gear in the pumprooms. The holding relay maintained power to the solenoid valve until the "close" button was depressed on the panel, thereby breaking the circuit at the holding relay, allowing the solenoid valve to return to the closed position, and venting the compressed air to the valve operating gear in the pumproom. The spring-loaded valve operating gear then closed the valve. The air was exhausted inside the control panel, providing the operator with an audible indication of valve closure. The spring-driven method of valve closing provided an automatic safeguard when control air was lost for any reason. If electrical power to the control console was lost, the solenoid valves could be controlled manually by inserting a brass actuating rod into each solenoid. These brass rods were threaded into the end of the solenoid housing through a brass bushing. After contacting the solenoid within the housing, the rods could then be further threaded in to override the solenoid spring. The compressed air would be then admitted to the line connecting the solenoid valve to the valve operating gear in the pumproom. Upon releasing the brass rod, the solenoid would return to its normal position, allowing the air to escape and the valve to close.

The control panel switches also provided visual indication of the position of each valve through an electrical circuit activated by a microswitch at the valve operating gear in the pumprooms. The switch buttons on the panel were color coded. A valve in the closed position showed a red light on the "close" side of the switch, and a valve in the open position showed a green light on the "open" side of the switch. If the valve was in motion, either during closing or opening, or stopped in mid-position for any reason, both lights would go out. There was no provision for throttling. The valves were designed to be either fully opened or fully closed. The manual valve at the sea suction also was equipped with an indicator on the control panel.
