# **UNITED STATES COAST GUARD**

**REPORT OF THE INVESTIGATION  
INTO THE  
EXCURSION VESSEL BLACKBEARD'S  
REVENGE (BAHAMAS REG NP:8095),  
PRESUMED DECEASED/LOSS OF LIFE IN  
THE VICINITY OF NASSAU HARBOR,  
BAHAMAS ON MAY 24TH, 2023**

**MAN OVERBOARD AND SUBSEQUENT LOSS OF LIFE FROM THE PASSENGER  
VESSEL BLACKBEARD'S REVENGE (BAHAMAS REGISTRY NP:8095) IN THE  
VICINITY OF NASSAU, BAHAMAS ON MAY 24, 2023**

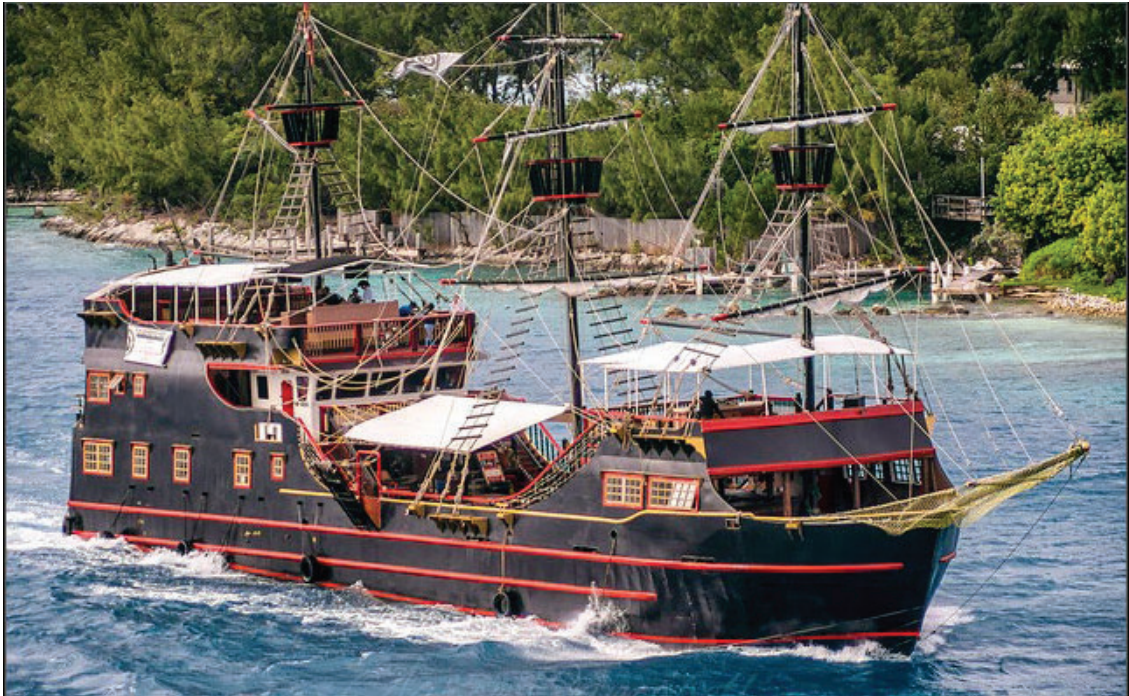
Figure 1: Photograph of *Blackbeard's Revenge*, Unknown date, and location (Source: With permission [REDACTED])

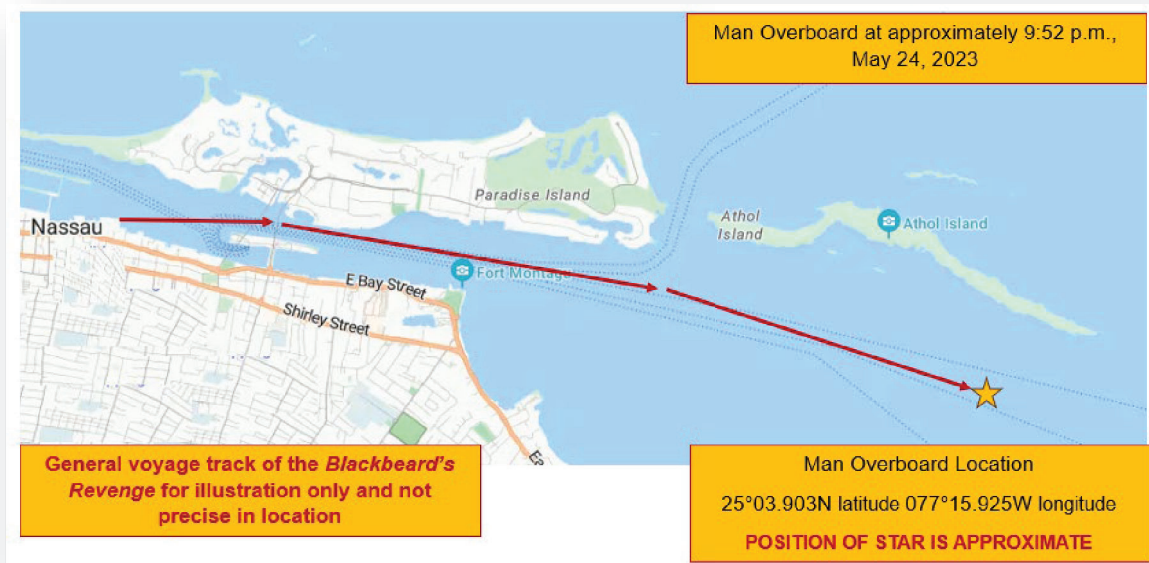
Figure 3 - Generalized voyage track of the accident voyage of the *Blackbeard's Revenge* on May 24, 2023. (Source: USCG and Bing Maps)

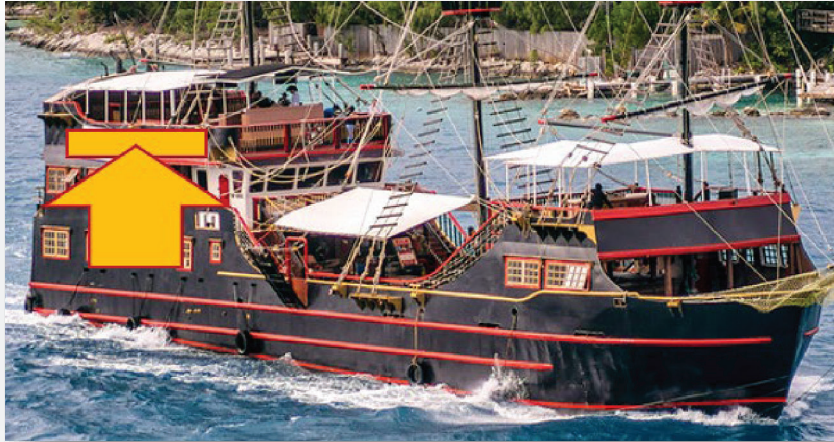
4.1.13. At 9:30 p.m., as the vessel transited east, and in potentially worsening weather, the passenger proceeded to the uppermost deck and mounted the starboard bulwark or railing and jumped into the water near the vessel's starboard side.

Figure 2- Yellow horizontal line indicates the approximate location from where the victim jumped into the water. This was on the upper deck, aft on the starboard side. (Source: USCG)

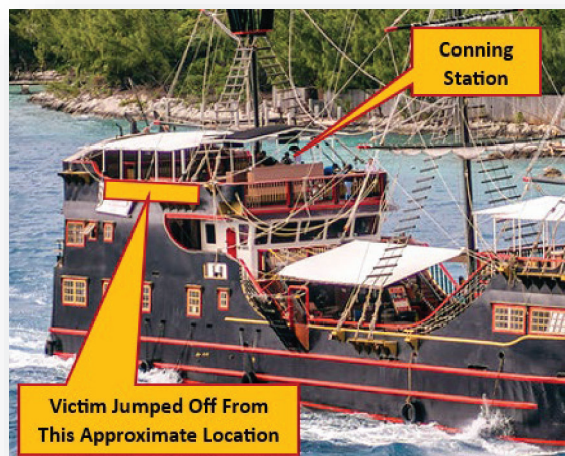
4.1.14. The location where the passenger jumped from, and the conning station were closely located together on the uppermost deck of the vessel.

Figure 4 - Starboard side of the vessel showing the approximate location where the victim jumped from the moving vessel and the conning location for the vessel. (Source: [REDACTED] with CG markups)

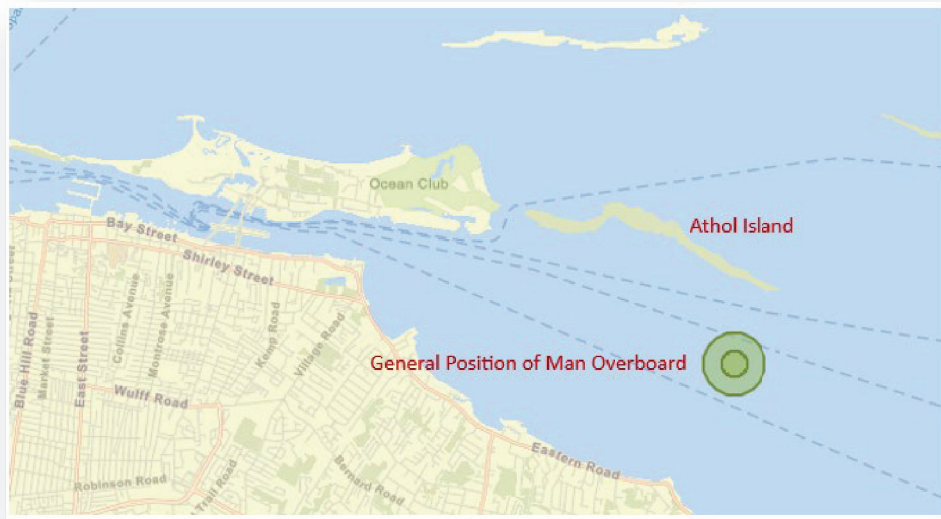
Figure 5 - General location of the location where the person entered the water. (Source: USCG)

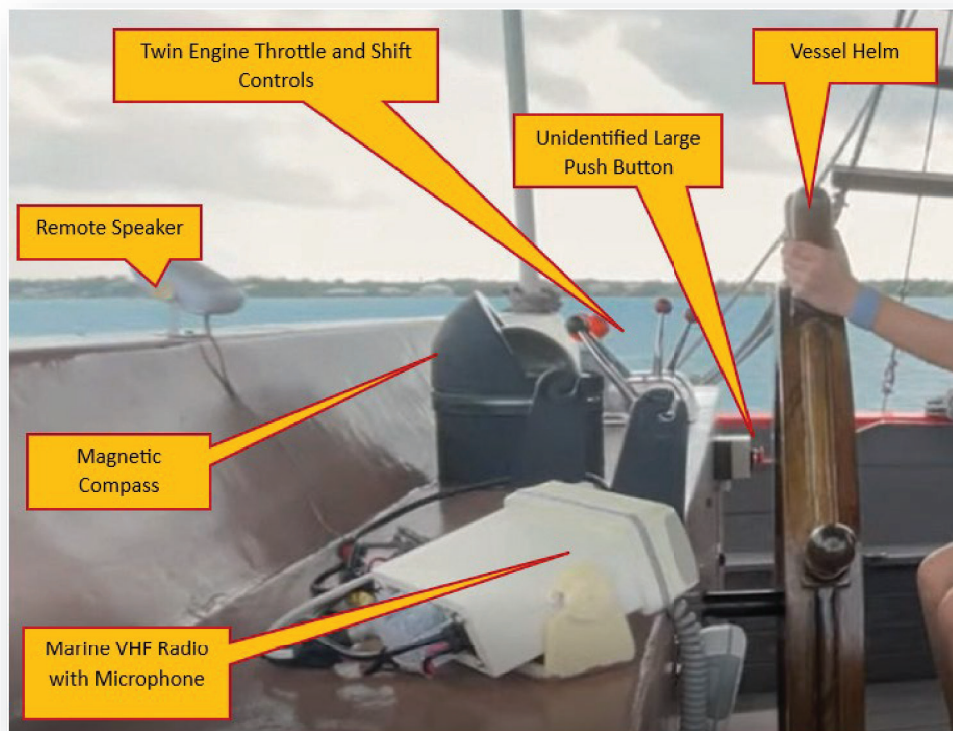
Figure 7 - Location of vessel equipment in the conning station onboard the *Blackbeard's Revenge*. An examination of this image shows that there is no GPS receiver at the conning position in this image. (Source: Screen Capture YouTube video, open source)

4.1.21. The exact vessel position of the man overboard is uncertain based upon the available evidence as there is no conclusive information that the vessel was equipped with a GPS unit at the conning location or that it was even utilized.

4.1.22. A GPS receiver or similar navigation equipment would mark the latitude and longitude with precision and that precise position information would aid in the Search and Rescue (SAR) efforts.

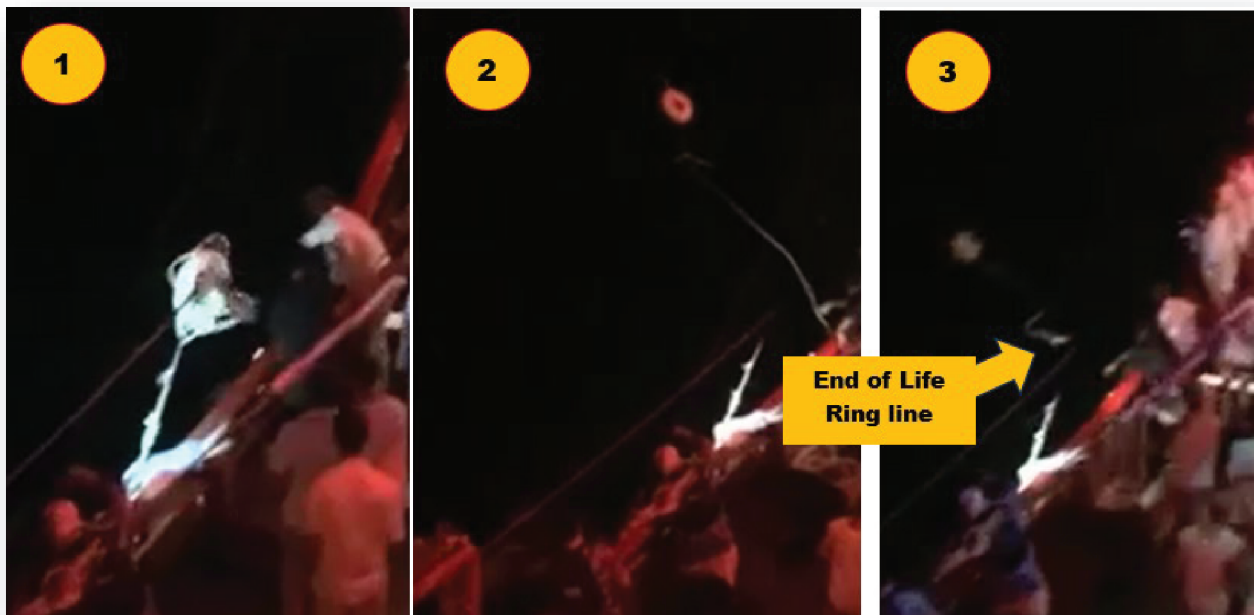
4.1.23. A person, believed to be a vessel crewmember, threw the passenger a life ring. Witness testimony indicates that some passengers and crew verbally called out to the passenger to encourage him to grab the flotation device. Based on the interviews and video, when the passenger was on the port side of the vessel a second life ring with a line attached was thrown into the water to assist the passenger. The end of the tether line was not held on to nor tied to the vessel, the line was observed floating in the water near the passenger.

Figure 8 - Sequence from video taken by a passenger showing a life ring thrown from the vessel's port side forward. Image one is readying to throw the buoyant ring, image 2 is the throw in the direction of the victim and image 3 shows the end of the attached line flying through the air and not attached onboard the vessel. (Source: Passenger video)

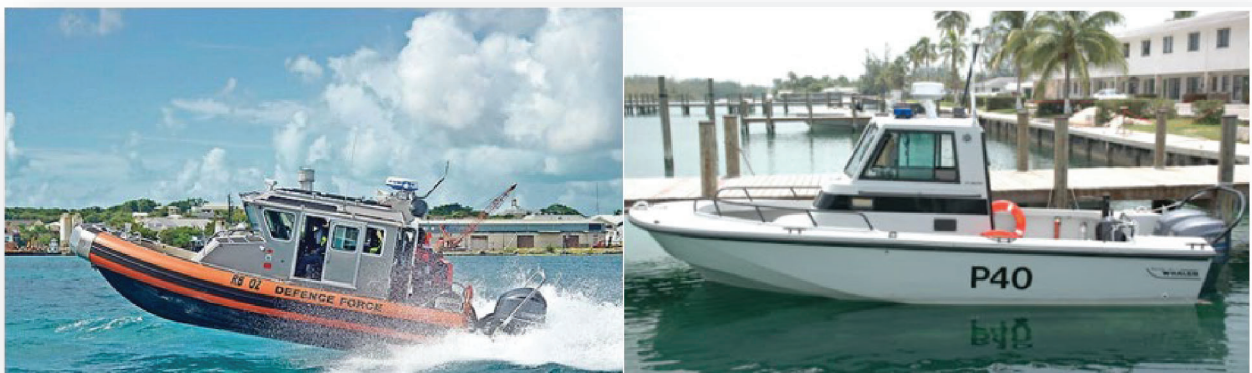
Figure 10 - On the left is RB 02 and on the right is P 40, two of the vessels that initially responded to the person in the water. The vessels and crew conducted search and support operations on the evening of May 24, 2023. (Source: Open)

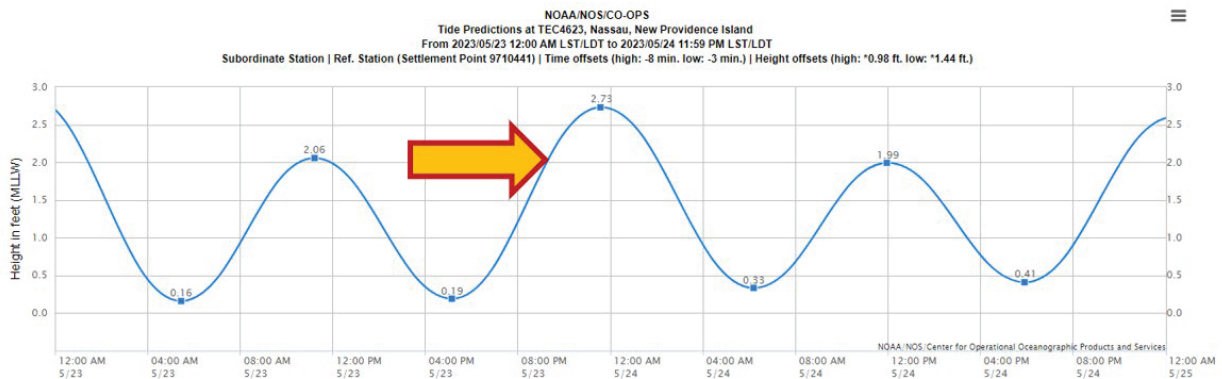
4.3.2. The tide on the waterway was approaching high tide which would occur shortly before midnight on May 24, 2023.

Figure 11 - Tidal tables for May 24, 2023, produced by the National Oceanographic and Atmospheric Administration (NOAA). Yellow arrow identifies time of man overboard on the vessel. (Source: NOAA Tide and Current Website)

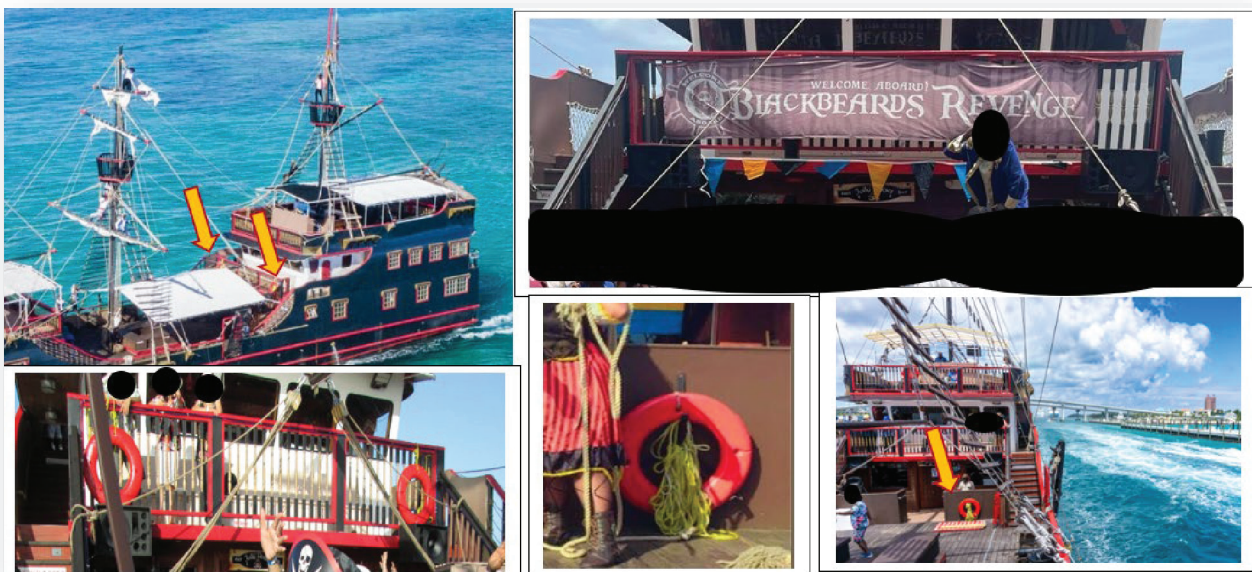
4.6.6. Interviews of witnesses and a search for images of the *Blackbeard's Revenge* was used to determine the number and location of life rings aboard the vessel at the time of the accident. The images available on the internet of the vessel have no date reference. But international orange life rings were in some of the images available on the internet. In some cases, images displayed, one life ring on each side on the deck above the main deck and affixed to a line or rope. There are no images showing the life rings in typical brackets used for quick and easy use, rather they appear in these images, tied to the railings.

Figure 14 - Images of life rings on the *Blackbeard's Revenge*, dates undetermined in some cases referenced by yellow arrow for ease of location. In two images there are international orange colored life rings on each side of the vessel on the first deck above the main deck aft. In images you can see some sort of polypropylene floatation line attached. In the lower right image, you can see one life ring on the main deck on the port side. (Source: Open)

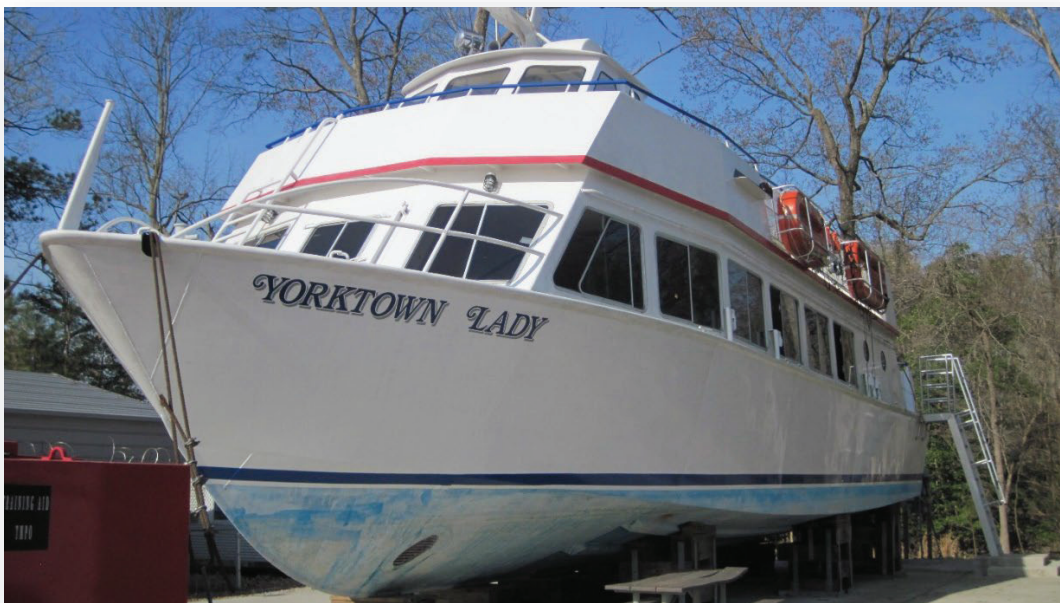
Figure 15 - Permanently moored USCG training vessel *Yorktown Lady* of a similar size as the *Blackbeard's Revenge*. This vessel is used to train Coast Guard marine inspectors on the regulations required for commercial passenger vessels. (Source: USCG)

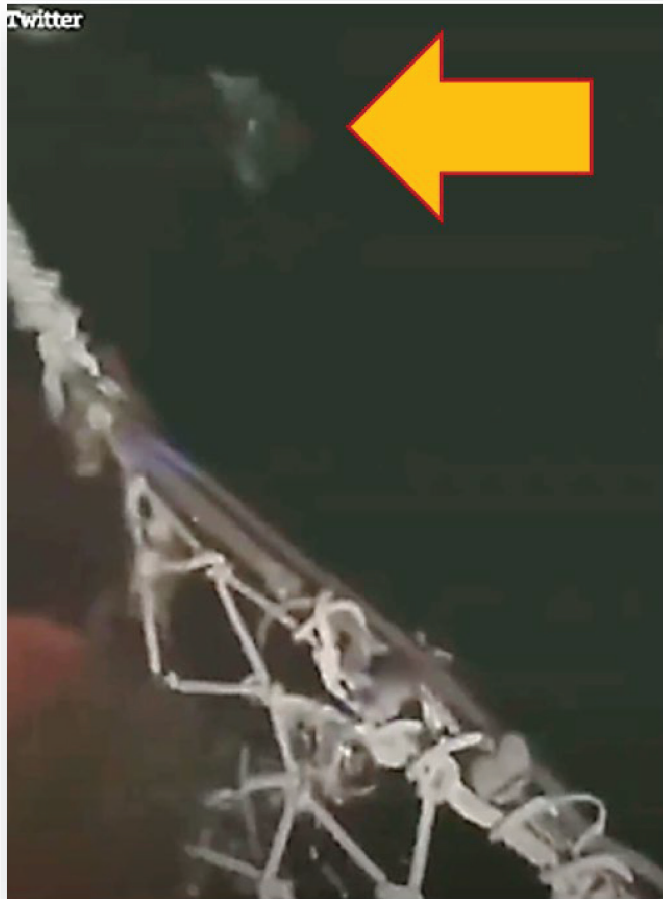
4.12.1. Both the Bahamas authorities and the public assert that there was a possibility of a shark attack during the time of the incident. In the extreme left of a video frame from a short video showing the passenger in the water there is a flashing, indicating movement associated with an object near the surface of the water and close to the side of the vessel.

Figure 21 - Yellow arrow indicated the object in the water on the starboard side of the *Blackbeard's Revenge*. In the lower left of the video the object is seen flashing on or near the surface of the water. The victim was swimming to the right of the object and there was the life ring between the victim and the object. (Source: Passenger video)
