## **MARINE SAFETY ALERT**

Safety Alert 05-25-CH1

## **IMPORTANCE OF ADHERING TO HOT WORK PROCEDURES & IMPLEMENTING ROBUST LOCKOUT/TAGOUT PROGRAMS**

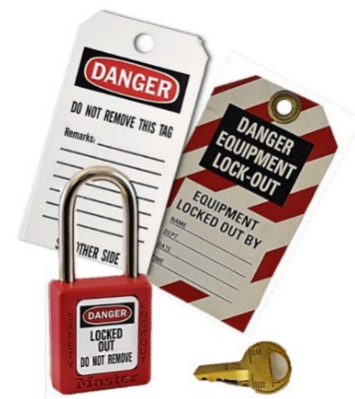
Figure 1. Example lockout/tagout equipment

The International Code of Safety For Ships Using Gases or Other Low-Flashpoint Fuels (IGF Code) section 18.7.1 requires *“Hot work in the vicinity of fuel tanks, fuel piping and insulation systems that may be flammable, contaminated with hydrocarbons, or that may give off toxic fumes as a product of combustion shall only be undertaken after the area has been secured and proven safe for hot work and all approvals have been obtained.”* Although the IGF Code was not specifically applicable to this vessel at the time of the incident, it is highly recommended that this prescriptive requirement be taken into consideration on all vessel's operating with LNG as a fuel source. The crewmembers in this incident performed hot work in the area without applying lockout/tagout procedures, as described in the IGF Code.

- **Review and Implement Lockout/Tagout Procedures.** Ensure LNG systems are tagged out before conducting any hot work in or near hazardous areas. Crewmembers must verify the lockout/tagout status of the system before beginning work.
