## **MARINE SAFETY ALERT**

Safety Alert 05-25

## **IMPORTANCE OF ADHERING TO HOT WORK PROCEDURES & IMPLEMENTING ROBUST LOCKOUT/TAGOUT PROGRAMS**

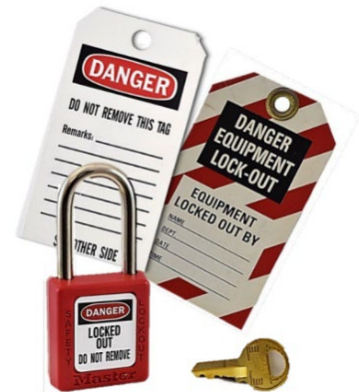
Figure 1. Example lockout/tagout equipment

- **Review and Implement Lockout/Tagout Procedures.** Ensure LNG systems are tagged out before conducting any hot work in or near hazardous areas. Crewmembers must verify the lockout/tagout status of the system before beginning work.
