**REPORT OF THE INVESTIGATION
INTO THE
SURE SHOT (O.N. 978662) COLLISION
WITH AN UNIDENTIFIED VESSEL, 16
NAUTICAL MILES SOUTH OF
SHINNECOCK, NY, IN THE ATLANTIC
OCEAN, WITH THE LOSS OF ONE LIFE,
ON OCTOBER 12, 2022**

16732/IIA #7577027
25 March 2025

**COLLISION OF THE RECREATIONAL VESSEL SURE SHOT (O.N. 978662) WITH
AN UNIDENTIFIED VESSEL, RESULTING IN THE LOSS OF ONE LIFE, IN THE
ATLANTIC OCEAN 16 NAUTICAL MILES SOUTH OF SHINNECOCK, NEW YORK,
ON OCTOBER 12, 2022**

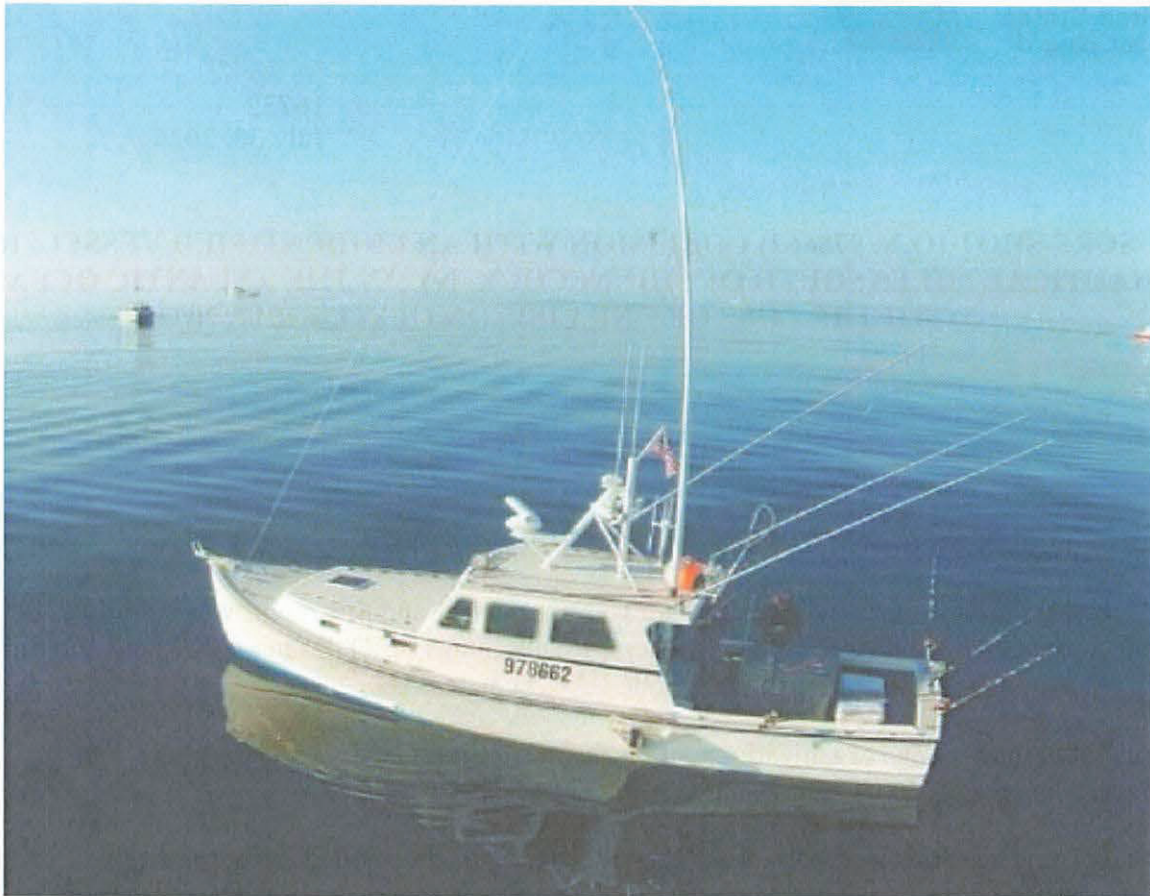
Figure 01. Photograph of SURE SHOT (O. N.978662), location unknown, posted online April 14, 2016 by Marvin Moy.

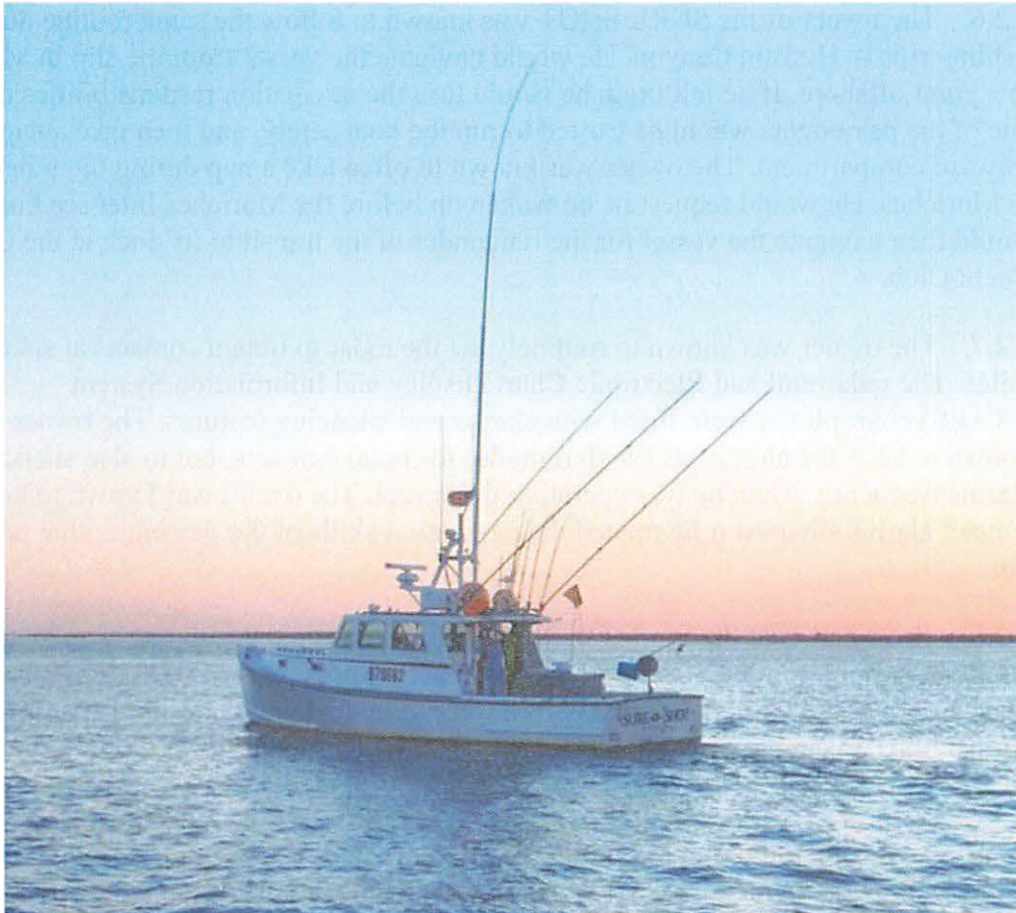
4.2.3. On April 7, 2022, the owner hired a company to change the name on the stern of the vessel from the MARILYN B (original name) to SURE SHOT (third and final name).

Figure 03. Photograph of SURE SHOT. Provided by [REDACTED] on October 21, 2022.

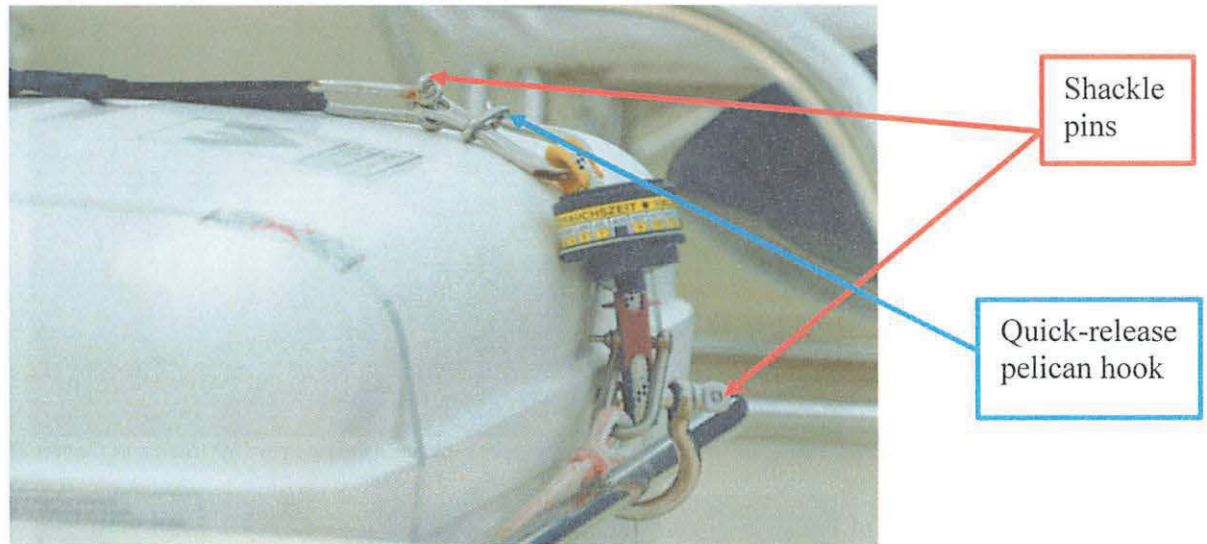
4.2.12.1. The passenger struggled to launch the life raft. The cradle and the pilot house roof were damaged in the collision. Additionally, the passenger was unfamiliar with the steps to launch a life raft. He did not know to use the quick-release pelican hook to free the life raft canister from its cradle. Instead, he

manually unscrewed the shackle pins to free the canister from the cradle. Once the shackle pins were removed, the passenger threw the canister overboard. He pulled the painter line but didn't pull enough out to activate the air cylinder and inflate the life raft.

Figure 06. Photograph of a life raft for reference (This is not the SURE SHOT's life raft)

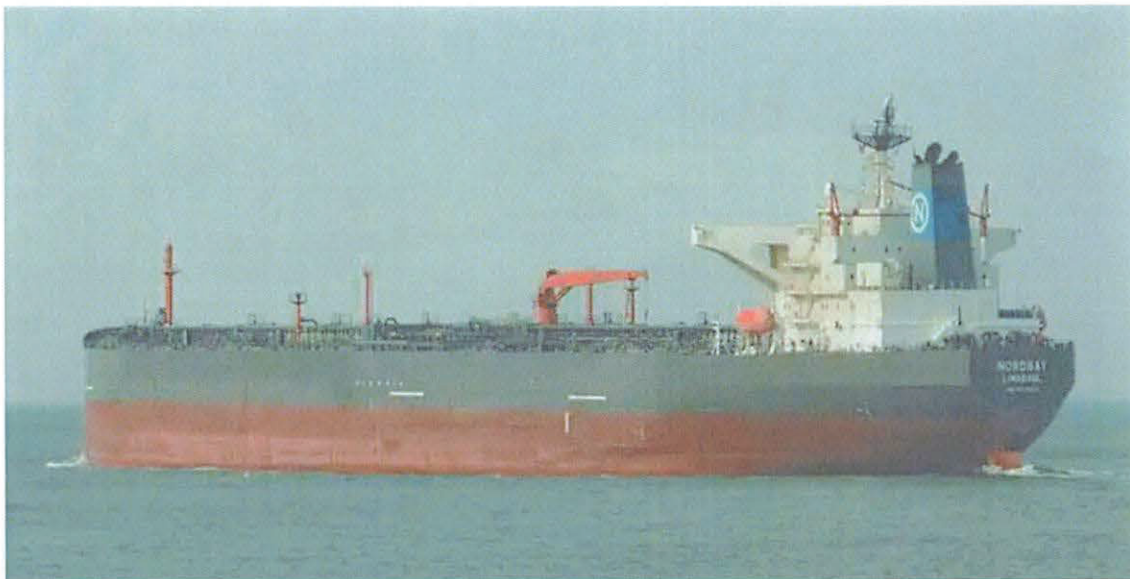
4.2.13.4. On October 10, 2022, the tank vessel NORDBAY departed Point Tupper, Canada with a scheduled arrival time of 8:00 p.m. at the Ambrose anchorage off New York. The vessel was scheduled to offload cargo at Bayway P66 Terminal in New Jersey with a scheduled departure time of 10:00 a.m. on October 18, 2022.

Figure 13: Photograph of the NORDBAY, taken from internet by [REDACTED] on October 14, 2022.

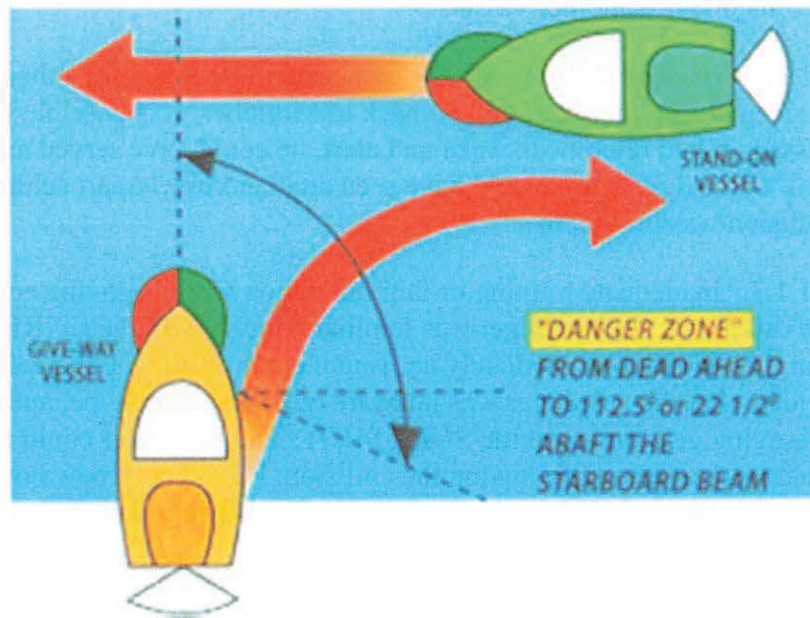
the westbound Safety Fairway established within 33 CFR 166.500. Crossing the Safety Fairway with a deep draft vessel within the Safety Fairway creating a collision course impeded the deep draft vessel's transit. The SURE SHOT would have been the give way vessel for this transit and should have altered speed, course, and/or both vessels should have made arrangements to avoid a collision via VHF radio and/or sound signals.

5.6.7. Rule 15 – Crossing Situation: When two power-driven vessels are crossing so as to involve risk of collision, the vessel which has the other on her own starboard side shall keep out of the way and shall, if the circumstances of the case admit, avoid crossing ahead of the other vessel. The SURE SHOT was on a northerly course when it approached and operated in and around the westbound safety fairway which would have made the deep draft vessel the stand on vessel and the SURE SHOT the give way vessel.

Figure 15. Diagram of Crossing Situation Rule, taken from internet by [redacted] on February 2, 2024.
