**UNINSPECTED PASSENGER VESSEL
WICKLIFFE CREWBOAT (O.N. 1221644),
CREWMEMBER LOSS OF LIFE IN THE OHIO
RIVER NEAR MILE MARKER 981 IN CAIRO, KY
ON MARCH 03, 2022**

**LOSS OF LIFE ONBOARD THE UNINSPECTED PASSENGER VESSEL
WICKLIFFE CREWBOAT (O.N. 1221644) ON THE OHIO RIVER AT
MILE MARKER 981, NEAR CAIRO, KENTUCKY ON MARCH 3, 2022**

INVESTIGATING OFFICER'S REPORT

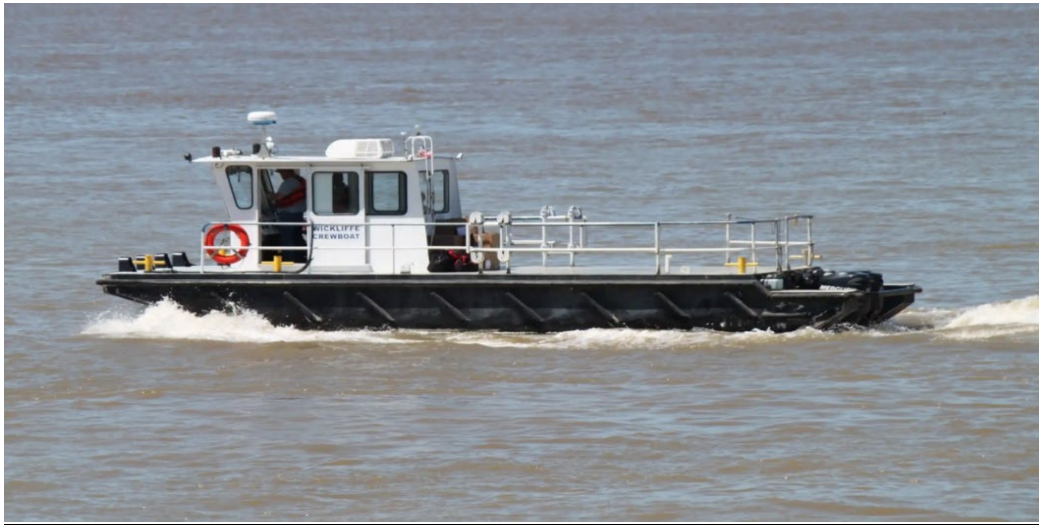
Figure 1. Photograph of WICKLIFFE CREWBOAT taken by [REDACTED] on 4/25/2014 on the Mississippi River, Wickliffe, KY, obtained from shipspotting.com.

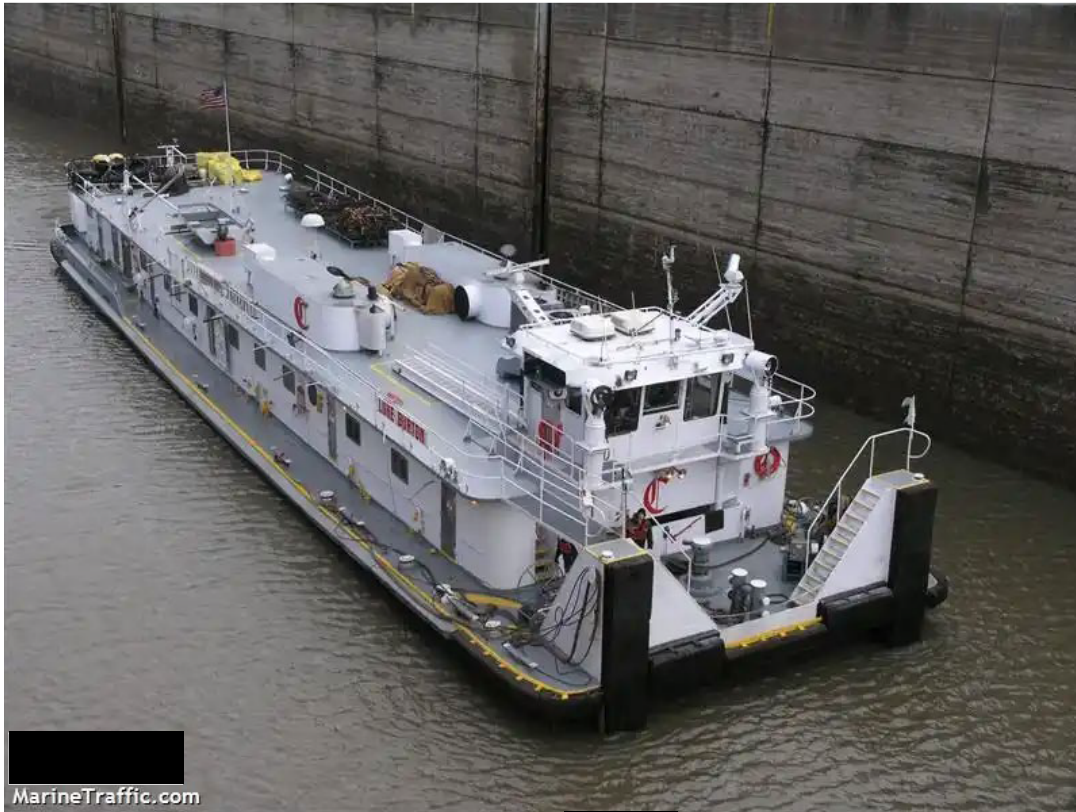
Figure 2. Photograph of the towing Vessel Luke Burton taken by [redacted] at Granite City, IL on 12/14/2009, obtained from MarineTraffic.com.
