**REPORT OF THE INVESTIGATION
INTO THE
ALLISION OF THE TANK VESSEL BOW
TRIUMPH (IMO 9669902) WITH JOINT BASE
CHARLESTON PIER BRAVO IN THE COOPER
RIVER ON SEPTEMBER 5, 2022**

**MISLE ACTIVITY NUMBER: 7568095
MISLE CASE NUMBER: 1320684**

**THE ALLISION OF THE NORWEGIAN FLAGGED TANK SHIP BOW TRIUMPH
(IMO 9669902) WITH JOINT BASE CHARLESTON PIER BRAVO IN THE
COOPER RIVER, SOUTH CAROLINA ON SEPTEMBER 5, 2022**

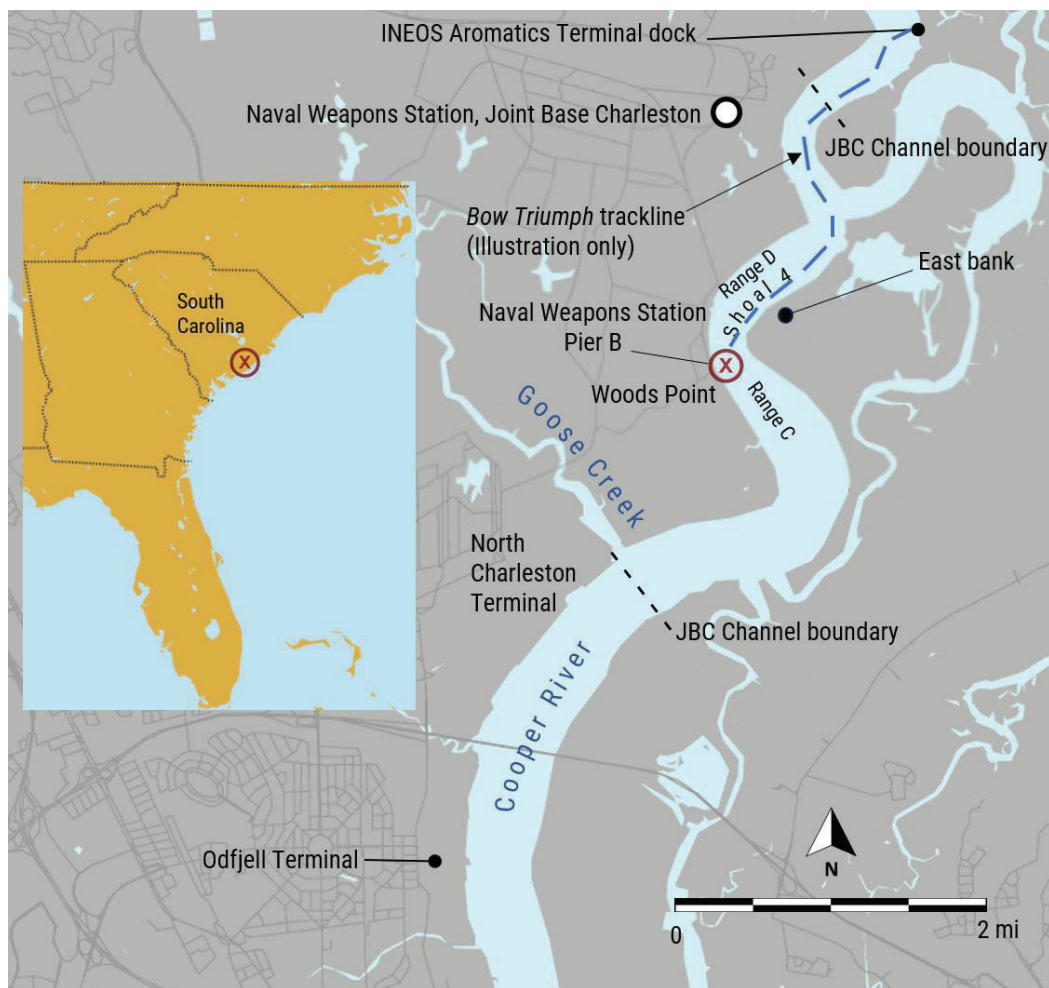
4.1.1. On 05 September 2022, the BOW TRIUMPH was scheduled to shift berths 6.7 nautical miles (NM) downriver on the Cooper River from INEOS Aromatics Terminal (formerly known as BP Cooper River Terminal), Wando, SC, to Odfjell Terminal, North Charleston, SC (see Figure 2). The ship was in a partially loaded condition, with Xylenes in three cargo tanks (No. 3 and No. 7 Starboard and No. 7 Port). All other cargo tanks had been discharged. There were 24 crew members onboard.

Figure 2 Depiction of the JBC channel within the Cooper River, BOW TRIUMPH's intended voyage, approximate trackline, and site of allision at Pier Bravo near Woods Point. Image: NTSB.

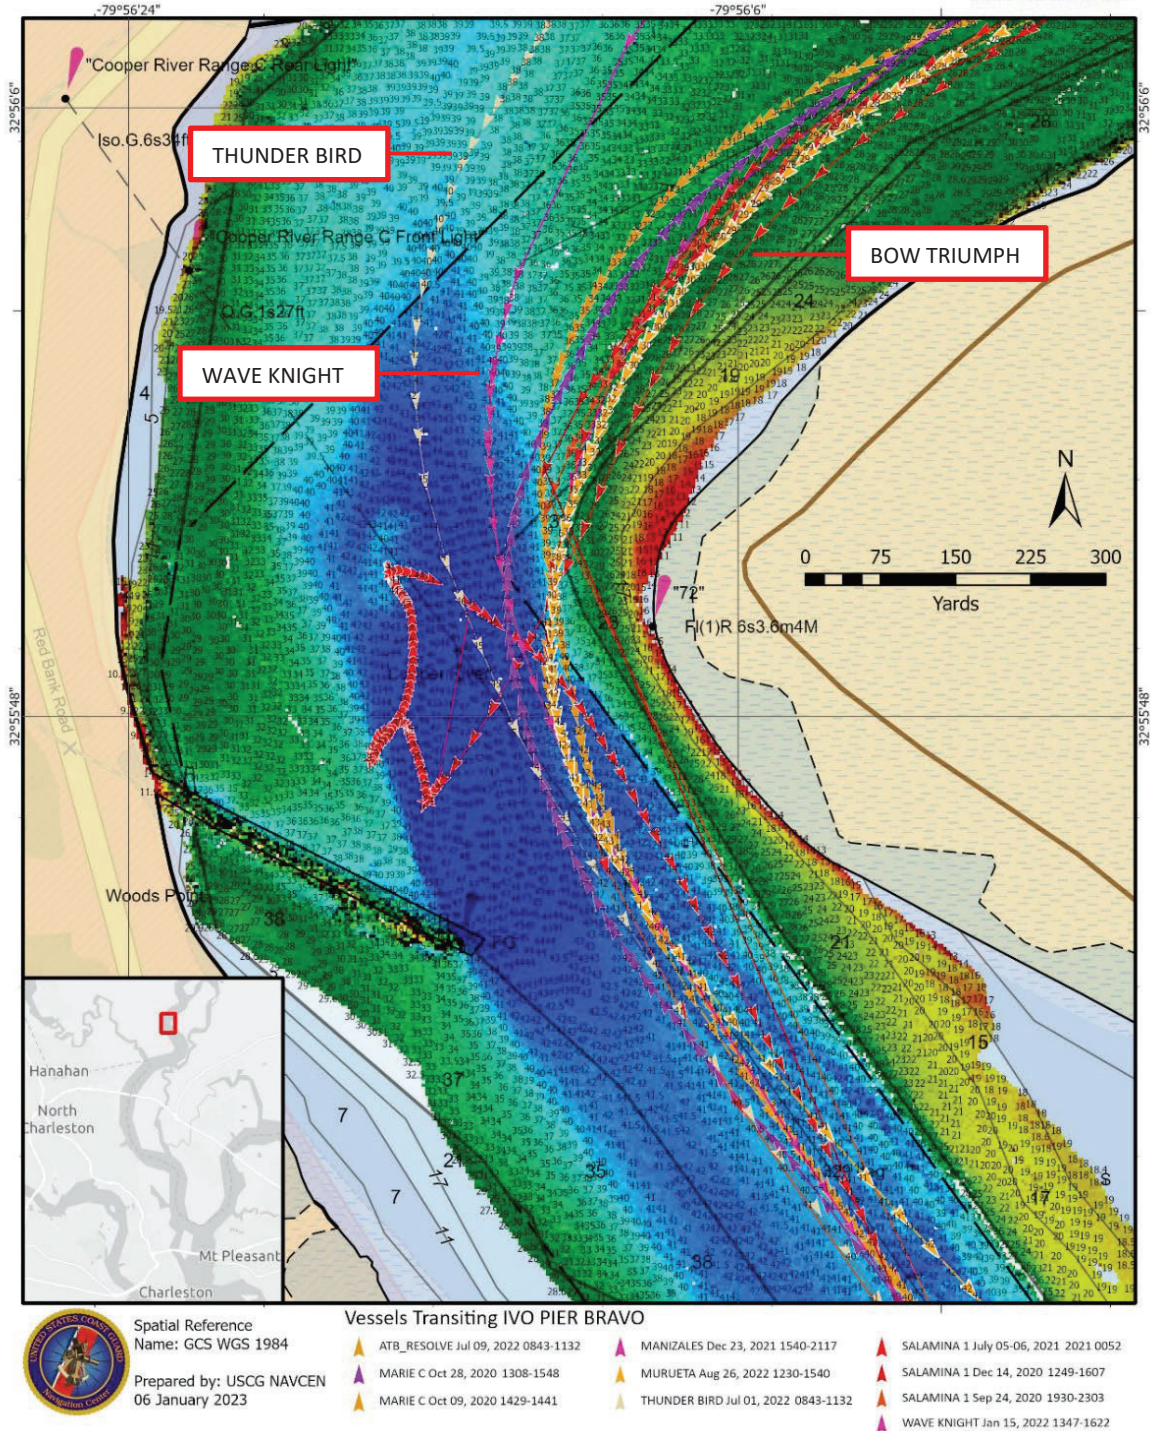
4.2.2.5. In the past two years leading up to the BOW TRIUMPH’s allision, the Harbor Pilot sailed ten other vessels of a similar size (drafts ranging from 21’10” to 29’6”) in the upper Cooper River (see Figure 8). The vessel with the greatest draft, WAVE KNIGHT (IMO 9168594), got underway from the nearby Wharf Alpha, not INEOS Aromatics Terminal; the THUNDER BIRD (IMO 9318943) sailed from Wharf Alpha as well.

Figure 8 Tracklines of 11 voyages conned by the Harbor Pilot from September 2020 to September 2022, overlaid with 06 September 2022 soundings. Image: USCG NAVCEN; Sounding Data: USACE.

5.1. *Failure to navigate in the center of the channel.* Upon reaching Range D, the Harbor Pilot sailed the BOW TRIUMPH to the left of the center of the channel and began applying port rudder early, in comparison with other pilots (Figure 9) and with his own prior voyages (Figure 8). The Harbor Pilot justified his choices through multiple points.

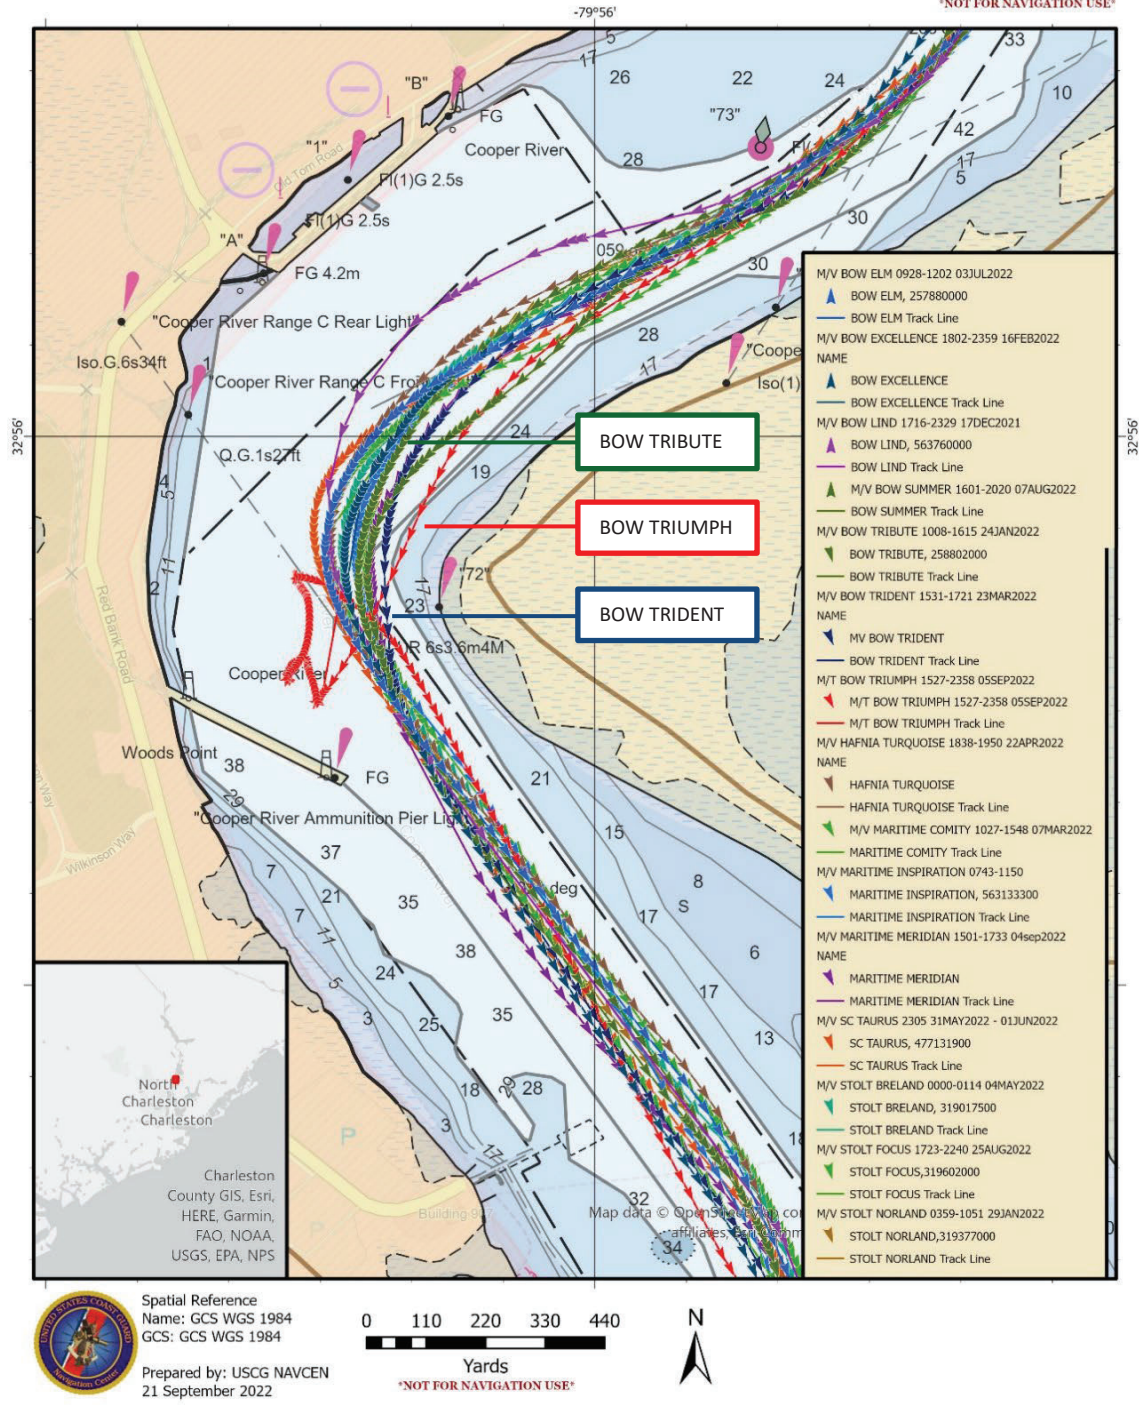
4.2.3.4. In the 12 months prior to 05 September 2022, there were 15 deep draft vessels that sailed the upper Cooper River to berth at INEOS Terminal (see Figure 9). Two of these vessels, BOW TRIDENT (IMO 9669897) and BOW TRIBUTE (IMO 9669885) were of the same class (i.e. same length, beam, and gross tonnage) as BOW TRIUMPH. On the date of the incident, BOW TRIUMPH began its port turn earlier and sailed slightly to the left of most other vessels which had sailed that year. There have been no other reported incidents amongst these vessels prior to the BOW TRIUMPH incident. However, in January 2024, while this report was being drafted, a second similar incident occurred, resulting in further damage to Pier Bravo.

Figure 9 Deep draft vessel downbound voyages between September 2021 and September 2022 in vicinity of Joint Base Charleston. Image: USCG NAVCEN.

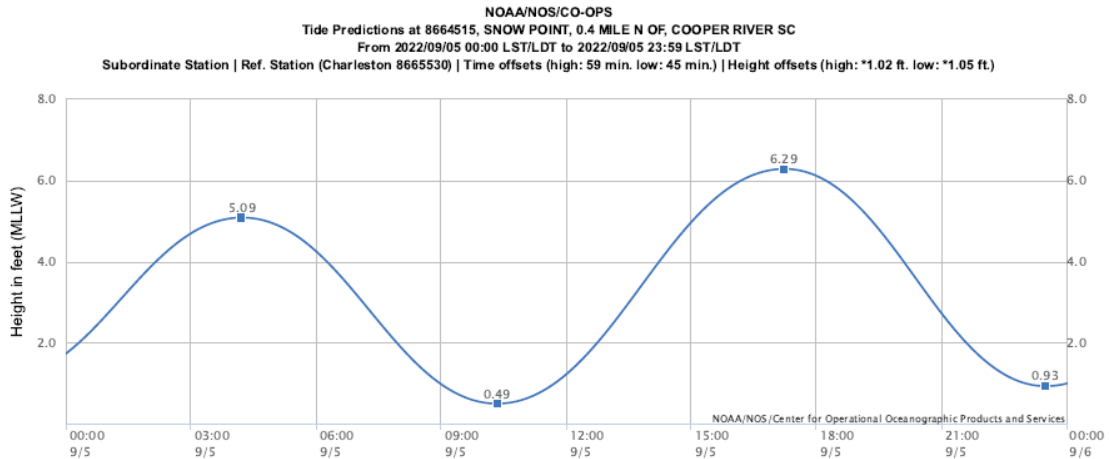
4.2.5.1. On this date, the tidal current reached a maximum flood of 0.81 kts at 1602. The height of tide was approximately 6 ft above Mean Lower Low Water (MLLW) at 1600 (see Figure 13). According to the ship’s voyage plan, the corrected water depth for WP8 was predicted to be a 32 ft minimum, which accounted for a 6 ft height of tide (HoT). The ship's dynamic draft was expected to be 29 ft with a UKC of 3 ft on Range D, the lowest expected UKC of the voyage plan. The Remarks for WP8 stated "Navigate within the fairway or channel. Monitor UKC. NO GO AREA Outside buoyed Channel," as similar to other WP remarks. The Voyage Plan also showed graphs indicating that as the ship's speed increases, squat increases and UKC decreases. The minimum UKC required by the ship’s operating company was 1.6 ft.

Figure 13 NOAA Tide Predictions for Snow Point, approx. 1700 yds upriver from the turn at Range C, showing high tide at 1714 of 6.29 ft above MLLW and the tide at 1600 to be approximately 6 ft above MLLW. Image: NOAA.
