**REPORT OF THE INVESTIGATION
INTO THE
FIRE ON BOARD THE NORWEGIAN
FLAGGED RO-RO CARGO SHIP
HOEGH XIAMEN (O.N. 9431848) WHILE
MOORED AT BLOUNT ISLAND
IN JACKSONVILLE, FLORIDA ON JUNE 4,
2020**

16732/IIA #6968687
January 21, 2025

**FIRE ON BOARD THE NORWEGIAN FLAGGED RO-RO CARGO SHIP
HOEGH XIAMEN (O.N. 9431848) WHILE MOORED AT BLOUNT ISLAND
IN JACKSONVILLE, FLORIDA ON JUNE 4, 2020**

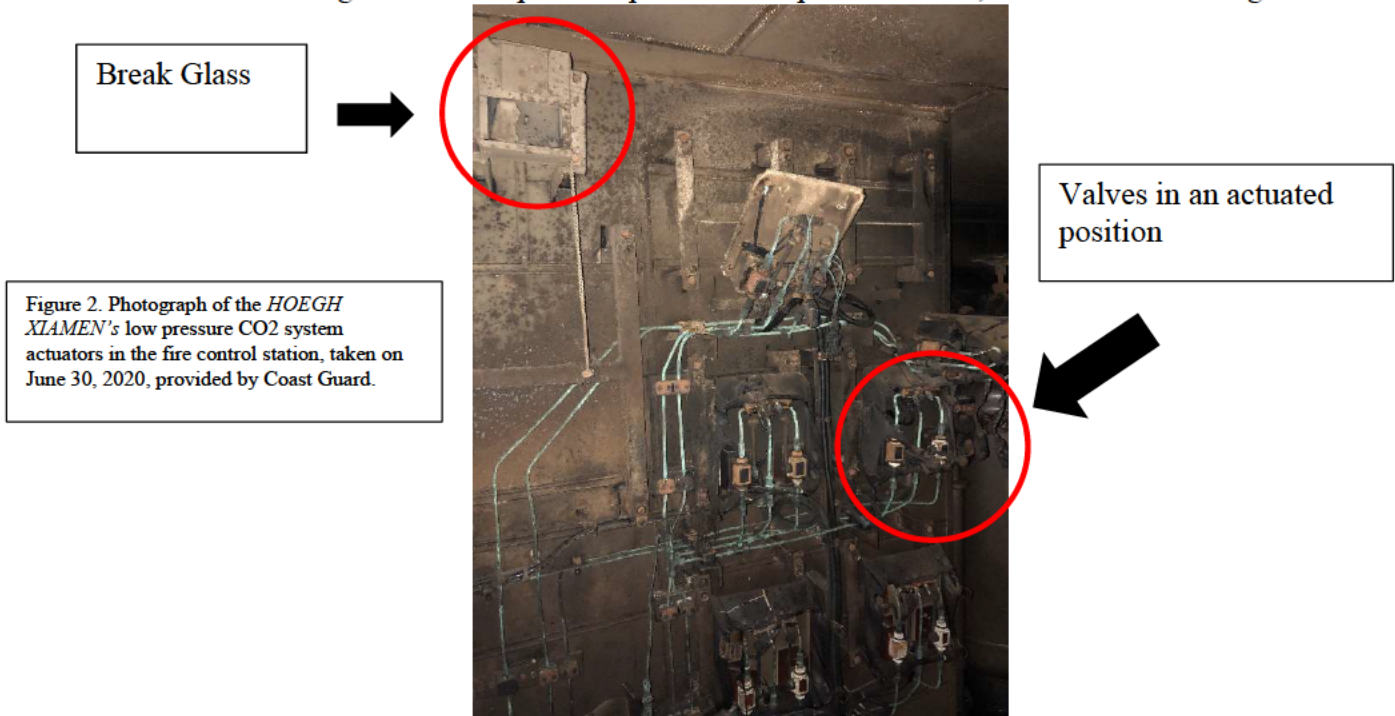
4.1.11. The Chief Engineer, Chief Officer, and Master then proceeded to the fire station on the weather deck and claimed to have successfully discharged the CO2 system to deck space 7 and 8. Due to the fire burning in excess of a week and low pressure CO2 holding tanks venting to the atmosphere to prevent over pressurization, Coast Guard investigators

were unable to determine if the fixed CO2 system was successfully discharged as described by the crew. Additionally, during the response by Jacksonville Fire Rescue Department (JFRD), the vents leading to decks 7 and 8 were reopened, which would have provided an additional ventilation route for any CO2 that may have been discharged.
